**Flat 1/2 47 Keir Street, Glasgow G41 2LA**

We propose replacing the existing sash and case windows with newly manufactured hardwood timber sash and case windows that will be manufactured in a like for like formation. Horn detail would be lifted from the existing windows to preserve the established style.

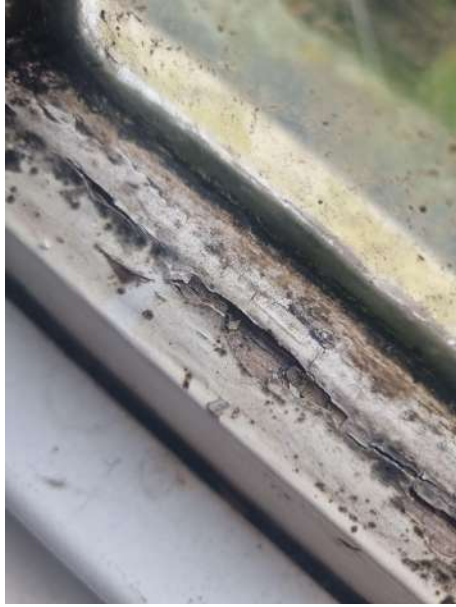
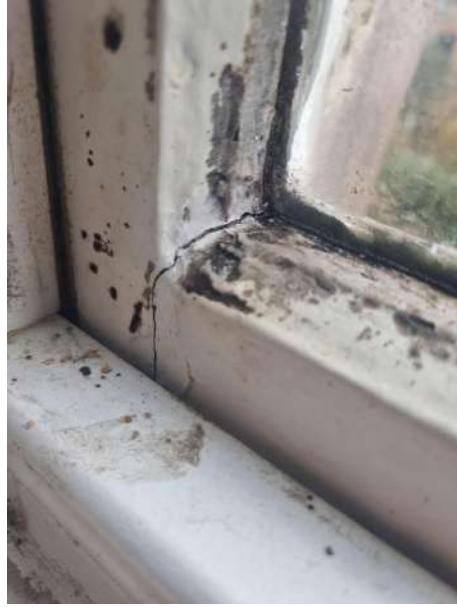
Internal woodwork is deteriorating and soft to touch. The second photo is of the tenon joint which is splitting.

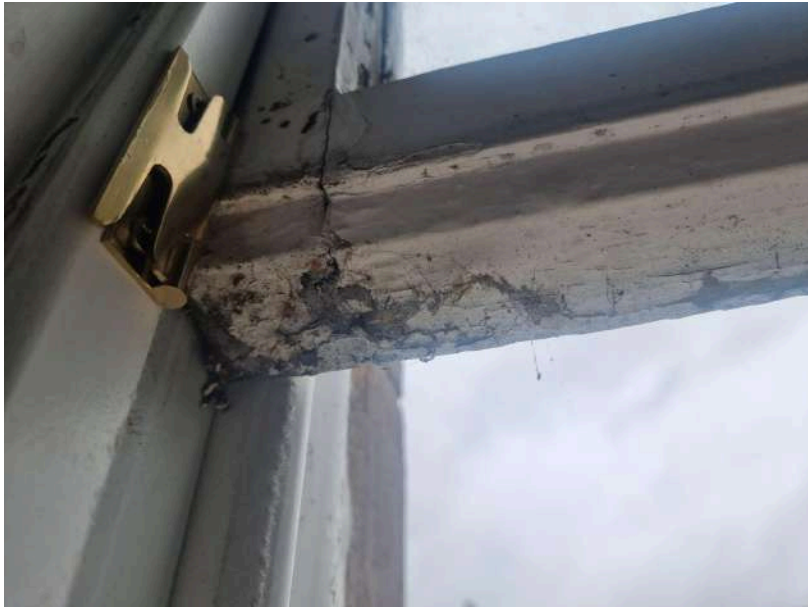
Failing tenon joint.

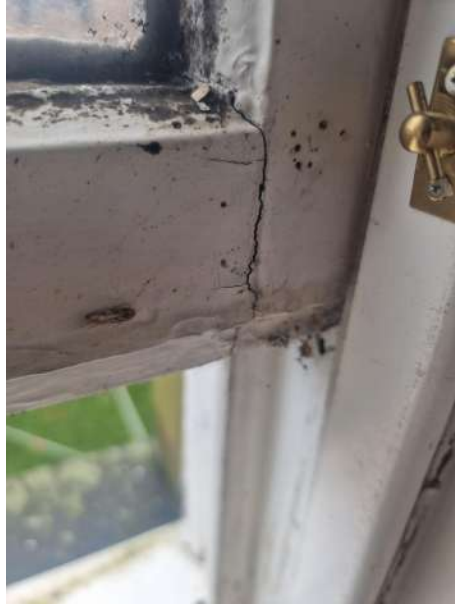
Splitting tenon joint.

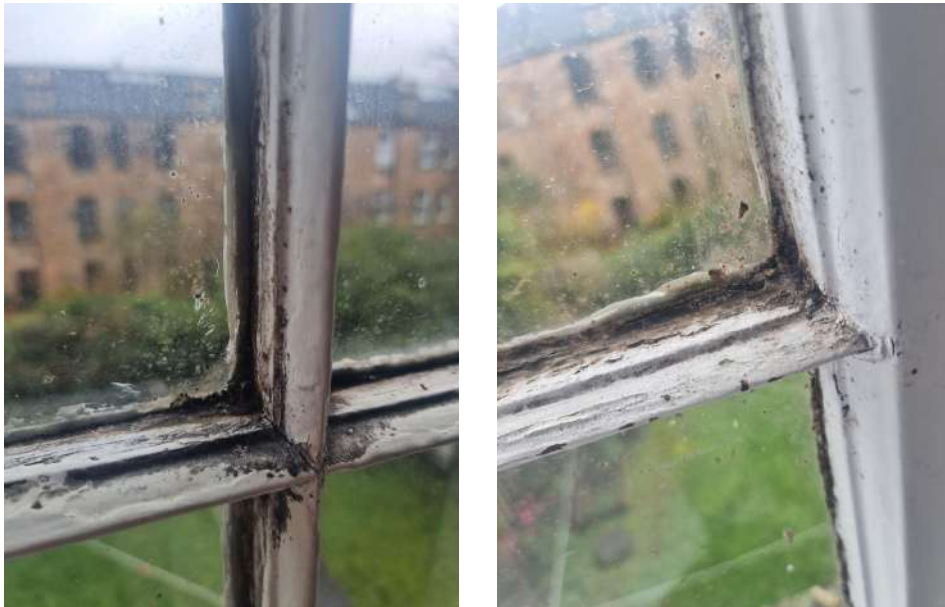
Rotting astragals

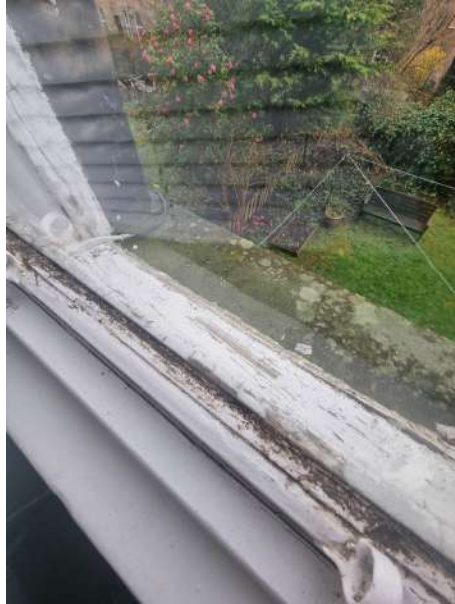
Photo shows the seals to the glass have failed which is allowing water to enter the woodwork and making the windows not efficient. The photo also shows the rotting sill externally.

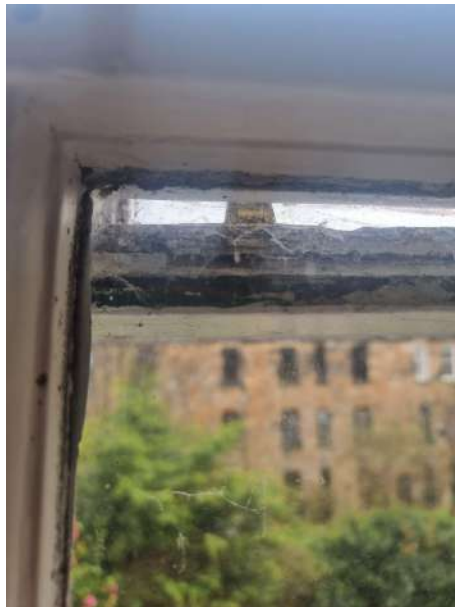
Rotting mid-rail.

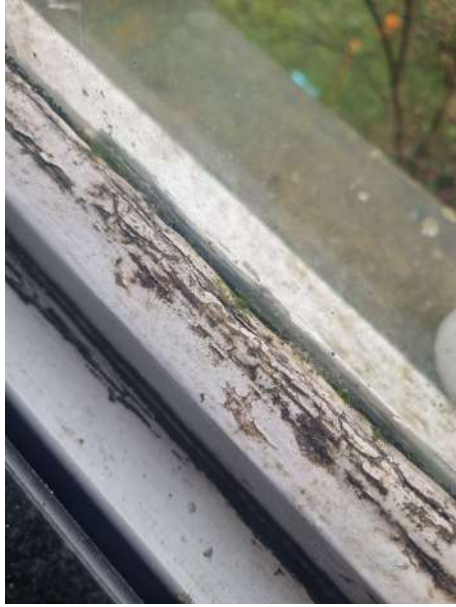
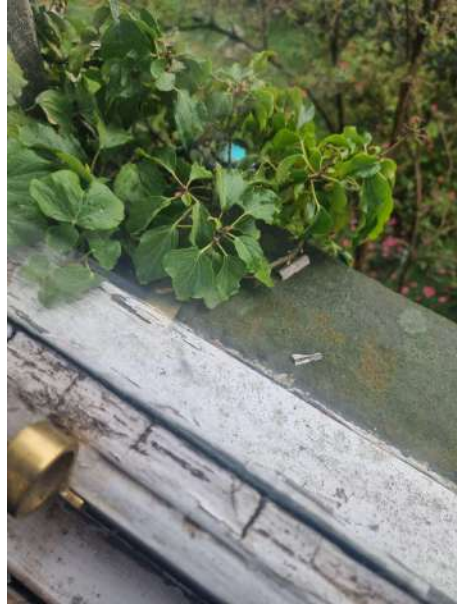
Seals and putty are failing to the windows.

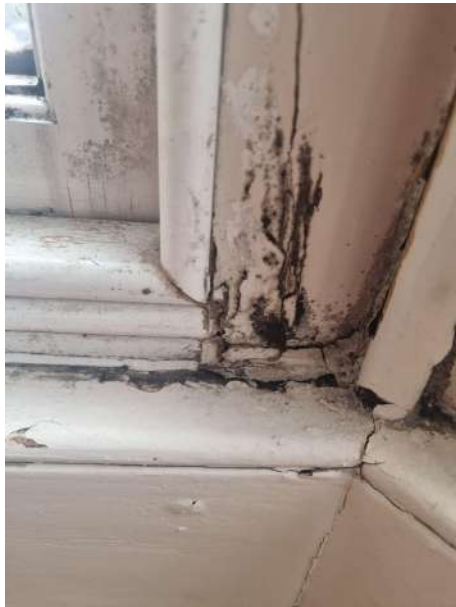
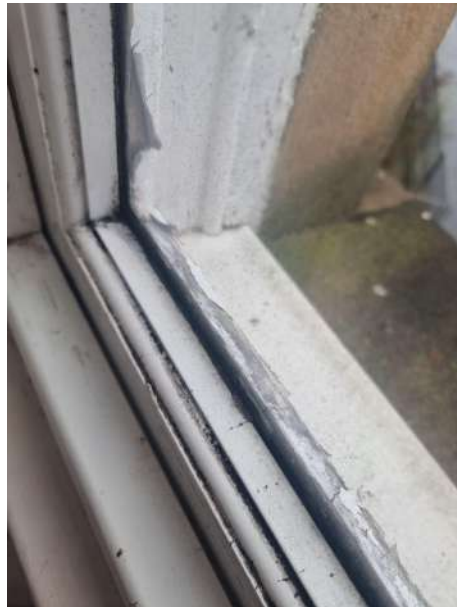
Rotting casement and external putty

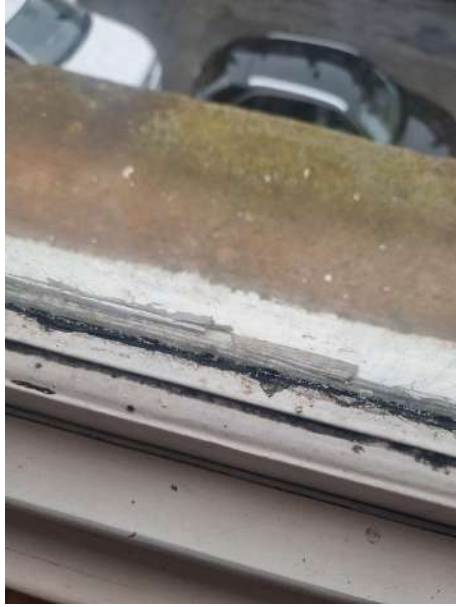
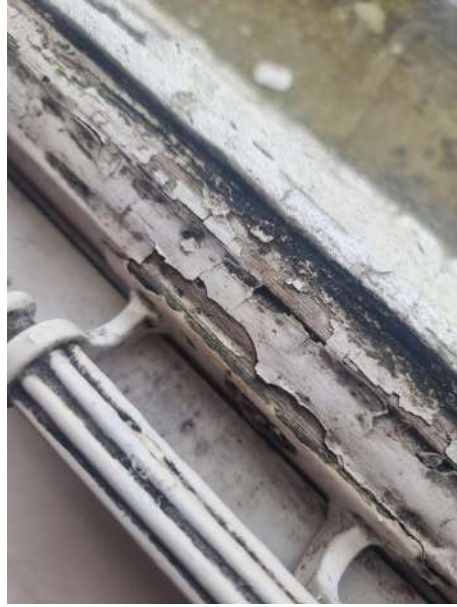
Failing external putty and deteriorated seals

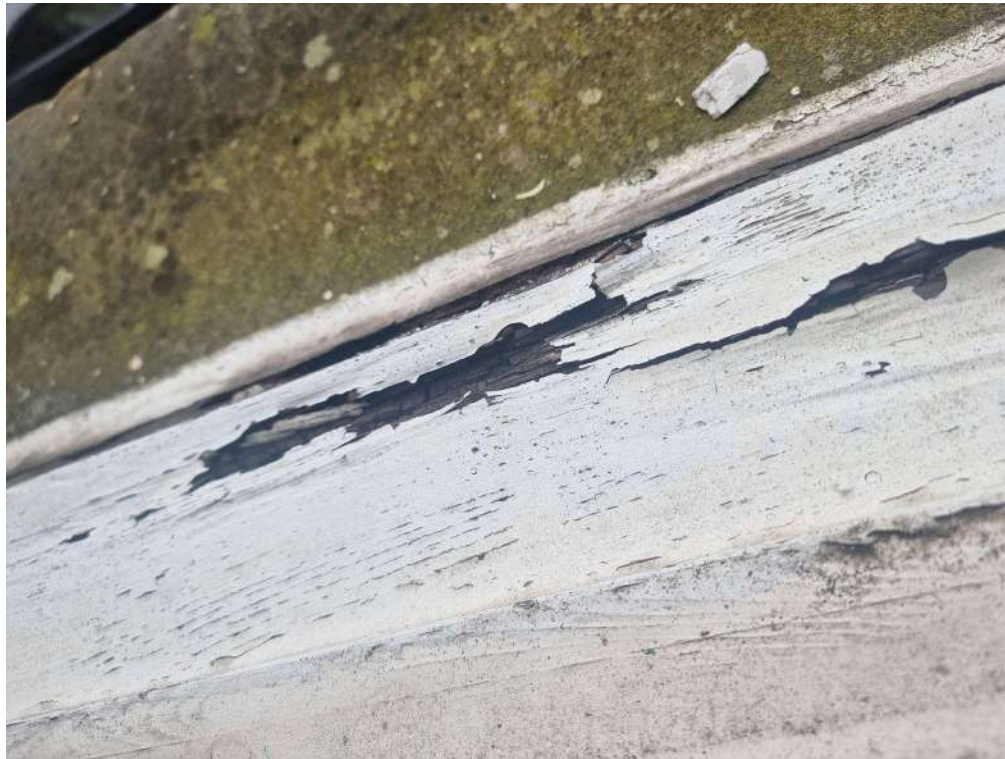
Rotten sill

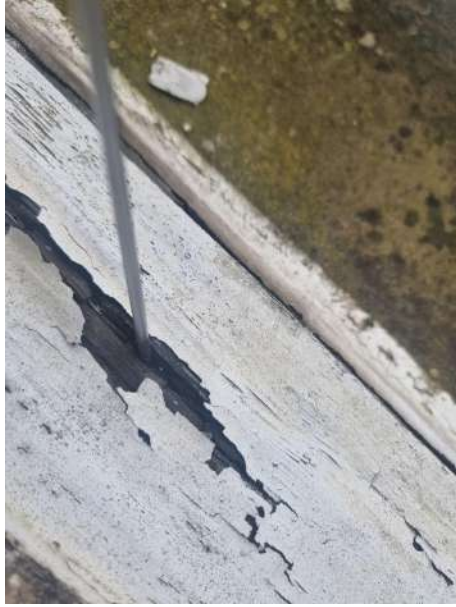
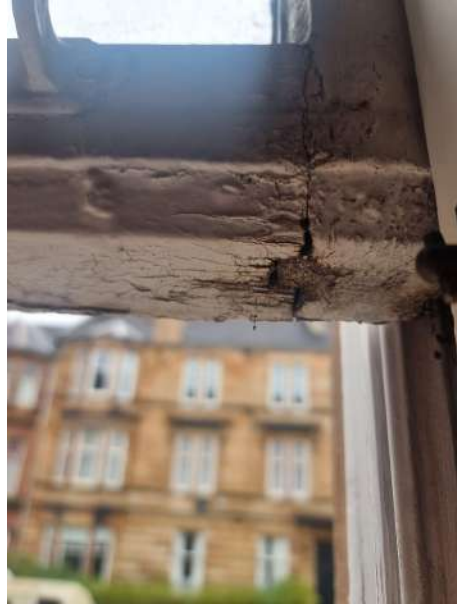
Rotten sill and failing tenon joint.

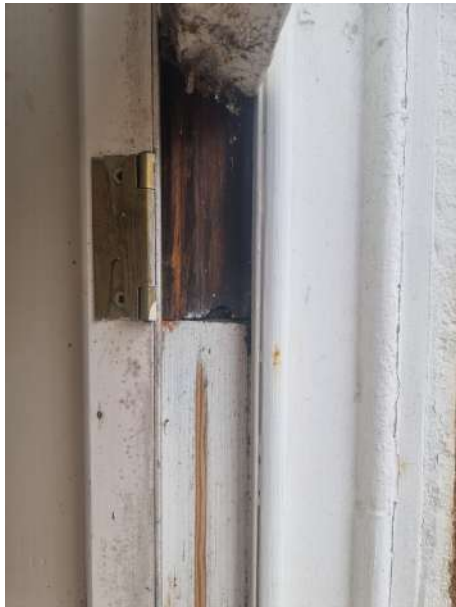
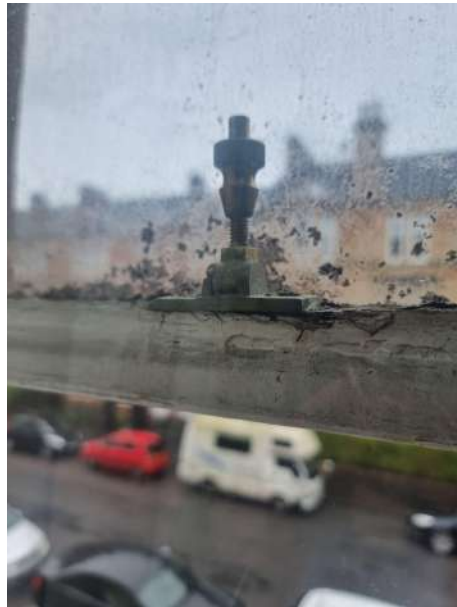
Rotting casement woodwork and midrail

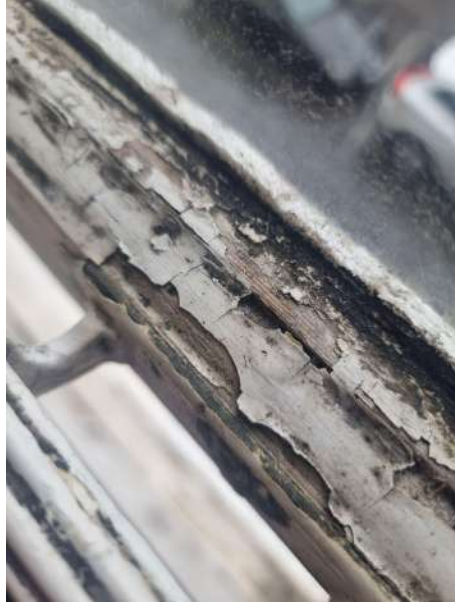
Deteriorated woodwork to the bottom rail.
