# Arboricultural Consultancy for Lloyds Bank

Insured	Mrs Pauline Wright	Address	37 West End, March Amby Cottage, Cambridgeshire, PE15 8DN		
Client	Subsidence Management Services	Contact	Nigel Buxton	Claim No.	IFS-LBG-SUB-22-0104134
ES Ref	SA-252510	Consultant	Kirk Thompson	Contact No.	0330 380 1036
Report Date	16/03/2023

# GEOTECHNICAL

# SOIL ANALYSIS

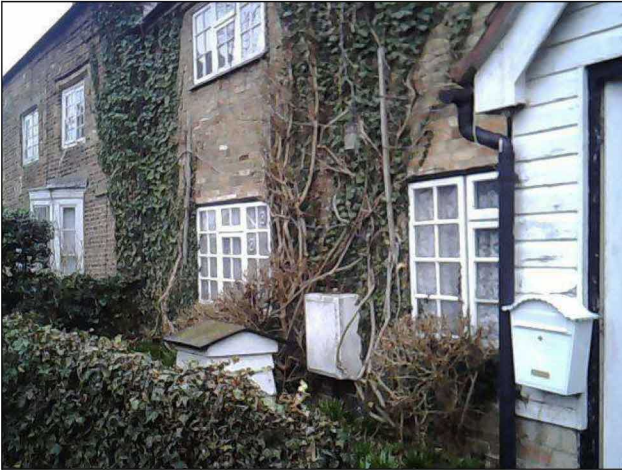
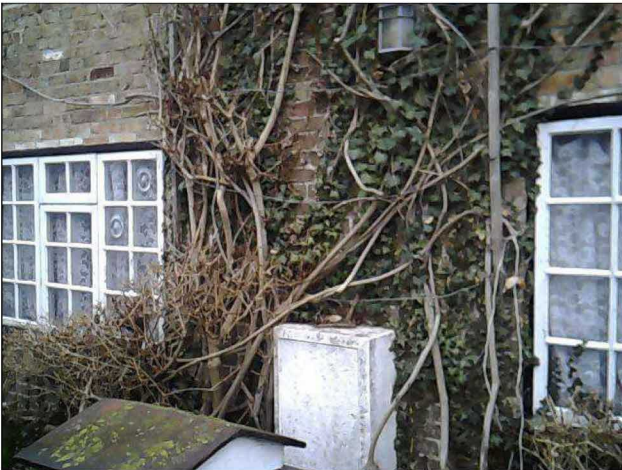
With due regards to species profile, size and proximity, C1 (Mixed species climbers) and T2 (Ash) are considered the dominant features proximate to the focal area of movement and accordingly, where vegetation is confirmed as being causal, we have identified them as the primary cause of the current subsidence damage.

C1 - Mixed species climbers

Consequently, we have advocated the complete removal of C1 (Mixed species climbers) and T2 (Ash) and as it will offer the most certain arboricultural solution likely to restore long-term stability.

Tree No.	Species	Age Cat	Approx. Height (m)	Distance to Building (m) *	Ownership	Action	Requirement
C1	Mixed species climbers: includes Wisteria, Forsythia and Ivy.	1	4.2	0.1	C - Insured	Remove	Remove close to ground level and treat stumps to inhibit regrowth.
T2	Ash	1	16	7.2	E - Boundary Veg (ownership to be confirmed)	Remove	Remove close to ground level and treat stump to inhibit regrowth.

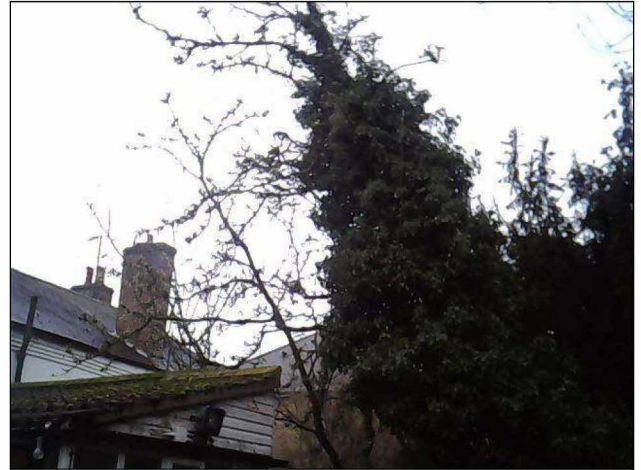
T7 - Laburnum

Leguminosae spp. include laburnum, Robinia (false acacia or locust), broom, the pagoda tree and the climber wisteria.

T7	Laburnum	1	10	4	A - Third Party	Action to avoid future risk	Crown reduce overall canopy by 30% (minimum) to achieve a crown volume reduction in line with BRE IP7/06. Maintain at reduced dimensions by re-pruning back to points of previous reduction on a 3 year (max) cycle.

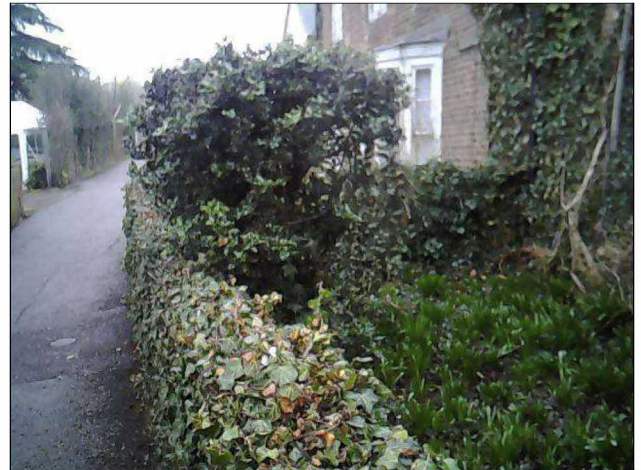
T1 - Holly

Tree No.	Species	Age Cat	Approx. Height (m)	Distance to Building (m) *	Ownership	Action	Requirement
S1	Euonymus	1	3.2	5.5	C - Insured	Action to avoid future risk	Maintain at broadly current dimensions by way of regular pruning.
T1	Holly	1	2	2.7	C - Insured	Action to avoid future risk	Maintain at broadly current dimensions by way of regular pruning.
T3	Walnut	1	12	11.5	C - Insured	Action to avoid future risk	Do not allow to exceed current dimensions by way of regular pruning.
T4	Hawthorn	1	5	7.4	C - Insured	Action to avoid future risk	Maintain at broadly current dimensions by way of regular pruning.
T5	Ash	1	25	14.5	A - Third Party	Action to avoid future risk	Crown reduce overall canopy by 30% (minimum) to achieve a crown volume reduction in line with BRE IP7/06. Maintain at reduced dimensions by re-pruning back to points of previous reduction on a 3 year (max) cycle.
T6	Yew	1	7	6	A - Third Party	Action to avoid future risk	Maintain at broadly current dimensions by way of regular pruning.

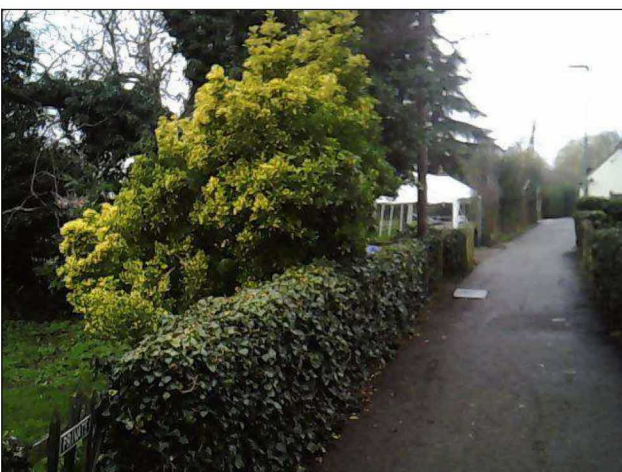
S1 - Euonymus

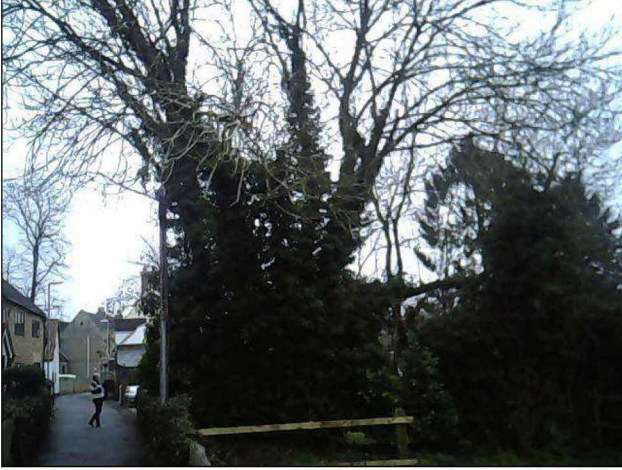
T2 - Ash

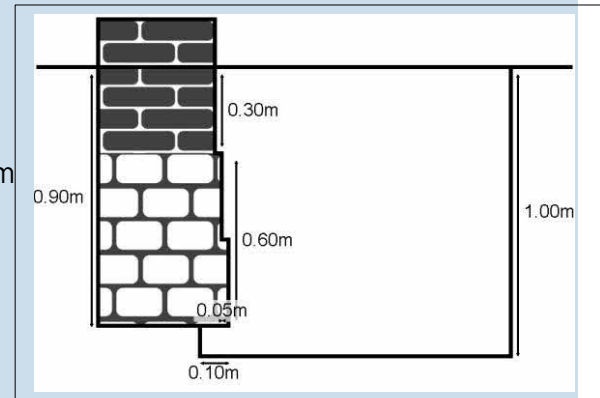
TP/BH1 Foundation Detail and Borehole Log

House foundation comprised of brick wall to 300mm bgl, bearing on stepped stone to 900mm bgl with a total projection of 50mm from the elevation. Underside of foundation (USF) was exposed to 100mm back from the face of the foundation and probed 300mm back from the face of the foundation.

At 0.90m to 1.90m bgl numerous roots of live appearance encountered and sampled in TP/BH1.
