LBE Services Chartered Surveyors

## Condition Survey Report

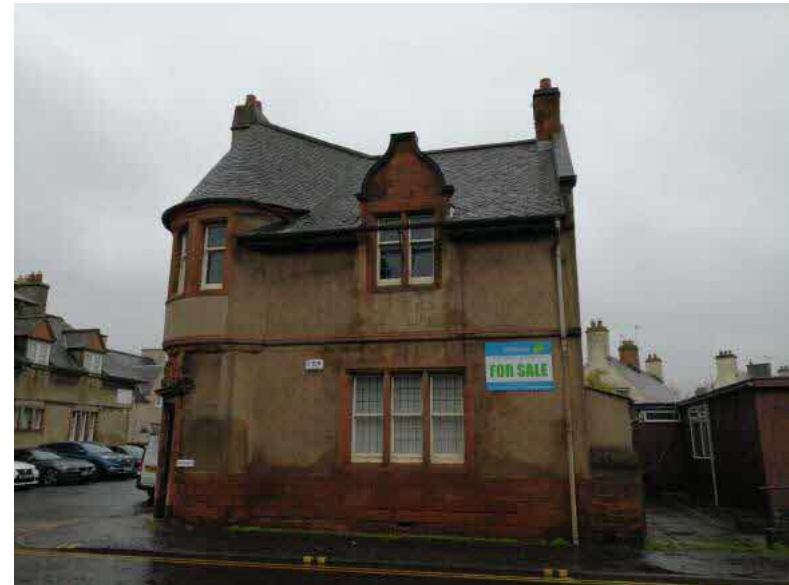
LBE Services were instructed by the client to undertake a detailed inspection of the building fabric on the subjects, which comprise a category B listed former government building situated within the Midlothian town of Bonnyrigg. The inspection included a review of the roofs, chimneys, rainwater-goods, elevation masonry, render, external windows & doors, internal fabric and external areas.

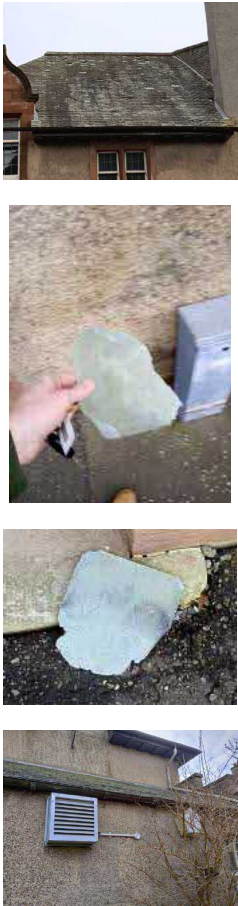
7. Detailed Condition Report								
No	Element	Photo	Description	Condition	Recommendation	Qty & Rate	Cost	Priority
1.	Ext - Pitched Roof – Covering's

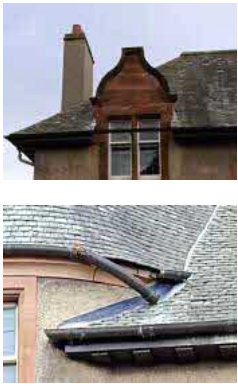
The majority of the roof abutments comprise lead water-gates & cover flashings with a coping detail to the ridge.	The lead-work appeared fair from ground level inspection, although further defects may come to light upon close inspection (IE –worn thin sections, cracked sections, etc); an 'Acropyl' type coating was noted to the RHS of the turret potentially indicating historic issues.	Undertake further close up inspection from scaffolding and allow for any necessary repairs during overhaul of slated pitches. Provisional sum allowed for repairs in meantime.	Provisional sum

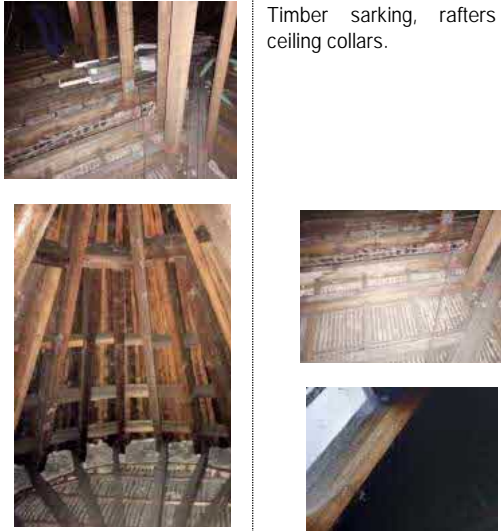
3.	Ext - Pitched Roof – Structure

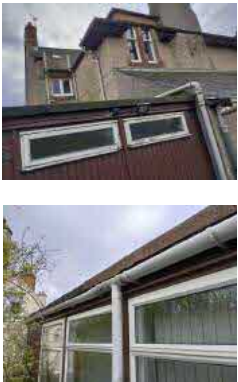
Built up felt bituminous flat roofs with solar reflective chips to NE extension.	Poor –flat roof coverings at end of life-span and beyond economical repair. Covering solar degraded and numerous patch repairs evident. Evidence of leaks internally; particularly to storage @ SE corner.	Remove and replace with new built up bituminous felt roof covering.  Note that it may be considered more economical to demolish the extension in entirety given its poor condition, poor architectural value & lack of insulation.	Flat roofs 130m2 [REDACTED]  Upgrade insulation 130m2 x [REDACTED]	[REDACTED]	[REDACTED]

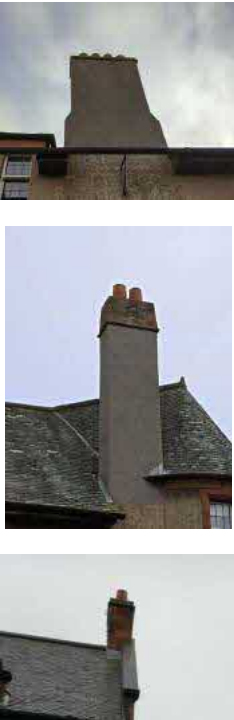
No	Elemen	Photo	Description	Condition	Recommendation	Qty & Rate	Cost	Priority
7.	Ext - Chimneys

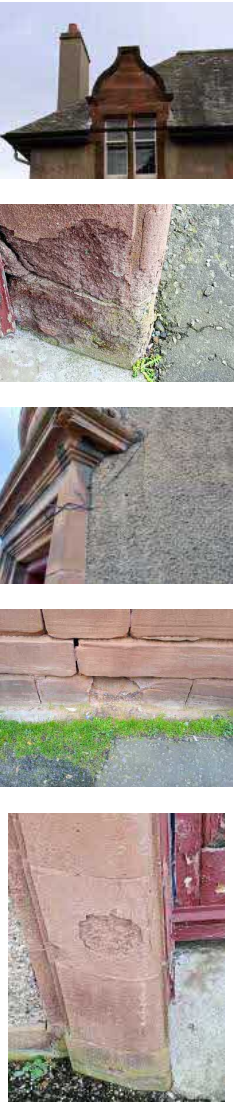
No	Elemen	Photo	Description	Condition	Recommendation	Qty & Rate	Cost	Priority
9.	Ext - Elevations - Stonework

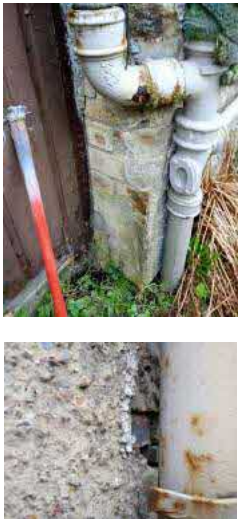
No	Elemen	Photo	Description	Condition	Recommendation	Qty & Rate	Cost	Priority
10.	Ext - Elevations - Brickwork

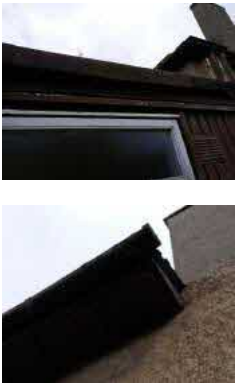
Projecting timber soffits & fascia's to original building and timber fascias to flat roofed extension.	The timber soffits & fascias are suffering from a lack of recent decoration with signs of blistering paintwork and rot; particularly at corners & abutments. The fascias to the flat roofed extension appeared rotten.	Allow provisional sum for rot repairs to original building (closer inspection required) and replace fascias to extension.	P Sum for rot repairs to original building  Decorations to soffits & fascia's original building  Soffits - 30m x [redacted]  Fascias £30m x [redacted]  Extension – Replacement fascia's  55m x [redacted]	[redacted]	[redacted]

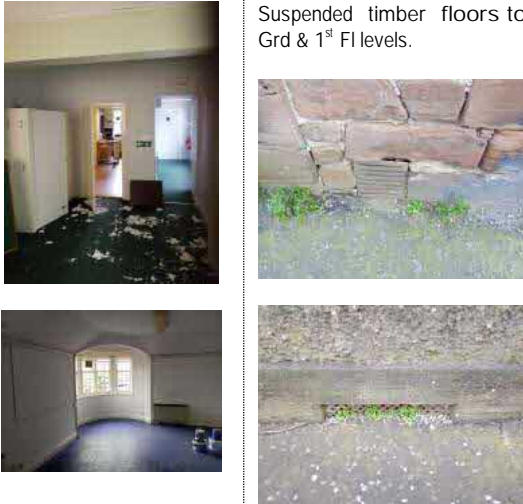
16.	Int –Solum & Suspended Floors

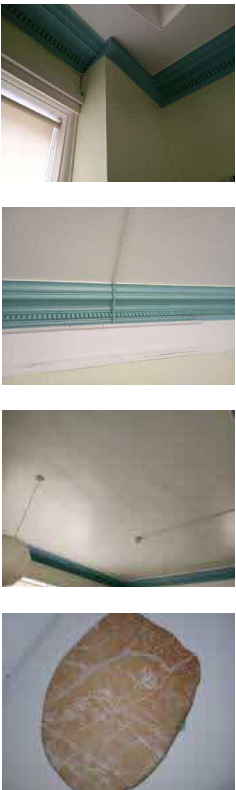
<p>The internal ceilings comprise lath &amp; plaster mounted to under-side of timber suspended floors and roof trusses.</p>

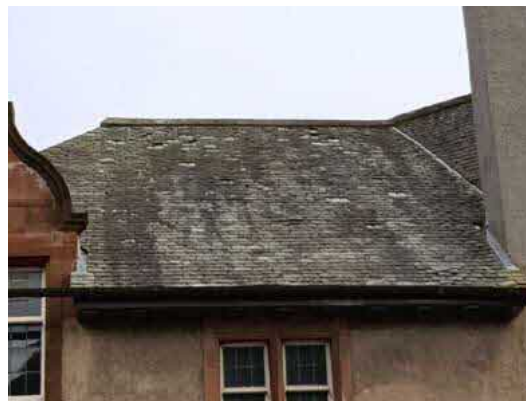
8. Defective slates to Douglas Crescent

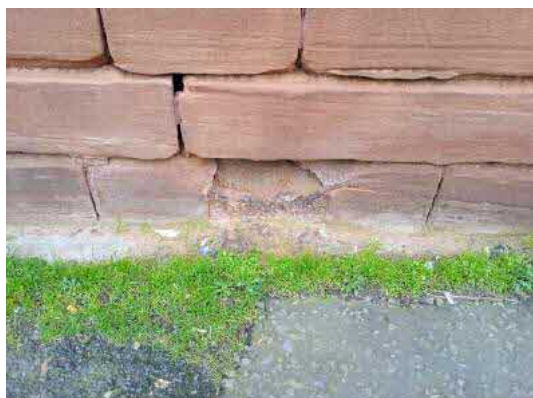
13. Salt damaged stone plinth

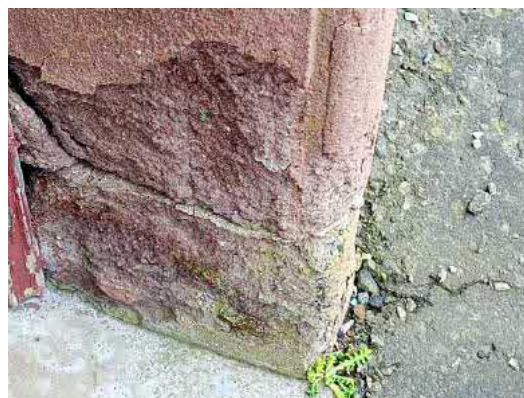
14. Salt damaged door jamb

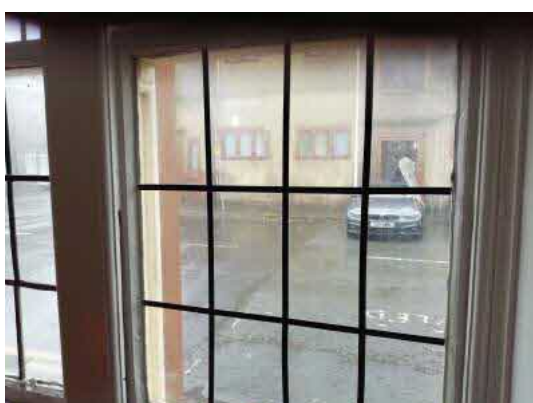
15. Plain glass overlay with insulating tape

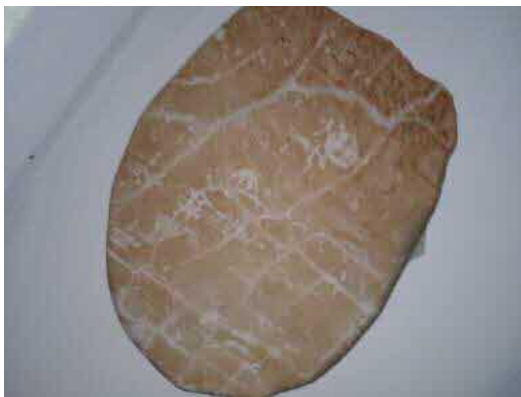
21. Failed plaster ceiling –GFL front room

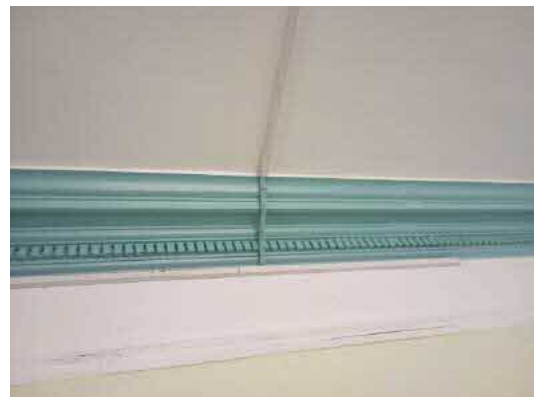
22. Surface mounted cabling over cornice

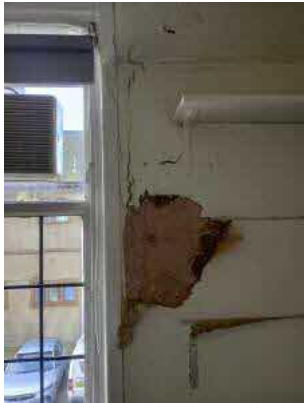
25. Dry rot to lath to side of 1<sup>st</sup> fl window

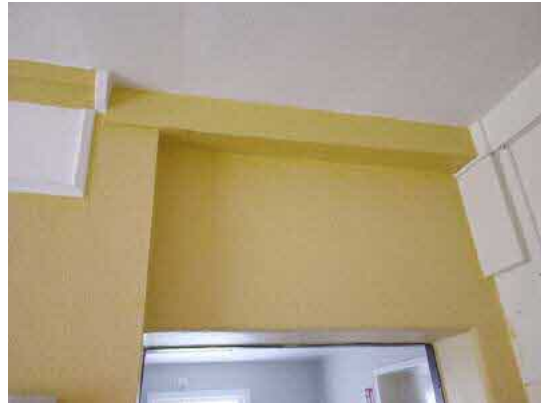
26. Evidence of previous structural slapping

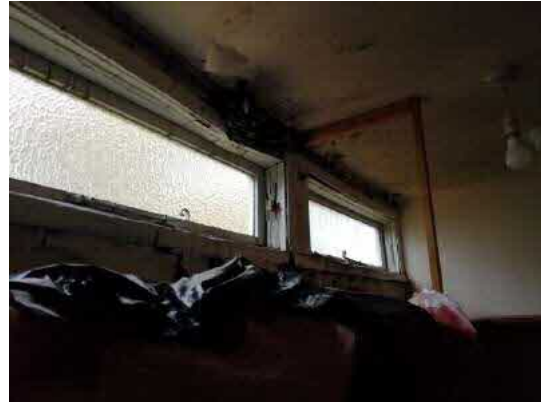
28. Evidence of moisture ingress & rot to NE extension store ceiling

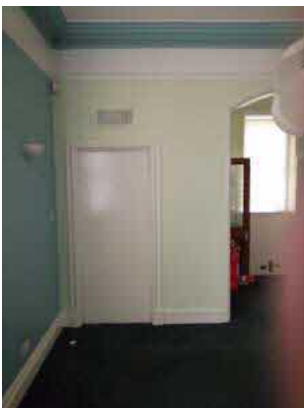
29. Previous blocked up opening to GFL
