East Devon
Tree Care

ARBORICULTURAL SITE APPRAISAL

Site Address	Penshurst High Street Newton Poppleford EX10 0DW
Client	Structure Haus
Prepared By	Matthew Shute - FdSc Arboriculture, M.Arbor.A East Devon Tree Care Ltd Blackhill House Woodbury Exeter EX5 1HE [REDACTED]
Report Reference	STRU-240318.0 - Arboricultural Report and Impacts Assessment at Penshurst
Version No	1
Date Issued	20.03.24

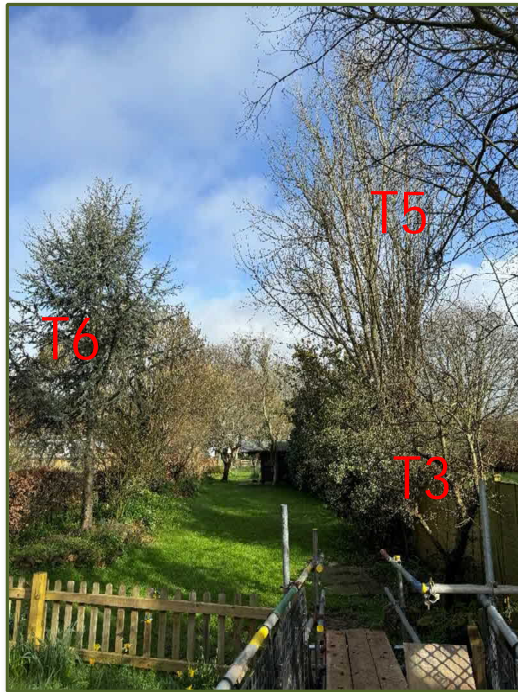
Figure 2: Overview of trees T3, T5 & T6.

5.5.4 T5 is a semi mature Ash. This tree has been historically topped at 3m affecting its form. The tree is now moderately affected by Ash Dieback affecting its assumed life expectancy.

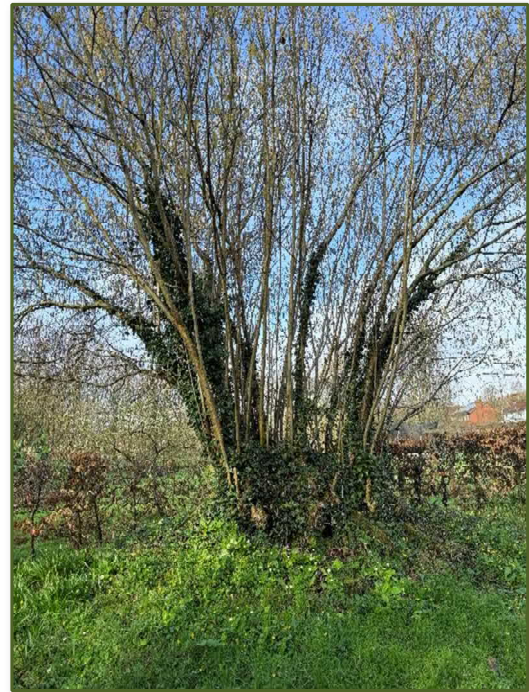
5.4.2 T6 is a young Blue Atlas Cedar with the potential to become a significant tree. T7 is a coppiced Hazel located on the western boundary of the garden. Both trees are located within the garden of Penshurst and both have the potential to make significant contributions to the site in the medium to long term.

Figure 3: Overview of T7.

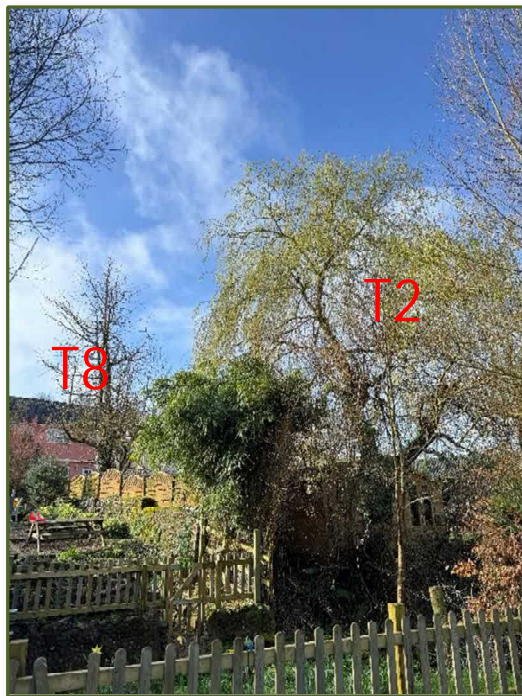
5.4.3 T2 is mature Willow, located off site in the garden to the west. This is a large and attractive tree visible from the rear gardens of the surrounding properties.

Figure 4: Overview of T2 & T8.

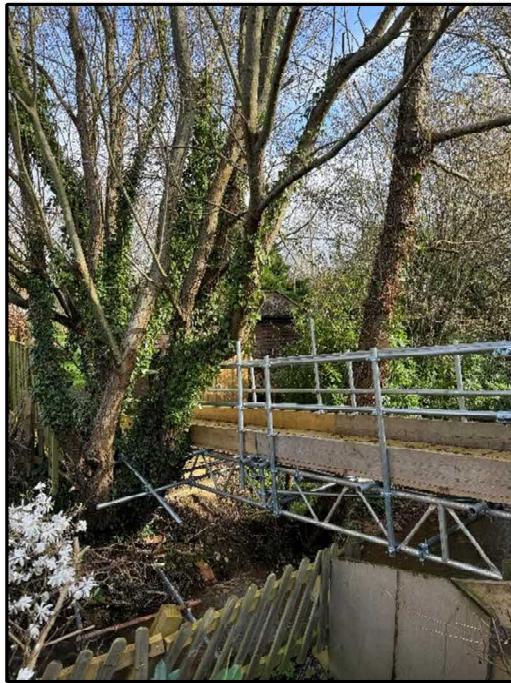
5.5.2 Directly beside the temporary bridge on the northern bank of the stream and within the neighbouring garden to the east are a multi stemmed Goat Willow (T1) and a semi mature Alder (T4). The Goat Willow comprises of six stems and is in moderate physiological condition typical for the species. The Alder has been suppressed by the Willow and as a result has developed a lean and canopy bias to the south. Due to the poor form of the Alder and the short-lived nature of Goat Willow stems, both trees have been classified as category C trees.

Figure 5: Overview of T1 with T4 to right.

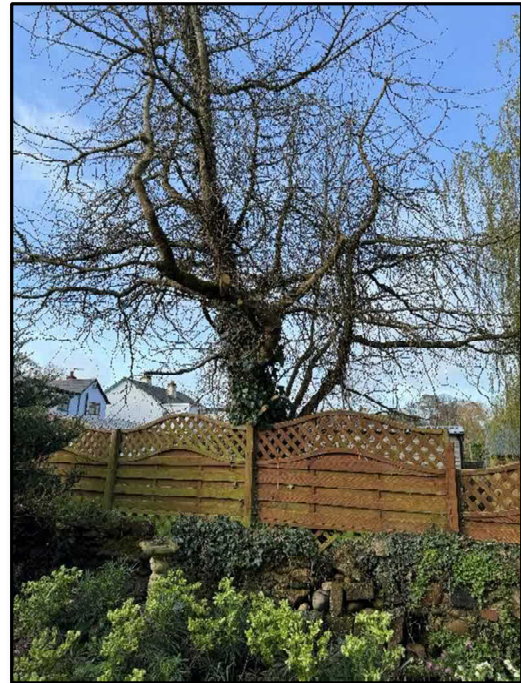
Figure 6: Overview of T8.

5.5.5 T8 is a Ginkgo Biloba in the courtyard garden west of Penshurst. Although this is still a semi mature tree, it has been planted very close to the boundary wall which is beginning to be affected by incremental growth of the tree. Due to the tree's impact on the wall, it is not likely to be retained as a long-term feature within the neighbouring garden.

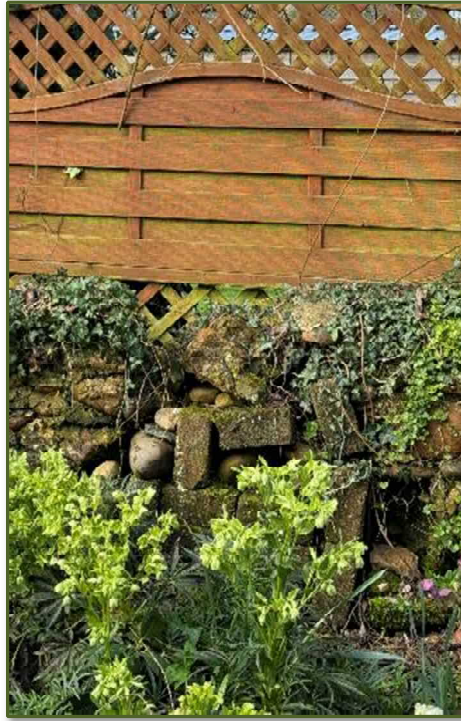
Figure 7: Damage to wall beside T8.

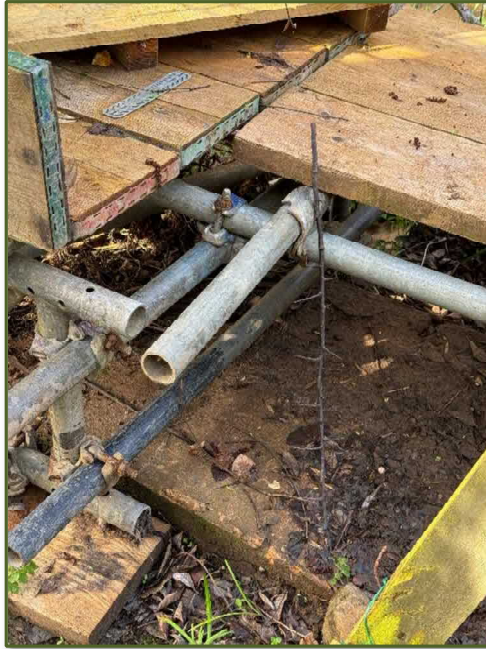
8.3.1 The RPA of T1 has been adjusted to discount the stone abutment on which the new bridge will sit. This existing abutment appears to be a concrete slab which very likely predates the growth of T1 in its current form.

Figure 8: Stone abutment on northern side of brook.

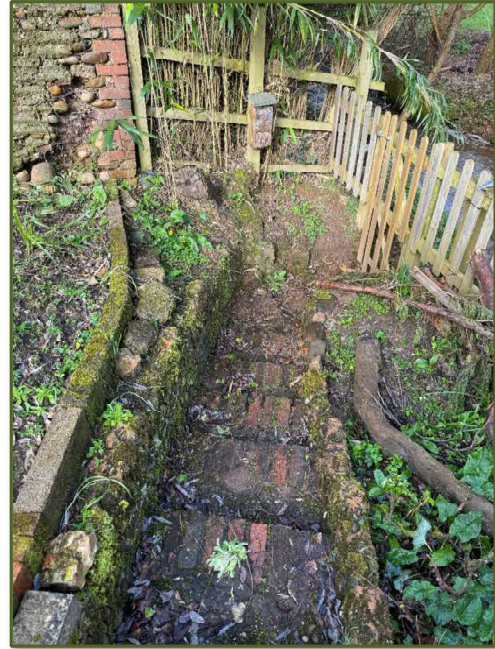
8.3.3 The existing hard landscaping and steps down to the stream that will be made good is not likely to have any significant impact to the trees on site. The RPA of T2 has been adjusted to be outside of this area. Willows can have very prominent surface roots which often cause direct damage to small walls, steps, and paving. The existing hard landscaping is very likely to predate the establishment of all trees on the site except for T7 and have formed a barrier to root growth. The lack of any noticeable disturbance of the landscaping is a strong indication that no significant tree roots are present below these structures.

Figure 9: Hard landscaping to be made good.
