Your survey report

42 Celtic Drive, Andover, Berkshire, United Kingdom, SP10 2UA

Inspection date

28/09/2023

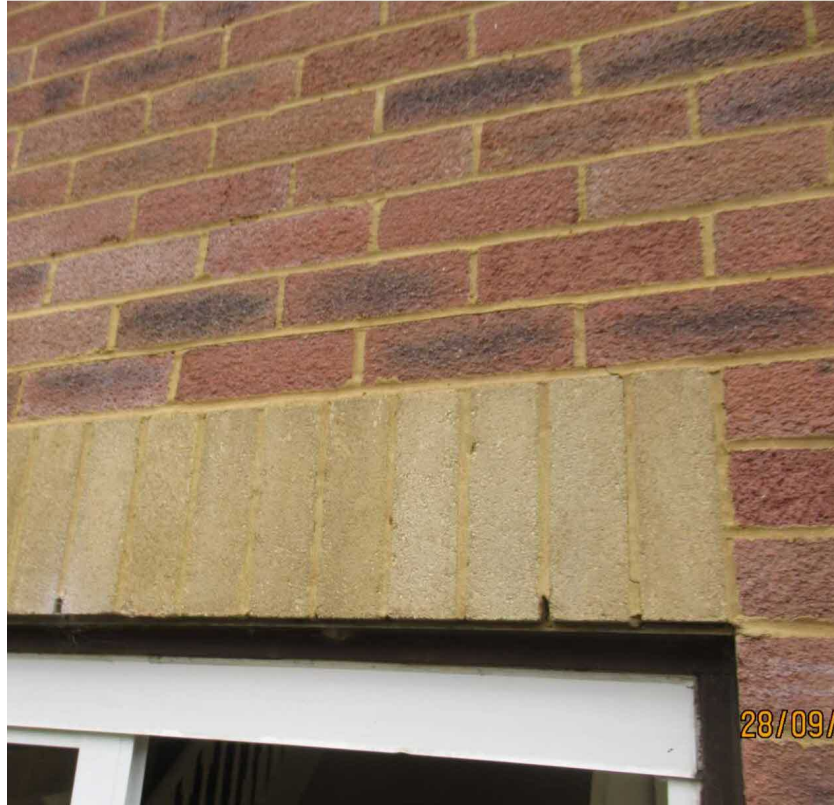
There are some minor cracks to a few mortar joints, for example above the patio doors. This cracking is not unusual and is not considered to be structurally significant, unless it worsens considerably over time. This should be checked periodically.

Minor cracking over patio doors

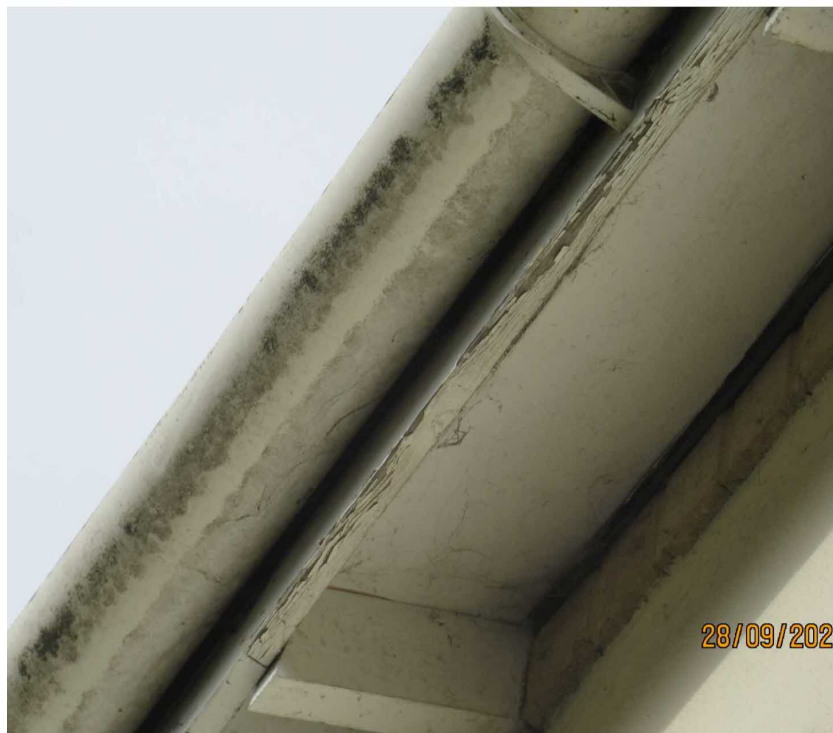
These are in serviceable order but require some redecoration soon to prolong their useful life.

Weathered fascia to the front

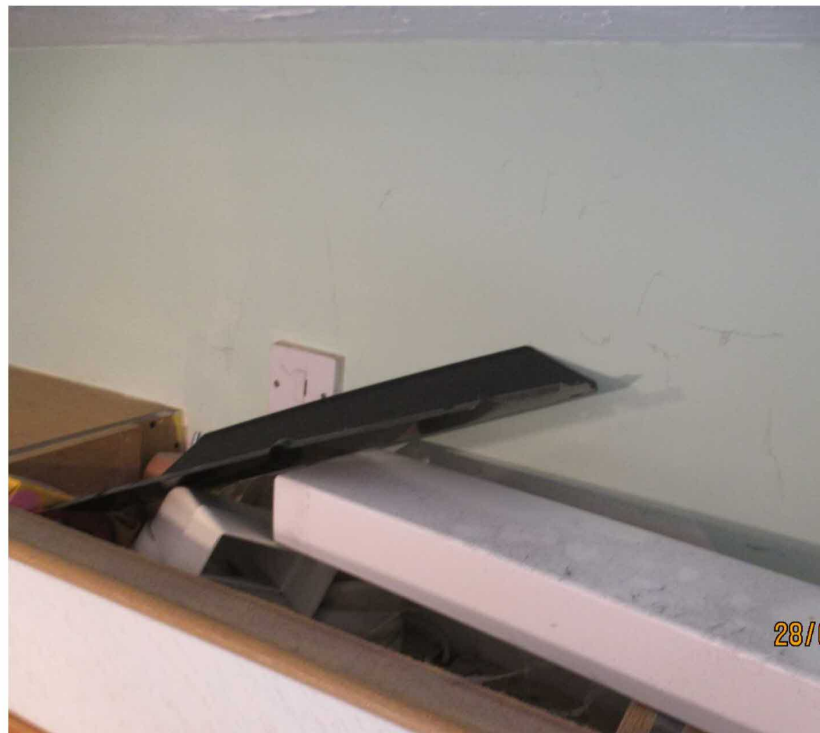
Disconnected kitchen extractor fan ducting

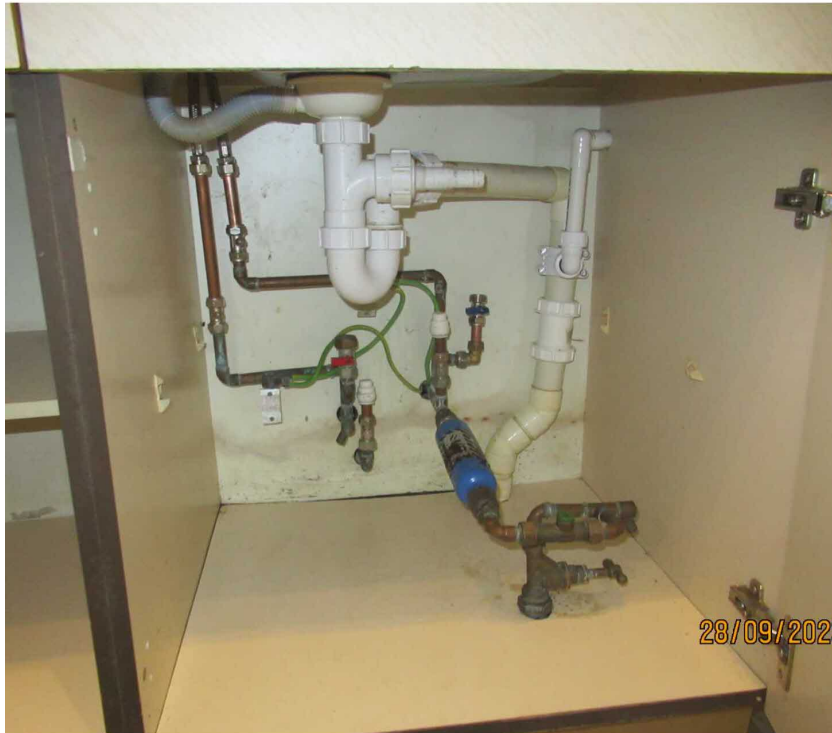
There was some water on the bottom of the kitchen unit under the sink. This does not appear to be from a leak to the pipework or fittings. It appears to be from the connection for the washing machine waste pipe that has not been blanked off after the pipe has been disconnected. This should be appropriately sealed off, the area dried out and then all of the pipework and fittings checked to ensure there are no other leaks. This should be done by a competent person.

Pipework and connections underneath kitchen sink

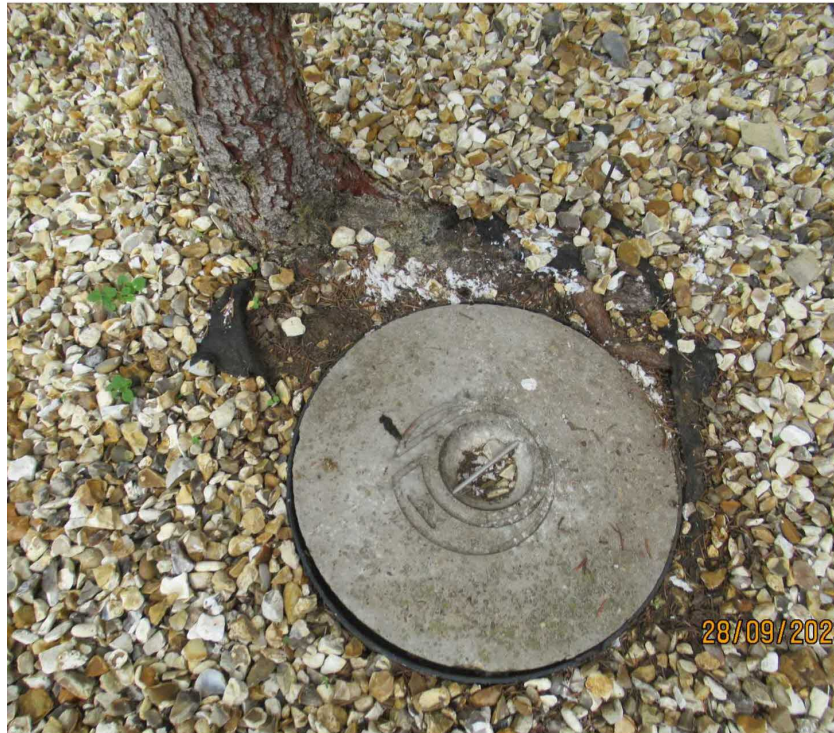
No evidence of any adverse tree root action affecting the main building was noted. There are several trees/large shrubs on the property and in neighbouring gardens. There is a fir type tree next to the inspection cover in the chippings to the front. The roots are growing around the chamber and may cause some damage to the drainage if the tree and roots grow much bigger. This tree should be removed before it causes a problem, as it is right next to the drainage and so close to the building. There are some large fir type trees in the neighbouring garden to the rear. You should ensure that your proposed insurance company is aware of the presence of all trees to ensure that tree related damage is covered.

Tree roots growing around inspection chamber

There is a fir type tree next to the inspection cover in the chippings to the front. The roots are growing around the chamber and may cause some damage to the drainage if the tree and roots grow much bigger. This tree should be removed before it causes a problem, as it is right next to the drainage and so close to the building. There are some large fir type trees in the neighbouring garden to the rear. You should ensure that your proposed insurance company is aware of the presence of all trees to ensure that tree related damage is covered.

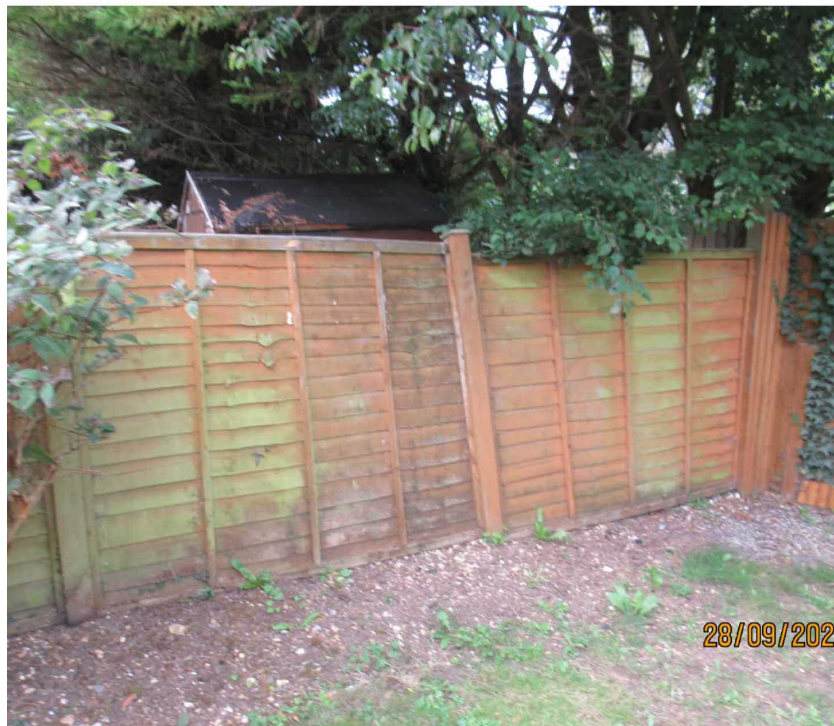
There is a loose/leaning post to the left boundary fence in the rear garden. This may need to be replaced. It is advisable to check all of the fencing and to repair/replace any as necessary.

Leaning fence to rear garden
