Your survey report

11 Tom Price Close, Cheltenham, GL52 2LE

Inspection date

13th September 2023

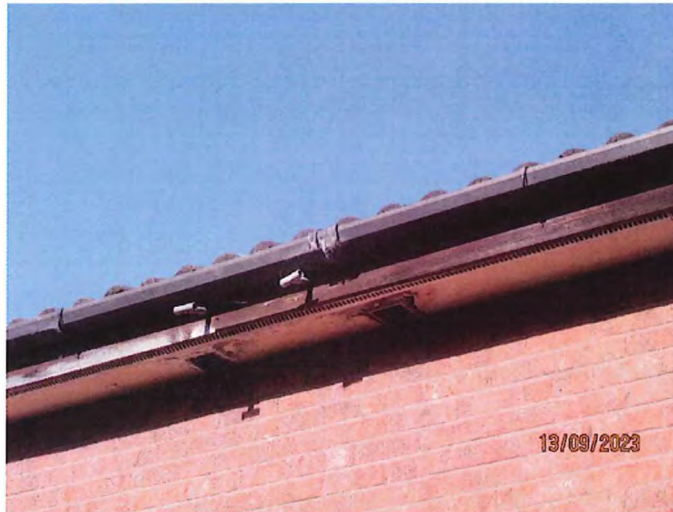
The gutters are leaking at joints. They should be cleaned out and overhauled as necessary.

Leaking gutter joint.

Condition Rating 2.

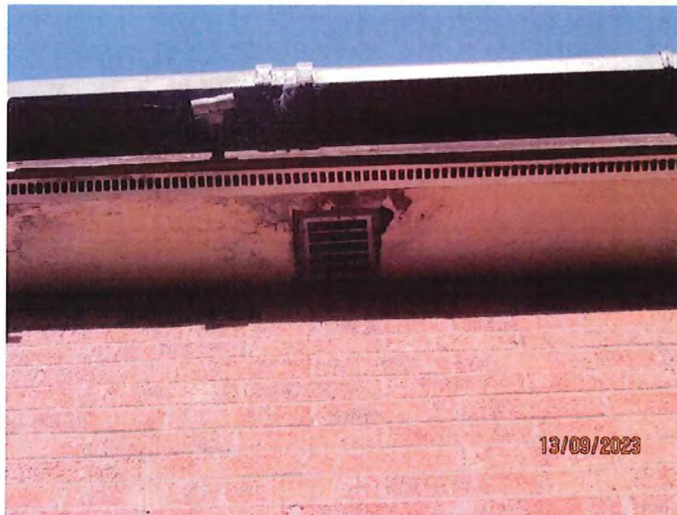
The joinery is weathered but generally in reasonable order for the age of the property. However, the soffit board adjacent to the extractor fan outlet to the rear right-hand side of the property is damaged and needs to be repaired or replaced.

Damaged soffit board.

The soffit boards may contain asbestos but only a detailed laboratory test can confirm this. In the meantime, the material should not be disturbed, sanded or drilled, without taking suitable safety precautions. As the soffit board is damaged and needs repair, a more detailed investigation is required before any work can go ahead. You should ask a specialist licensed asbestos removal contractor to inspect and advise you on the costs of removing any asbestos based material before exchange of contracts. For advice on instructing specialists to carry out further investigations and for obtaining quotations, see the page in this report entitled 'Further investigations and getting quotes'. This could lead to ill health. You must also take note of our comments in Section I - Risks.

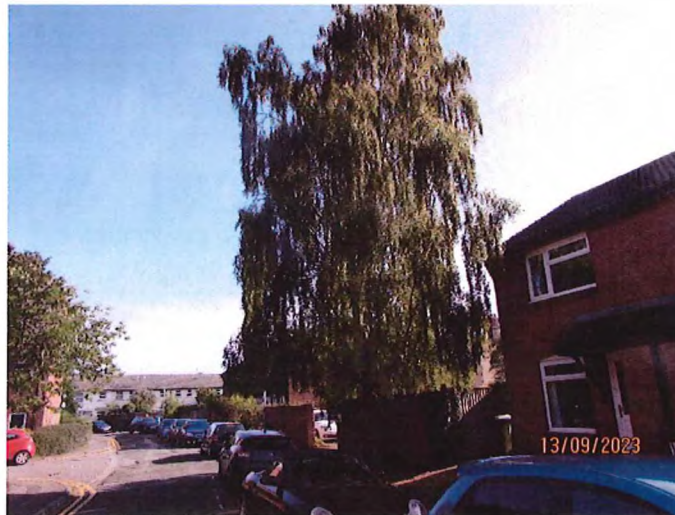
Large tree in believed Local Authority verge to front.

The large tree in the assumed local authority verge some 3.5 metres from the house may be a danger during stormy weather and as roots may be under or close to drains and the building's foundations. This tree has caused serious cracking in the brick wall to the front of the shared parking area. The tile and brick capping to the top of the wall is also loose and missing in places. This could lead to instability and accidents. You must also take note of our comments in Section I - Risks.

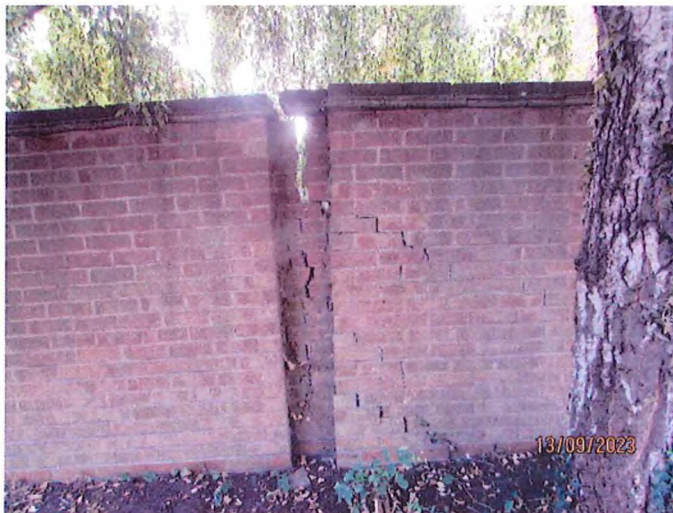
Cracked / damaged wall to front of shared parking area.

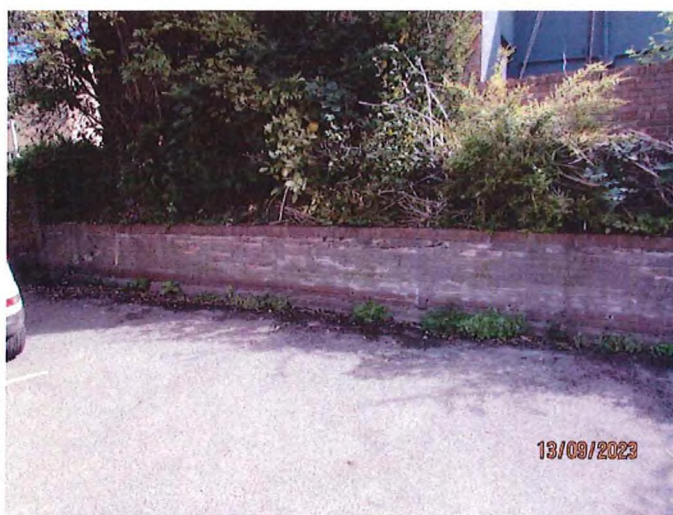
The brick wall to the rear of the shared parking area is also badly spalled.

Spalled brickwork to wall to rear of shared parking area.
