# SAVOY PARK HOTEL AT 16 Racecourse Road, Ayr KA72UT

# TREE SURVEY AND PROPOSALS for PROPOSED EXTENSION TO HOTEL

March 2024

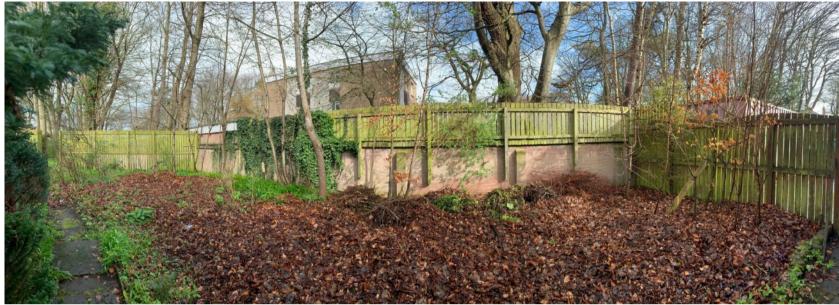
Site of proposed extension, existing area between the two existing fences on the North side of the hotel service wing has Group 1 trees consisting of a selection of self sown saplings, and proposed removal of these.

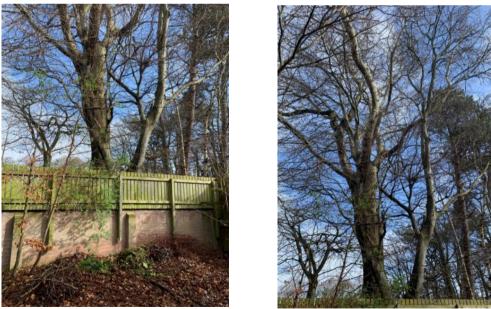
A mature sycamore tree on the North side of the boundary wall in the neighbour's property has A large bough hanging over the wall and lopping is required to avoid clash with proposed extension

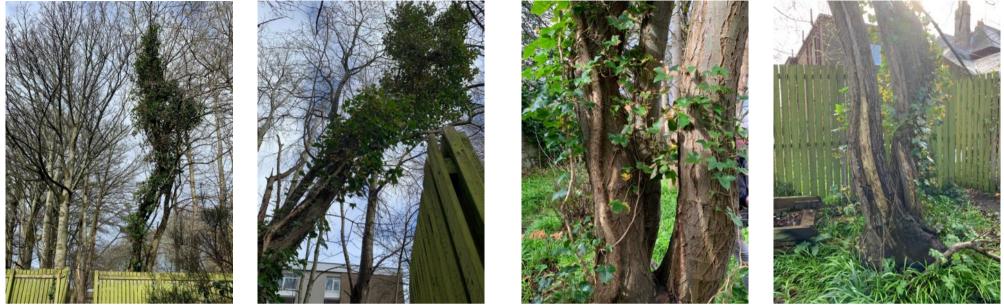
Trees tag 716 and untagged 1 are closely adjacent to outhouse building and proposed extension, undermining building foundations and condition of untagged 1 is poor with Splitting bark on both stems, leaning over the fence and with extensive ivy growth, and removal of both trees are a priority.

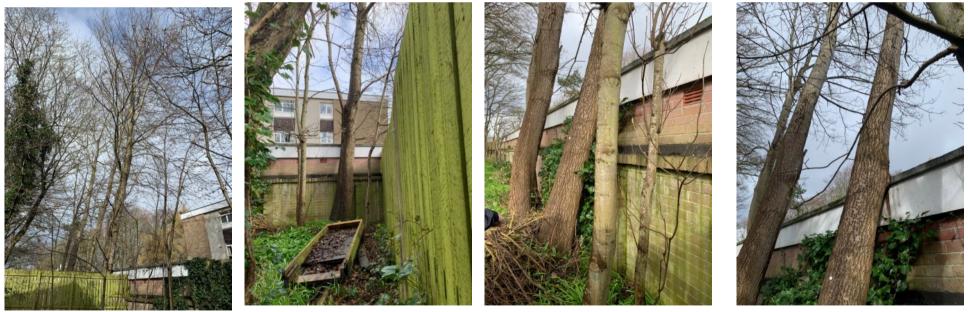
5no trees, untagged 2, tags 718, 719, 720, 721 are very close to the boundary wall are very tall and poorly maintained, undermining the wall and neighbours garage buildings, and removal is a safety priority

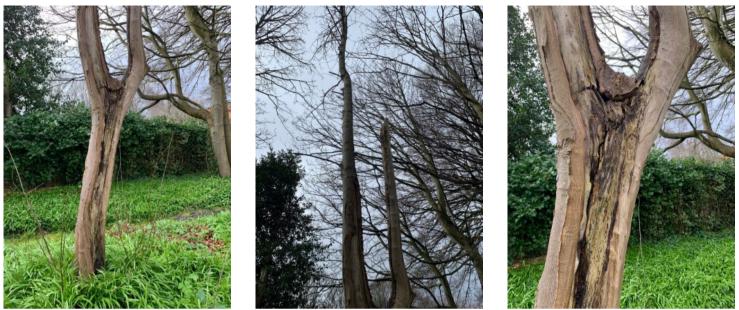
Tree tag 721 poor condition

tree tag 722 in very poor condition with bark loss, rot and split stems and insect infestation, recommend removal

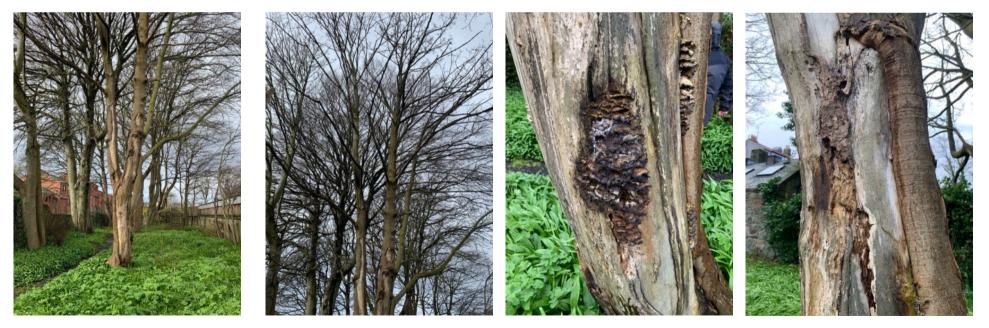
Trees tag 723 and 724 in poor condition with split bark, split stems with fungal growth and insect infestation, recommend removal,

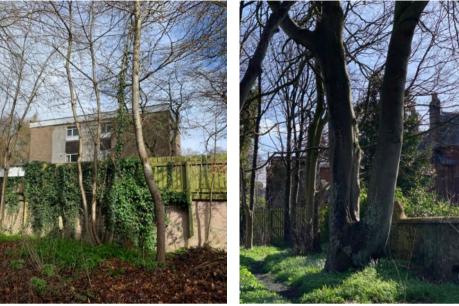
Group 2 sycamore saplings to remove and tag 725 is close to inner garden wall and some lopping maintenance to improve shape and safety recommended

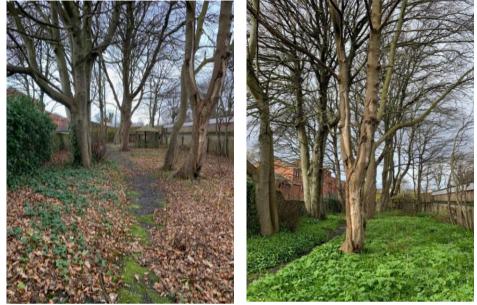
trees beyond tag 724 to the south of the woodland area cause less concern and would benefit from routine maintenance

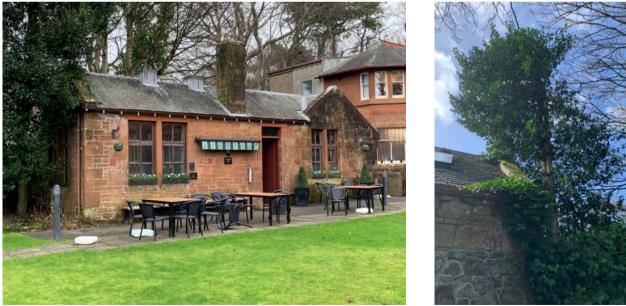
Tag 759 holly tree (Ilix) against the south gable of the outhouse is overgrown and undermining the building and should be removed.
