STRUCTURAL INSPECTION

HILL FARM, BELLBROUGHTON

1.0 INTRODUCTION

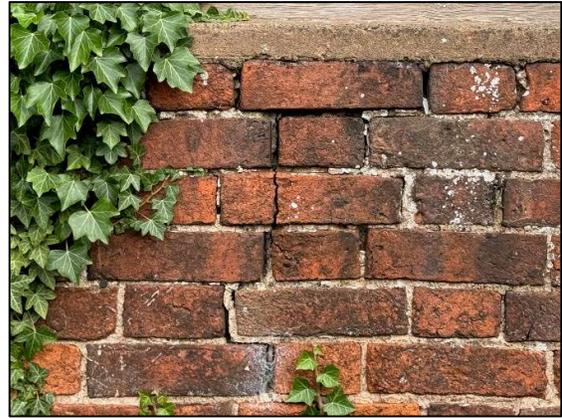
- 4.1 Externally on the front south elevation of the farmhouse, there is some vertical cracking in the brickwork beneath one of the windows, several patches of vegetation/ivy growth up the brickwork and patches of spalled bricks at high level over the front door. (Photo 8, 9 & 10).

Photo 8: Cracking in Brickwork Beneath Ground Floor Window

- 5.2 We recommend that all the vegetation growing up and through the external walls is removed.
- 5.3 The cracks in the brickwork walls both internally and externally should be repaired by installing Helifix or similar crack stitching bars inserted into the joints. Any cracked bricks would be locally replaced. Any spalled bricks should be locally cut out and replaced. The large cracks around the arch internally will need the arch to be locally demolished and rebuilt due to the size of the cracks/movement.

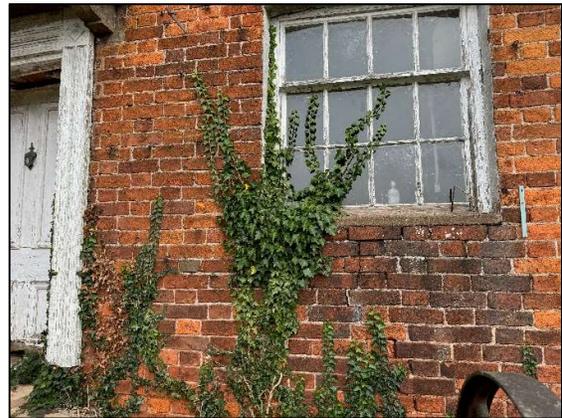
Photo 9: Vegetation Growth on Brickwork

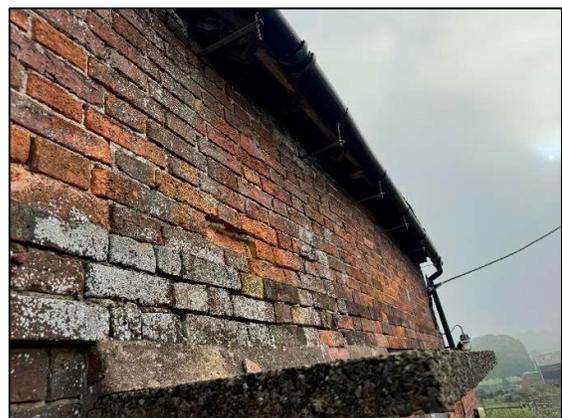
Photo 10: Spalled Brickwork at High Level

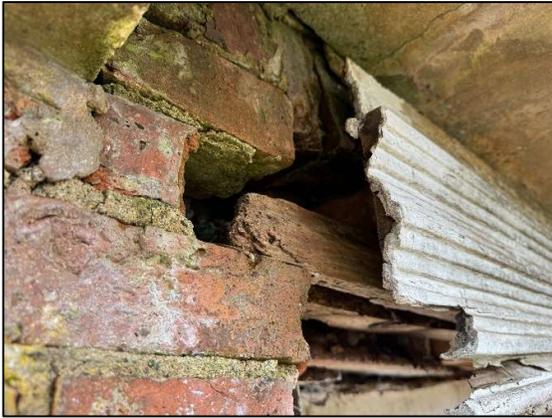
- 4.2 The timber lintel over the front door has decayed at the bearing and there are cracked and missing bricks to the left-hand side of the front door. (Photo 11 & 12).

Photo 11: Decayed Timber Lintel over Front Door

- 5.4 The decayed timber lintel over the front door will need to be removed and replaced. The missing bricks to the side of the door should also be replaced and bonded into the existing brickwork.

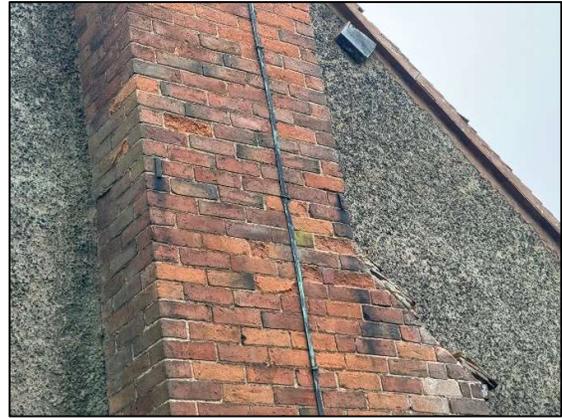
- 4.3 On the west gable elevation, there are spalled bricks within the chimney and missing tiles to the chimney. The chimney also appears to be leaning slightly at high level. (Photos 13, 14 & 19).

Photo 13: Spalled Brickwork to Chimney on West Elevation

- 5.5 A closer inspection of the chimney's should be carried out. The missing/loose bricks will need to be replaced and the verticality of the potentially leaning chimney checked. This may need to be demolished down to roof level and rebuilt if necessary.

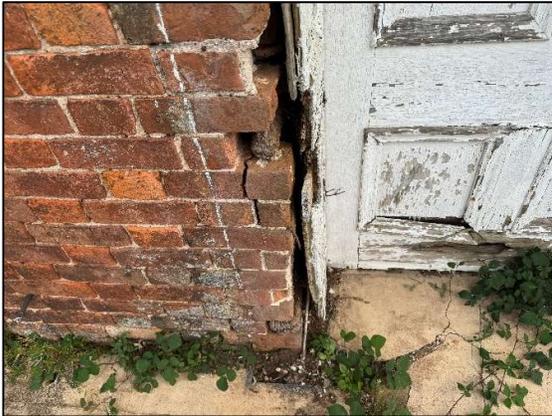
Photo 12: Cracked/Missing Brickwork to Side of Front Door

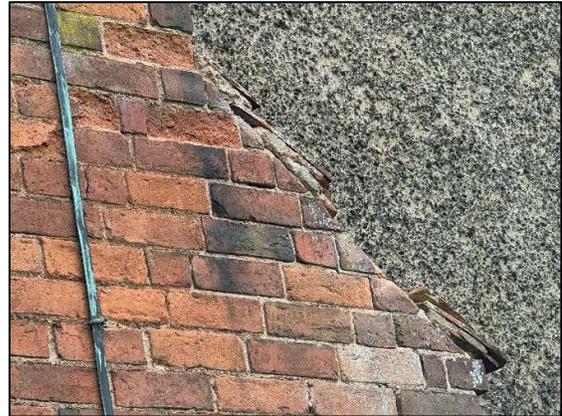
Photo 14: Missing Roof Tiles to Chimney

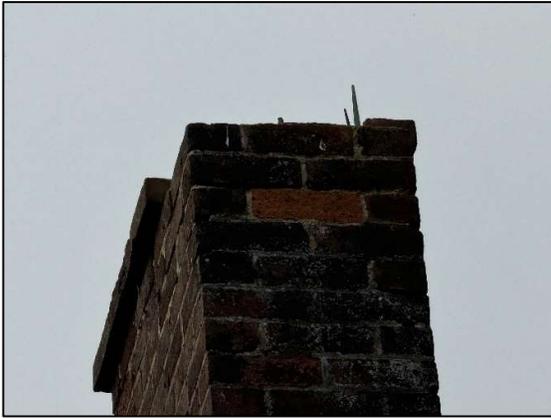
- 4.4 The chimney towards the centre of the roof has missing and loose bricks near the top. (Photos 15 & 20).
- 4.5 On the rear, north elevation, there are missing roof tiles at eaves level. (Photo 16).

Photo 15: Missing Bricks to Top of Chimney

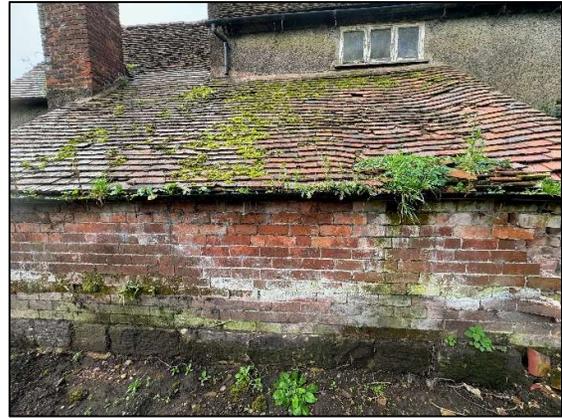
- 4.6 On the rear extension, there is significant damaged/missing bricks to the northwest corner and the roof appears to be uneven suggesting deflection of the roof structure. (Photos 17 & 18).

Photo 18: Uneven Roof to Rear Extension

- 5.6 The outer leaf of brickwork on the corner of the rear extension will need to be rebuilt. We also recommend the roof and ceiling structure of this extension be removed and replaced due to the condition of some of the timbers.

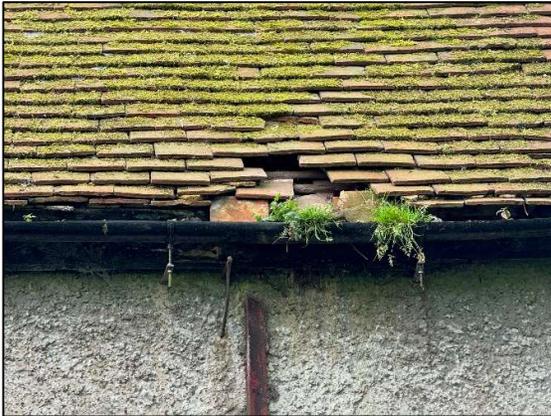
Photo 16: Missing Roof Tiles

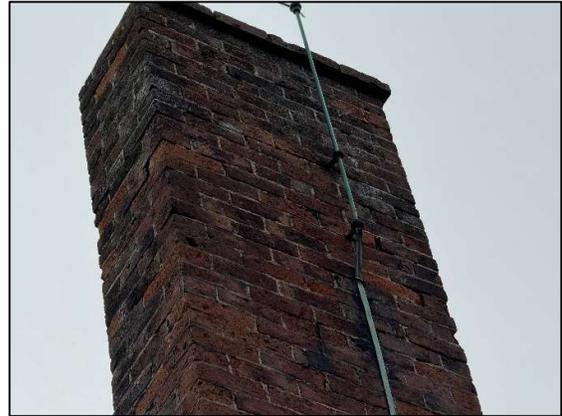
Photo 19: Leaning Chimney

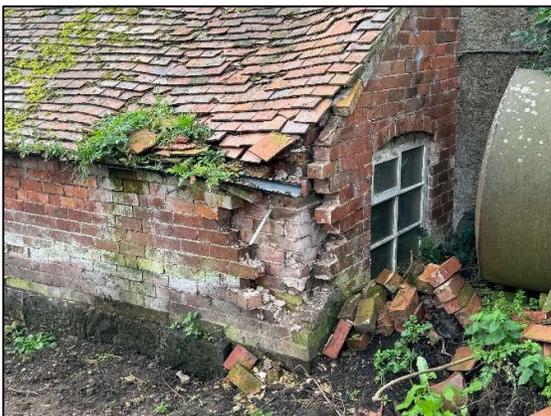
Photo 17: Damaged/Missing Brickwork to Corner of Rear Extension

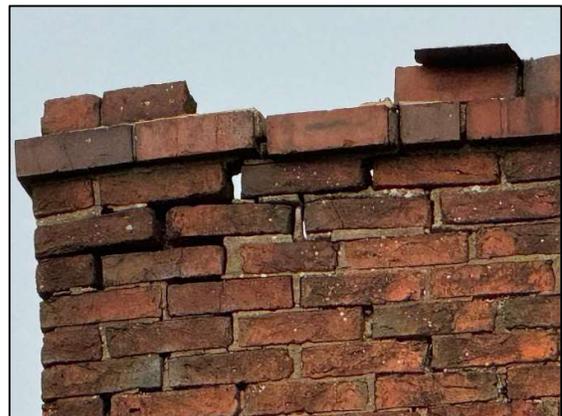
Photo 20: Loose/Displaced Brickwork to Chimney

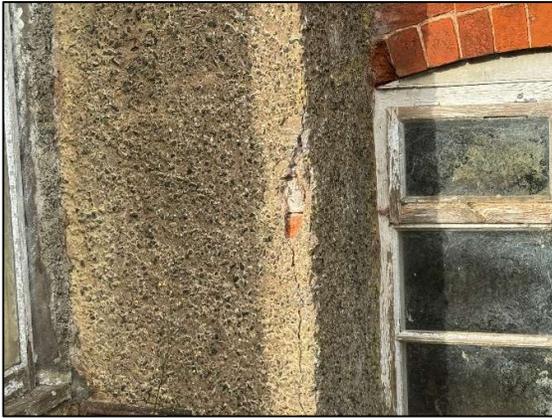
- 4.7 On the east elevation of the farmhouse, there are a couple of cracks in the render. (Photos 21 & 22).
- 4.8 On the north elevation of the barn, there is a diagonal crack in the brickwork, missing roof tiles to a small section, a collapsed roof to the central part of the barn with the north elevation brickwork leaning outwards and significant vegetation growing through and over the eastern end of the barn. (Photos 23-26).

Photo 21: Crack to Render on East Elevation

- 5.7 There are a few cracks in the external render, but we understand this is due to be removed as part of the refurbishment. This will also allow a closer inspection of the brickwork behind to check for any defects.

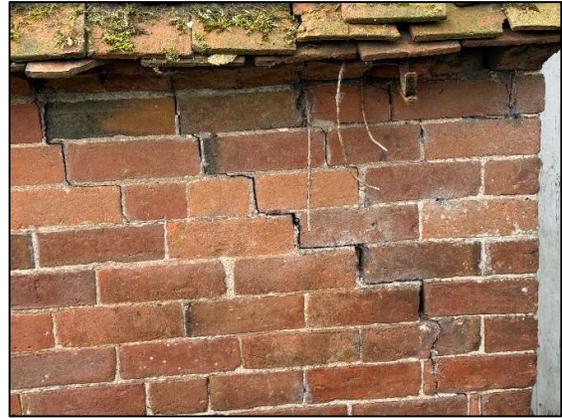
Photo 23: Crack in Brickwork on North Elevation of Barn

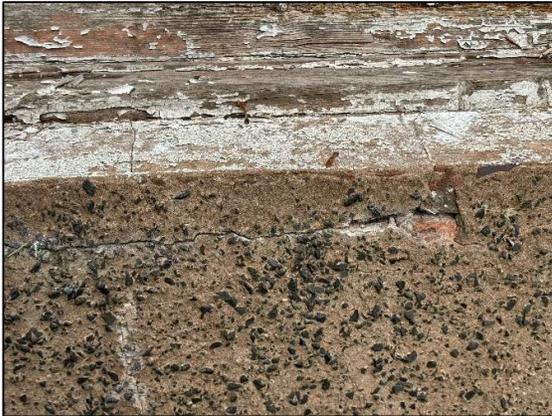
Photo 22: Crack to Render on East Elevation

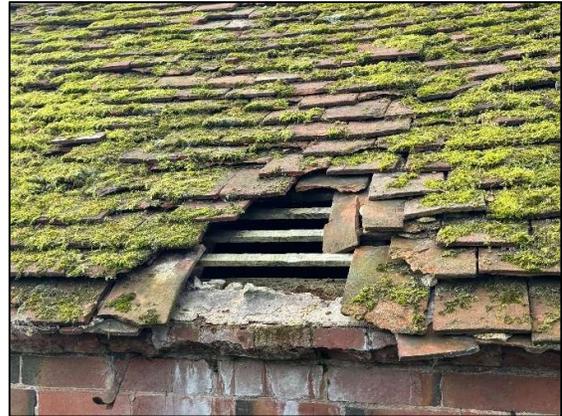
Photo 24: Missing Roof Tiles to Barn Roof

- 5.8 The leaning section of the northern wall to the adjoining barn will need to be demolished and rebuilt. The missing/collapsed section of roof will also need to be replaced.

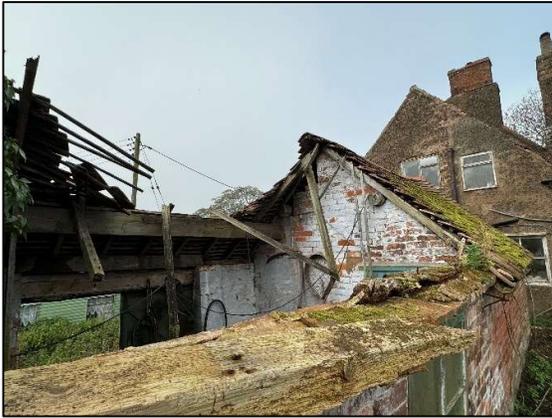
Photo 25: Collapsed Roof to Barn and Leaning Side Wall

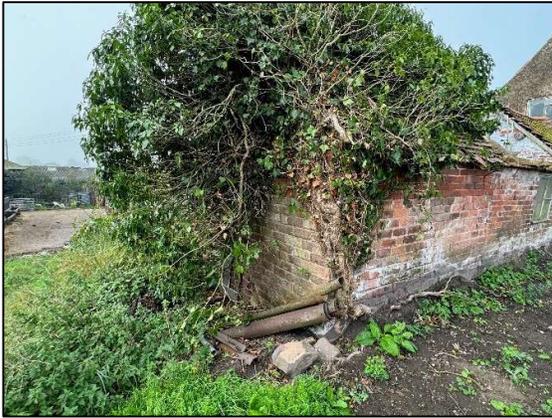
Photo 26: Tree Growing Through and Over Barn Roof

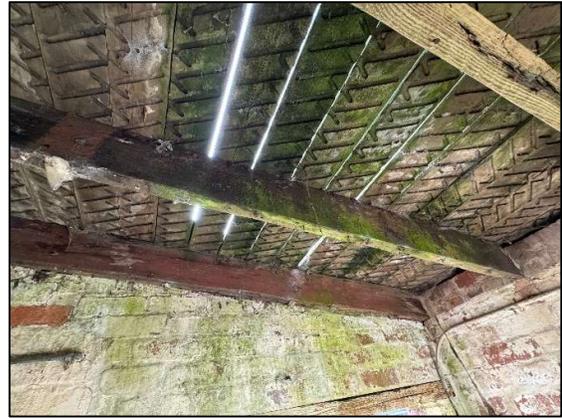
- 4.9 Within single storey link section between the main house and the barn, there are gaps in the timber boards forming the roof with missing felt over which is allowing water ingress into the building. (Photo 28).

Photo 28: Gaps in Link Building Roof with Missing Felt

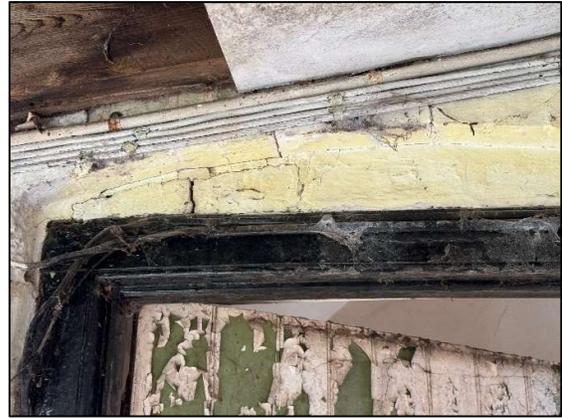
- 4.10 There are large cracks in the brickwork arch above the doorway between the link building and the barn. There are smaller cracks in the brickwork arch above the door between the link building and main farmhouse. (Photos 30 & 31).

Photo 31: Cracks in Brickwork above Door
Between Link Building and House

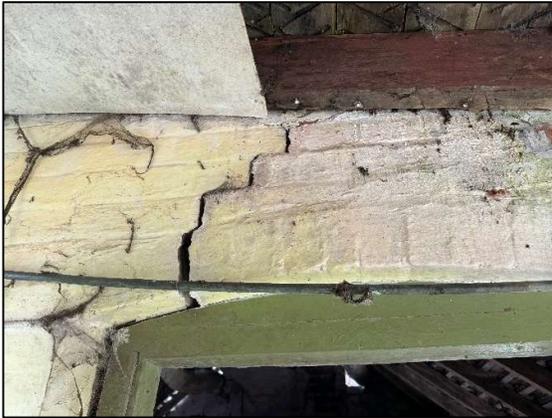
Photo 30: Cracks in Brick Arch above Door
between Link Building and Barn

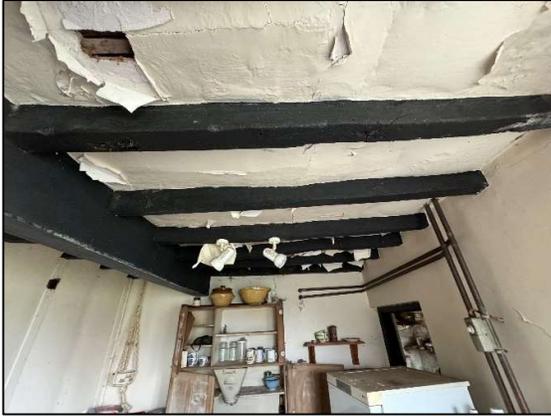
- 4.11 Internally, within the kitchen on the ground floor, there are signs of damp within the ceiling from a leaking roof above and significant section of timber missing from one of the floor joists above the kitchen, although this appears to be historic. (Photos 33 & 34).

Photo 33: View of Damp to Kitchen Ceiling

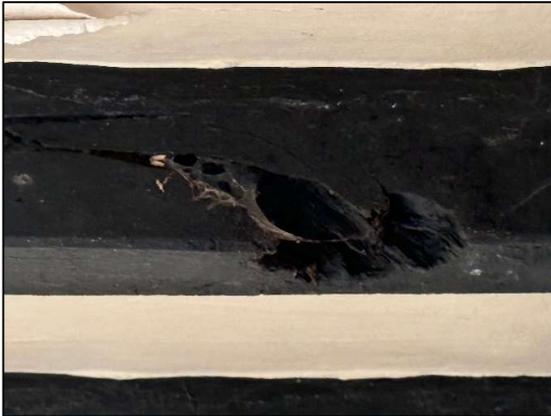
Photo 34: Missing Section of Floor Joist
over Kitchen

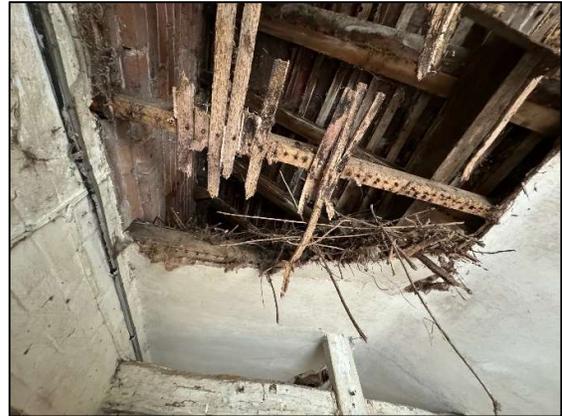
- 4.12 Within the room forming the rear extension to the building, the ceiling has collapsed in places revealing decayed timber ceiling joists and rafters. There is also a diagonal crack in the brickwork to the gable wall to the side of the window. (Photos 36-40).

Photo 36: Collapsed Ceiling to Rear
Extension

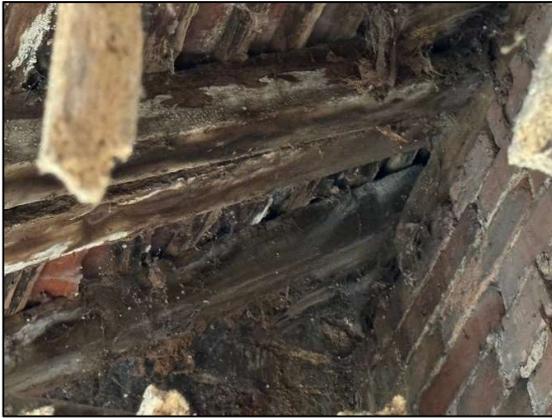
Photo 37: Decayed Roof Joists to Rear
Extension

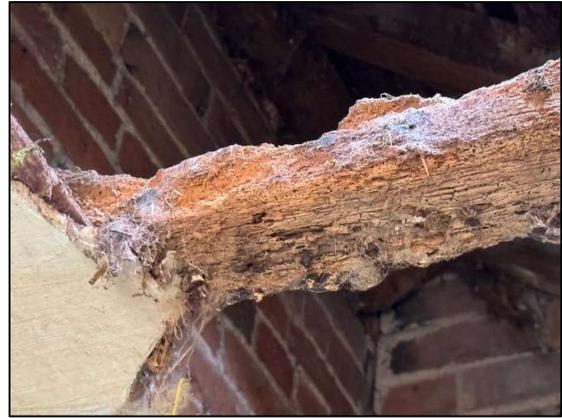
Photo 39: Decayed Ceiling Joist to Rear
Extension

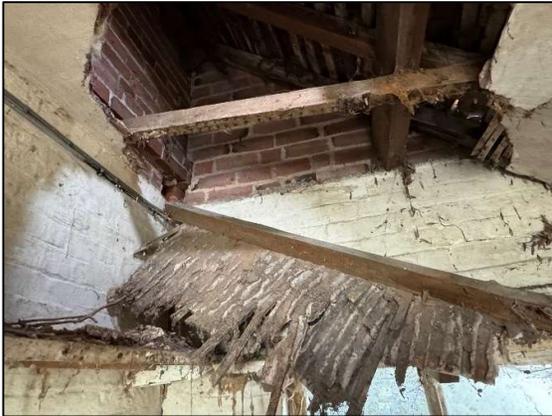
Photo 38: Collapsed Ceiling Joist to Rear
Extension

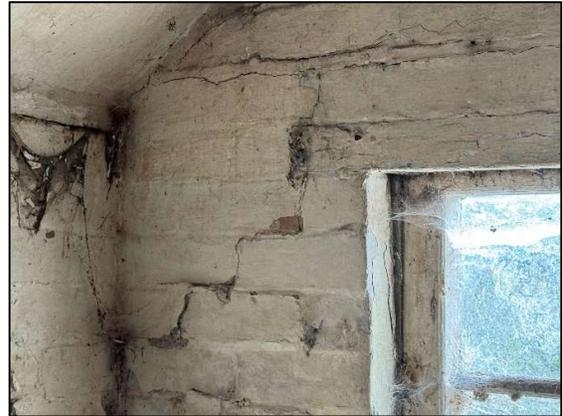
Photo 40: Cracking to Gable Wall to Rear
Extension

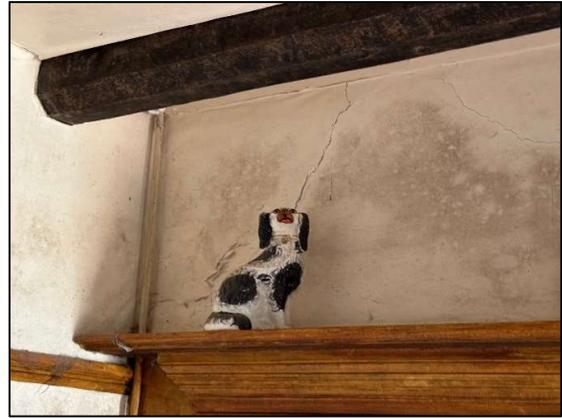
- 4.13 Within the front rooms on the ground floor there is a crack in the wall above the fireplace. It is unknown if this is just in the plaster or continues into the brickwork wall. There are also signs of damp in the front (south) wall and ceiling. (Photos 44 & 46).

Photo 44: Crack in Wall above Fireplace

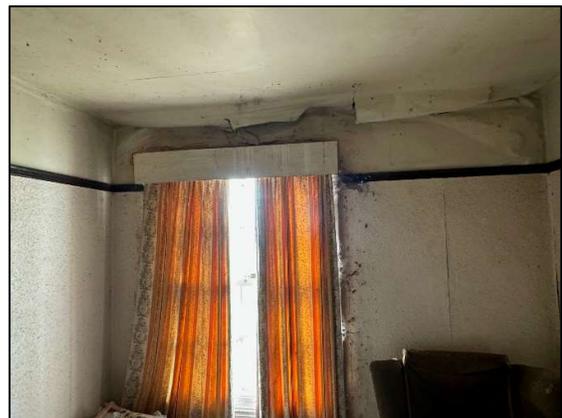
Photo 46: Damp to Front Wall and Ceiling

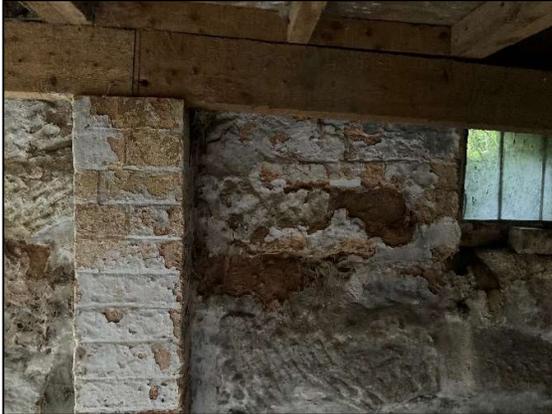
- 4.14 Within the basement on the western end of the house, there is some spalled brickwork on the external gable wall. (Photo 48).
- 4.15 On the first floor, there is a partially collapsed ceiling above the landing to the stairs. (Photo 49).

Photo 48: Spalled Brickwork to External Wall to Basement

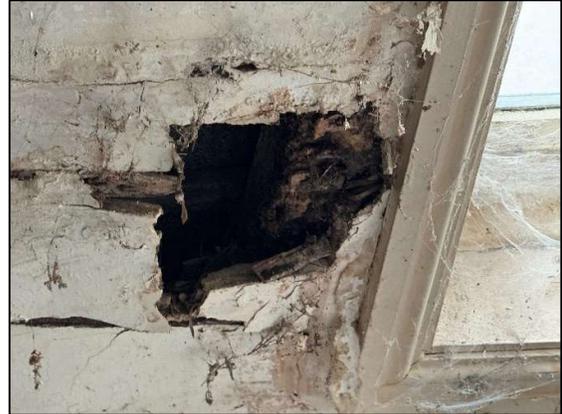
- 4.16 In the first-floor bedroom on the front of the building there is a hole in the ceiling and a decayed rafter is visible. (Photo 51).
- 4.17 On the first-floor corridor, there is a hole in the floorboards due to decay/water ingress from the roof above. There was no safe access to the remainder of the first-floor rooms beyond this point. (Photo 53).
- 4.18 There are several sections of missing/collapsed ceiling above the first-floor corridor. The roof structure to the eastern end of the farmhouse was mostly visible from these areas. The majority of the roof timbers look to be in reasonable condition, but a closer inspection is recommended. There are several holes in the roof which is allowing water ingress. (Photos 55-57).

Photo 51: Decayed Ceiling/Rafter in First Floor Bedroom

- 5.9 Based on the extent of the visual inspection, the majority of the floor and roof timbers to the main farmhouse appear to be in reasonable condition and can remain. There may be a few timbers that need to be replaced locally to where the water ingress has occurred if they have decayed. The holes in the roof and floorboards will need to be locally repaired. Once the floor is safe, we recommend the western end of the house is inspected for any defects.

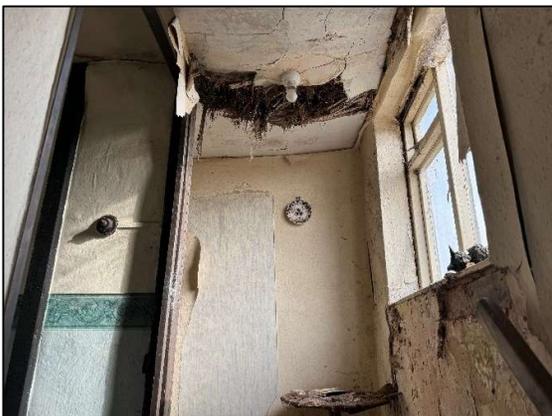
Photo 49: Partially Collapsed Ceiling at First Floor Landing

- 5.10 We also recommend the ceilings are removed to allow for a closer inspection of the timber structure where not currently visible.

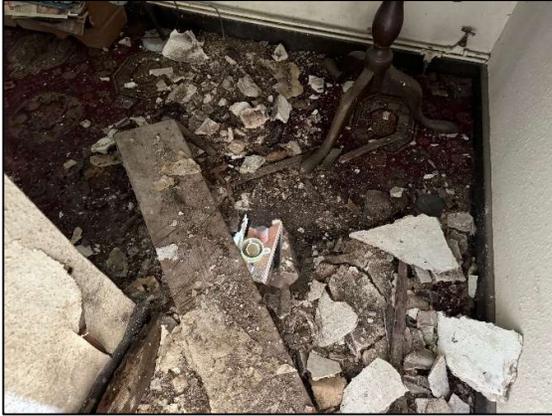
Photo 53: Hole in Floorboards in First Floor Corridor

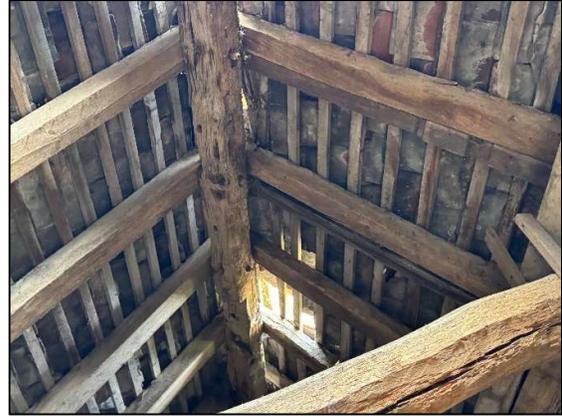
Photo 55: View of Roof Structure to Eastern End of Building with Hole in Roof

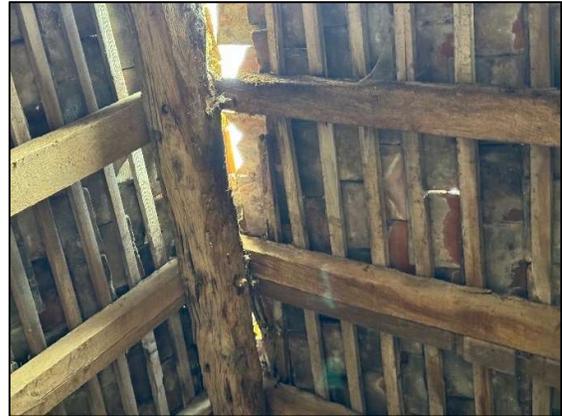
Photo 56: Holes in Roof

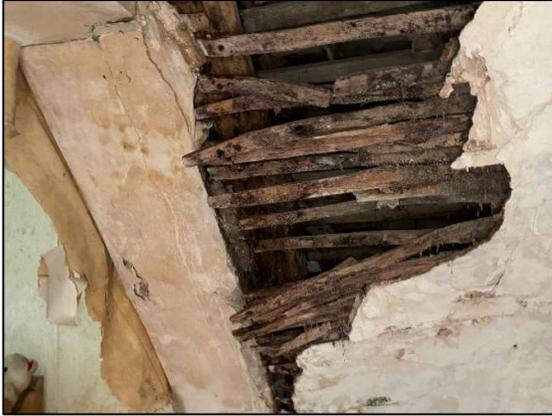
Photo 57: Decayed Ceiling at First Floor
Level
