Tree Condition Survey and Risk Assessment

Site: **Wolseley Trust, Community Building Childcare Nursery PL2 3BY**

Date: **17th October 2023**

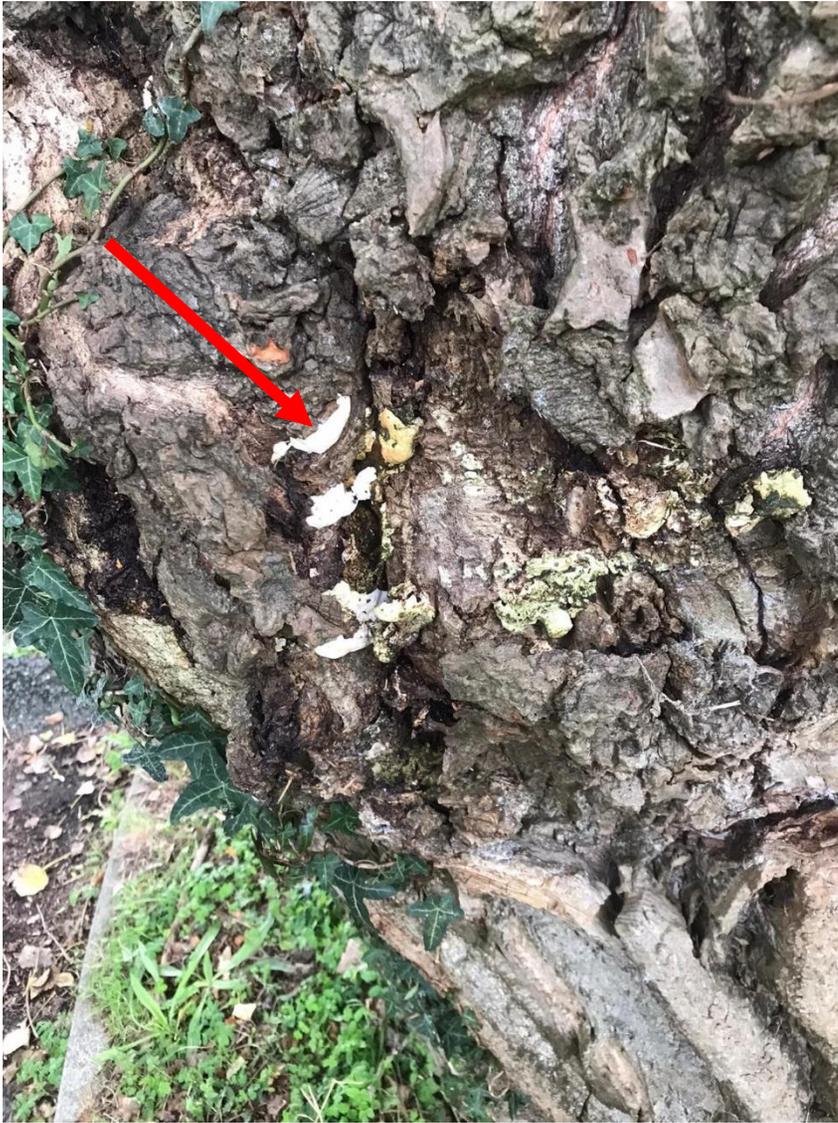
- 4.8 T001 is a black hybrid poplar with a height of 15 metres and a stem diameter at 1.5 metres of 1310mm. This tree has historically been pollarded at *circa*. 8 metres from ground height, and has been managed in this way for some time. There are multiple large wounding areas on the structure of the tree, from historic failures and branches that have been pruned. These areas show signs of small fungal fruiting bodies of *Perenniporia fraxinea* (See figure 3). There are sounds of hollowing within the main trunk of the tree when tapped with an acoustic sounding mallet, the extent of which is unknown. T001 leans over car parking area to the east of the site. Targets included car parking area and public footpath to the north.

- 5.8 T001 is a black hybrid poplar which has historically been maintained as a pollard. The numerous wounding points on the main stem has fungal fruiting bodies of *Perenniporia fraxinea*, these currently appear to be localised. Tapping with an acoustic mallet detects sounds of decay surrounding the stem and despite sounding localised, the extent is unknown. According to the QTRA template this tree is considered a 'Tolerable' risk and recommendations have been made.

Figure 3 - showing fungal brackets on T001.

- 6.8 T001 – I recommend carrying out a PiCUS test to gain better knowledge as to the extent of decay, to be able to monitor the speed at which decay is reducing the structural integrity of the tree. I also recommend re-pollarding the tree in line with its current pollard regime as re-growth is in excess of 7 metres.

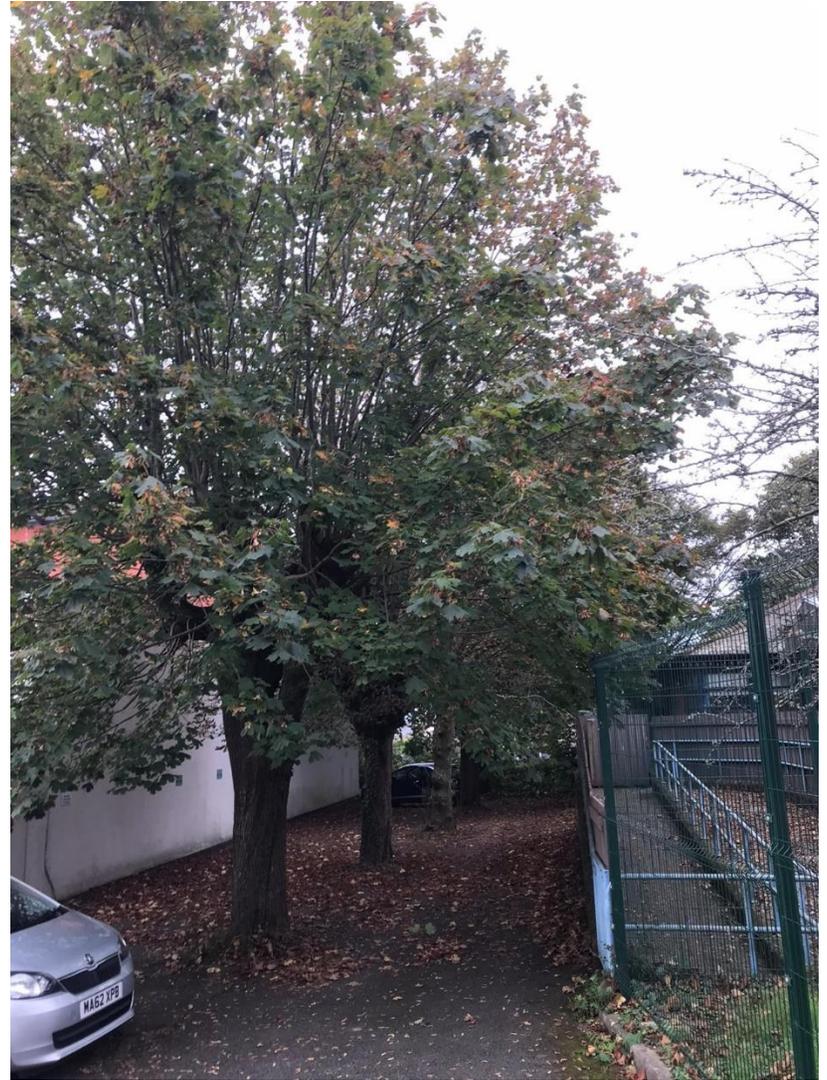
4.1 G005 is a group of: 1 Horse chestnut (*Aesculus hippocastanum*), 3 Norway maple (*Acer platanoides*), 2 European lime (*Tilia x europaea*), 1 Common ash (*Fraxinus excelsior*) and 1 European hop-hornbeam (*Ostrya carpinifolia*). The entirety of the avenue has historically been pollarded (see figure 4) with the exception of the Hornbeam at the western-most point of the avenue. The re-growth on all the trees now measures up to 5 metres. The ash (see figure 5) is suffering from severe Ash Dieback Disease (ADB) and has very limited leaf material left in the crown. The target area for these trees is predominantly the car parking bays beneath the trees.

- 5.1 G005 is a group of trees that have had a cyclic pollard regime introduced. These trees have not been pollarded for a few years and the regrowth is at 5 metres on some trees. The ADB within the ash tree is relatively severe producing moderate deadwood within the canopy. According to the QTRA template these trees are considered a 'Tolerable' risk and recommendations have been made.

Figure 4 – showing G005 an avenue of pollarded trees

- 6.2 I would recommend the following:
- 6.3 G005 – I recommend that the ash tree is removed and replaced with a Gingko biloba tree and that all other trees are re-pollarded back to the original pollard points in line with good tree management of cyclic pruning.

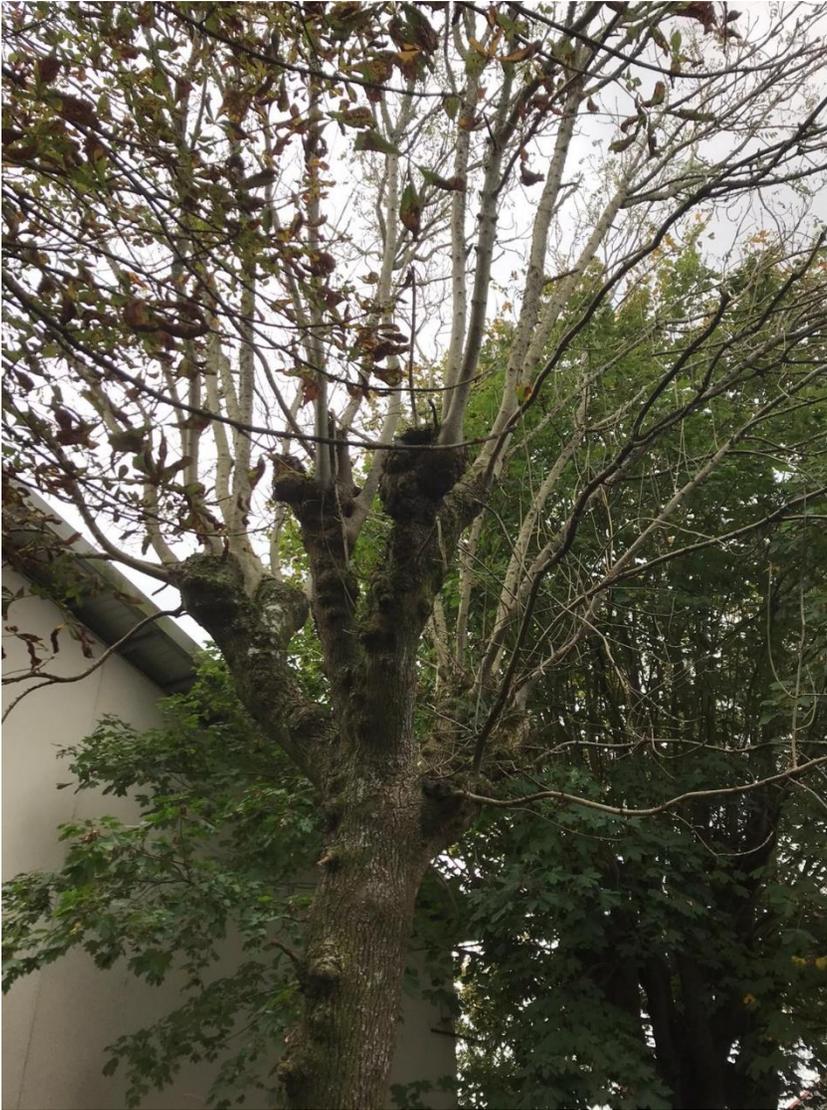
Figure 5 - ash with poor vitality to remove in G005

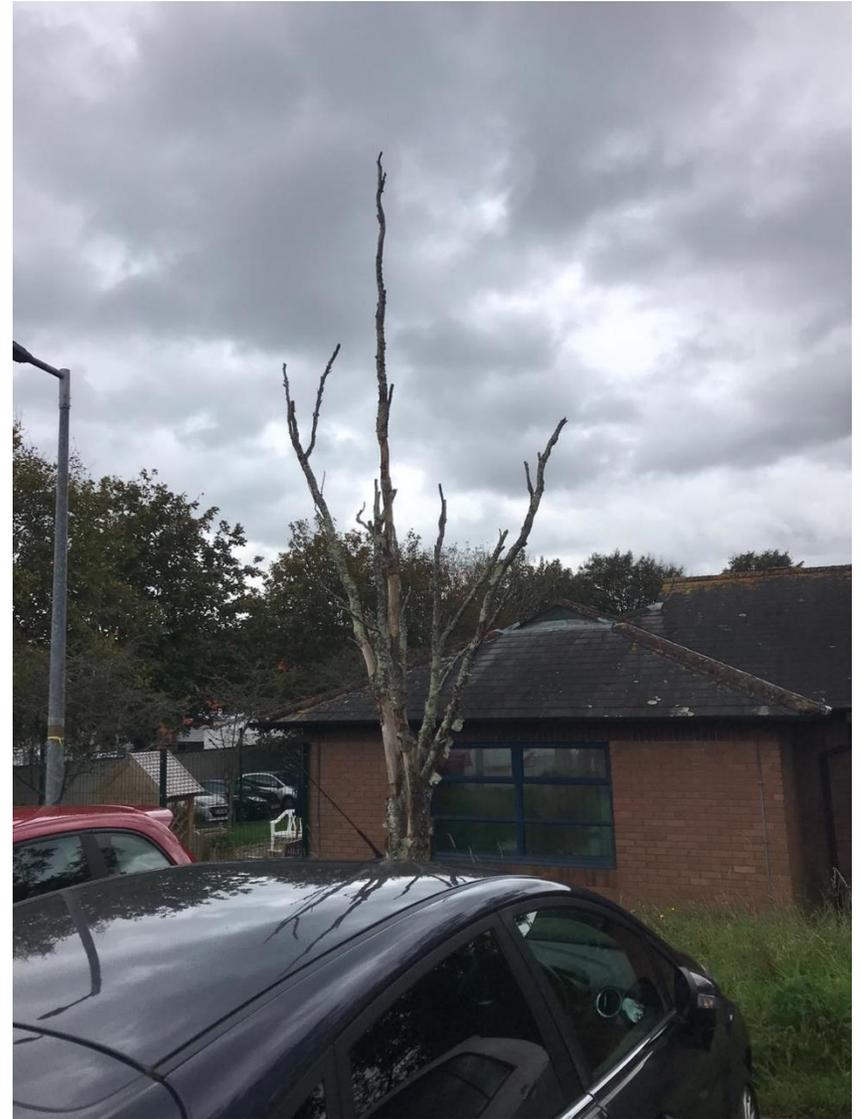
- 4.11 T004 is a Wild cherry (*Prunus avium*) with a height of 6 metres and a stem diameter at 1.5 metres of 220mm. This tree has no leaf material and is considered dead, and its target area is the car park and footpath (see figure 6).

- 4.11 T004 is a wild cherry that is considered dead. It is within falling distance of both the footpath and parked cars. According to the QTRA template this tree is considered a 'Unacceptable' risk and recommendations have been made.

Figure 6 - T004 dead tree to remove

- 6.10 T004 – I recommend felling this tree to ground level due to it being considered dead and within falling distance of target areas.
- 6.11 T007 & T008 – I recommend both trees require pruning on the north western aspect to give a 2-metre clearance from buildings.

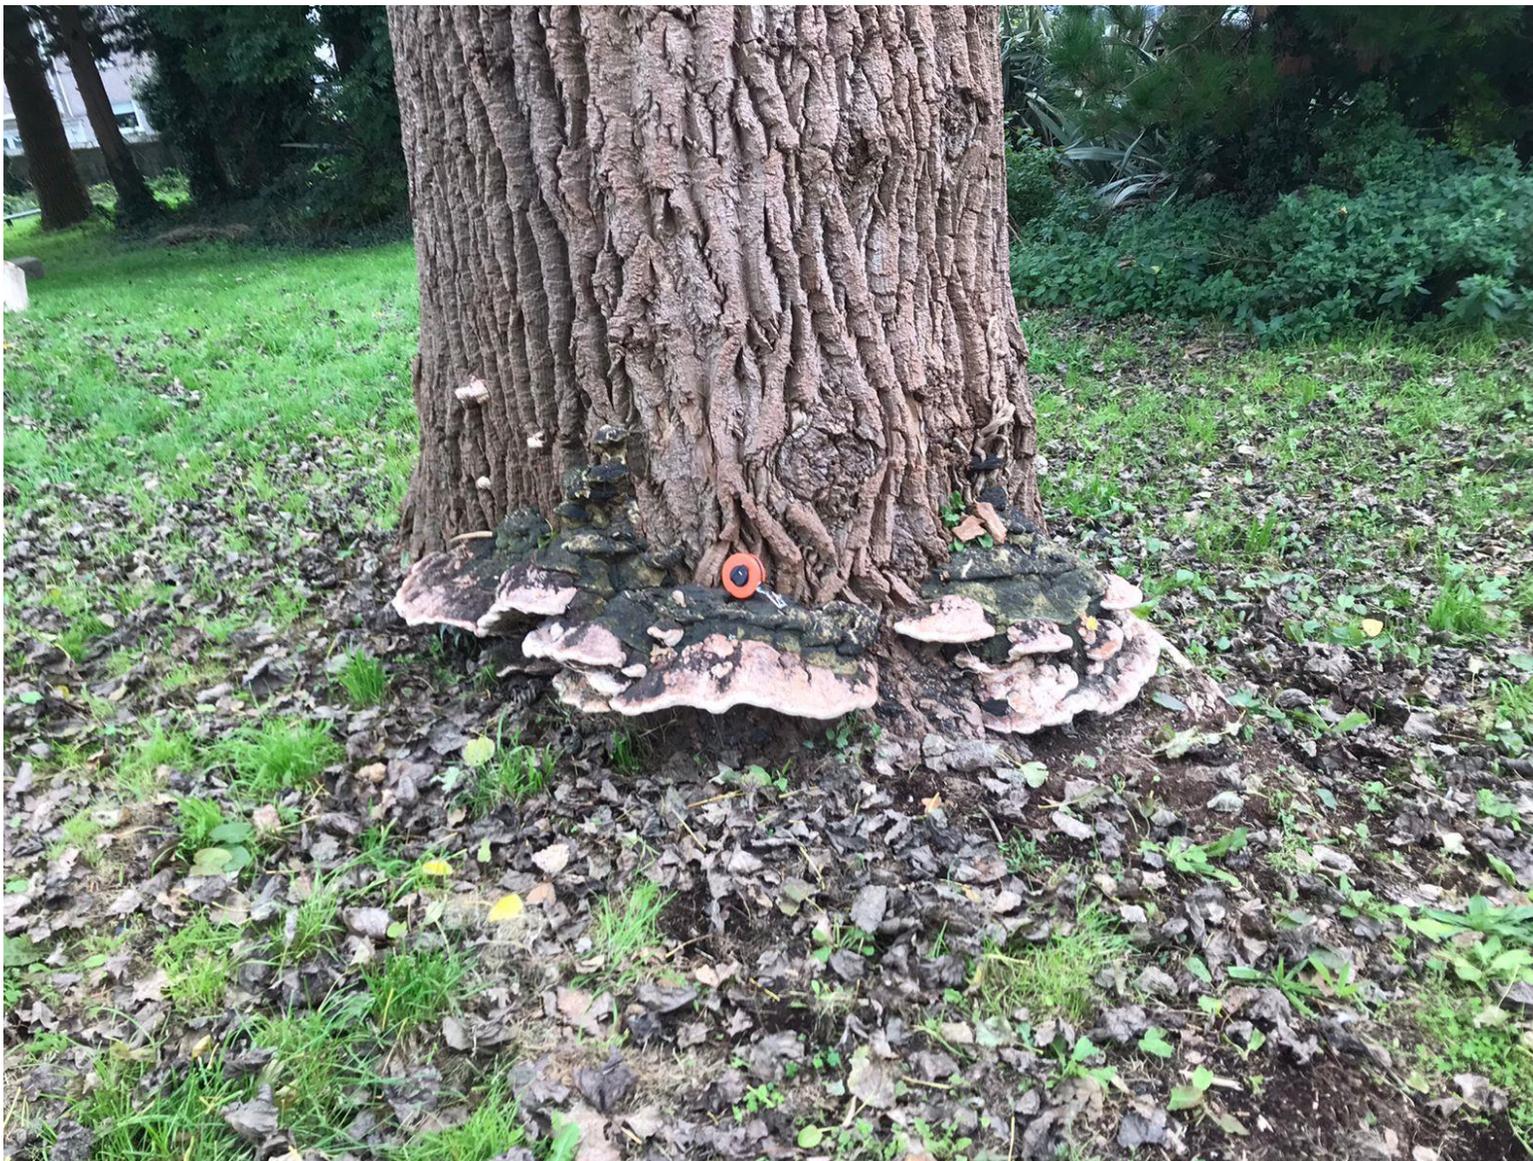
- 4.14 T013 is a black hybrid poplar, with a heigh of 15 metres and a stem diameter at 1.5 metres of 1250mm. This tree has historically been pollarded at a mature stage, which has produced re-growth of approximately 2 metres. The tree has large fruiting bodies at its base of *Rigidoporus ulmarius*, which surround the basal flare of the tree. When tapped with an acoustic sounding mallet significant hollowing was heard throughout the main trunk of the tree. Target areas include a car parking area and neighbouring property garden areas.

- 4.14 T013 is a black hybrid poplar with poor vitality. It has historically been pollarded at a mature age more than likely due to the presence of decay. The decay throughout the base of the tree is due to *Rigidoporus ulmarius* (see figure 7) which is a fungus that produces brown rot in the heartwood of the tree. The decay has now become extensive and the structural integrity of the tree compromised. According to the QTRA template this tree is considered a 'Tolerable' risk and recommendations have been made.

Figure 7 - T013 with significant fruiting bodies at the base.

- 6.12 T009 – Dead tree, dismantle and fell to ground level.
- 6.13 T013 – Monolith tree at 4 metres in height from ground level to reduce the risk of failure on to targets due to extensive basal decay.

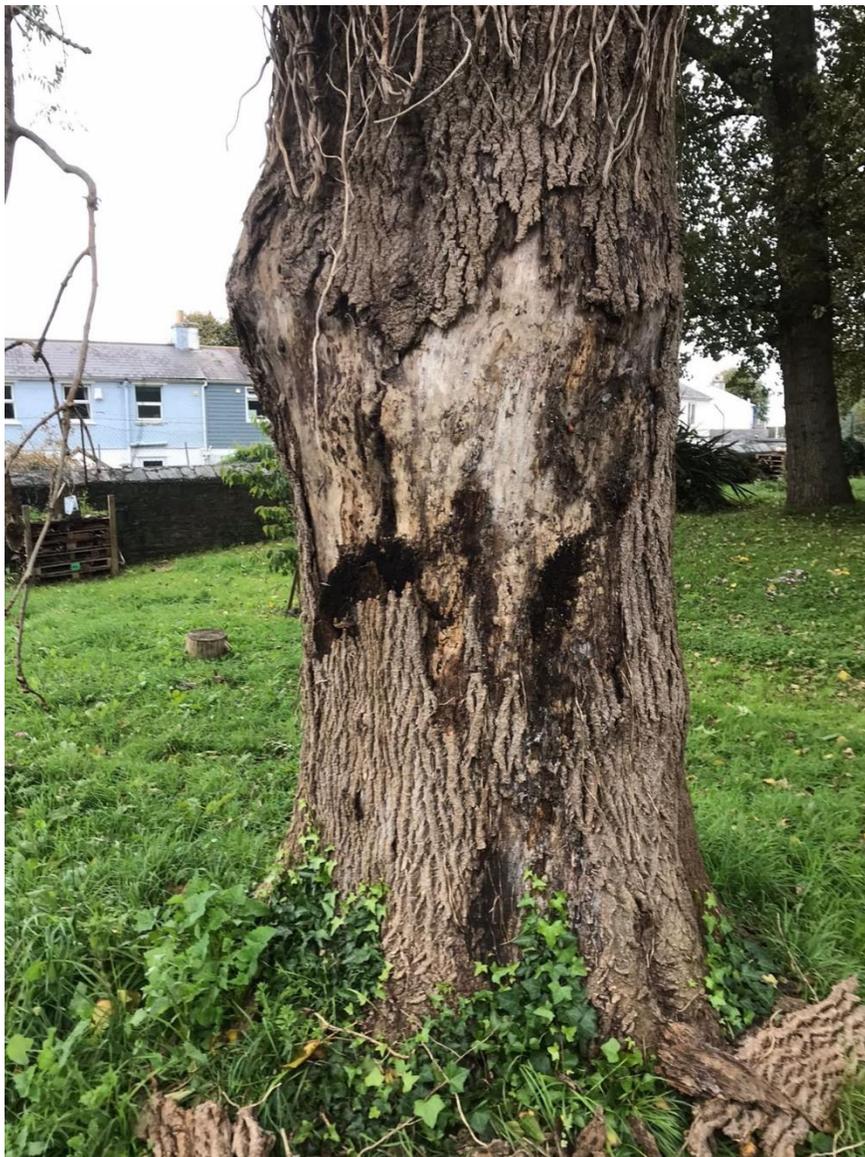
- 4.16 T018 is a Common ash tree with a height of 15 metres and a stem diameter at 1.5 meters of 700mm. It has ADB throughout the crown shown in a reduction of leaf density and an increase in deadwood throughout the crown. This tree is also suffering from delamination of bark (See figure 8) on the eastern aspect of the main stem, the cause of which is unknown.

- 4.16 T018 is a Common ash suffering from ADB and significant bark delamination of the main trunk of the tree exposing the cambium and in area sapwood. The cause of the delamination is unknown, and my opinion is the tree is unlikely to recover from this. This opinion is based on the tree showing

no signs of response to this defect. According to the QTRA template this tree is considered a 'Unacceptable' risk and recommendations have been made.

Figure 8 - T018 significant wounding and delamination of bark

- 6.14 T018 – Fell tree to ground level due to the poor structural and physiological condition as represented by wounding on the main stem and loss of leaf cover in the canopy. I recommend re-planting with a Dawn redwood (*Metasequoia glyptostroboides*).
