Field House, Cannard's Grave Road, Shepton Mallet BA4 4LU
Prepared by Matt Cotley

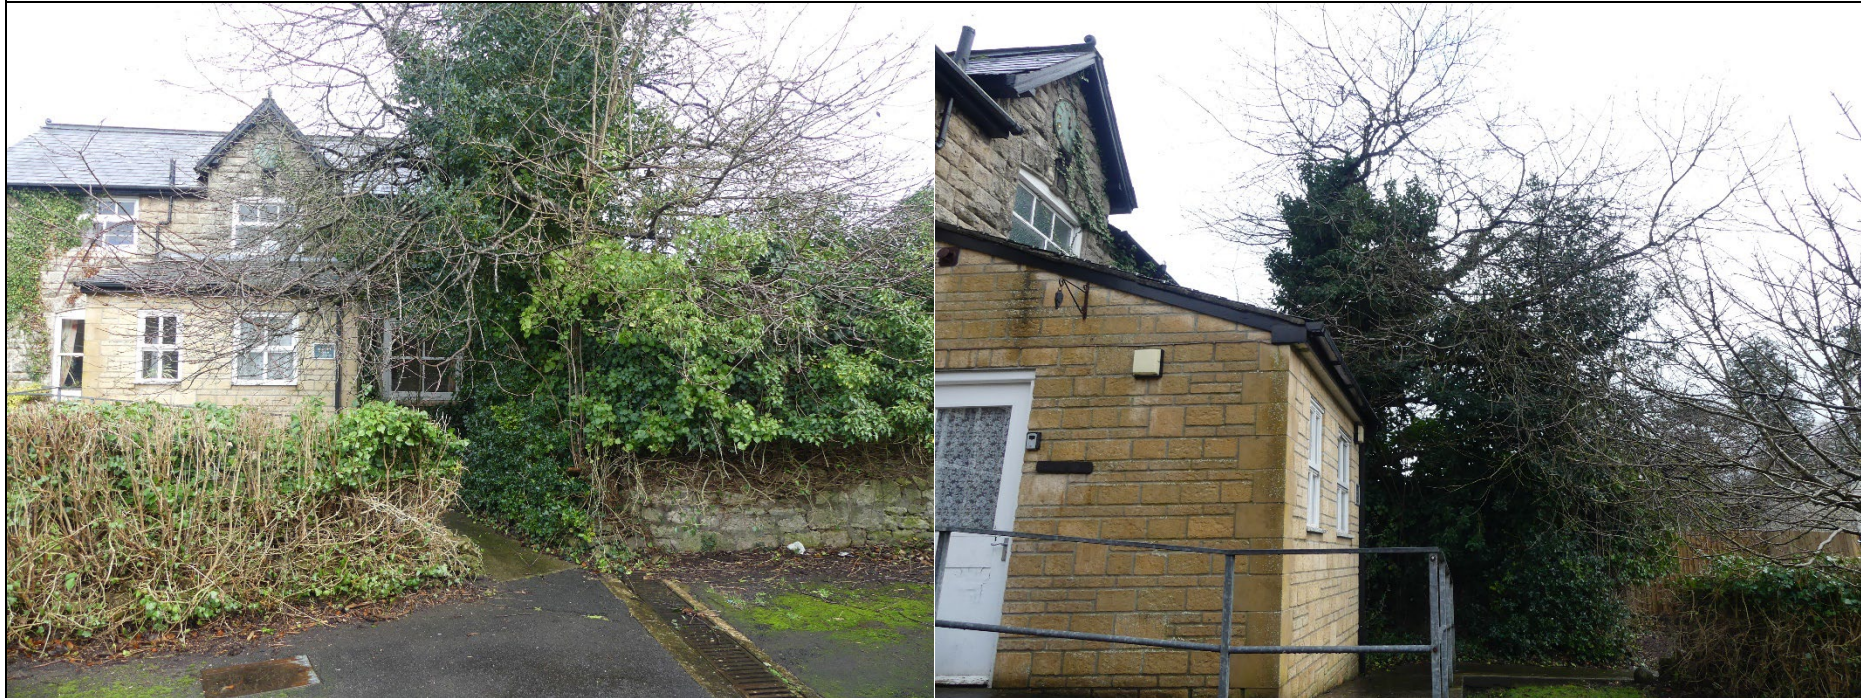
Tree Number:	G2	Species:	<i>Prunus sp. & Sambucus nigra</i>		
Failure Foreseeable:	Yes	No			
Risk of Harm:	Low		Moderate		High
Specific Target:	Users of garden, adjacent building/property.				
Intervention Required:	Yes	No	Within what time frame:	6 months	
Work Requirements:	Remove Elder (spot marked) Crown raise trees and prune away from building.

Two mature cherry trees situated in close proximity to training room building within a small shrub bed, dense Ivy growth around tree base and upper stem, branches in contact with building and low branches over pathway and wall into neighbouring property. Small twin stem Elder growing through the canopy of Southern most tree, overextending and in close proximity to stone wall (unsuitable for retention).

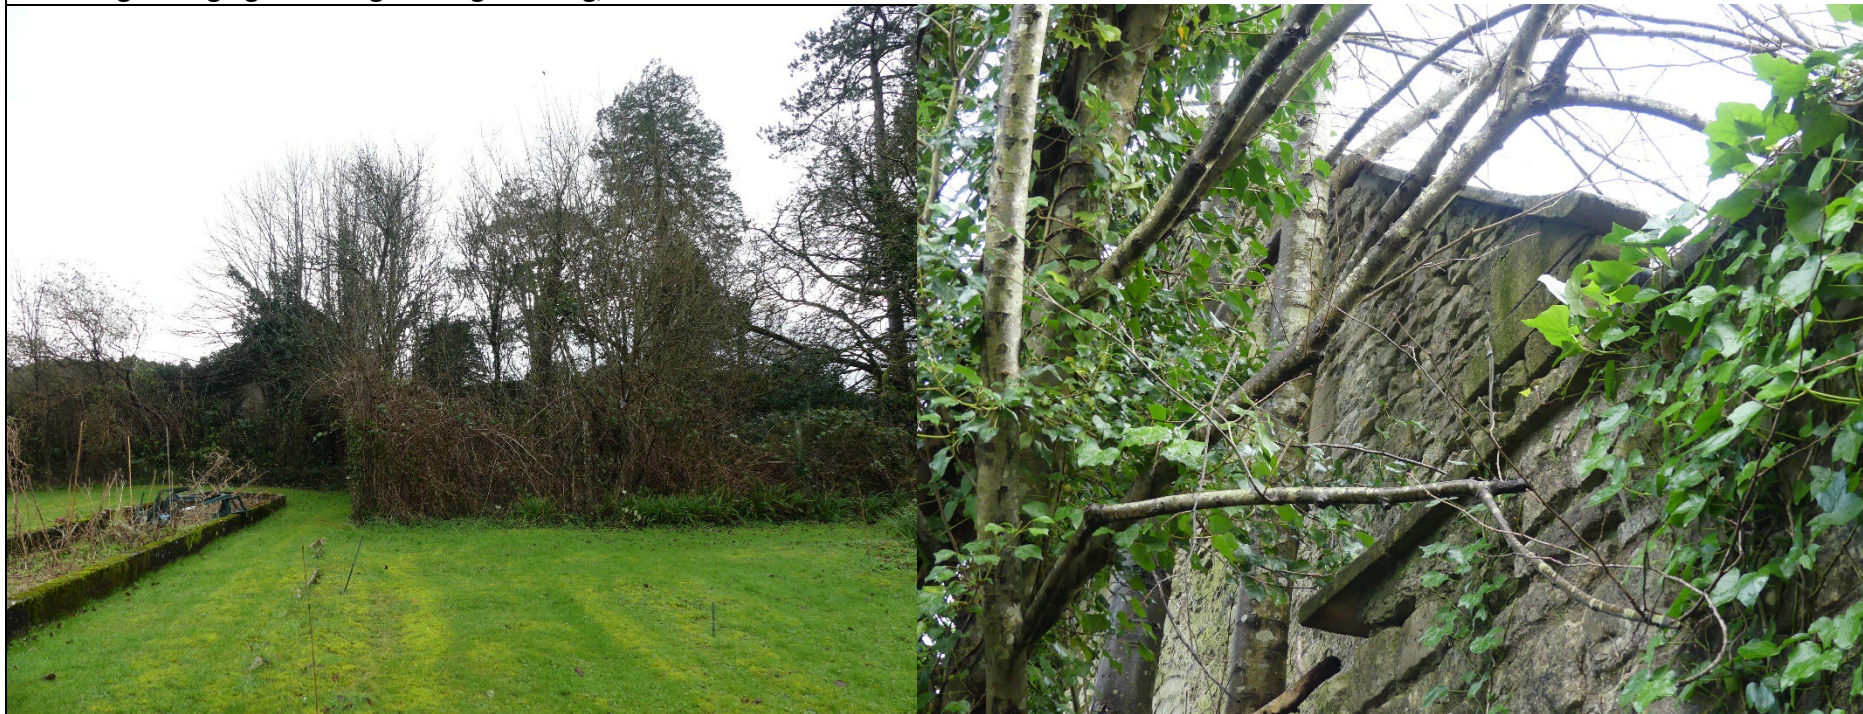
Tree Number:	G3	Species:	Various		
Failure Foreseeable:	Yes	No			
Risk of Harm:	Low		Moderate		High
Specific Target:	Users of garden, adjacent buildings.				
Intervention Required:	Yes	No	Within what time frame:	6 Months	
Work Requirements:	Prune Sycamores away from roof.

Group of young and mature trees situated in the eastern corner of the walled garden, dense area of mostly self-set species, including bramble and other weed species, multiple small dead trees, some minor deadwood present in established trees, group of Sycamore stems to East growing against neighbouring building, in contact with roof.

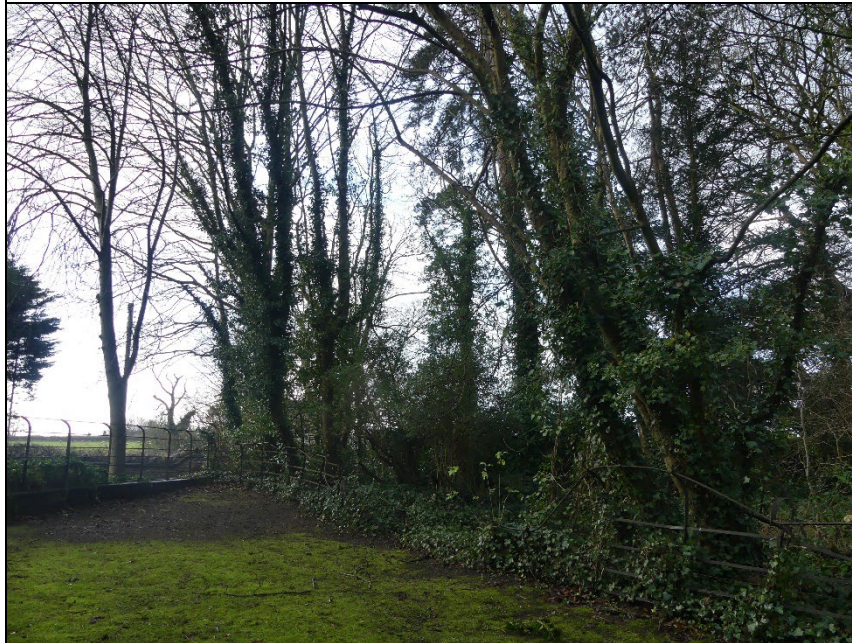
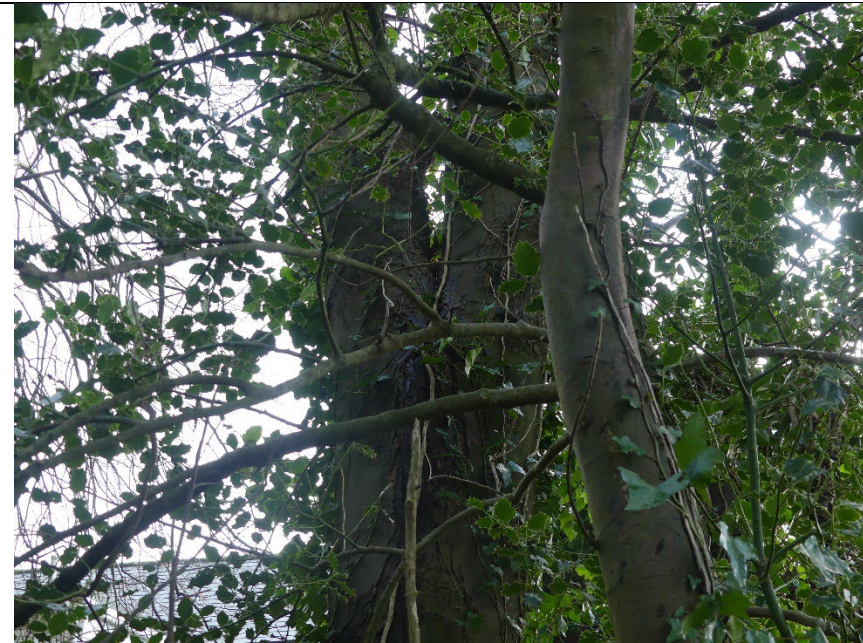
Tree Number:	G7	Species:	<i>Sycamore Acer pseudoplatanus</i>		
Failure Foreseeable:	Yes	No			
Risk of Harm:	Low		Moderate		High
Specific Target:	Users of garden, neighbouring property, public highway.				
Intervention Required:	Yes	No	Within what time frame:	6 months	
Work Requirements:	Sever Ivy. Remove spot marked trees. Remove significant deadwood over driveway and highway. Inspect compression fork at 3 meters and report to consultant.

Group of fourteen mature and semi mature Sycamores majority of group in close proximity to boundaries in the Southeastern corner adjacent public highway, neighbouring property and driveway. Significant ivy growth throughout group obscuring the base and the root collar also covering compression fork at 3m on largest tree in centre of the group. Notable bias to Southeast, several smaller trees leaning heavily and resting on adjacent Estate fencing (spot marked for removal). Significant deadwood over neighbouring driveway/entrance minor over highway.

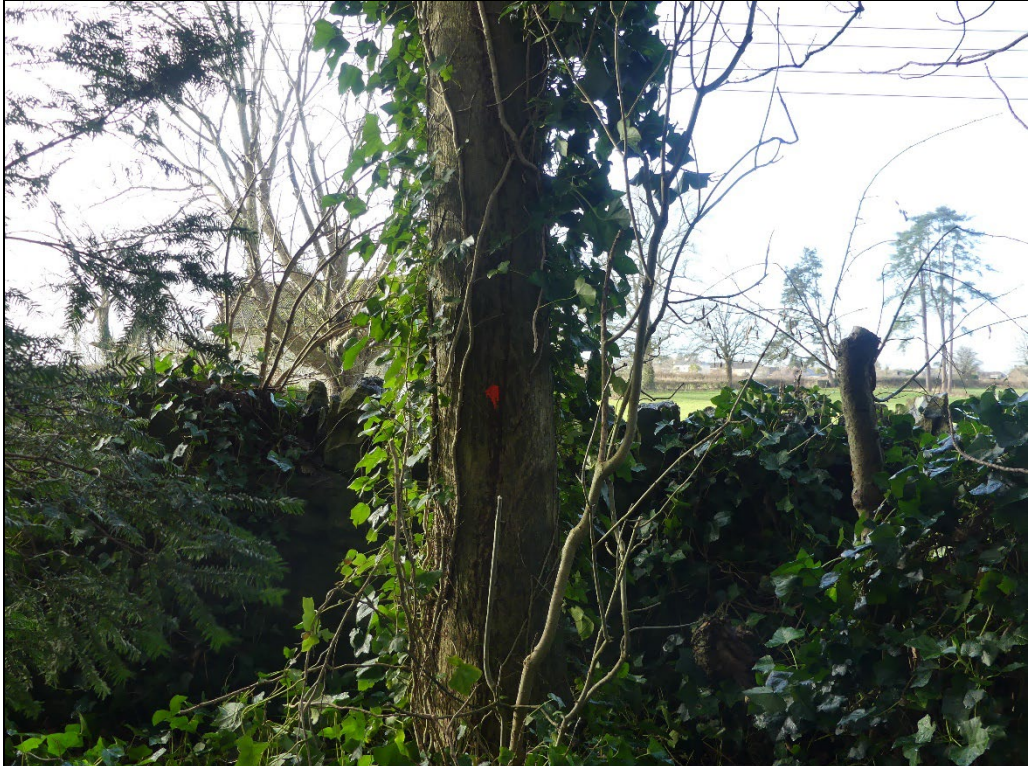
Tree Number:	T6	Species:	Ash <i>Fraxinus excelsior</i>		
Failure Foreseeable:	Yes	No			
Risk of Harm:	Low		Moderate		High
Specific Target:	Users of garden, neighbouring property, public highway.				
Intervention Required:	Yes	No	Within what time frame:	6 months	
Work Requirements:	Remove tree.				
Comments					
Mature Ash tree <1m from Southern boundary wall adjacent public highway, crown asymmetry and bias to South. Category two Ash Die Back, spot marked for removal.

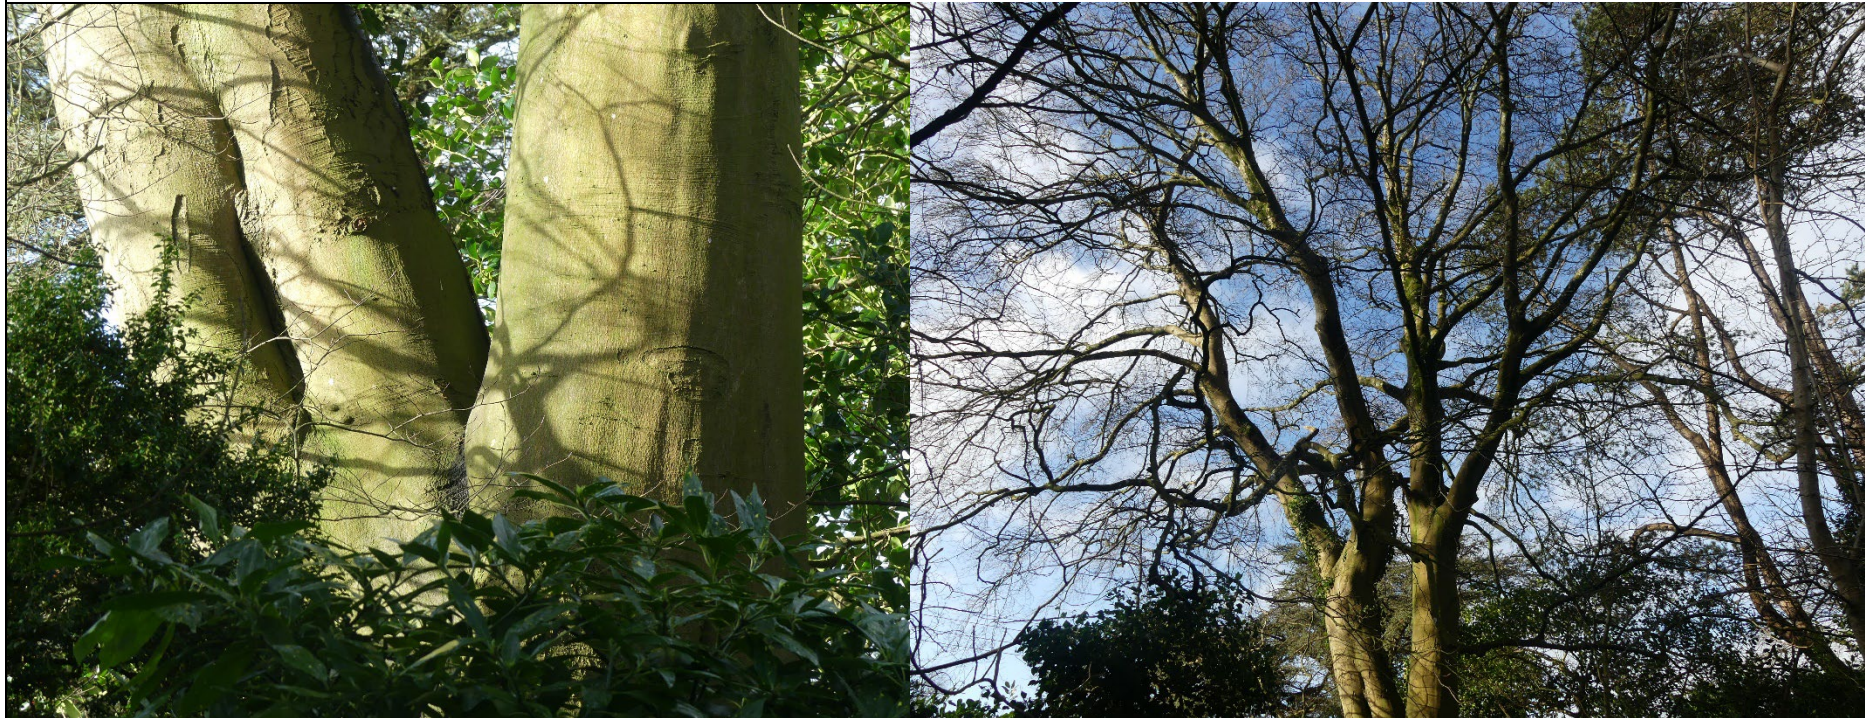
Tree Number:	T9	Species:	Common Beech <i>Fagus sylvatica</i>		
Failure Foreseeable:	Yes	No			
Risk of Harm:	Low		Moderate		High
Specific Target:	Users of garden, public highway.				
Intervention Required:	Yes	No	Within what time frame:	1 month	
Work Requirements:	Inspect stem union, report findings to consultant. Remove significant deadwood over highway.

A large mature Beech tree in very close proximity to Southern boundary wall adjacent the public highway, crown spread extends over the highway and domestic overhead cables on the opposite side. stem bifurcates at 2m compression fork with inclusions and again at 5m significant imbalance to co dominant stem. Stem over the highway has some major deadwood. Aerial inspection of main fork union required to assess stability and suitability of carrying out stem reduction over highway, findings to be reported to consultant.

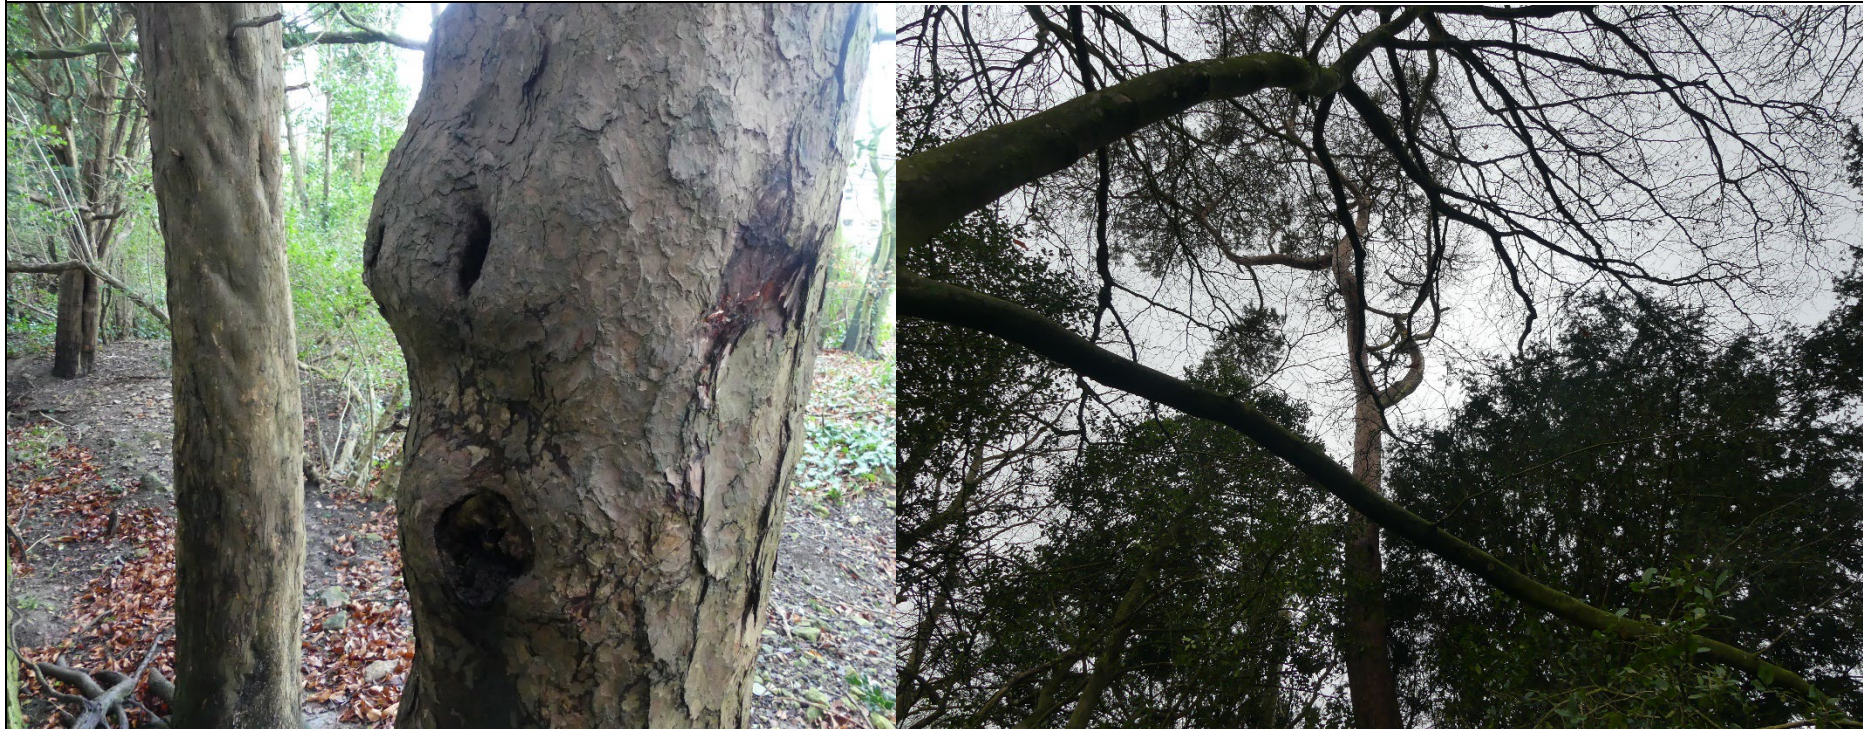
Tree Number:	T16	Species:	Scots Pine <i>Pinus sylvestris</i>		
Failure Foreseeable:	Yes	No			
Risk of Harm:	Low		Moderate		High
Specific Target:	Users of garden, public highway.				
Intervention Required:	Yes	No	Within what time frame:	3 months	
Work Requirements:	Remove tree.

Mature tree situated in close proximity to Southern boundary wall, grade increase around base of tree from badger activity. Several historic pruning wounds at 2m percussion tested and probed to maximum of 300mm indicating significant internal decay. Several additional pruning wounds further up the stem. Dead branch at 10m over road, thinning crown and declining vigour evident.

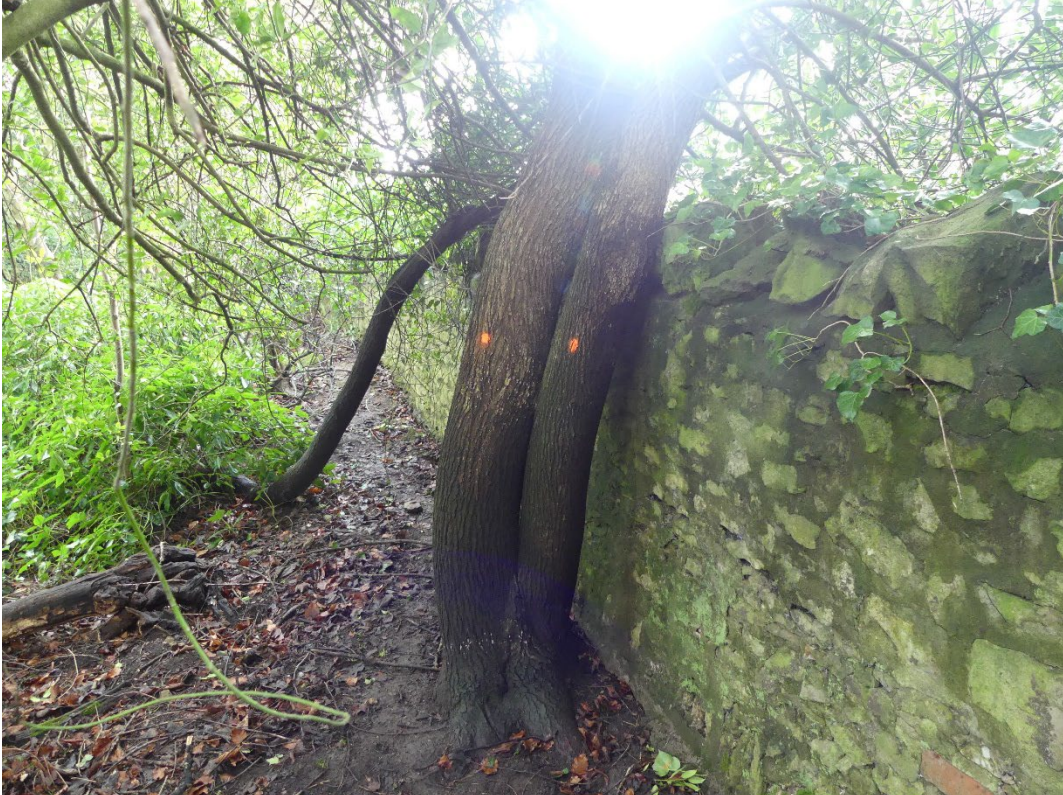
Tree Number:	T17	Species:	<i>Ulnus Sp.</i>		
Failure Foreseeable:	Yes	No			
Risk of Harm:	Low		Moderate		High
Specific Target:	Users of public highway.				
Intervention Required:	Yes	No	Within what time frame:	12 months	
Work Requirements:	Remove tree.				
Comments					
A mature twin stemmed tree growing against Southern boundary wall, crown asymmetrical and mostly over highway. Tree unsuitable for retention. Spot marked.

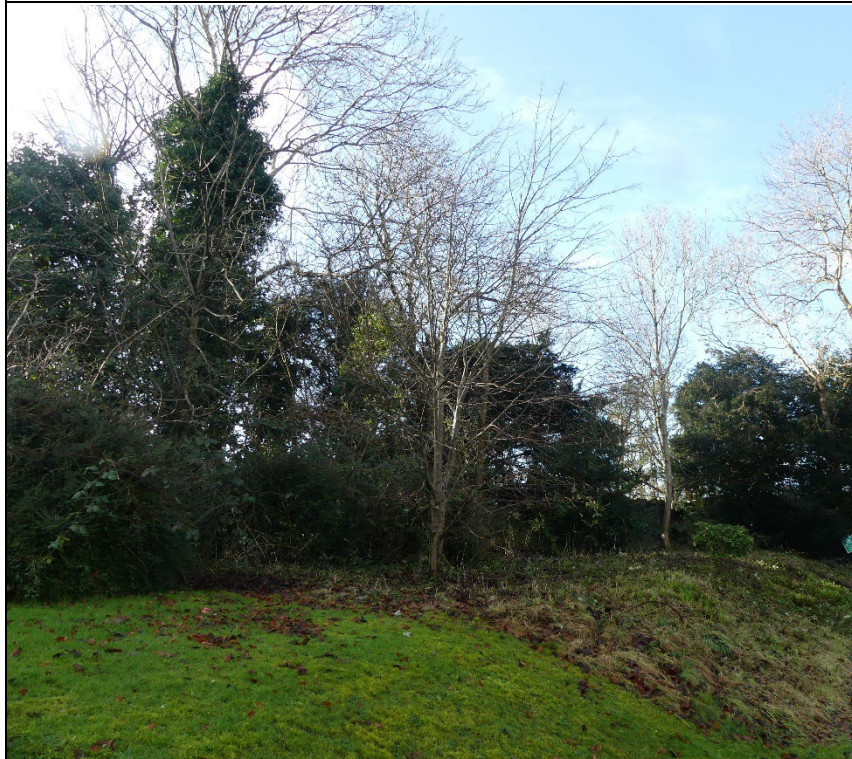
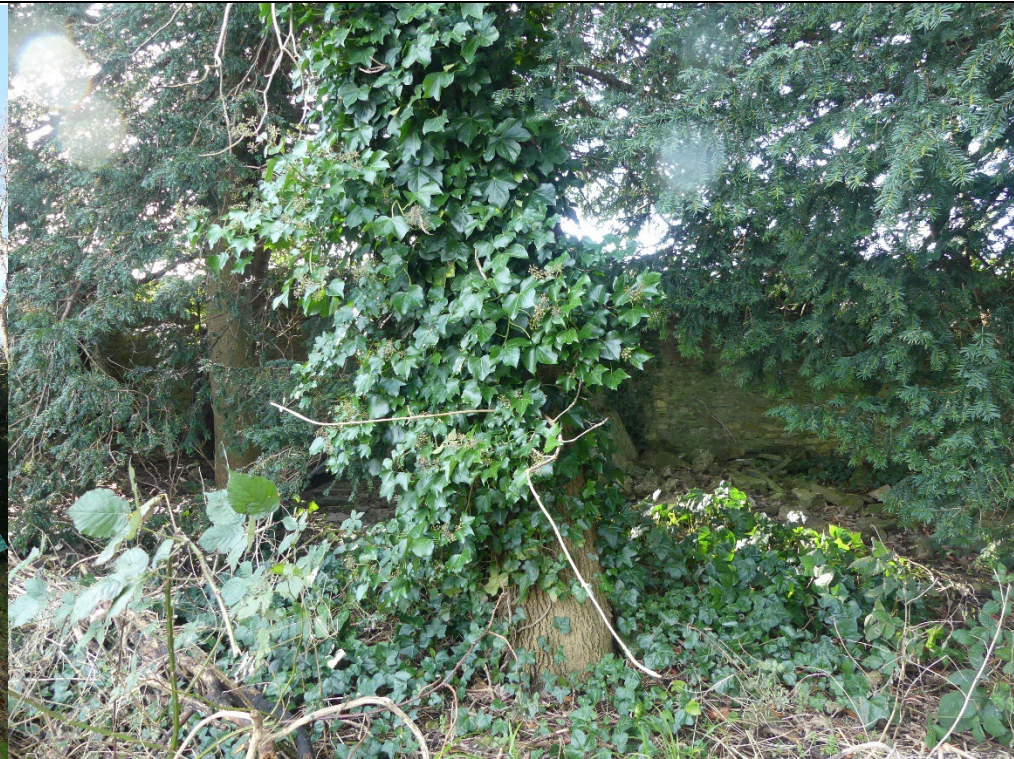
Tree Number:	G10	Species:	Ash <i>Fraxinus excelsior</i>		
Failure Foreseeable:	Yes	No			
Risk of Harm:	Low		Moderate		High
Specific Target:	Users of garden, car park, public highway.				
Intervention Required:	Yes	No	Within what time frame:	3 months	
Work Requirements:	Remove two spot marked trees. (West) Sever Ivy re inspect May 2024				
Comments					
Group of five mature Ash trees, situated alongside the Southern boundary of the site adjacent the public highway trees are showing some signs of Ash Die Back, the two trees (spot marked) West of group category 2, adjacent the car park, remaining trees some minor and heavy growth of ivy around the base obscuring you of the root collar and stem, re inspect trees May 2024

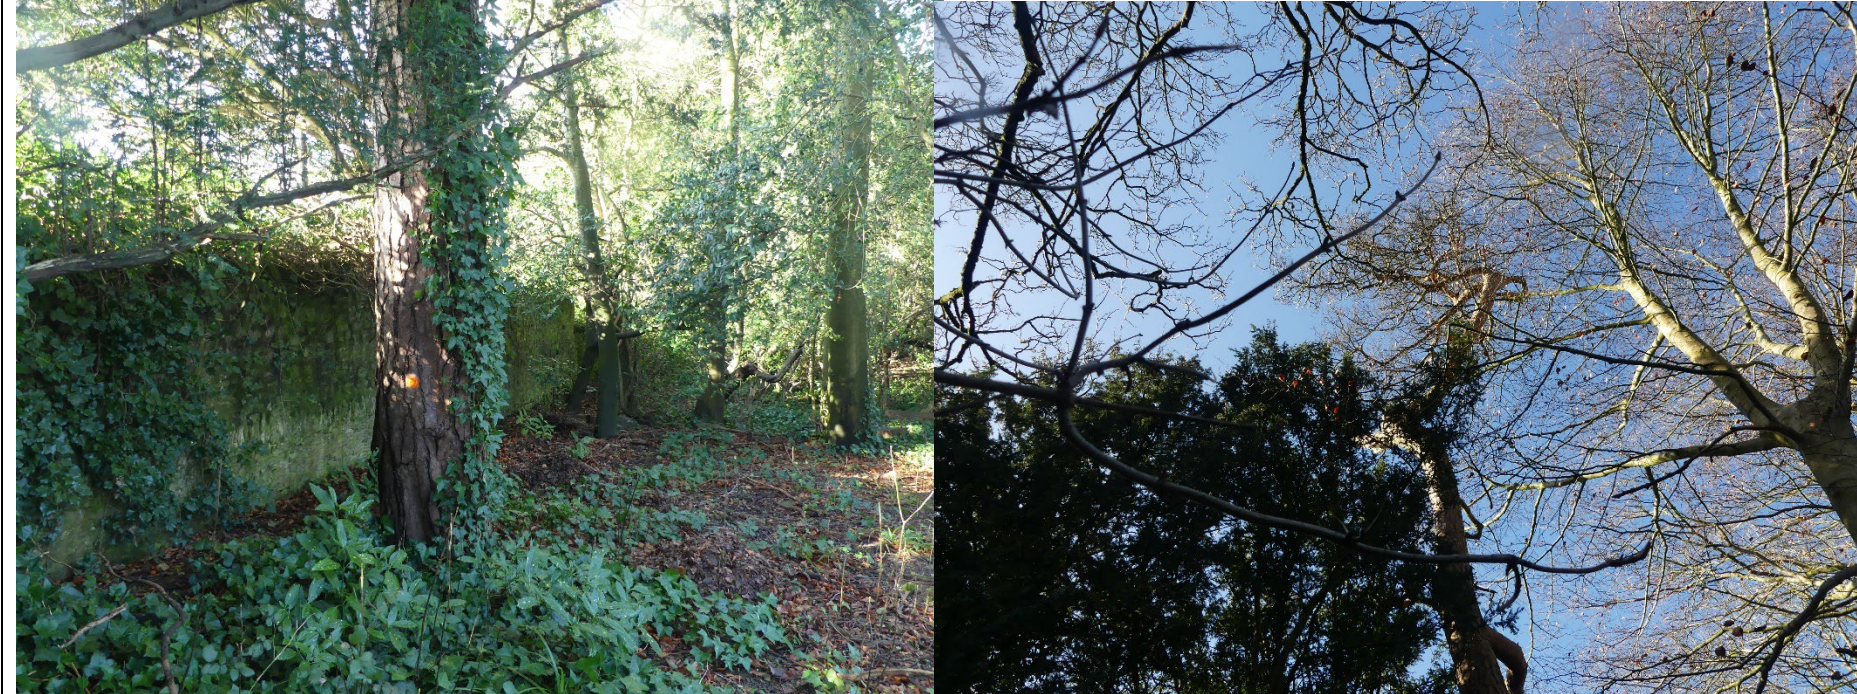
Tree Number:	T18	Species:	Scots Pine <i>Pinus sylvestris</i>		
Failure Foreseeable:	Yes	No			
Risk of Harm:	Low		Moderate		High
Specific Target:	Users of garden, public highway.				
Intervention Required:	Yes	No	Within what time frame:	1 month	
Work Requirements:	Remove tree.

Mature tree situated in close proximity to Southern boundary wall, systemic decline tree dead above lowest branch (10m) overextending toward highway.

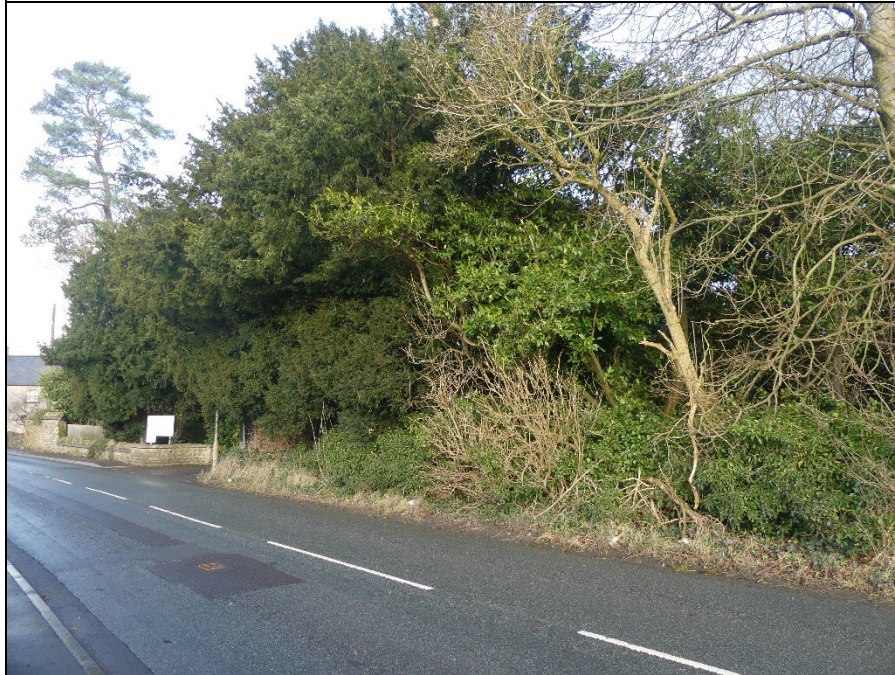
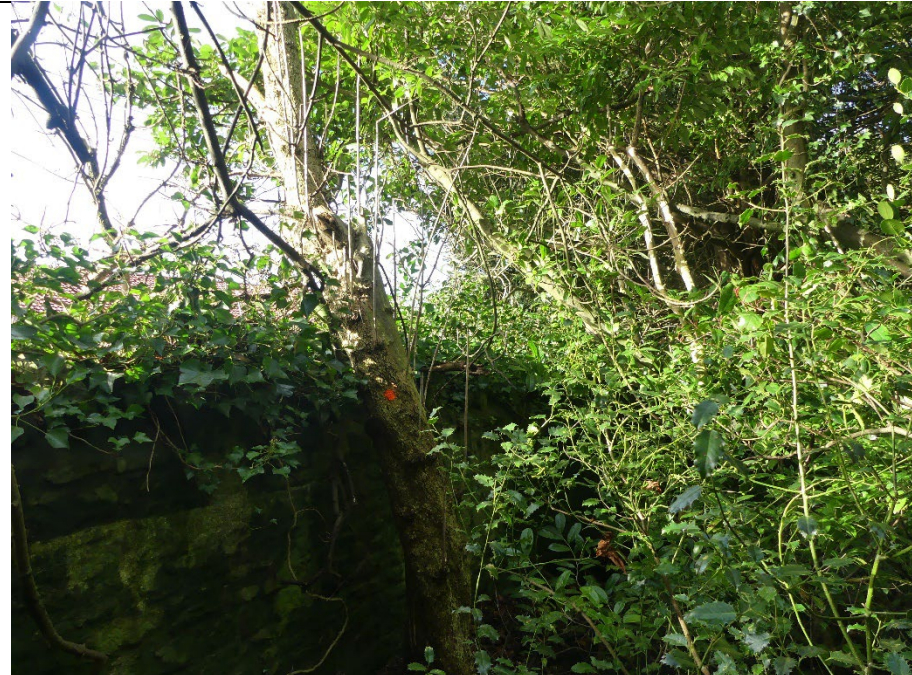
Tree Number:	G14	Species:	Various
Failure Foreseeable:	Yes	No	
Risk of Harm:	Low		Moderate
Specific Target:	Users of garden, entrance drive, footpath, public highway.		
Intervention Required:	Yes	No	Within what time frame: 6 months
Work Requirements:	Remove spot marked tree.

Group comprising of understory vegetation self-set trees and some larger planted mature trees, including some large Yews either side of entrance driveway. Spot marked Elder is resting against boundary wall top growth mostly over highway, tree has significant basal decay. Several failed stems in centre of group, other significant defects; heavy Ivy growth, major and minor deadwood, historic tear outs and cavity formation on several trees posing limited threat to site and highway users. Minor deadwood in Yews adjacent driveways entrance, 'air pruned' with adequate clearance.

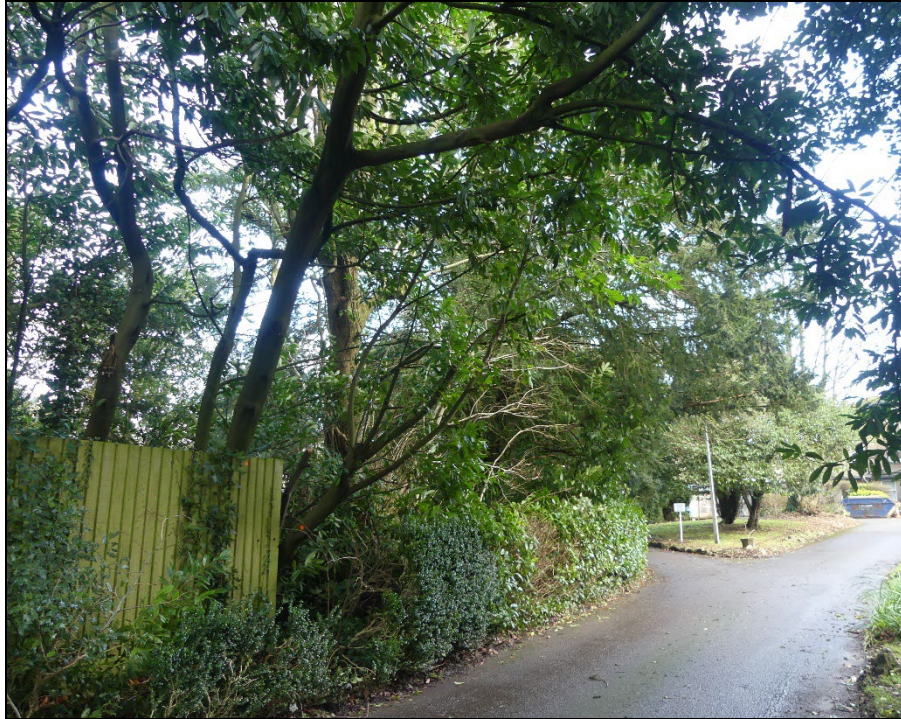
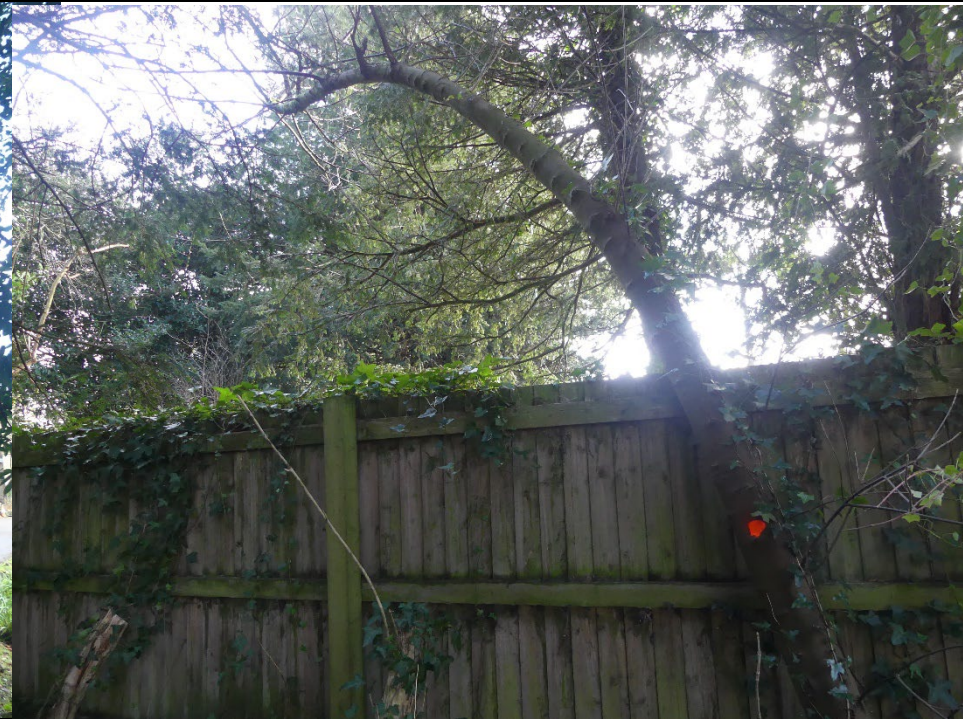
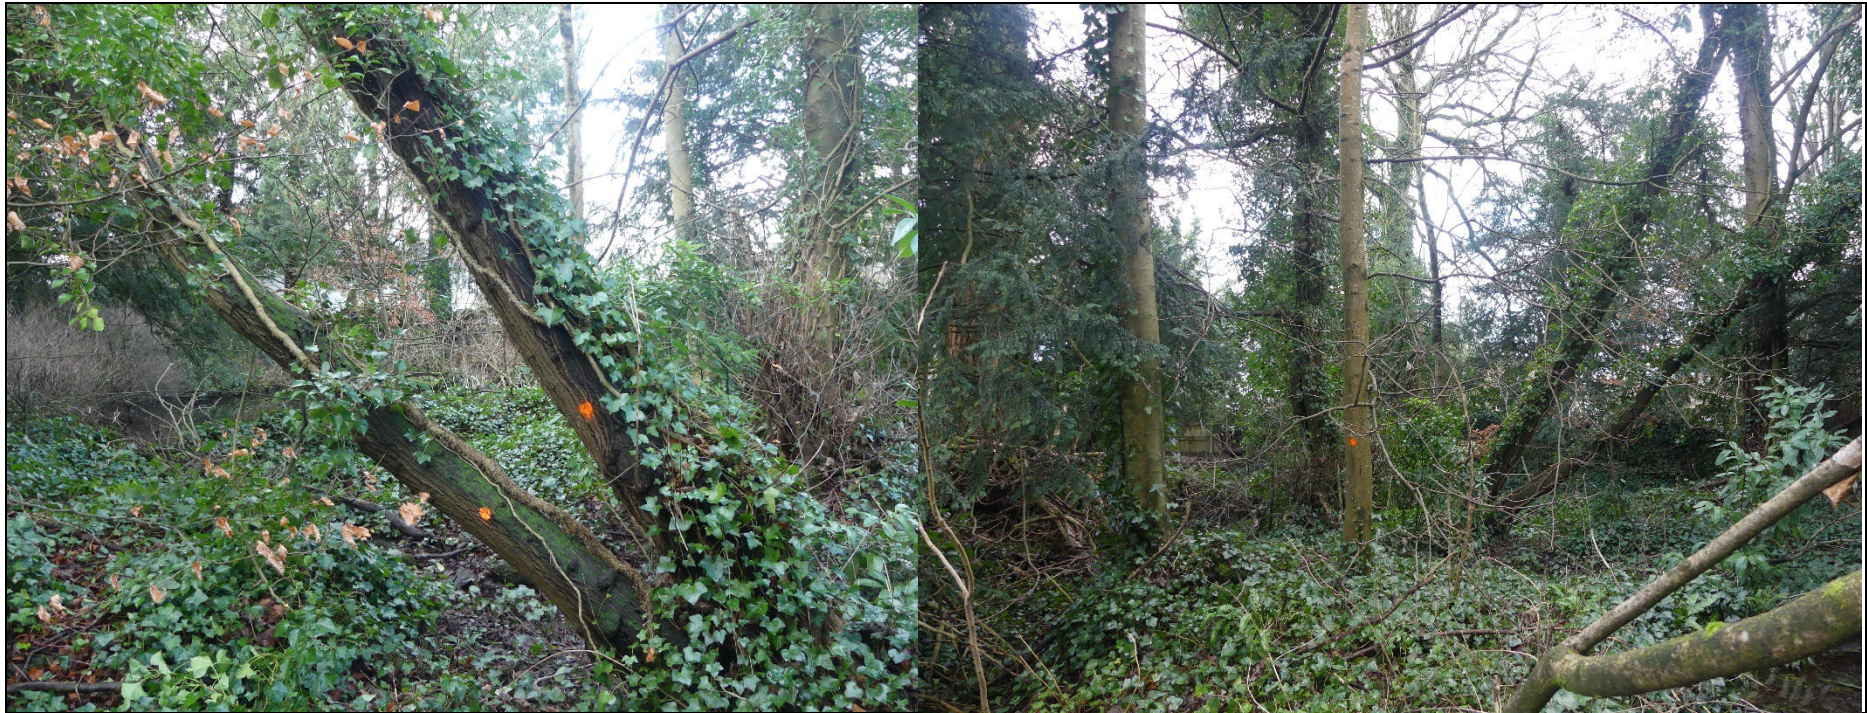
Tree Number:	G15	Species:	Various		
Failure Foreseeable:	Yes	No			
Risk of Harm:	Low		Moderate		High
Specific Target:	Users of garden, entrance drive, footpath, public highway.				
Intervention Required:	Yes	No	Within what time frame:	12 months	
Work Requirements:	Crown raise trees over driveway. Remove spot marked trees.

Unmaintained woodland Garden area adjacent the sites main entrance/drive a fenced area with no defined access containing various mature trees and self-set plantings, low branches over driveway, some dead stems, major and minor deadwood throughout, partial route plate failures, one mature Lime failed and leaning into adjacent tree, two Ash trees, one category 3 several low overextending stems resting on fencing. Significantly defective trees unsuitable or dangerous spot marked for removal.

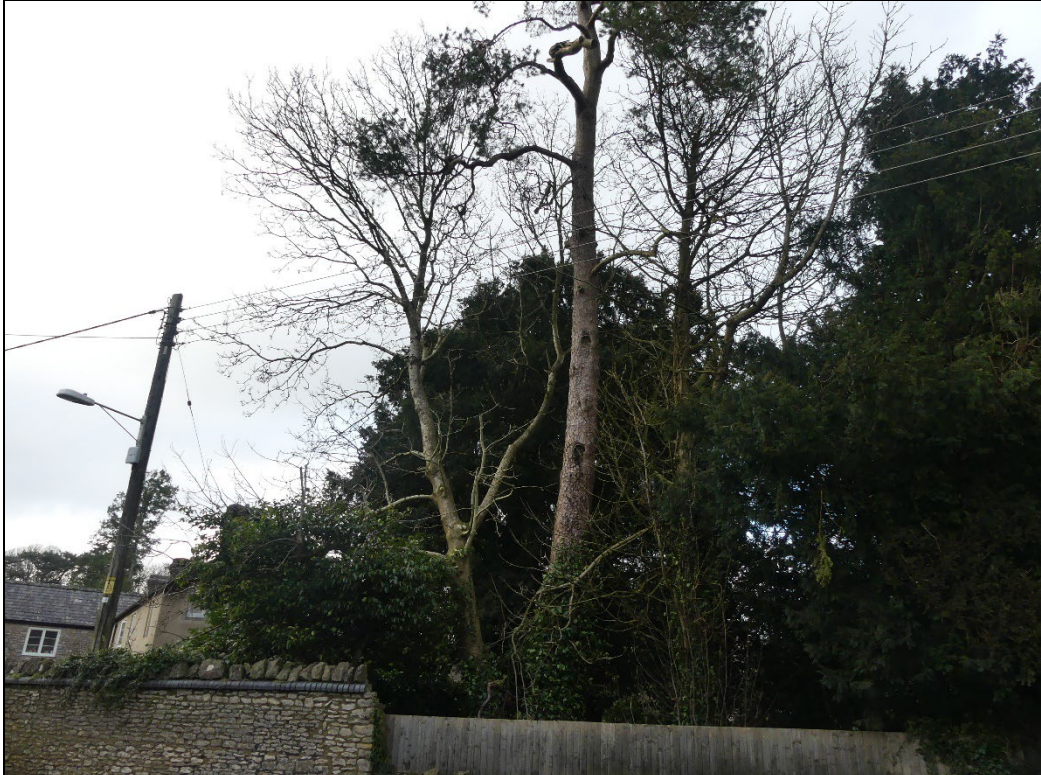
Tree Number:	T22	Species:	Scots Pine <i>Pinus sylvestris</i>		
Failure Foreseeable:	Yes	No			
Risk of Harm:	Low		Moderate		High
Specific Target:	Users of garden, entrance drive, footpath, public highway.				
Intervention Required:	Yes	No	Within what time frame:	6 months	
Work Requirements:	Remove damaged branch, and significant deadwood.				
Comments					
Mature Scots Pine situated adjacent T21 & T23 some asymmetry to crown towards highway South. Tree bases obscured with Ivy, epicormic and waste branches, poor pruning has left stubs on the South side, several split branches and significant deadwood over road.

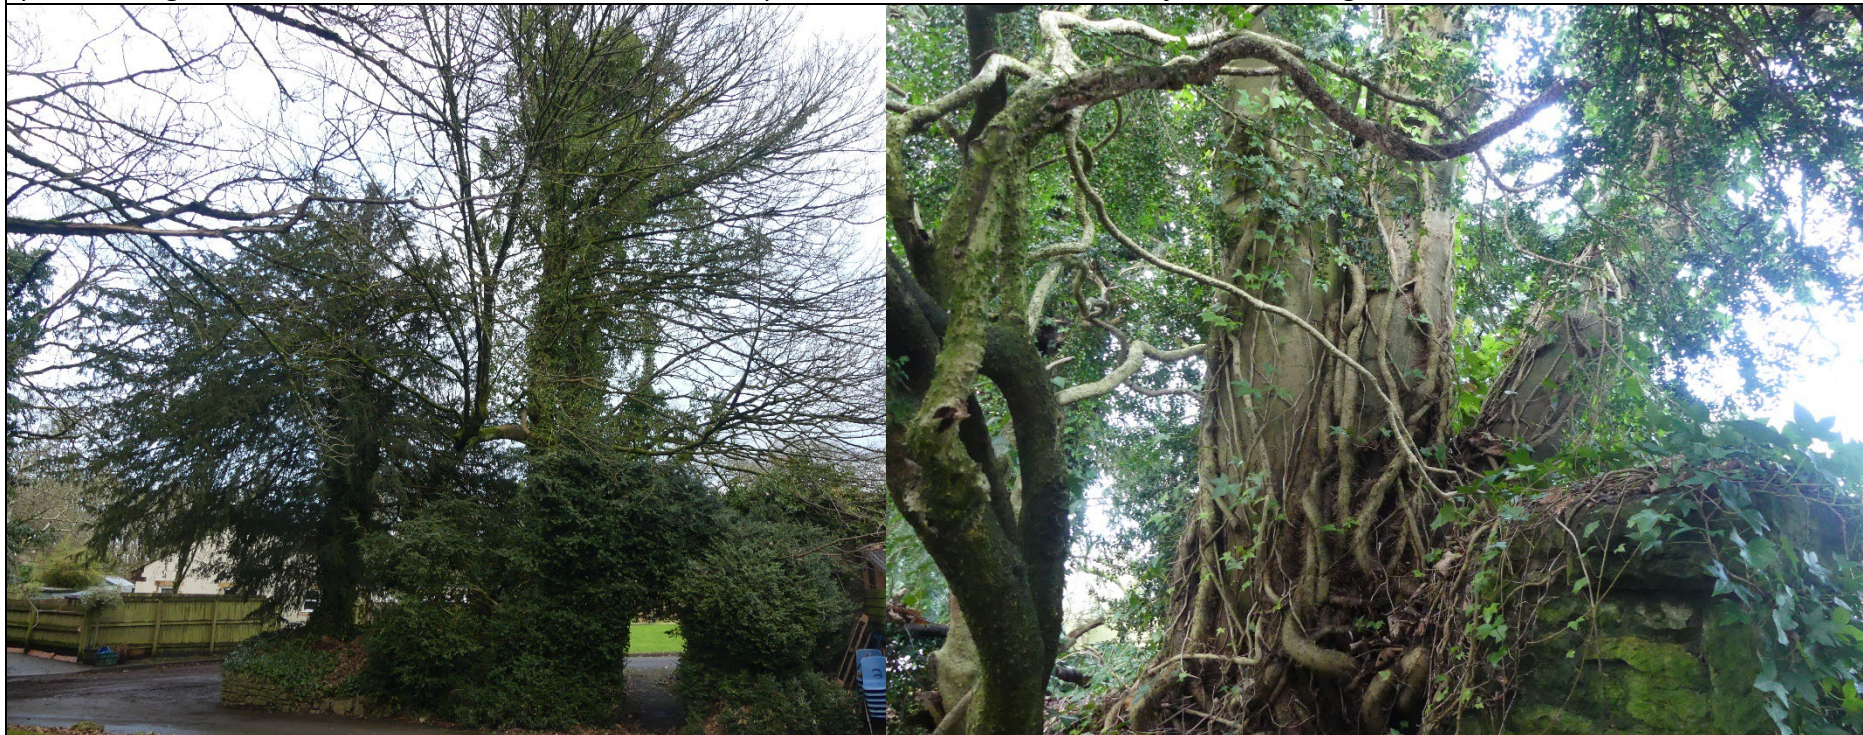
Tree Number:	G17	Species:	Yew <i>Taxus Baccata</i> Sycamore <i>Acer pseudoplatanus</i>		
Failure Foreseeable:	Yes	No			
Risk of Harm:	Low		Moderate	High	
Specific Target:	Users of entrance driveway, footpath.				
Intervention Required:	Yes	No	Within what time frame:	12 months	
Work Requirements:	Crown raise trees, remove significant deadwood over pathway and sever Ivy.

Two mature trees situated in a raised boarder in the North of the car park. Heavy ivy growth full assessment of base and root collar not possible. Tight forks and unions, dead branches over footpath and low branches over adjacent building

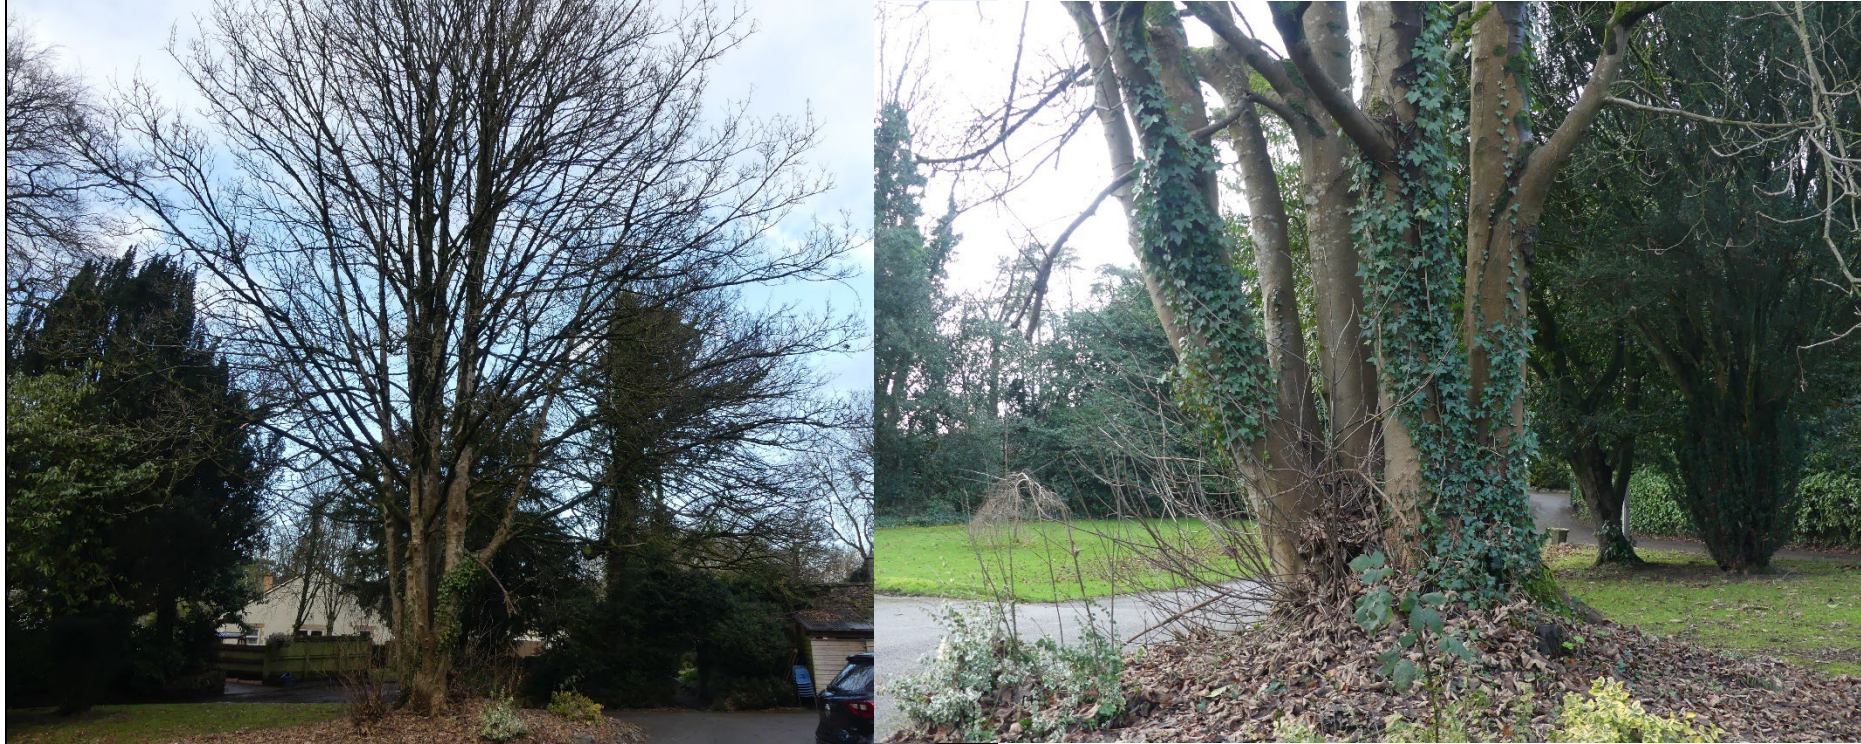
Tree Number:	T25	Species:	<i>Sycamore Acer pseudoplatanus</i>		
Failure Foreseeable:	Yes	No			
Risk of Harm:	Low		Moderate		High
Specific Target:	Users of garden, entrance drive, footpath.				
Intervention Required:	Yes	No	Within what time frame:	12 months	
Work Requirements:	Crown raise tree.

Mature multi-stemmed tree situated within a car park Island towards the entrance of the site multi-stemmed tree some tight unions at base Ivy and epicormic obscuring root collar minimal minor deadwood present, low branches over service yard area and car park.
