Phase 4 Validation Report
Proposed Care Home Stoney

Ridge Road
Bingley

Client: Torsion Projects

Aug 2023

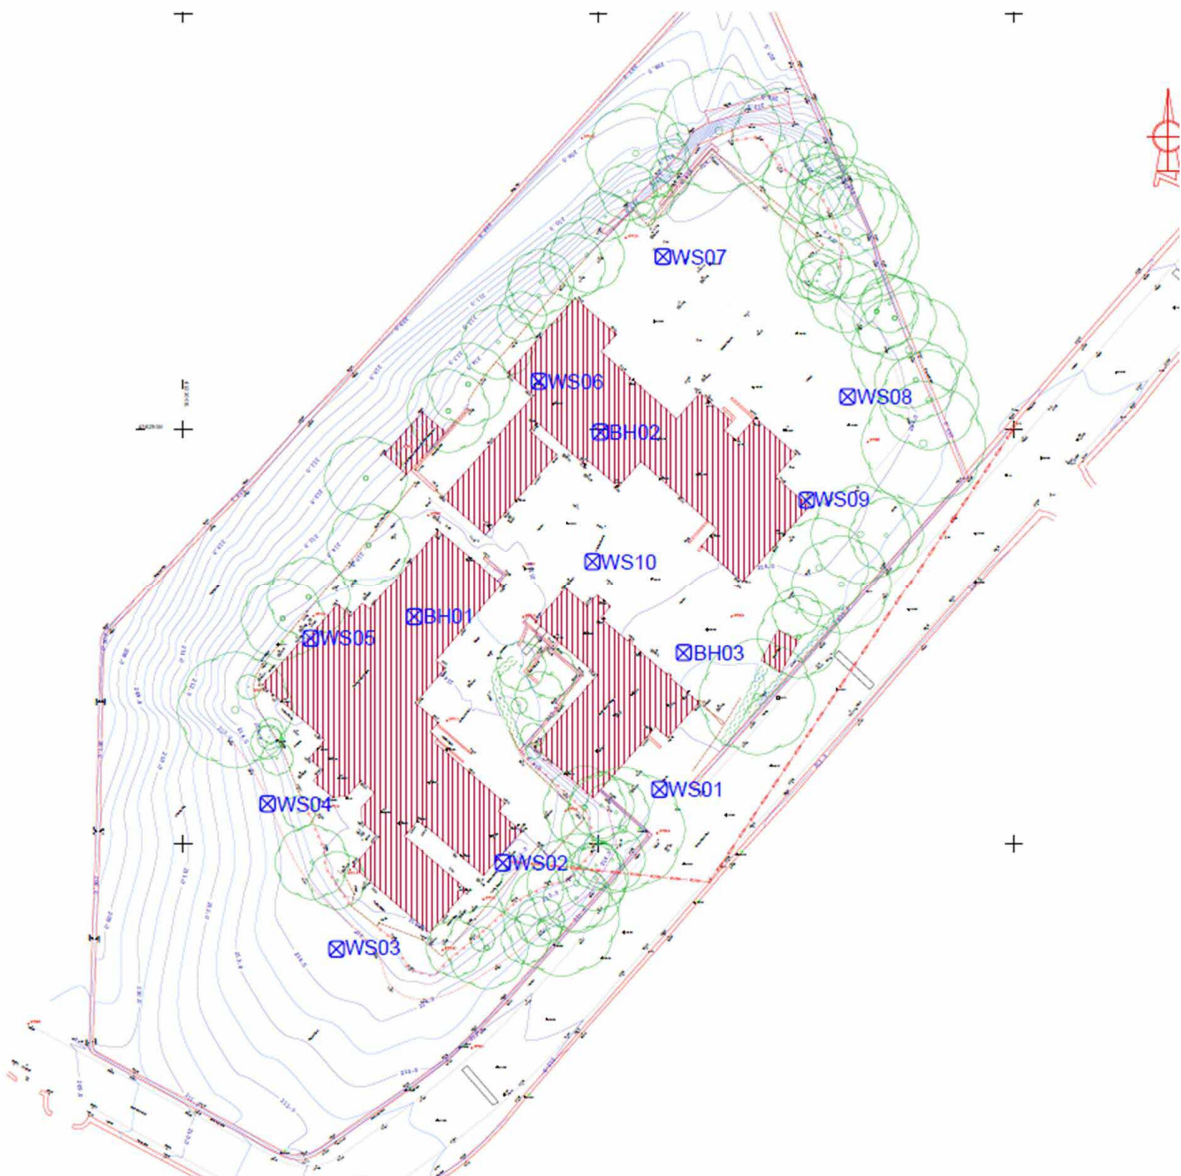
In June 2022 Ardmore Point Ltd completed a Phase 2 Ground Investigation Report for the site, plan of borehole positions shown below.

Made ground was encountered across the site in all exploratory positions to a typical proven depth of 0.8-1.0m. Made ground generally consisted of reworked sands , gravels with some rubble, brick , concrete

The results of laboratory tests, from the intrusive site investigation together with consideration of the conceptual and exposure models for the proposed development led to the remediation strategy recommendation to address the presence of asbestos locally encountered in WS08.

The remedial works shall include localised excavation of the known asbestos hotspot documented in the Phase 2 Report , ie around borehole WS08 ,was excavated to form a 3m x 3m x 1m section and the material removed from site to licenced landfill site. Following this samples were collected from the base and sides of this excavation , and then subsequent soil testing was carried, these works were carried out on 18/07/2023 and testing as carried out by I2 analytical.
