ADDENDUM TECHNICAL REPORT

Crawford Reference: SU2206126

**Stanton Guildhouse Ltd
The Stanton Guildhouse
Broadway
Worcestershire
WR12 7NE**

SUBSIDENCE CLAIM

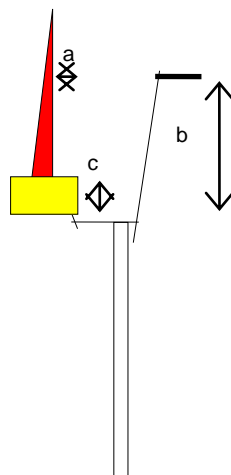
A trial hole was excavated to expose the foundations - see site plan for location and the diagram below for details. Four trial holes have been undertaken at the property as follows.

- Trial hole one was undertaken on the front elevation of the main building to its lefthand side. This confirmed that at this point the structure benefitted from a concrete foundation which stepped out from the face of the buildings wall by 180mm. This foundation was 680mm thick in total and the underside of the foundation was 1100 deep underground and sited in soils described as being stiff brown and grey CLAY.

- Trial hole two was undertaken against the main building on the internal courtyard side of the outrigger on the building which housed the ground floor bedroom. This confirmed that the building at this point had a concrete foundation which projected 190mm out from the external face of the wall. This foundation was 700mm thick and it was 1000mm deep underground to its underside. The foundations at this point sat in soils described as being stiff brown and grey CLAY.

- Trial three at the property was undertaken on the front lefthand corner of the workshop beside the entrance door. This confirmed that the structure benefitted from a concrete foundation which projected 170mm out from the face of the building and was 110mm thick. The foundations of the workshop were found to be 810mm deep underground at this point of the building and they sat in soils described as being stiff brown and grey CLAY.

- A final trial hole, trial hole 4 was taken on the rear right hand side of the workshop and this confirmed that at this point the structure benefitted from a concrete foundation which projected away from the external face of the building by 100mm, the foundation was found to be 500mm thick and it was 1900mm deep to its underside. As with each other trial hole the foundations were found to be sitting in soils described as being stiff brown and grey CLAY.

No.	Borehole Depth	Footing (a)	Underside (b)	Thickness (c)
TH1	3.00 m.	180 mm.	1,100 mm.	680 mm.
TH2	3.00 m.	190 mm.	1,000 mm.	700 mm.
TH3	3.00 m.	170 mm.	810 mm.	110 mm.
TH4	3.00 m.	100 mm.	1,900 mm.	500 mm.
