**TECHNICAL REPORT ON A SUBSIDENCE CLAIM**

**Crawford Reference: SU2206126**

**Stanton Guildhouse Ltd  
The Stanton Guildhouse  
Broadway  
Worcestershire  
WR12 7NE**

**SUBSIDENCE CLAIM**

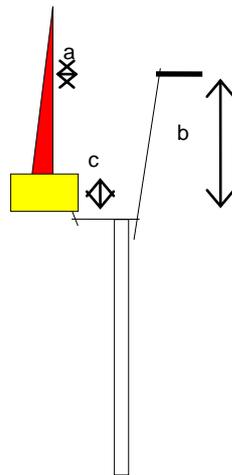
Foundation Details

Trial hole one was undertaken on the front elevation of the main building to its lefthand side. This confirmed that at this point the structure benefitted from a concrete foundation which stepped out from the face of the buildings wall by 180mm. This foundation was 680mm thick in total and the underside of the foundation was 1100 deep underground and sited in soils described as being stiff brown and grey CLAY.

Trial hole two was undertaken against the main building on the internal courtyard side of the outrigger on the building which housed the ground floor bedroom. This confirmed that the building at this point had a concrete foundation which projected 190mm out from the external face of the wall. This foundation was 700mm thick and it was 1000mm deep underground to its underside. The foundations at this point sat in soils described as being stiff brown and grey CLAY.

Trial hole three at the property was undertaken on the front lefthand corner of the workshop beside the entrance door and the external stairs. This confirmed that the structure benefitted from a concrete foundation which projected 170mm out from the face of the building and was 110mm thick. The foundations of the workshop were found to be 810mm deep underground at this point of the building and they sat in soils described as being stiff brown and grey CLAY.

A final trial hole, trial hole 4 was taken on the rear right hand side of the workshop and this confirmed that at this point the structure benefitted from a concrete foundation which projected away from the external face of the building by 100mm, the foundation was found to be 500mm thick and it was 1900mm deep to its underside. As with each other trial hole the foundations were found to be sitting in soils described as being stiff brown and grey CLAY.

No.	Borehole Depth	Footing (a)	Underside (b)	Thickness (c)
TH1	3.00 m.	180 mm.	1,100 mm.	680 mm.
TH2	3.00 m.	190 mm.	1,000 mm.	700 mm.
TH3	3.00 m.	170 mm.	810 mm.	110 mm.
TH4	3.00 m.	100 mm.	1,900 mm.	500 mm.
