# Arboricultural Appraisal Report

## Subsidence Damage Investigation at:

The Stanton Guildhouse  
 Broadway  
 WR12 7NE

| MWA REF: | SUB230210-12320 |

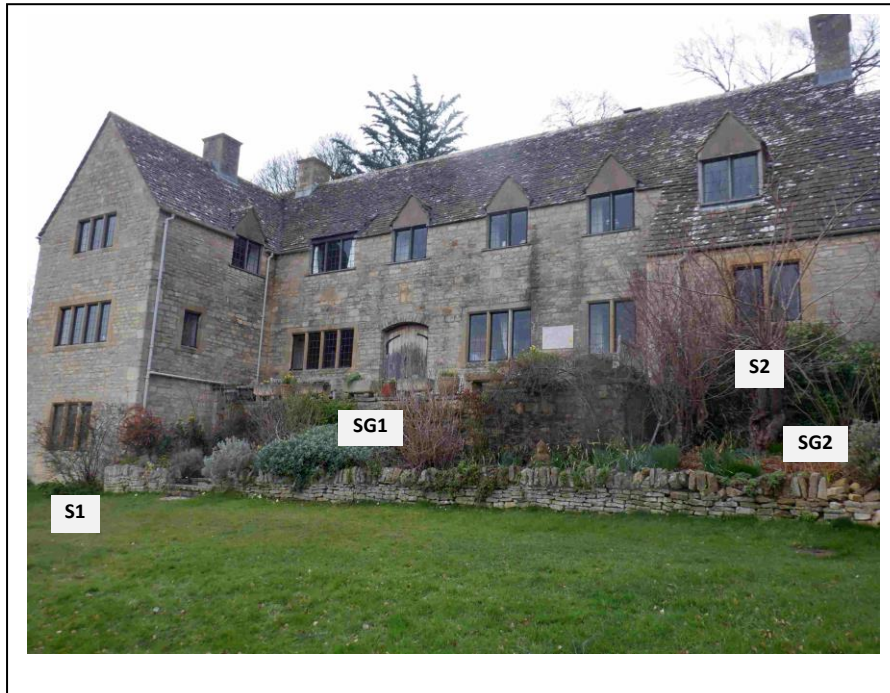
Irrespective of the identification of recovered root samples, the roots of the Cherry (T19), the Cypress (T20), the Plum (T2 and T15), the Prunus spp. (T13), the Apple (T14), the Pear (T8), the Shrub (S1), the Cotinus (S2) and the Shrub group (SG1 & SG2) are also likely to be present below foundation level in proximity to the area of movement/damage and influencing soil moisture and volumes.

View of the rear elevation S1, S2, SG1 & SG2

| Tree No. | Species | Ht (m) | Dia (mm) | Crown Spread (m) | Dist. to building (m) | Age Classification | Ownership |
|---|---|---|---|---|---|---|---|
| Recommendation | | Remove (fell) to near ground level and treat stump to inhibit regrowth. | | | | | |

| Tree No. | Species | Ht (m) | Dia (mm) | Crown Spread (m) | Dist. to building (m) | Age Classification | Ownership |
|---|--|--|---|---|---|---|---|
| Recommendation | | Remove (fell) to near ground level and treat stumps to inhibit regrowth. | | | | | |

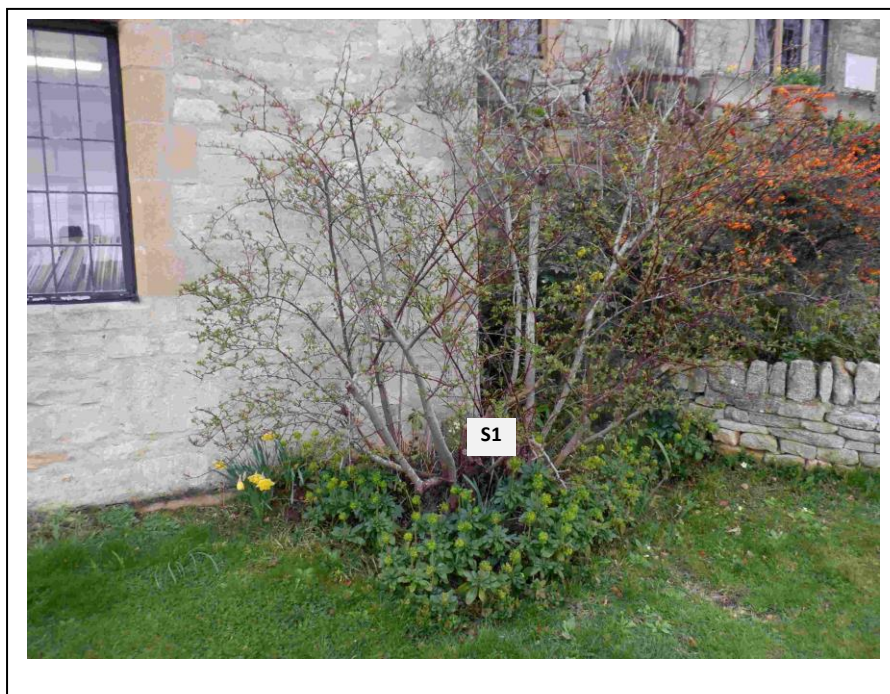
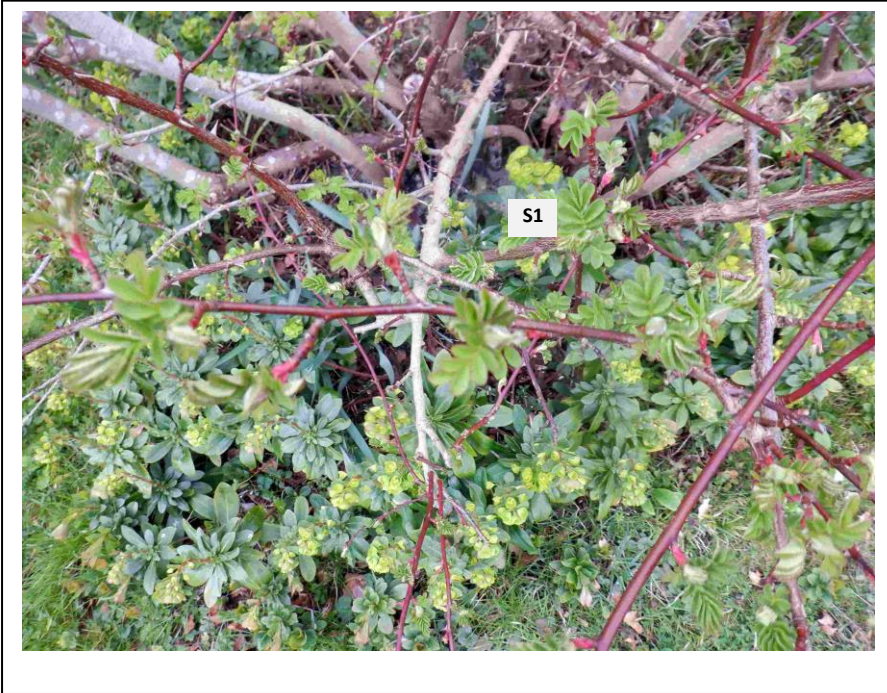
| Tree No. | Species | Ht (m) | Dia (mm) | Crown Spread (m) | Dist. to building (m) | Age Classification | Ownership |
|---|---|---|---|---|---|---|---|
| S1 | Shrub (unknown) | 2.3 | 35 Ms * | 2.5 | 0.5 | Younger than Property | Policy Holder |

View of S1

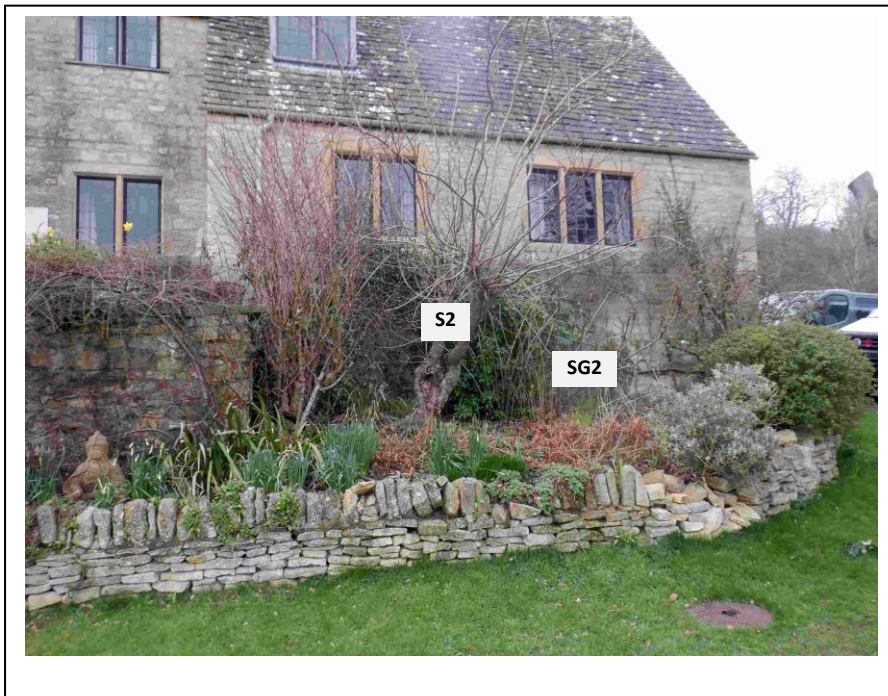
| Tree No. | Species | Ht (m) | Dia (mm) | Crown Spread (m) | Dist. to building (m) | Age Classification | Ownership |
|---|---|---|---|---|---|---|---|
| S2 | Cotinus (tentative) | 4.8 | 130 Ms * | 5.25 | 2.2 | Younger than Property | Policy Holder |

View of S2 & SG2

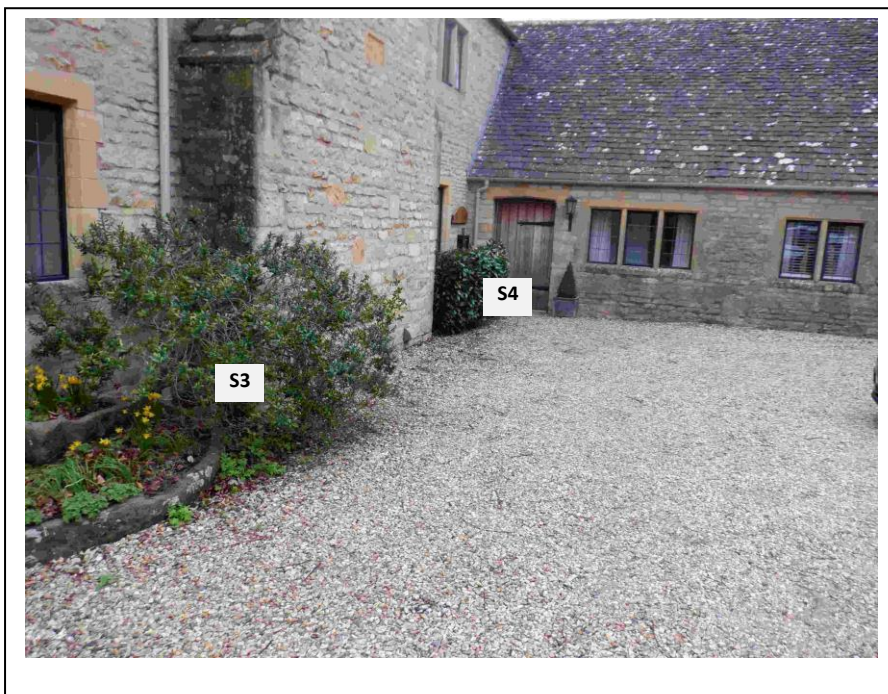
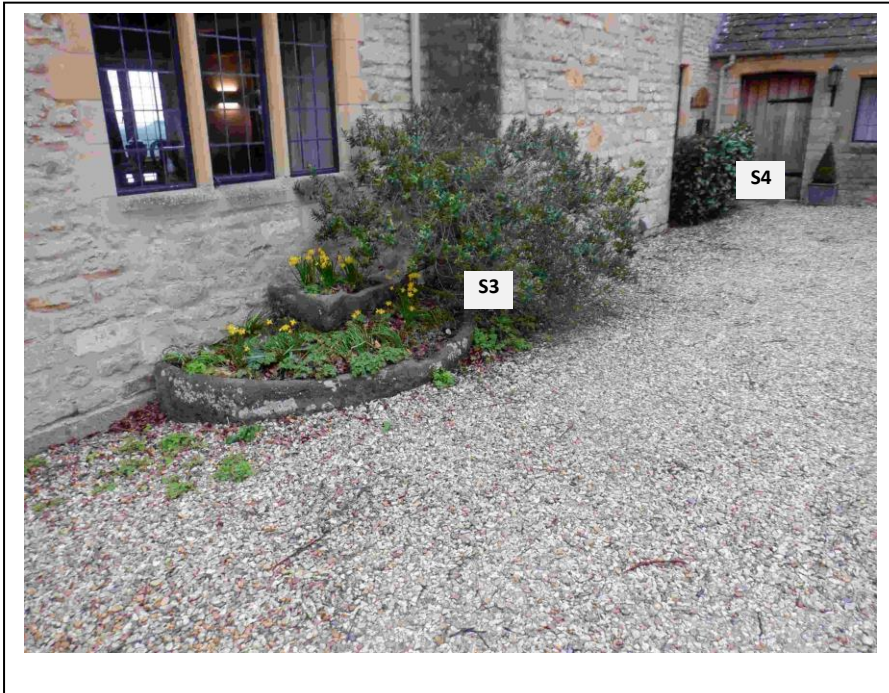
| Tree No. | Species | Ht (m) | Dia (mm) | Crown Spread (m) | Dist. to building (m) | Age Classification | Ownership |
|---|--|--|---|---|---|---|---|
| S4 | Bay laurel | 1.6 | 10 Ms<br>* | 2 | 0.4 | Younger than Property | Policy Holder |

View of S3 & S4

| Tree No. | Species | Ht (m) | Dia (mm) | Crown Spread (m) | Dist. to building (m) | Age Classification | Ownership |
|---|--|--|---|---|---|---|---|
| Recommendation | | Remove (fell) to near ground level and treat stump to inhibit regrowth. | | | | | |

| Tree No. | Species | Ht (m) | Dia (mm) | Crown Spread (m) | Dist. to building (m) | Age Classification | Ownership |
|---|---|--|---|---|---|---|--|
| Recommendation | | No works at present. | | | | | |

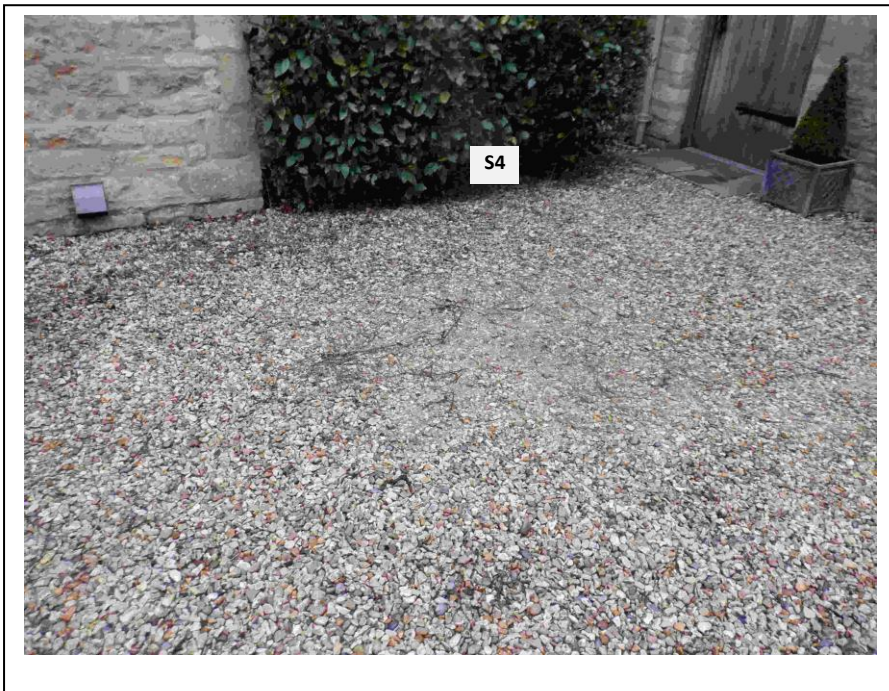
View of S4

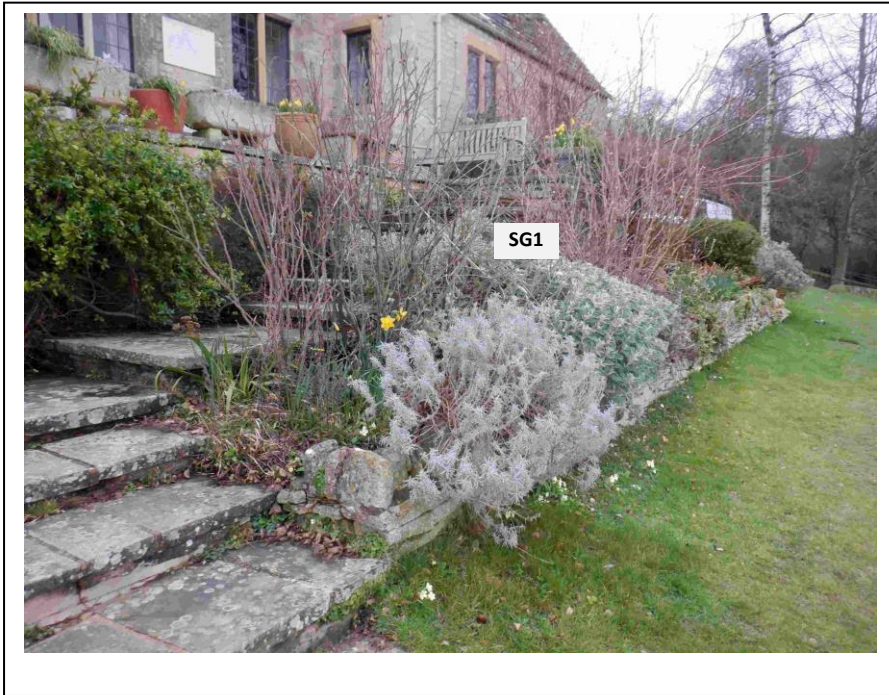
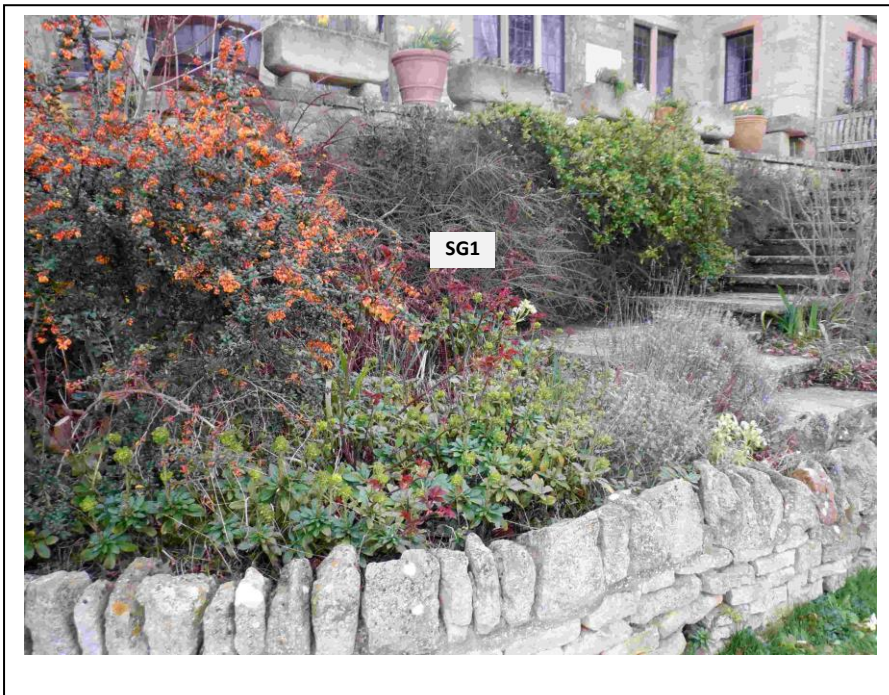
| Tree No. | Species | Ht (m) | Dia (mm) | Crown Spread (m) | Dist. to building (m) | Age Classification | Ownership |
|---|--|--|---|---|---|---|---|
| SG1 | Mixed species shrubs including Cotoneaster, Mahonia, Choisya, Berberis, Lilac (tentative), Honeysuckle, Rose, Viburnum | 2.1 | 25 Ms<br>* | 3 | 0.1 | Younger than Property | Policy Holder |

View of SG1

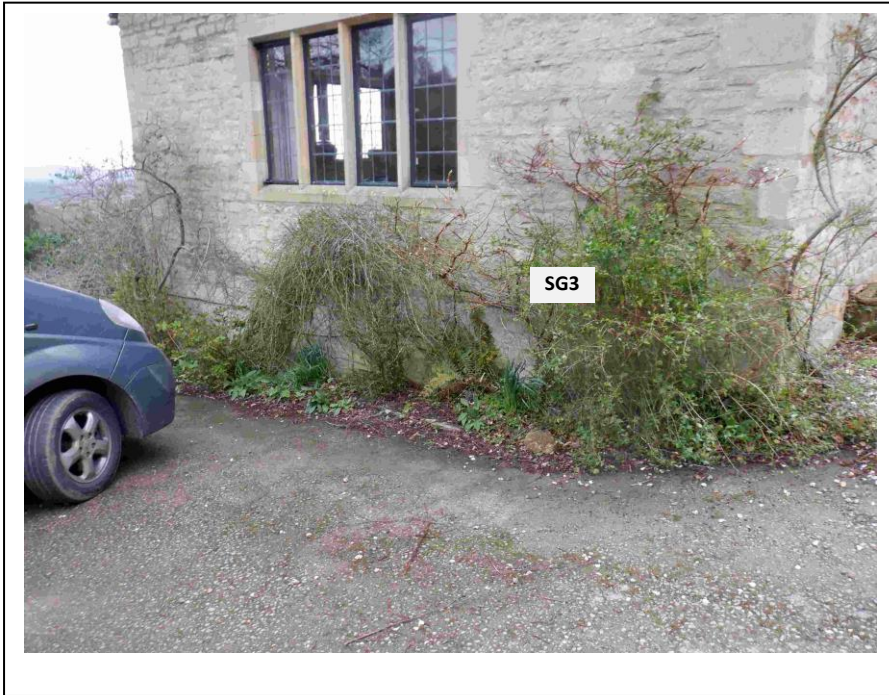
| Tree No. | Species | Ht (m) | Dia (mm) | Crown Spread (m) | Dist. to building (m) | Age Classification | Ownership |
|---|---|--|---|---|---|---|--|
| SG3 | Mixed species shrubs including Jasmine, Climbing Hydrangea, Cotoneaster and Hypericum | 2 | 2.5 Ms * | 1 | 0.2 | Younger than Property | Policy Holder |

View of SG3

| Tree No. | Species | Ht (m) | Dia (mm) | Crown Spread (m) | Dist. to building (m) | Age Classification | Ownership |
|---|---|--|---|---|---|---|--|
| Recommendation | | Maintain broadly at no more than current dimensions by periodic pruning. | | | | | |

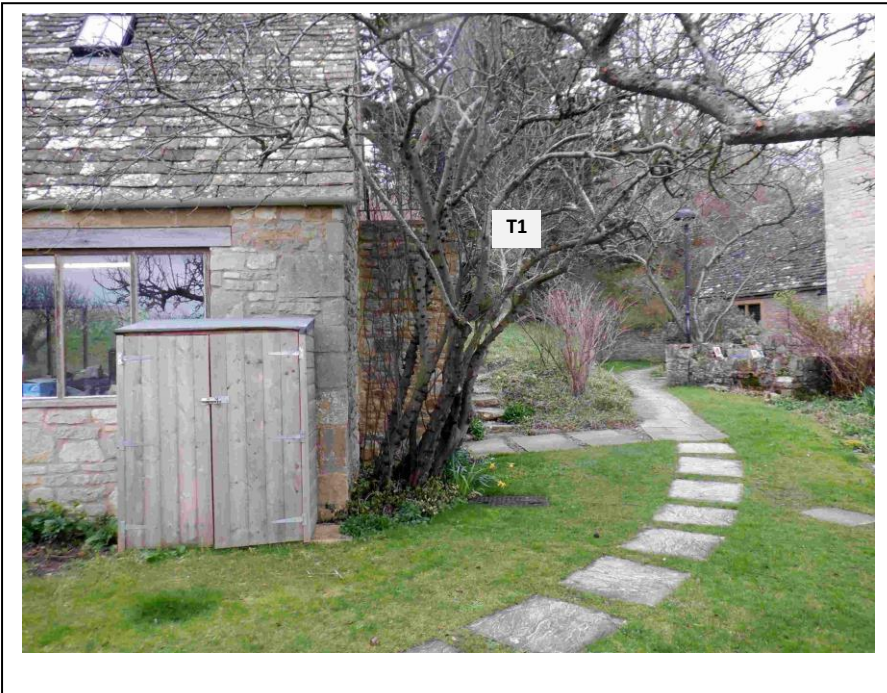
| Tree No. | Species | Ht (m) | Dia (mm) | Crown Spread (m) | Dist. to building (m) | Age Classification | Ownership |
|---|---|---|---|---|---|---|--|
| T1 | Medlar | 6.5 | 110 Ms * | 6.5 | 0.2 | Younger than Property | Policy Holder |

View of T1

| Tree No. | Species | Ht (m) | Dia (mm) | Crown Spread (m) | Dist. to building (m) | Age Classification | Ownership |
|---|---|---|---|---|---|---|--|
| Recommendation | | Remove (fell) to near ground level and treat stump to inhibit regrowth. | | | | | |

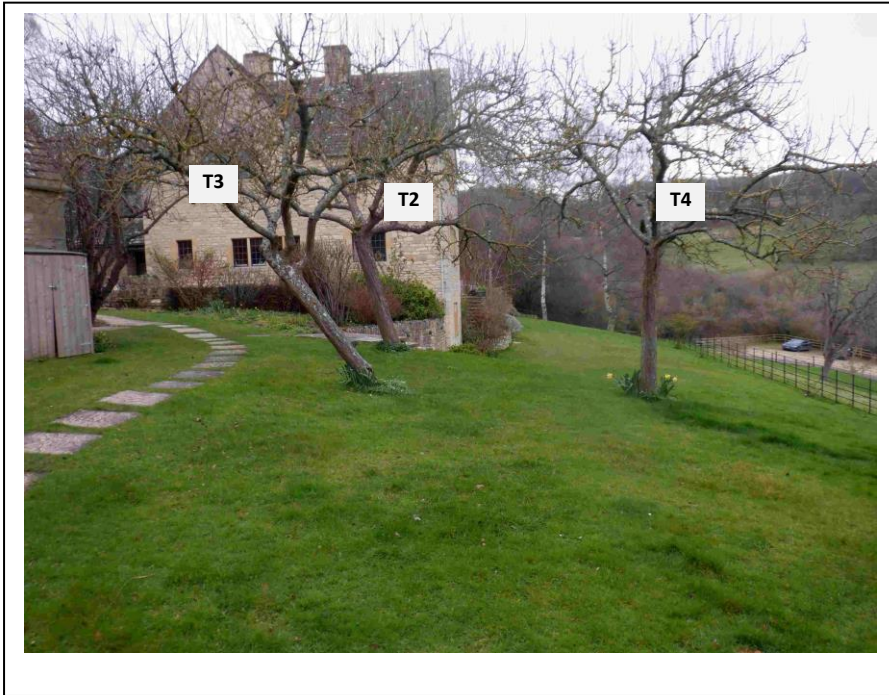
| Tree No. | Species | Ht (m) | Dia (mm) | Crown Spread (m) | Dist. to building (m) | Age Classification | Ownership |
|---|---|---|---|---|---|---|--|
| T2 | Plum | 5.1 | 240 | 6.2 | 4.8 | Younger than Property | Policy Holder |

View of T2, T3 & T4

| Tree No. | Species | Ht (m) | Dia (mm) | Crown Spread (m) | Dist. to building (m) | Age Classification | Ownership |
|---|---|---|---|---|---|---|--|
| Recommendation | | Remove (fell) to near ground level and treat stump to inhibit regrowth. | | | | | |

| Tree No. | Species | Ht (m) | Dia (mm) | Crown Spread (m) | Dist. to building (m) | Age Classification | Ownership |
|---|---|--|---|---|---|---|---|
| Recommendation | | Do not allow to exceed current dimensions. | | | | | |

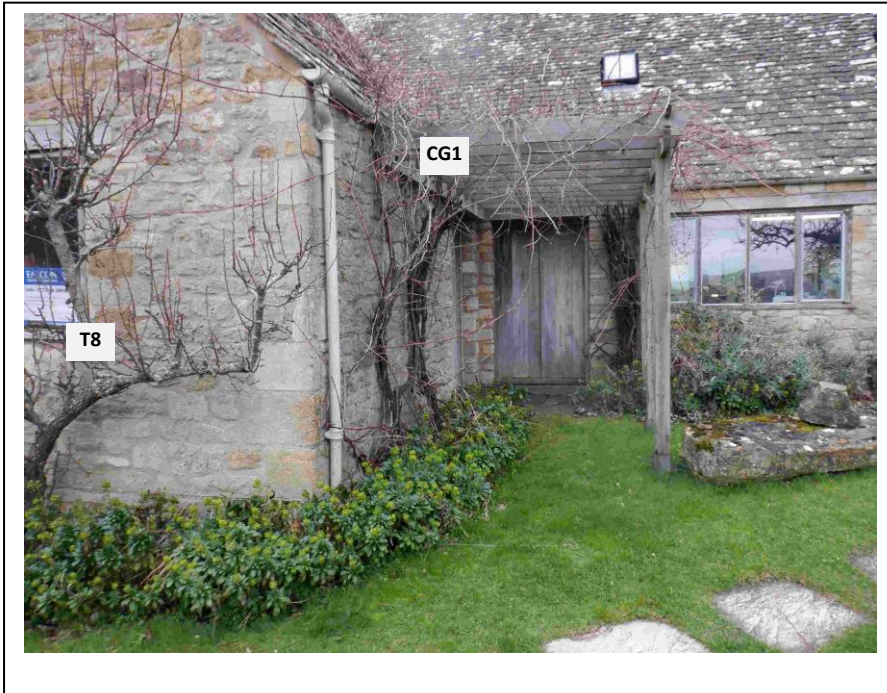
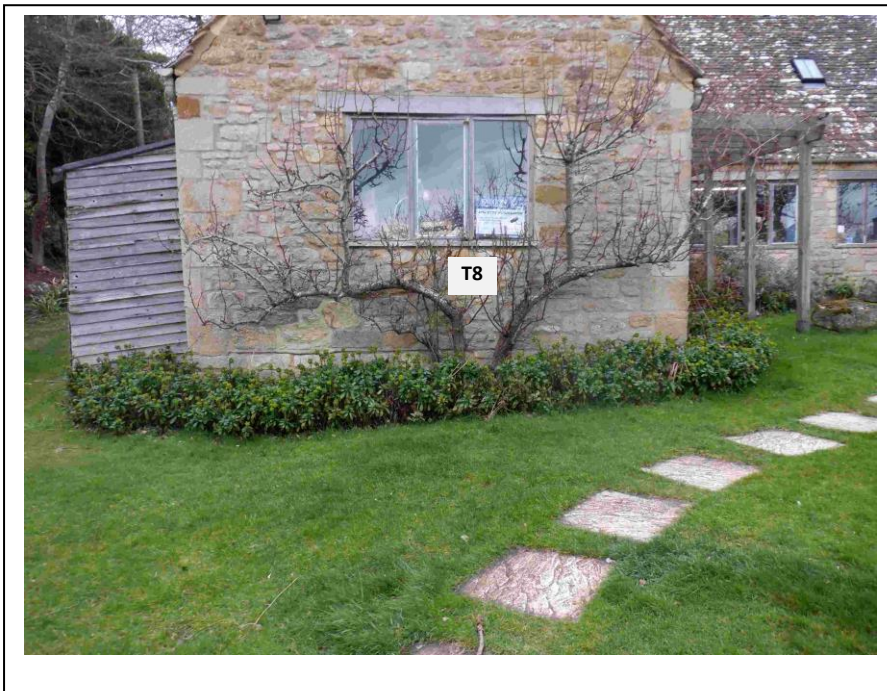
| Tree No. | Species | Ht (m) | Dia (mm) | Crown Spread (m) | Dist. to building (m) | Age Classification | Ownership |
|---|---|---|---|---|---|---|--|
| T8 | Pear | 3.1 | 70 Ms * | 5 * | 0.2 | Younger than Property | Policy Holder |

View of T8 & CG1

| Tree No. | Species | Ht (m) | Dia (mm) | Crown Spread (m) | Dist. to building (m) | Age Classification | Ownership |
|---|---|---|---|---|---|---|--|
| Recommendation | | Remove (fell) to near ground level and treat stump to inhibit regrowth. | | | | | |

| Tree No. | Species | Ht (m) | Dia (mm) | Crown Spread (m) | Dist. to building (m) | Age Classification | Ownership |
|---|---|--|---|---|---|---|---|
| Recommendation | | Do not allow to exceed current dimensions. | | | | | |

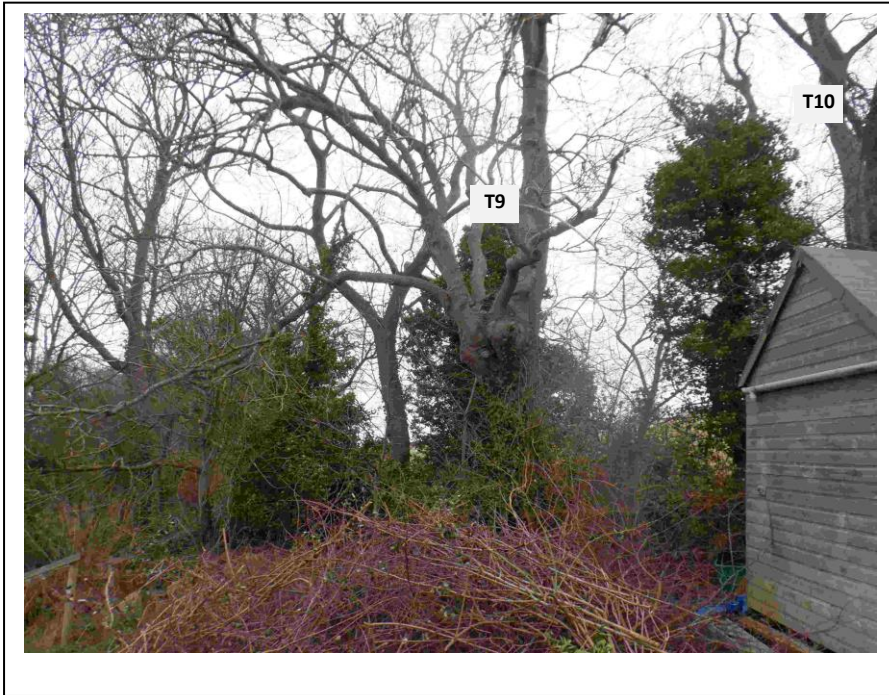
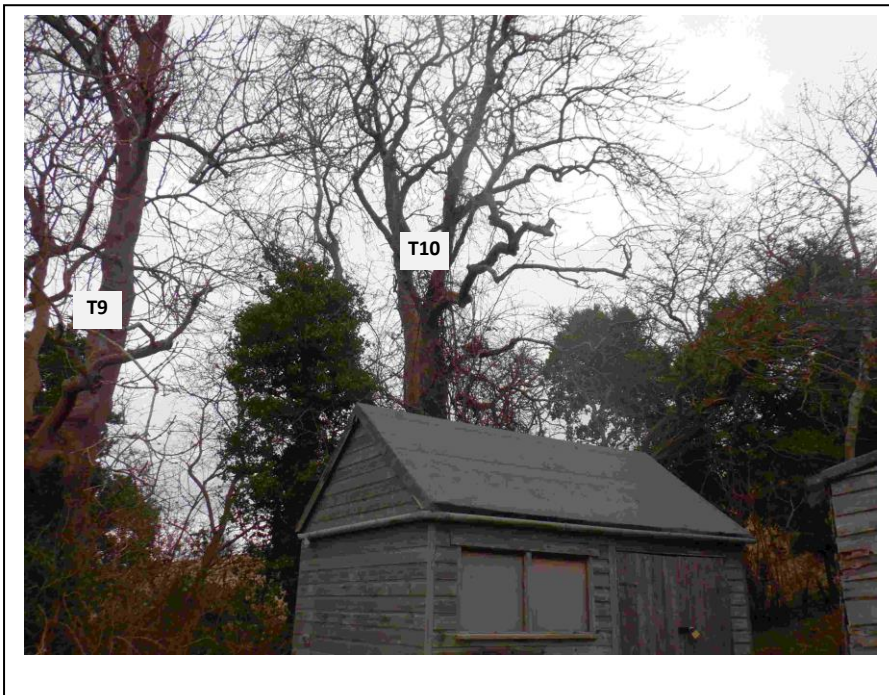
| Tree No. | Species | Ht (m) | Dia (mm) | Crown Spread (m) | Dist. to building (m) | Age Classification | Ownership |
|---|---|---|---|---|---|---|--|
| T9 | Ash | 17.8 | 600 * | 12.75 | 9.2 | Similar Age to Property | No registrations |
| T10 | Ash | 17.8 | 600 * | 12 | 8.4 | Similar Age to Property | Severn Trent Water Limited<br>Severn Trent Centre<br>CV3 9FH |
| Management history | | No significant recent management noted. Split stem, dangerous tree. | | | | | |

View of T9 & T10

| Tree No. | Species | Ht (m) | Dia (mm) | Crown Spread (m) | Dist. to building (m) | Age Classification | Ownership |
|---|---|---|---|---|---|---|--|
| Recommendation | | Remove (fell) to near ground level and treat stump to inhibit regrowth. | | | | | |

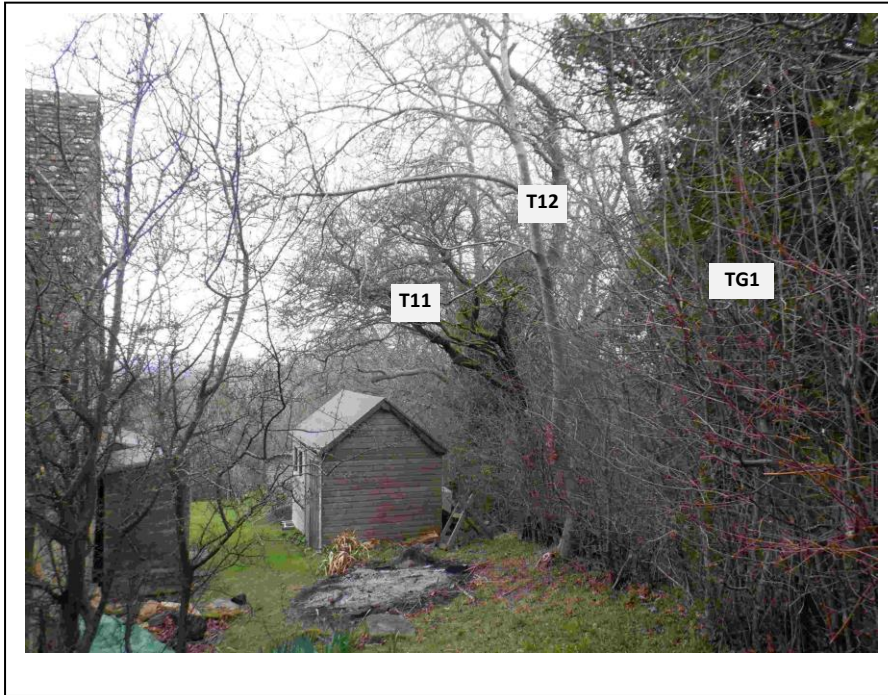
| Tree No. | Species | Ht (m) | Dia (mm) | Crown Spread (m) | Dist. to building (m) | Age Classification | Ownership |
|---|---|---|---|---|---|---|--|
| T12 | Ash | 11.5 | 175 | 10 | 5.7 | Younger than Property | Policy Holder |

View of T11 & T12

| Tree No. | Species | Ht (m) | Dia (mm) | Crown Spread (m) | Dist. to building (m) | Age Classification | Ownership |
|---|---|---|---|---|---|---|--|
| Recommendation | | Remove (fell) to near ground level and treat stump to inhibit regrowth. | | | | | |

| Tree No. | Species | Ht (m) | Dia (mm) | Crown Spread (m) | Dist. to building (m) | Age Classification | Ownership |
|---|---|--|---|---|---|---|--|
| Recommendation | | Maintain broadly at no more than current dimensions by periodic pruning. | | | | | |

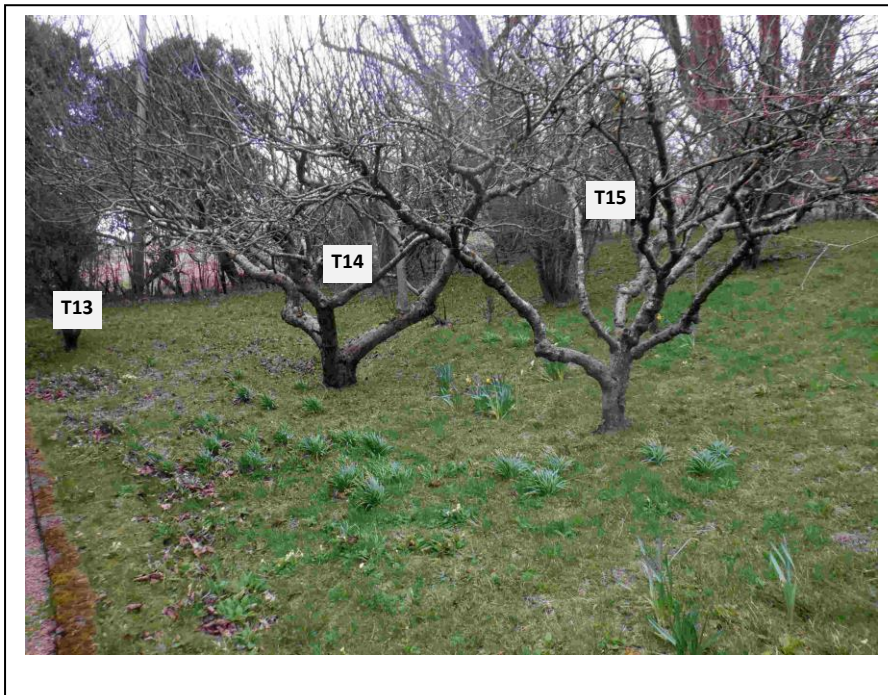
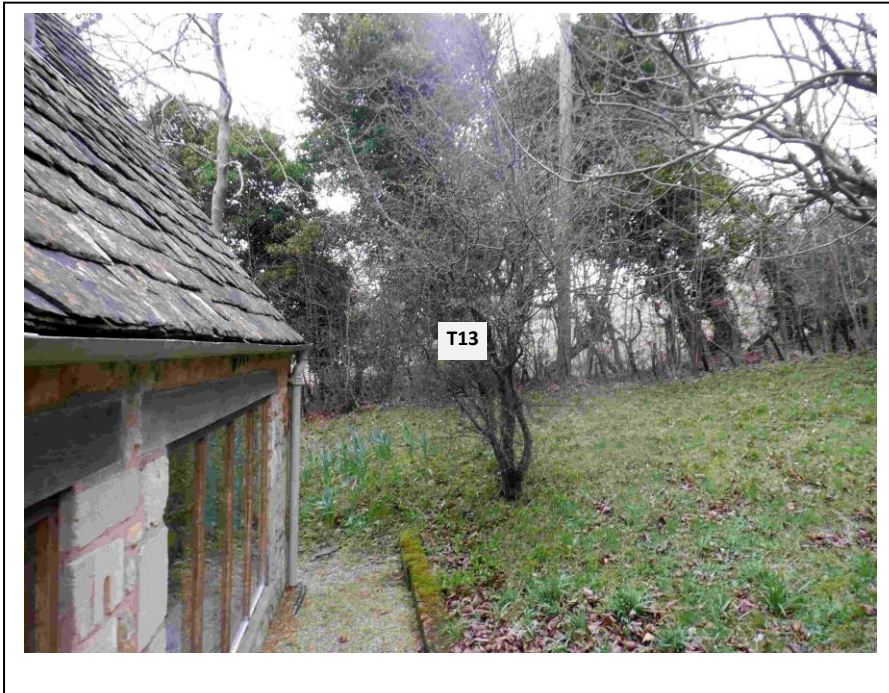
| Tree No. | Species | Ht (m) | Dia (mm) | Crown Spread (m) | Dist. to building (m) | Age Classification | Ownership |
|---|---|---|---|---|---|---|--|
| T13 | Prunus spp. | 5.2 | 55 Ms * | 3.8 | 1.9 | Younger than Property | Policy Holder |
| T14 | Apple | 4.2 | 150 Ms * | 7.25 | 3.95 | Younger than Property | Policy Holder |
| T15 | Plum | 3 | 100 Ms * | 6.7 | 4.5 | Younger than Property | Policy Holder |

View of T13, T14 & T15

| Tree No. | Species | Ht (m) | Dia (mm) | Crown Spread (m) | Dist. to building (m) | Age Classification | Ownership |
|---|---|---|---|---|---|---|--|
| Recommendation | | Remove (fell) to near ground level and treat stump to inhibit regrowth. | | | | | |

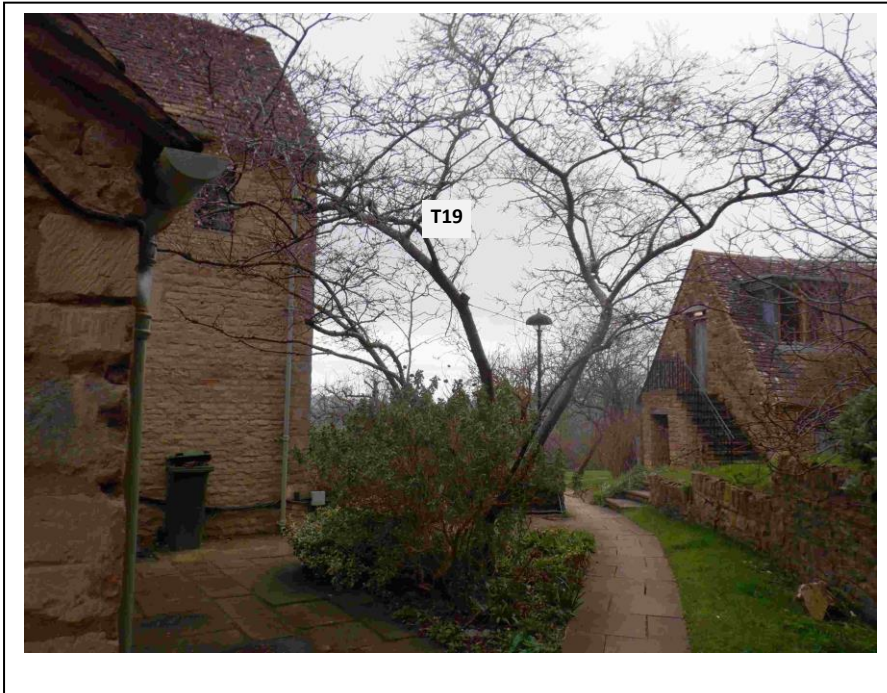
| Tree No. | Species | Ht (m) | Dia (mm) | Crown Spread (m) | Dist. to building (m) | Age Classification | Ownership |
|---|---|---|---|---|---|---|---|
| T19 | Cherry | 6.5 | 140 Ms * | 8.25 | 3.1 | Younger than Property | Policy Holder |

View of T19

| Tree No. | Species | Ht (m) | Dia (mm) | Crown Spread (m) | Dist. to building (m) | Age Classification | Ownership |
|---|---|---|---|---|---|---|---|
| Recommendation | | Remove (fell) to near ground level and treat stump to inhibit regrowth. | | | | | |

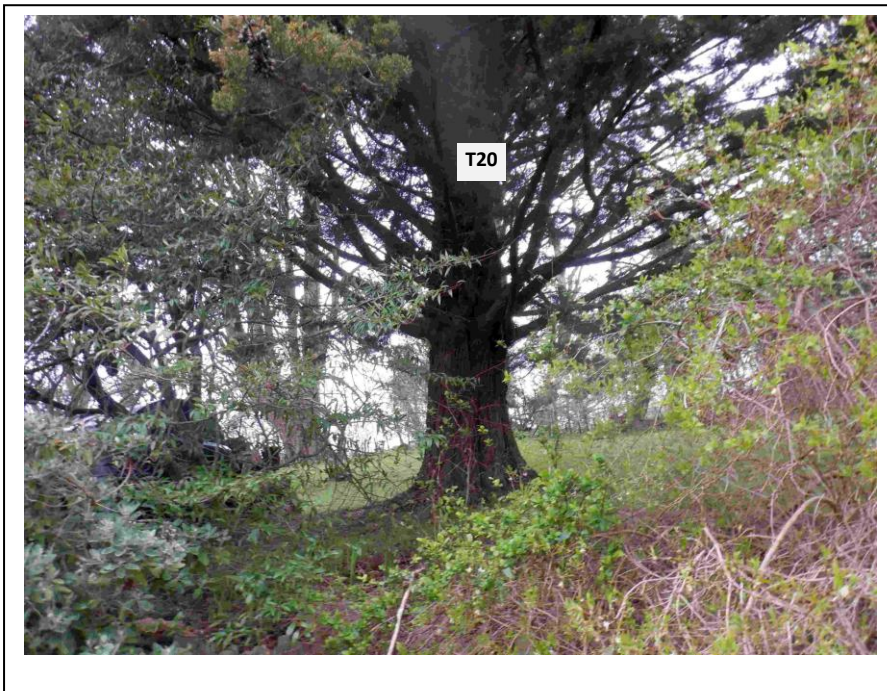
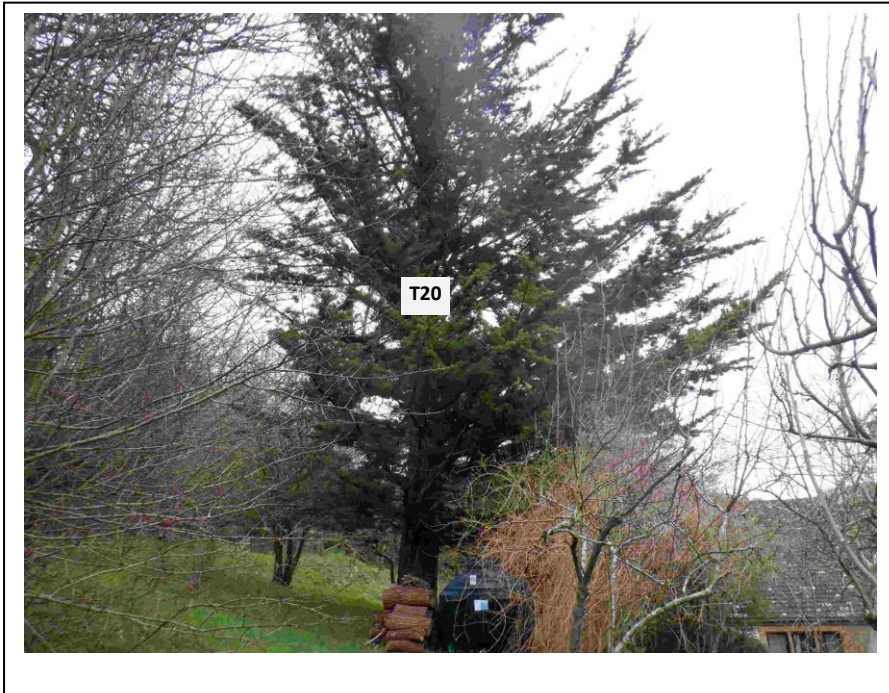
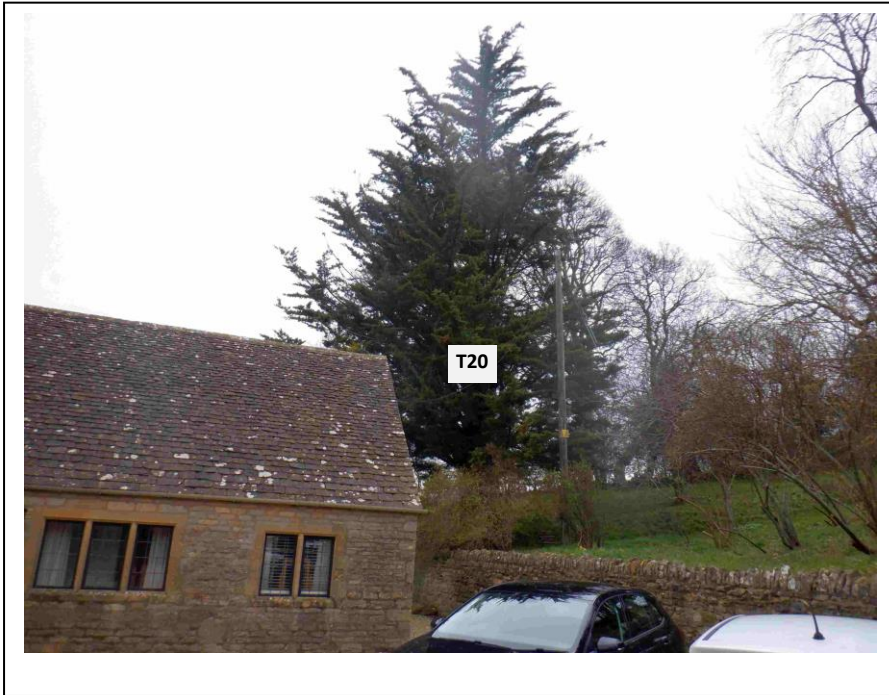
| Tree No. | Species | Ht (m) | Dia (mm) | Crown Spread (m) | Dist. to building (m) | Age Classification | Ownership |
|---|---|---|---|---|---|---|---|
| T20 | Cypress (Monterey) | 21.4 | 860 | 15.6 | 8.3 | Older than Property | Policy Holder |

View of T20

| Tree No. | Species | Ht (m) | Dia (mm) | Crown Spread (m) | Dist. to building (m) | Age Classification | Ownership |
|---|---|---|---|---|---|---|---|
| Recommendation | | Remove (fell) to near ground level and treat stump to inhibit regrowth. | | | | | |

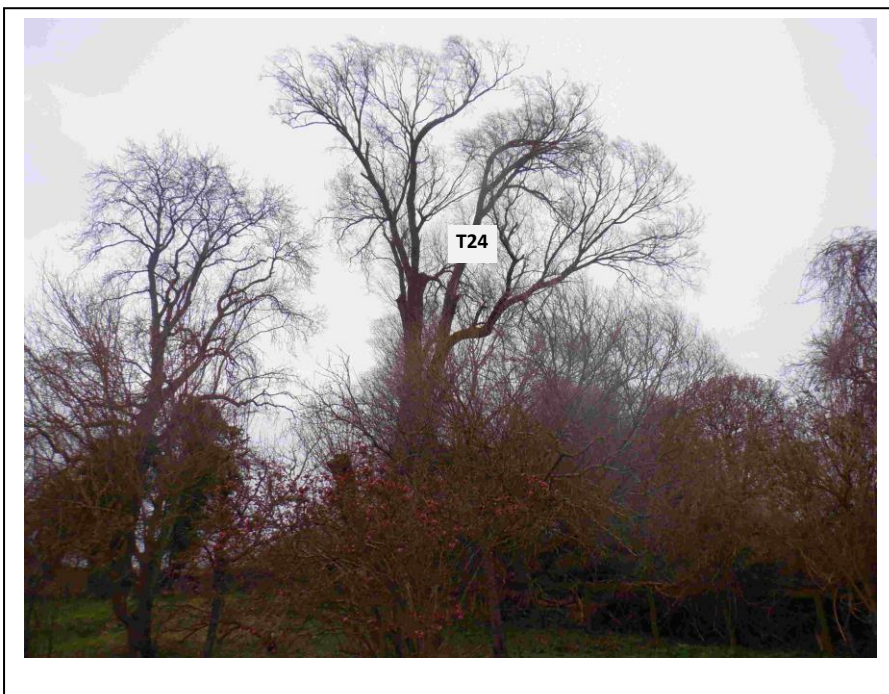
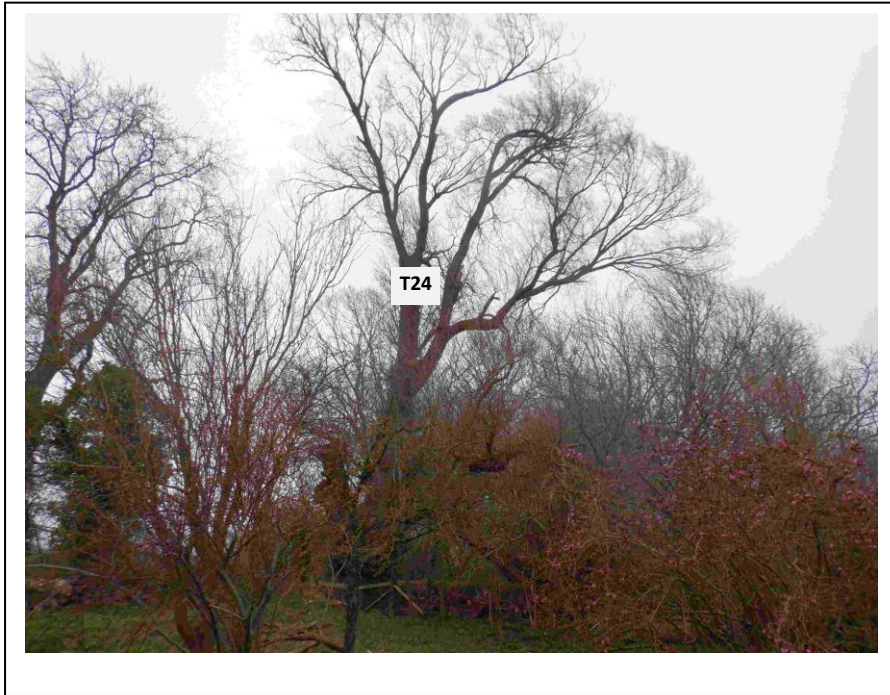
Based on the technical reports currently available, engineering opinion and our own site assessment we conclude the damage is consistent with shrinkage of the clay subsoil related to moisture abstraction by vegetation. Having considered the information currently available, it is our opinion that be the Willow (T24), the Bay Laurel (S4), the Medlar (T1), the Ash (T9, T10, T12 and T18), the Cherry (T19), the Cypress (T20), the Plum (T2 and T15), the Prunus spp. (T13), the Apple (T14), the Pear (T8), the Shrub (S1), the Cotinus (S2) and the Shrub group (SG1 & SG2) are the principal cause of or are materially contributing to the current subsidence damage.

| Tree No. | Species | Ht (m) | Dia (mm) | Crown Spread (m) | Dist. to building (m) | Age Classification | Ownership |
|---|---|---|---|---|---|---|---|
| T24 | Willow | 25 | 1500 * | 25 * | 21 | Similar Age to Property | Third Party Washpool Equestrian Centre WR12 7AQ |

View of T24

| Tree No. | Species | Ht (m) | Dia (mm) | Crown Spread (m) | Dist. to building (m) | Age Classification | Ownership |
|---|---|---|---|---|---|---|---|
| Recommendation | | Remove (fell) to near ground level and treat stump to inhibit regrowth. | | | | | |
