SITE INVESTIGATION FACTUAL REPORT

Report No: SI-616421
Client: Crawford Claims Management
Site: Stanton Guild House
Worcestershire
Client Ref: SU2206126
Date of Visit: 26/05/2023

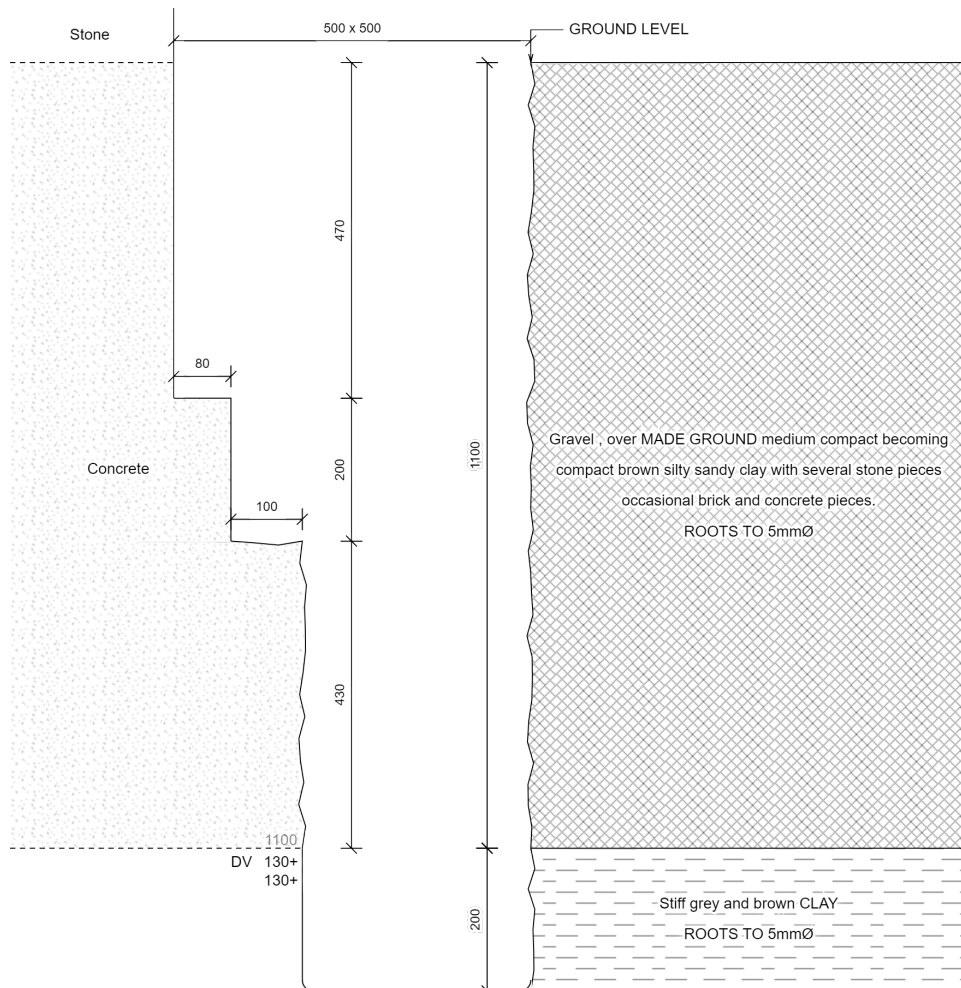
TEST REPORT: Trial Pit
REPORT NUMBER: C1077739 / 255918.1.1.1
TRIAL PIT REF: TP1 **DATE:** 26/05/2023
CLIENT: Crawford & Co **SITE:** STANTON GUILD HOUSE
JOB NO: 616421 **WEATHER:** Dry
EXCAVATION METHOD: Hand tools

Curved steel pin driven 200mm under concrete foundation at 1100mm below ground level.

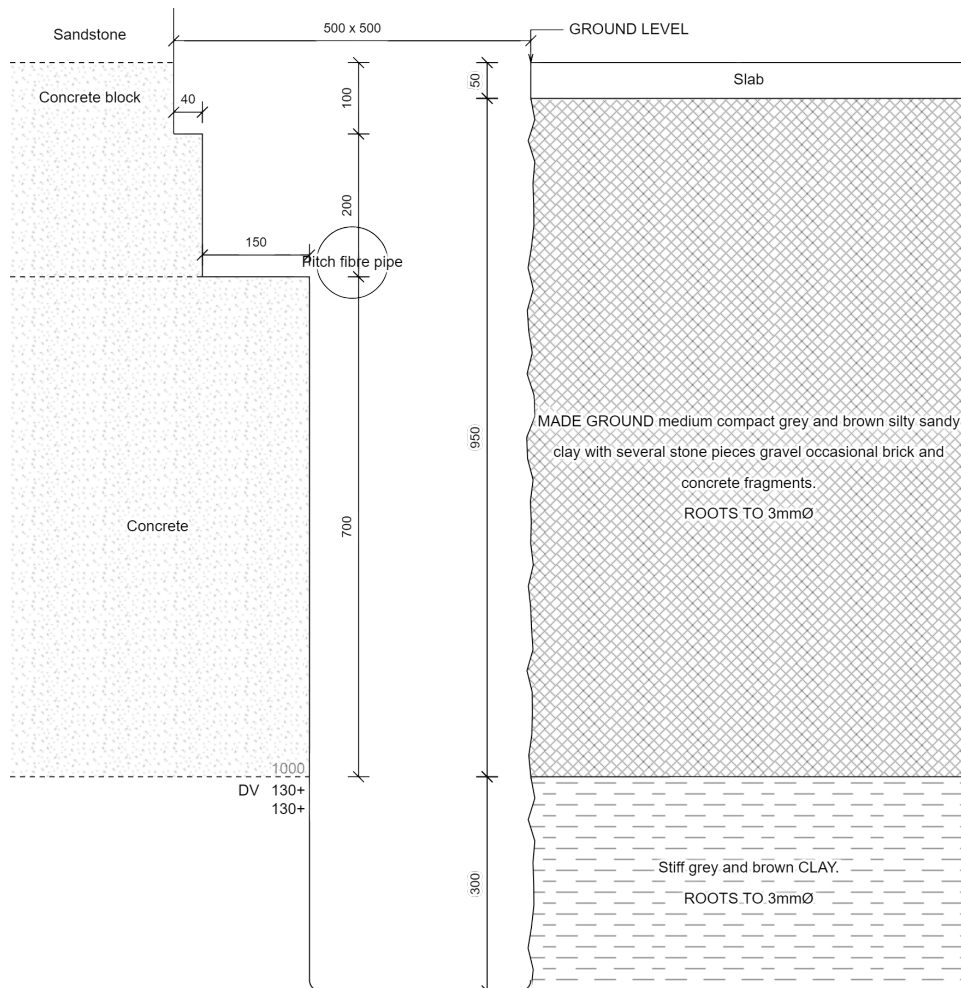
TEST REPORT: Trial Pit
REPORT NUMBER: C1077739 / 255918.1.1.2
TRIAL PIT REF: TP2 **DATE:** 26/05/2023
CLIENT: Crawford & Co **SITE:** STANTON GUILD HOUSE
JOB NO: 616421 **WEATHER:** Dry
EXCAVATION METHOD: Hand tools

Curved steel pin driven 200mm under concrete foundation at 1000mm below ground level.

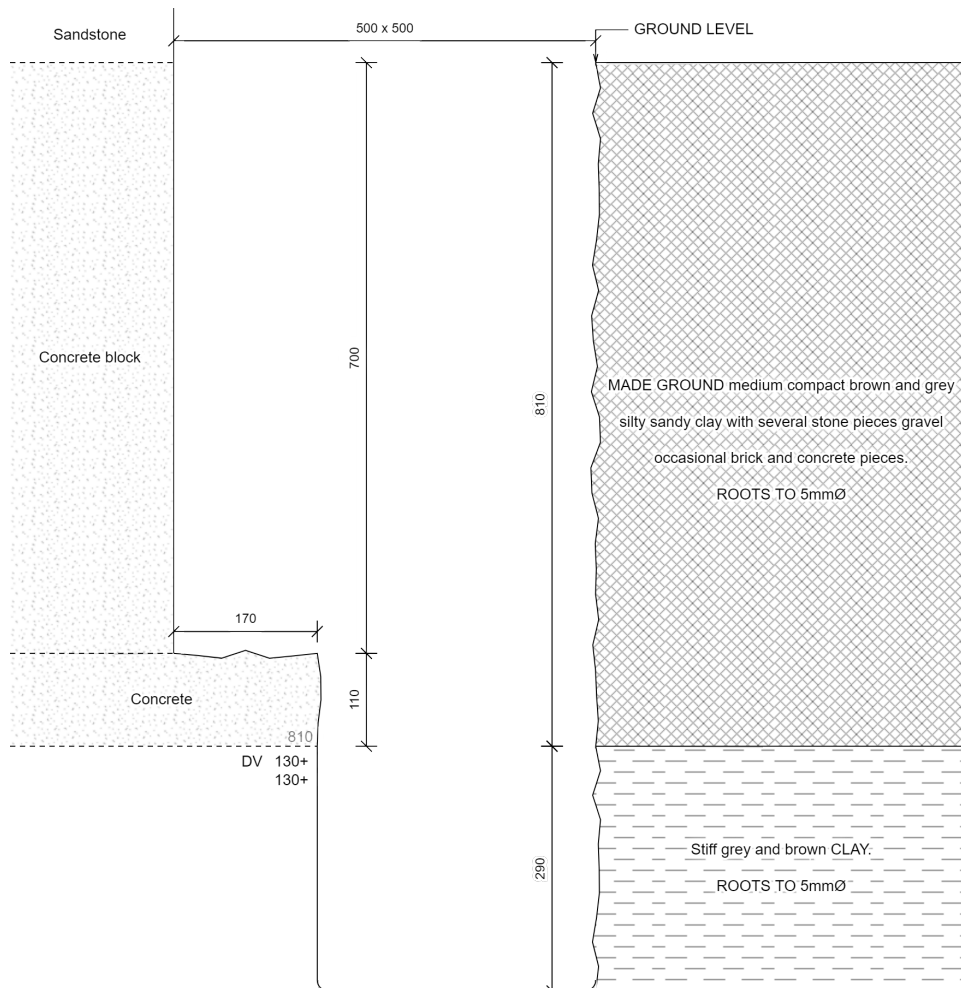
TEST REPORT: Trial Pit
REPORT NUMBER: C1077739 / 255918.1.1.3
TRIAL PIT REF: TP3 **DATE:** 26/05/2023
CLIENT: Crawford & Co **SITE:** STANTON GUILD HOUSE
JOB NO: 616421 **WEATHER:** Dry
EXCAVATION METHOD: Hand tools

Curved steel pin driven 200mm under concrete foundation at 810mm below ground level.

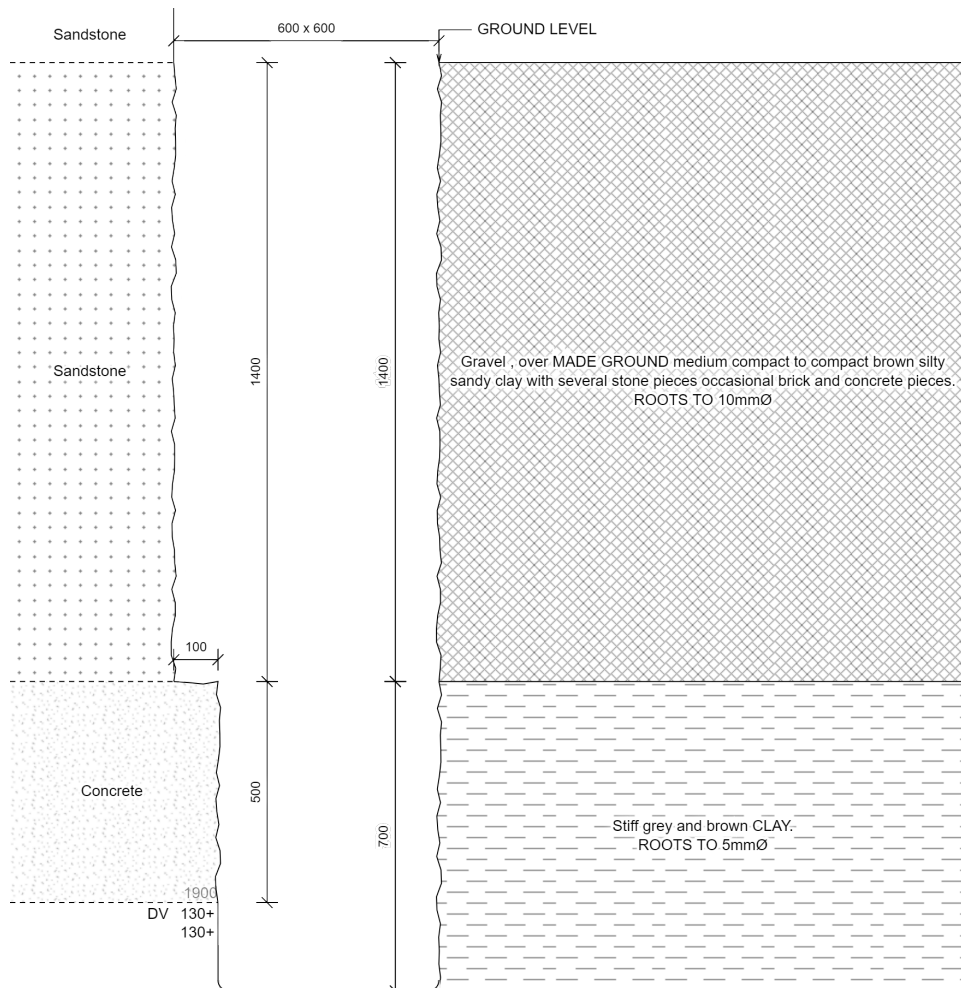
TEST REPORT: Trial Pit
REPORT NUMBER: C1077739 / 255918.1.1.4
TRIAL PIT REF: TP4 **DATE:** 26/05/2023
CLIENT: Crawford & Co **SITE:** STANTON GUILD HOUSE
JOB NO: 616421 **WEATHER:** Dry
EXCAVATION METHOD: Hand tools

Curved steel pin driven 200mm under concrete foundation at 1900mm below ground level.
