PROJECT
HARMONY HOUSE,
LONGNIDDRY
STATUS
LBC

DRAWING TITLE
TYPICAL EXISTING & PROPOSED
WINDOW DRAWINGS

DATE
MAR 24'
DWG. NO.
(31)100

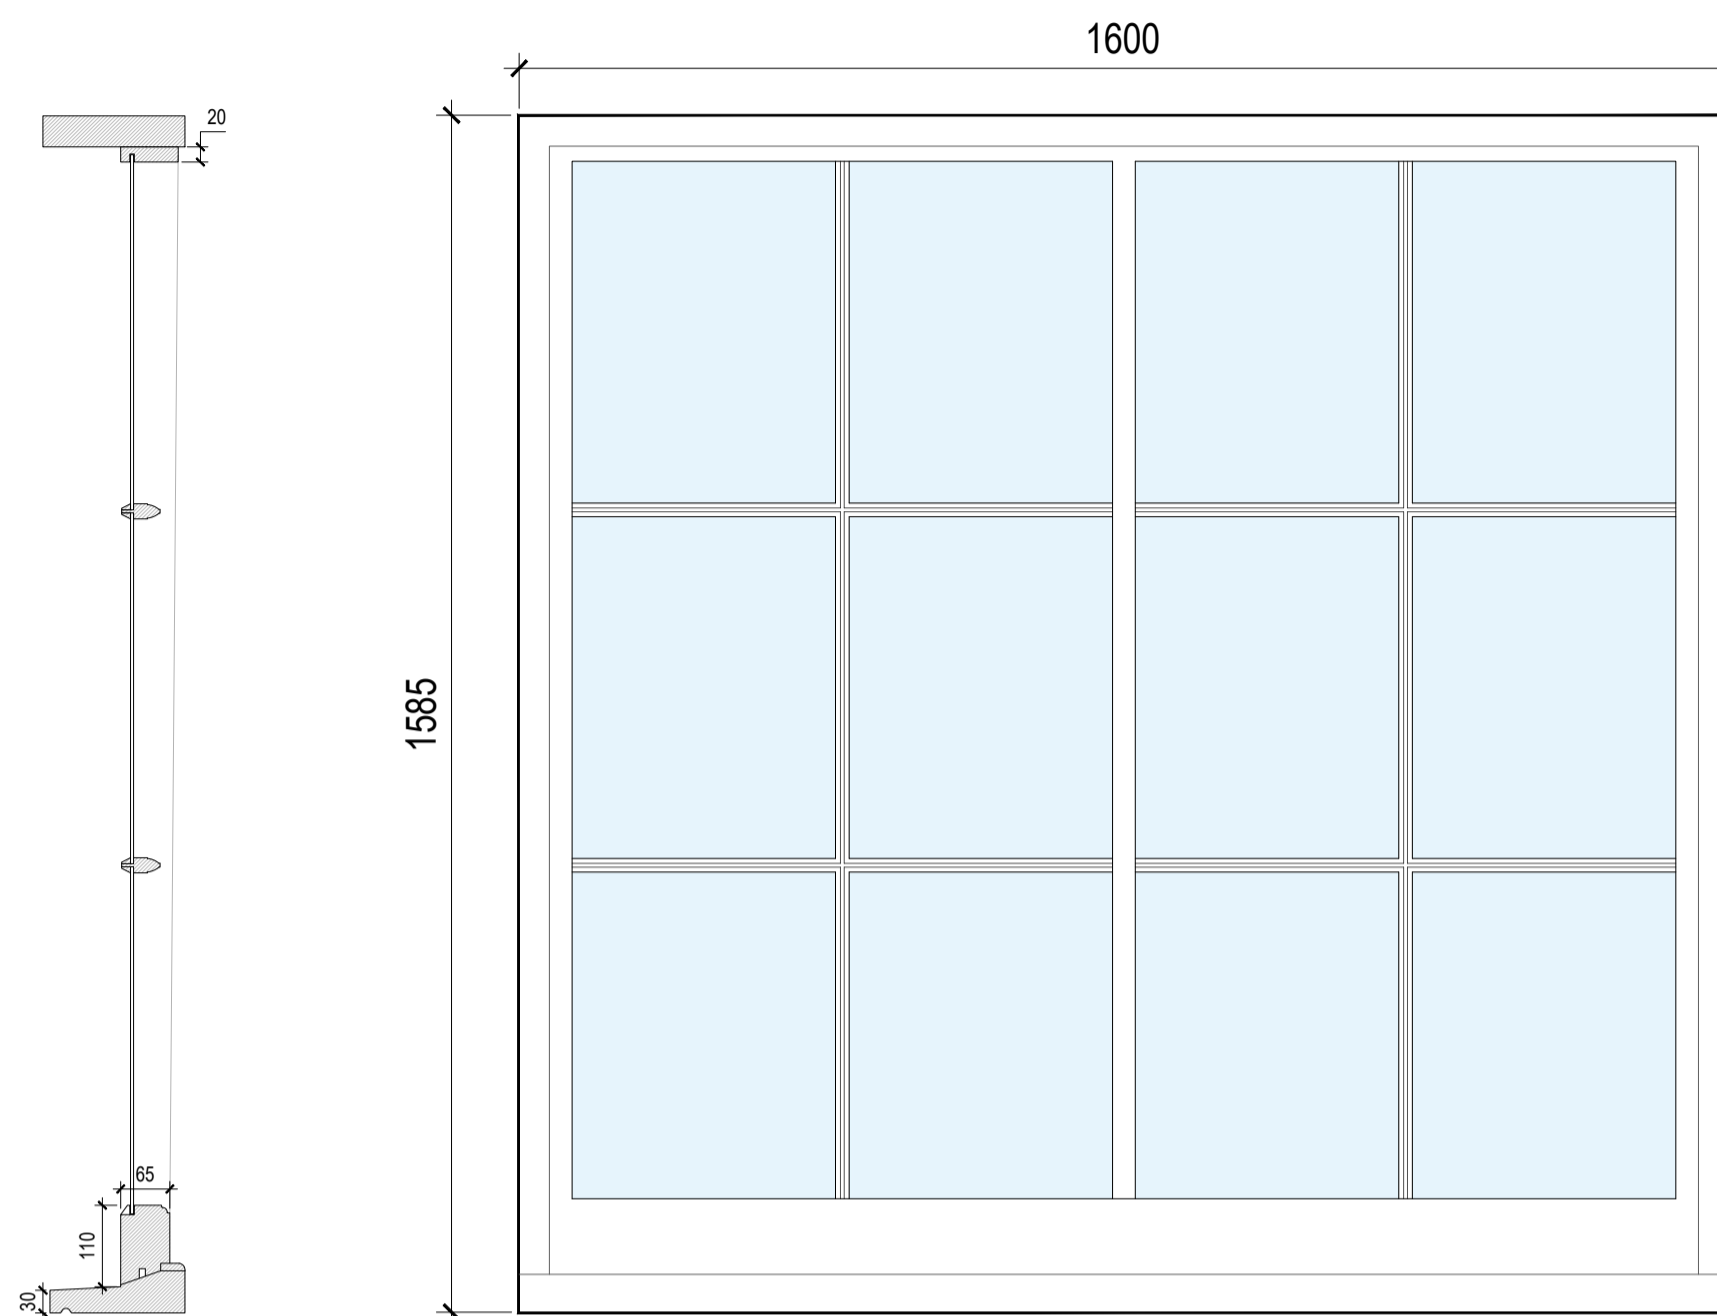
TYPICAL EXISTING TIMBER
FRAMED WINDOW SECTION
scale 1:10

All timber windows are non original and are rotten beyond repair, causing water ingress and damage to internal finishes.

Previous non sympathetic putty repair have deteriorated the timbers to window frames further to NW corner of building resulting in very soft timbers that are fully saturated with water from driving rain from the west.

Windows are fixed with no opening functionality.

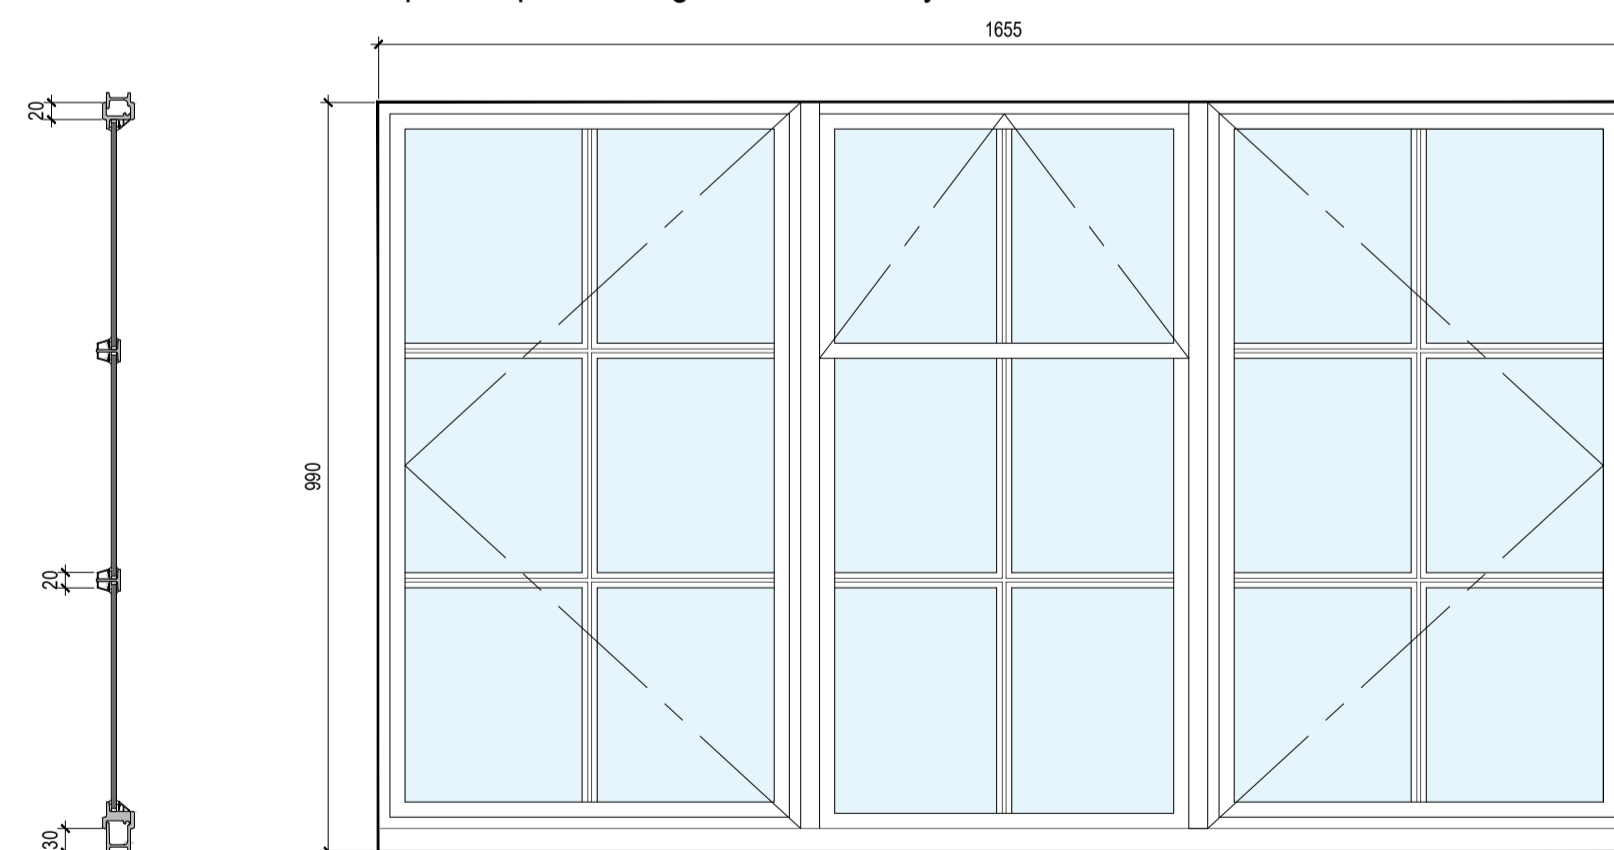
TYPICAL EXISTING STEEL
CRITTALL STYLE WINDOW SECTION
scale 1:10

All existing Single Glazed Steel Crittall Style windows have been painted shut and are unopenable. Windows have various defects as follows:

- Windows are non openable and as a result have prevented ventilation into rooms allowing condensation and mould to form on the glazing and drip onto the steel internally causing rut and deterioration.
- Some panes to the windows have cracked window panes allowing water ingress, further deteriorating the condition of the windows to a state beyond repair.
