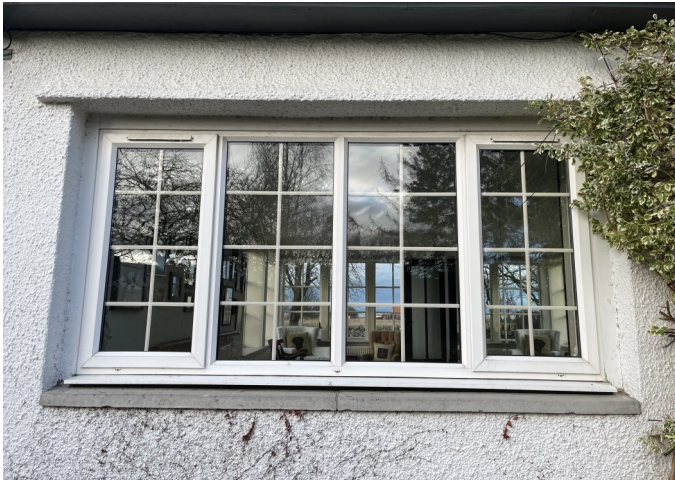
No. 01 - PVC
Signs of double glazing failing causing internal condensation, loose internal astragals and inappropriate existing material.

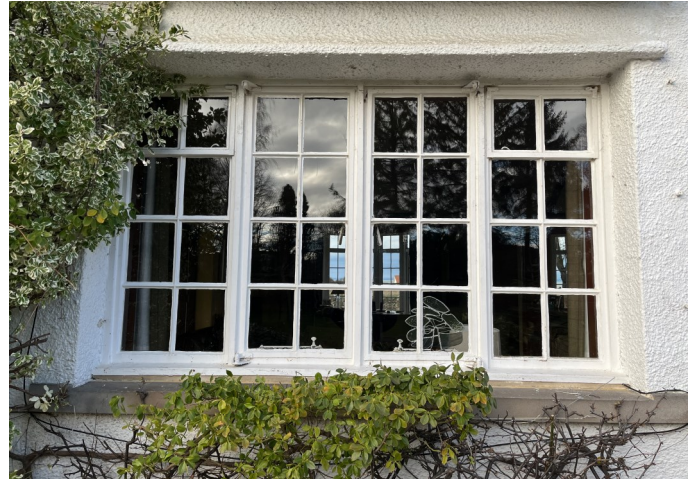
No. 02 - Existing Steel Crittall Style
Windows are drafty, deteriorating, rusting beyond repair and not functional due to failure to open causing lack of ventilation. Additionally window panels are cracked due to ageing and weathering.

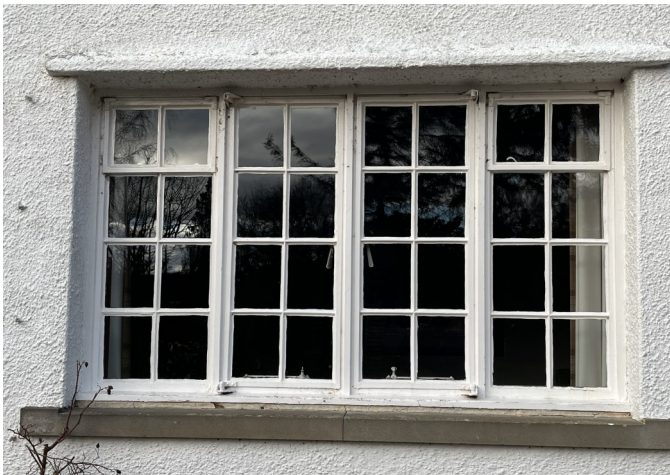
No. 03 - Existing Steel Crittall Style
Windows are drafty, deteriorating, rusting beyond repair and not functional due to failure to open causing lack of ventilation.

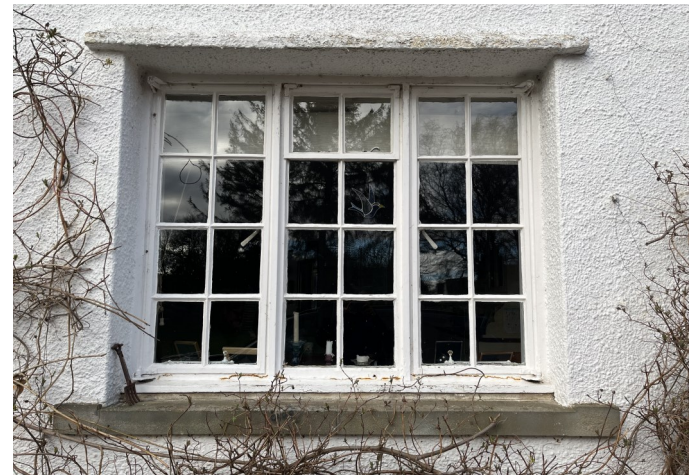
No. 04 - Existing Steel Crittall Style
Windows are drafty, deteriorating, rusting beyond repair and not functional due to failure to open causing lack of ventilation.

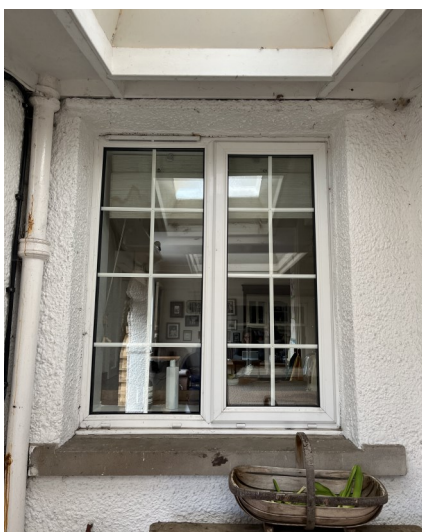
No. 05 - PVC
Signs of internal condensation, loose internal astragals and inappropriate existing material.

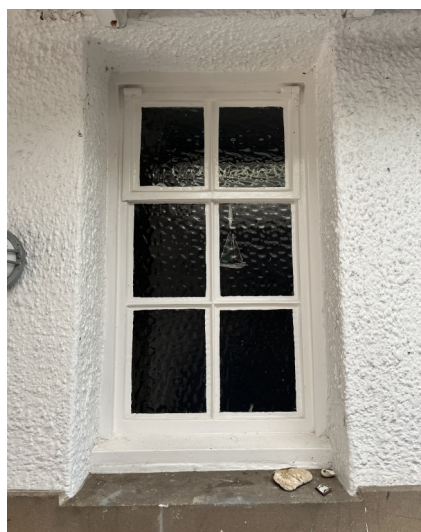
No. 06 - Existing Steel Crittall Style
Windows are drafty, deteriorating, and not functional due to failure to open causing lack of ventilation.

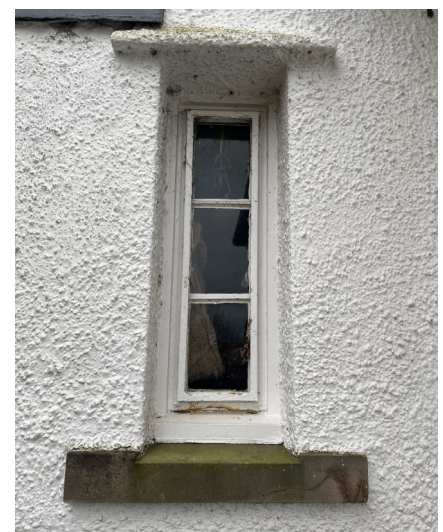
No. 07 - Existing Steel Crittall Style
Windows are drafty, deteriorating, rusting beyond repair and not functional due to failure to open causing lack of ventilation.

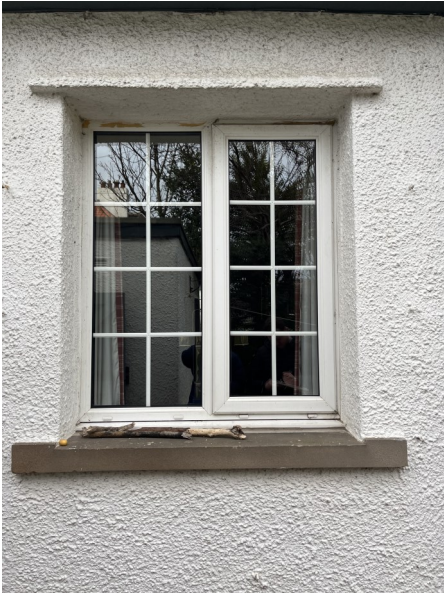
No. 08 - PVC

Signs of double glazing failing causing internal condensation and ventilation issues, loose internal astragals and inappropriate existing material.

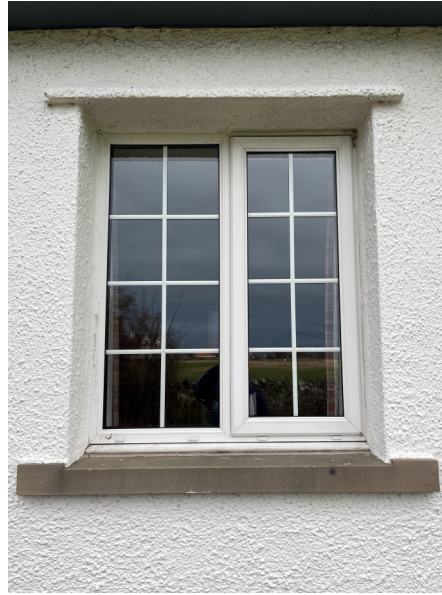
No. 09 - PVC

Signs of double glazing failing causing internal condensation and ventilation issues, loose internal astragals and inappropriate existing material.

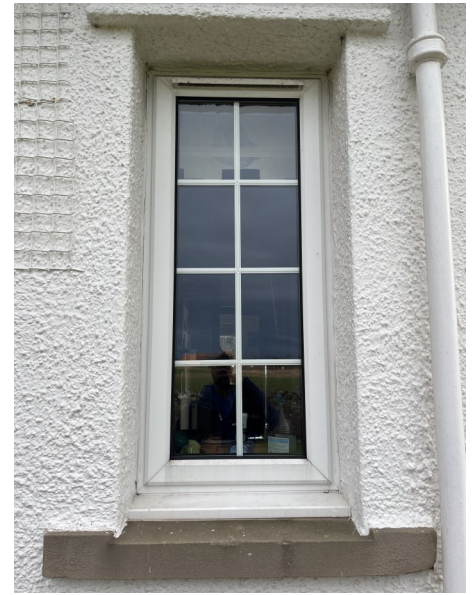
No. 10 - PVC

Signs of double glazing failing causing internal condensation and ventilation issues, loose internal astragals and inappropriate existing material.

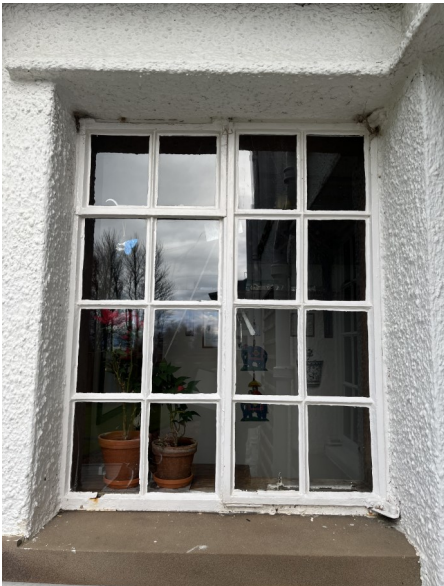
No. 11 - Existing Steel Crittall Style

Windows are drafty, deteriorating, rusting and not functionable due to failure to open causing lack of ventilation. Additionally window panel is cracked due to ageing and weathering.

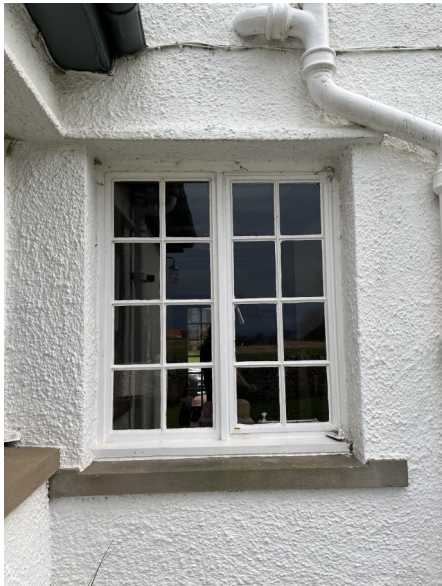
No. 12 - Existing Steel Crittall Style

Windows are drafty, deteriorating, rusting and not functionable due to failure to open causing lack of ventilation.

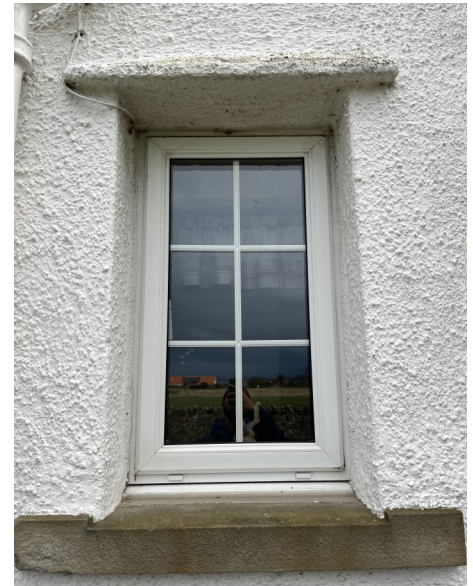
No. 13 - PVC

Signs of double glazing failing causing internal condensation and ventilation issues, loose internal astragals and inappropriate existing material.

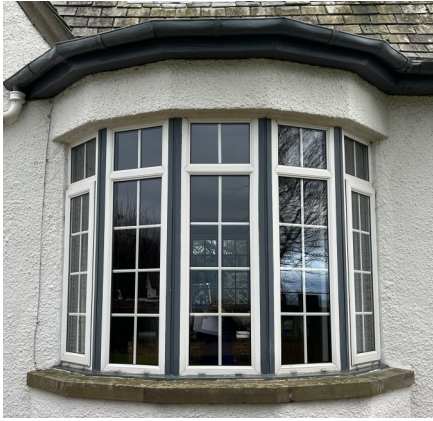
No. 14 - PVC

Signs of double glazing failing causing internal condensation and ventilation issues, loose internal astragals and inappropriate existing material.

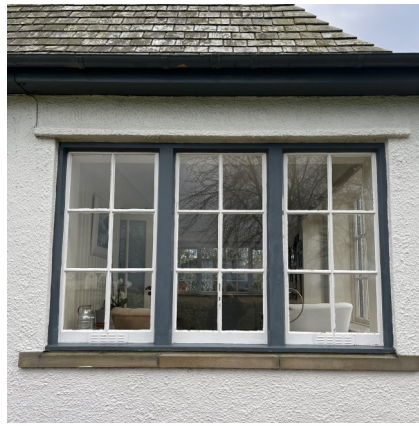
No. 15 - Timber Frame

Timber frame rotting beyond repair due to water and moisture ingress causing damage to internal finished.

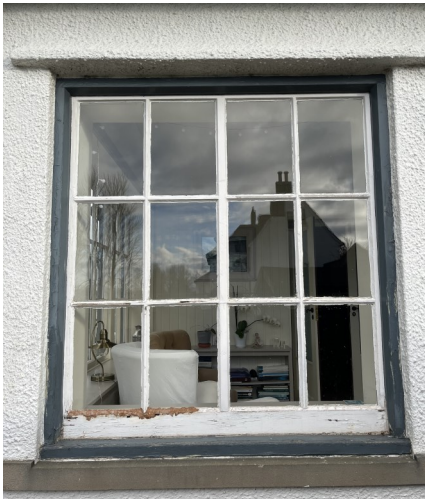
No. 16 - Timber Frame

Timber frame rotting beyond repair due to water and moisture ingress causing damage to internal finished. Poor repair has been carried out to window frame.

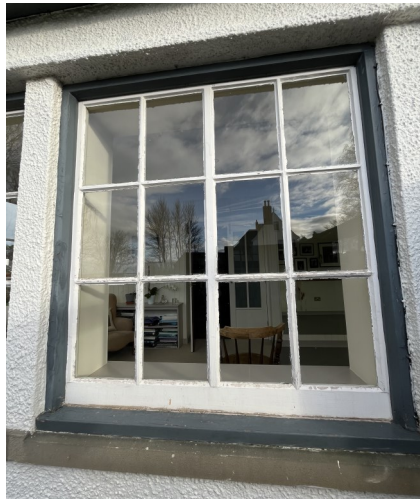
No. 17 - Timber Frame

Timber frame rotting beyond repair due to water and moisture ingress causing damage to internal finished.

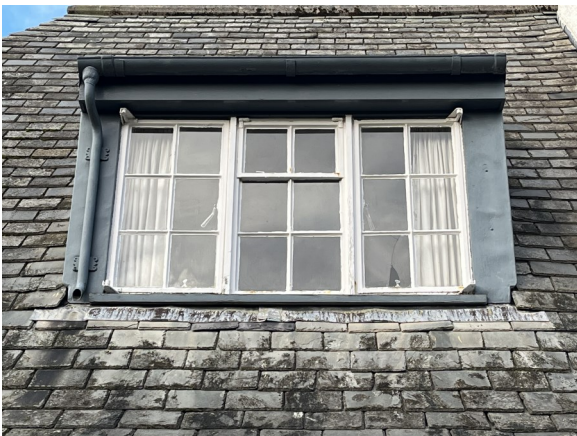
No. 18 - Existing Steel Crittall Style

Windows are drafty, deteriorating, rusting and not functionable due to failure to open causing lack of ventilation. Additionally window panels are cracked due to ageing and weathering.

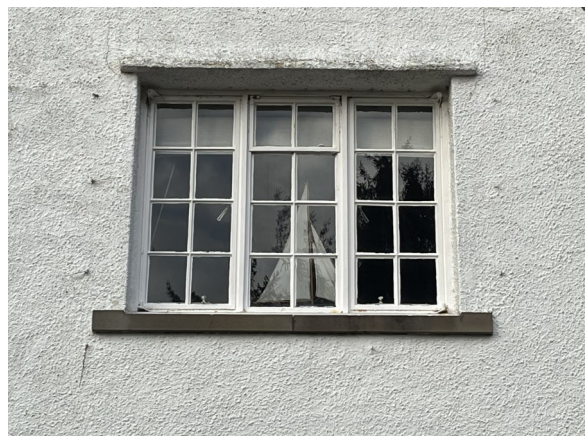
No. 19 - Existing Steel Crittall Style

Windows are drafty, deteriorating, rusting and not functionable due to failure to open causing lack of ventilation.

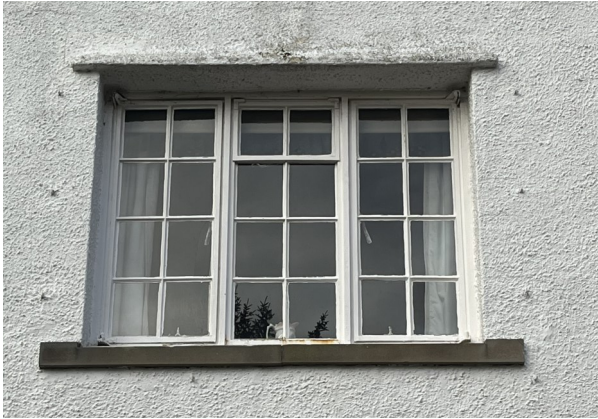
No. 20 - Existing Steel Crittall Style
Windows are drafty, deteriorating, rusting and not functional due to failure to open causing lack of ventilation. Additionally window panels are cracked due to ageing and weathering.

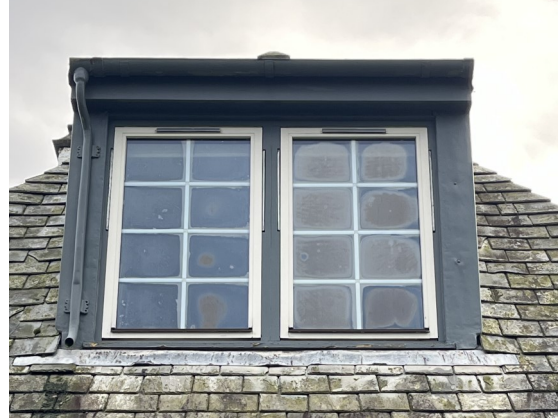
No. 22 - PVC
Double glazing failing causing internal condensation between panels, loose internal astragals and inappropriate existing material.

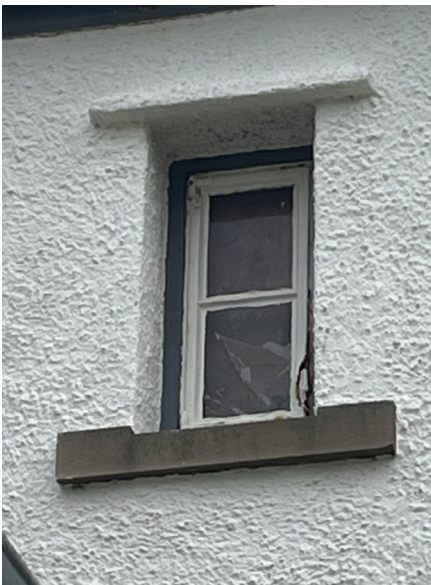
No. 23 - Existing Steel Crittall Style
Boarded up window due to extreme damage and crack to the glazing.

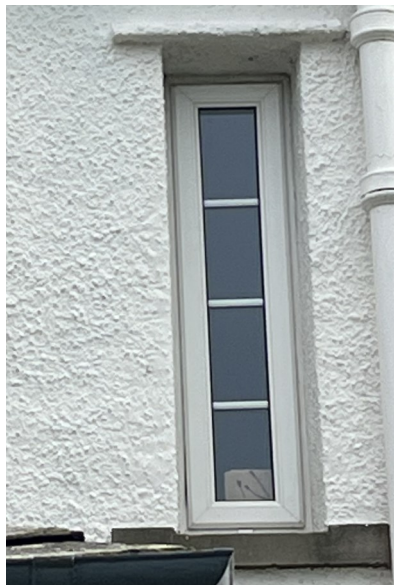
No. 24 - PVC
Signs of double glazing failing causing internal condensation, loose internal astragals and inappropriate existing material.

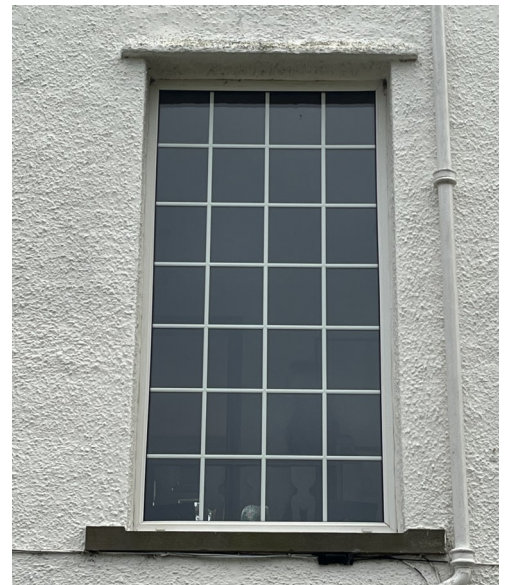
No. 25 - PVC
Signs of double glazing failing causing internal condensation, loose internal astragals and inappropriate existing material.

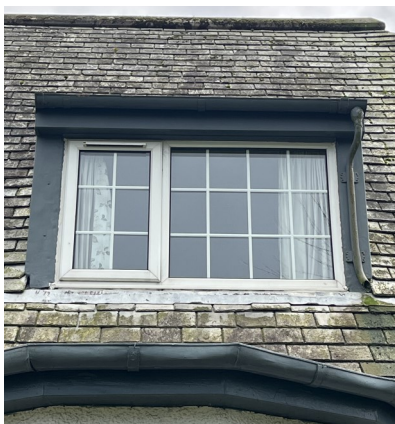
No. 26 - PVC
Signs of double glazing failing causing internal condensation, loose internal astragals and inappropriate existing material.

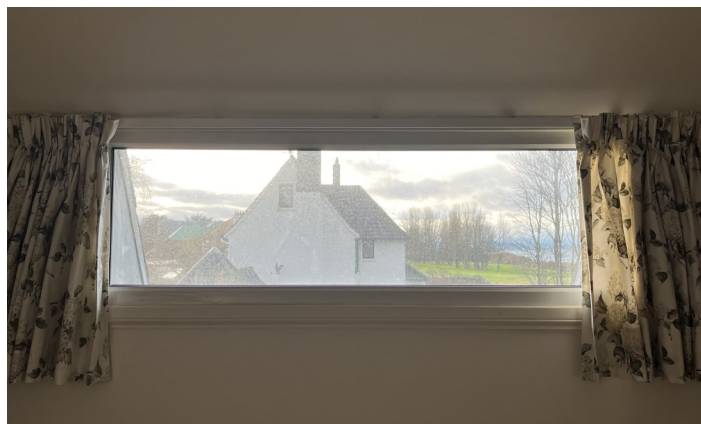
No. 21 & 27 - PVC
Signs of double glazing failing causing internal condensation, loose internal astragals and inappropriate existing material.
