STONE BUILDING

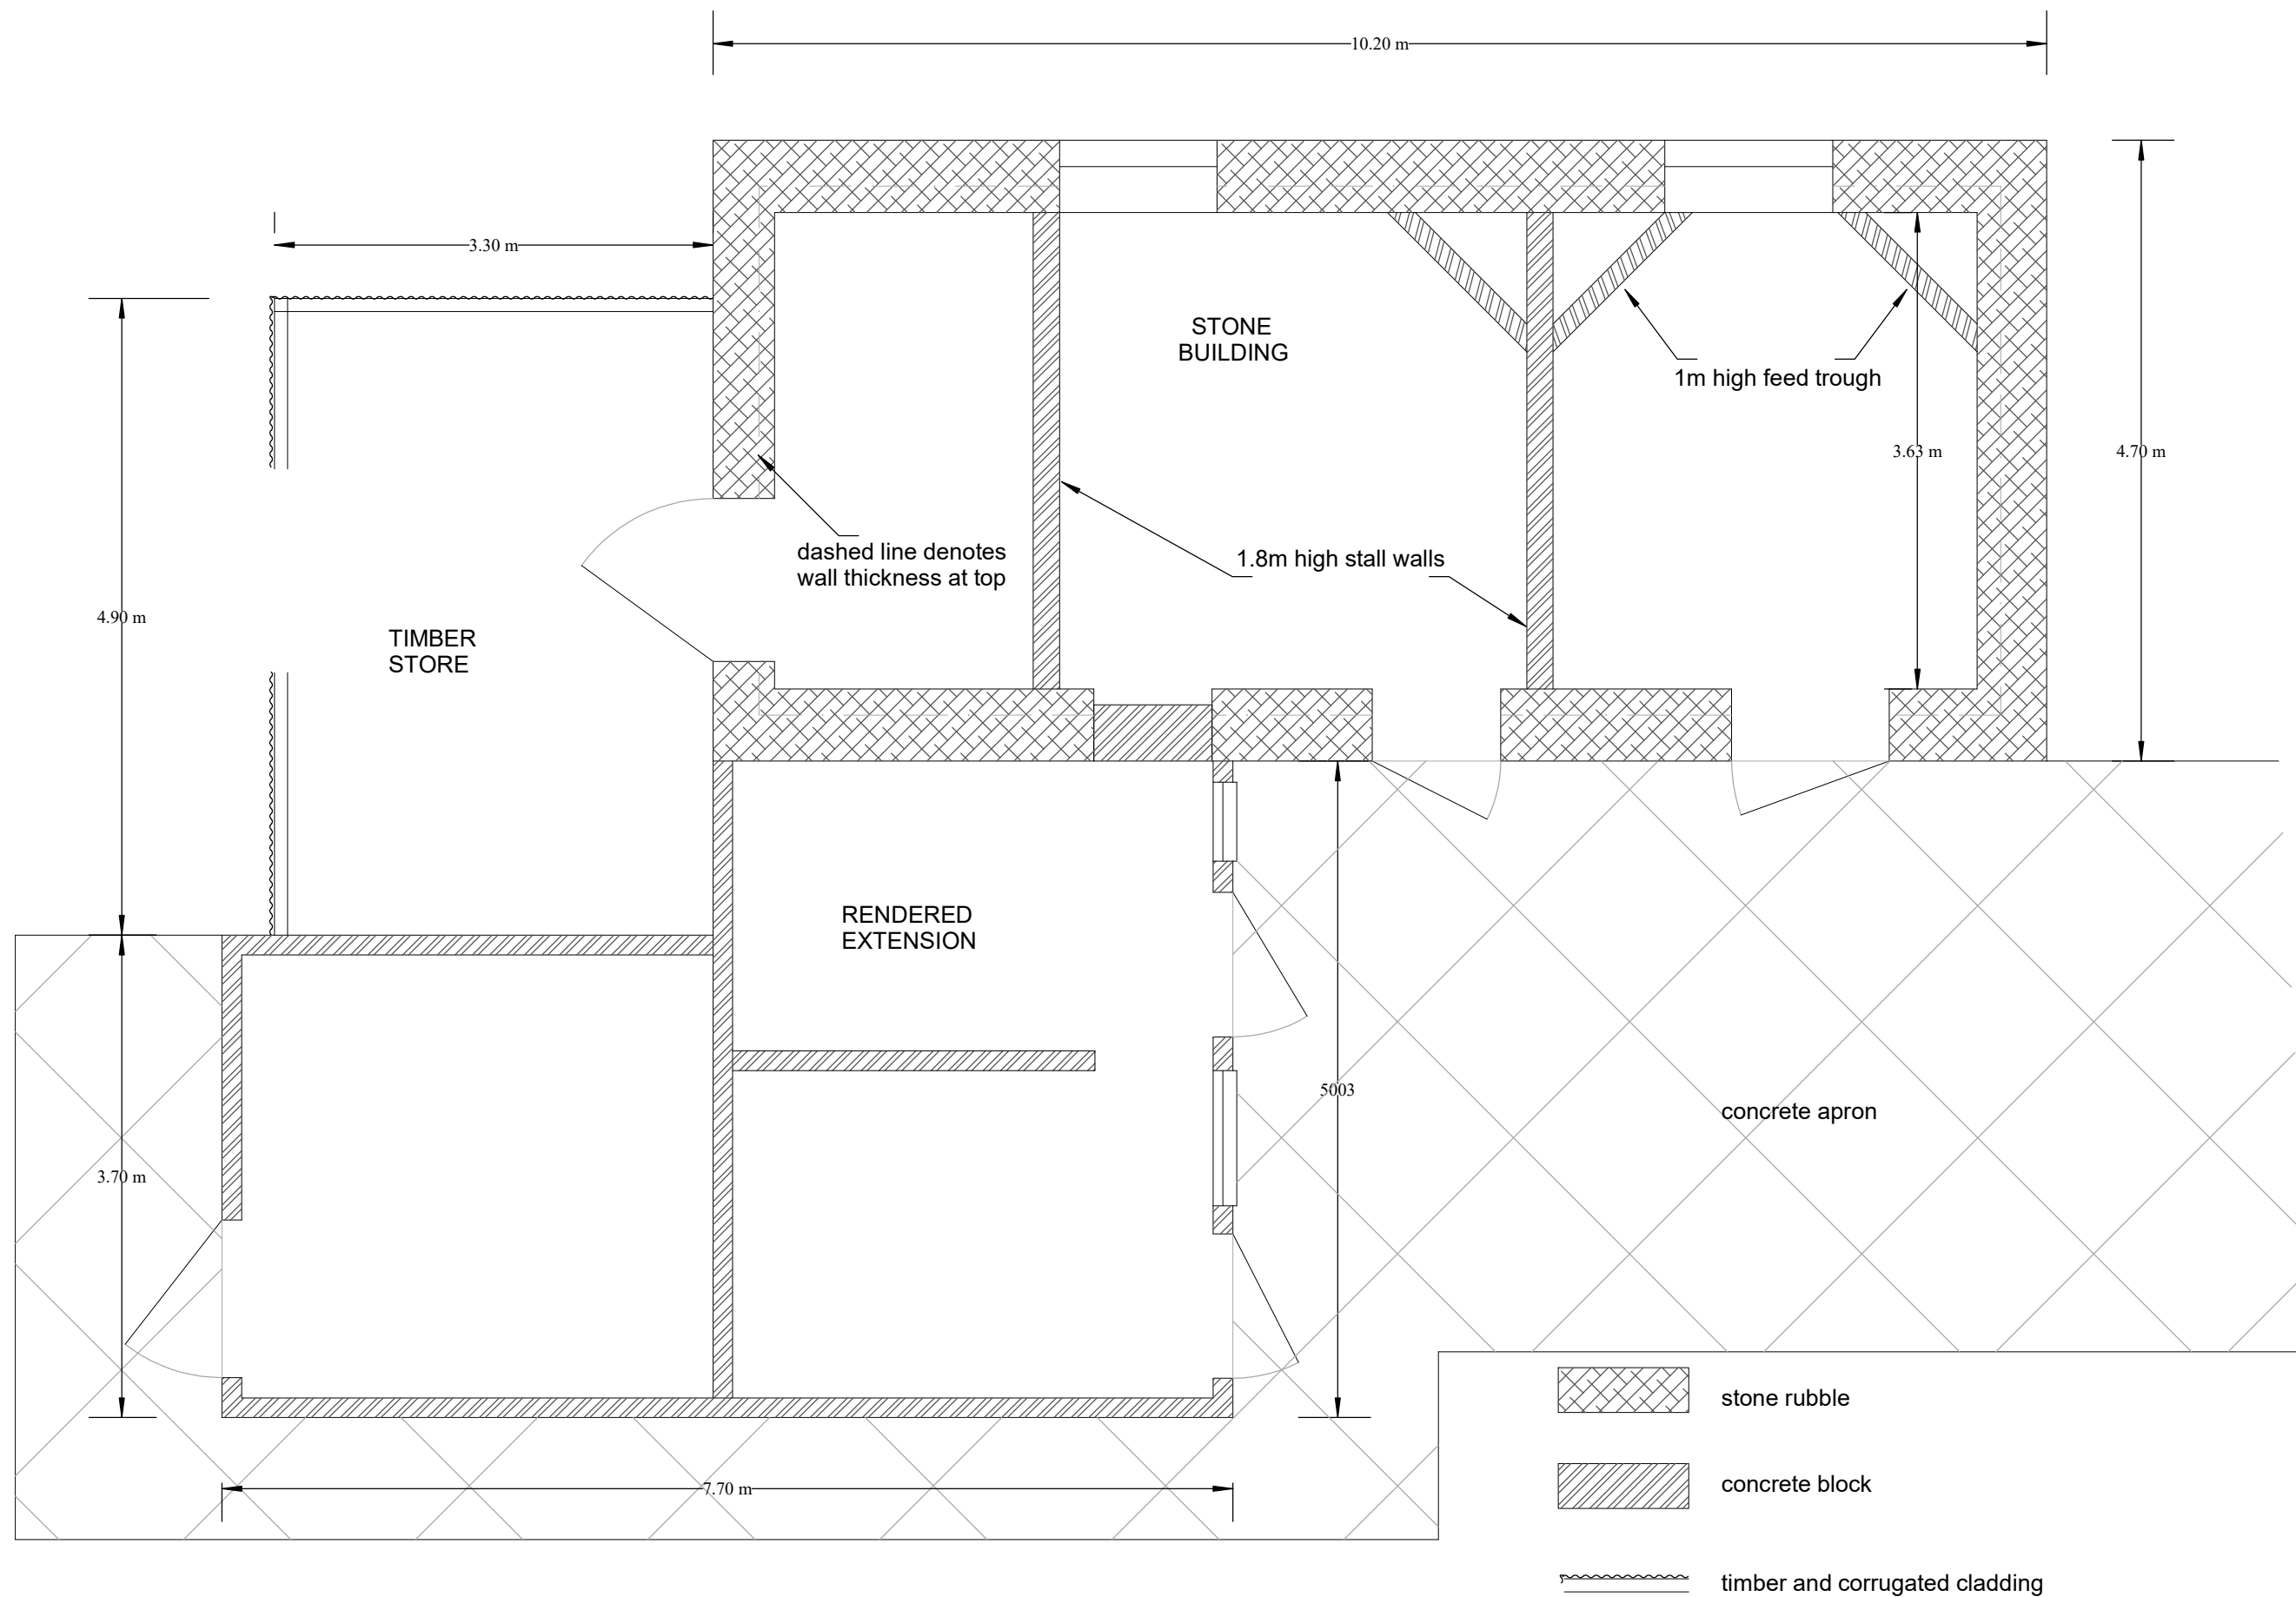
Solid masonry construction semi dressed inferior lias and sandstone quoins to corners and openings, with flint/chert rubble infill.

The wall to the west elevation appears to have undergone substantial alteration and is now in need of repair.

Original roofing likely to have been hipped and thatched. Later alteration to wall heights to accommodate a mono, shallow pitch corrugated metal roof (now failed).

All the original window openings have been altered. Those to the east elevation have been infilled with concrete block and a single metal casement window in a painted wooden frame. Those to the west elevation have been opened up and converted into doorways.

Cement fibre corrugated roofing sheets on softwood timbers (now failed).
