### **Design and access proposal.**

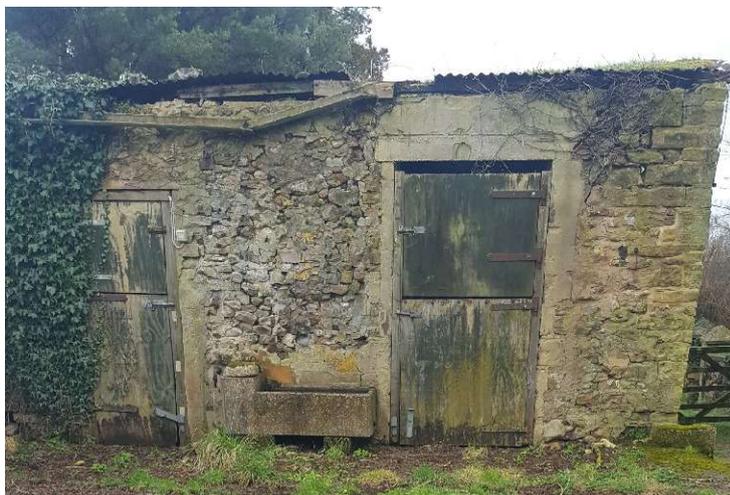
*Figure 2. west elevation*

The window and door openings have also been subject to alteration. The west elevation has three openings, two external as doorways *fig 2* and one internal (now infilled). The central door (left on *fig 2*) has stone reveals with some later concrete block, it has timber and concrete lintels over. It is possible that this is the position of the original back door and those to either side are where windows used to be, this arrangement would mirror the east elevation and create a floorplan that would be the same as that of the farmhouse. The two outermost openings have concrete block reveals to the majority with concrete lintels over.

- Repair and repoint all failed mortar.
- Remove existing mono pitch roof.
- Repair failed masonry to west elevation, remove concrete blockwork around door openings and replace with toothed brick quoins, maintaining current opening widths. Fit new concrete lintels over.

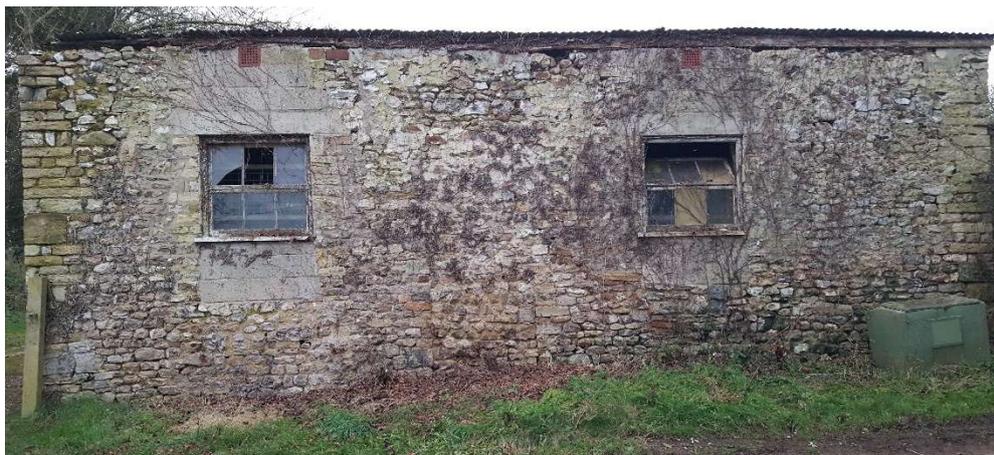
*Figure 3. east elevation*

There has been extensive alteration to the openings in the east elevation *fig 3*. The position of the original central doorway is clearly evident in the masonry *Fig 4*, albeit having been subsequently infilled with matching masonry. The window openings have also been infilled, the current windows have concrete blockwork above and below. It is possible that, like the farmhouse, there were originally pairs of windows to the ground and first floors which were the same width with the upper ones being directly above those on the ground floor and, during the alterations these pairs of openings were combined and re-configured.

- Remove 2 x existing windows and lower blockwork infill on east elevation. Install new single glazed timber windows.
- Remove existing blockwork infill above window openings and replace with matching stonework.

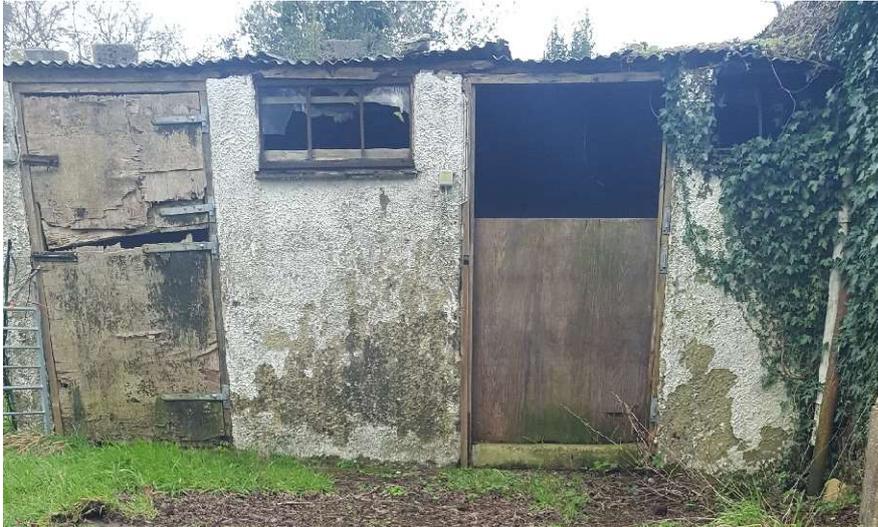
*Figure 5. South elevation*

To the west and north of the stone building there is an attached stable block extension of concrete block and rendered construction under a mono pitch corrugated concrete fibre roof *fig 5*. It is evident that this section of the building has also suffered from insufficient maintenance and poor design. The minimal roof pitch and the use of untreated timbers has resulted in failing timbers and the subsequent loss of fixing of the roofing sheets. The plywood doors have also failed, particularly on the more exposed south elevation.

- Remove existing mono pitch roof.
- Increase wall height of south elevation and reduce wall height of north elevation to create a gabled roof profile of approx. 12 degrees.
- Create new gabled roof over stable and timber store with softwood timbers and corrugated metal covering. Fit new rainwater goods.
- Fit vertical timber cladding to gable end.
- Remove, refurbish and reinstall existing windows.
- Fit new solid timber stable doors.
- Repaint render.
