Tree Decay Investigation Report -
The Station, Ottery Saint Mary
T00 1 – Mature Oak

TREE DECAY INVESTIGATION REPORT

SITE ADDRESS (THE SITE):	The Station, Mill Street, Ottery Saint Mary EX11 1AH
LOCAL PLANNING AUTHORITY:	East Devon District Council

HI-LINE JOB REFERENCE:	RSKHL_8289.24		
SURVEYED BY:	Mark Read	DATE:	6 th March 2024
REVIEWED BY:	David Hansford	DATE:	13 th March 2024

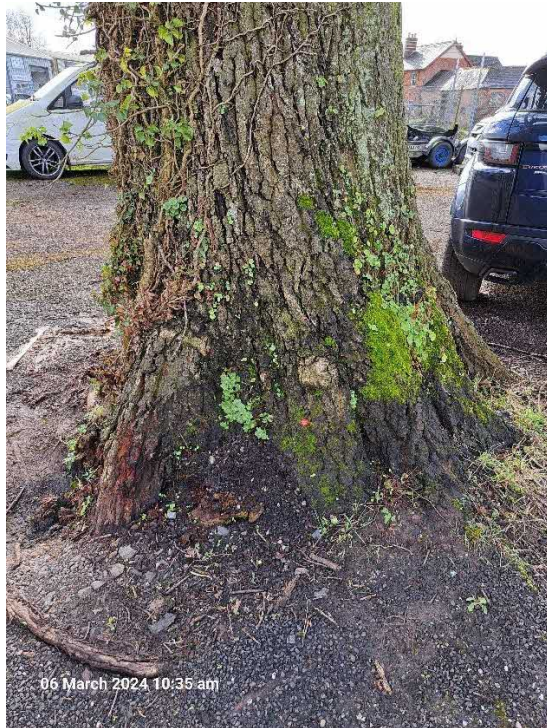
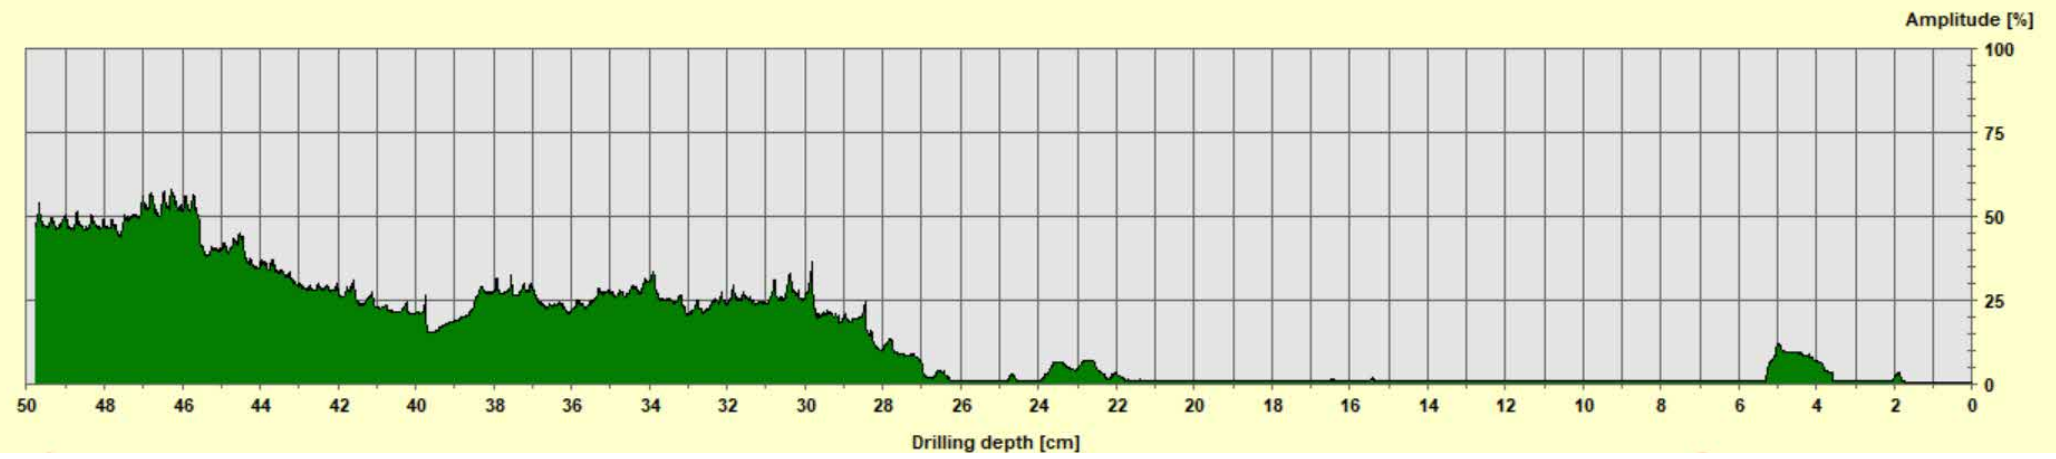
Drill point: North

- 5.8.1 Northern aspect: A drill shot was taken from the northern side of the stem, at a primary buttress root considered to be significant in terms of the tree's stability under tension. The shot was taken at approximately 300mm above ground level at a site in close proximity to fungal fruiting body (hereafter; ffb) association with *Pseudoinonotus dryadeus*. Pathogenic fungal action appears to have significantly affected the drill site, as the reading at the initial 270mm depth shows negligible resistance / very low amplitude. Normal resistance is observed from 280mm depth to the full 500mm tested, with the expected early and latewood peaks/troughs clearly visible. The very low amplitude reading to 270mm depth is significant in terms of strength loss of one of the tree's most prominent buttress roots on the tension side.

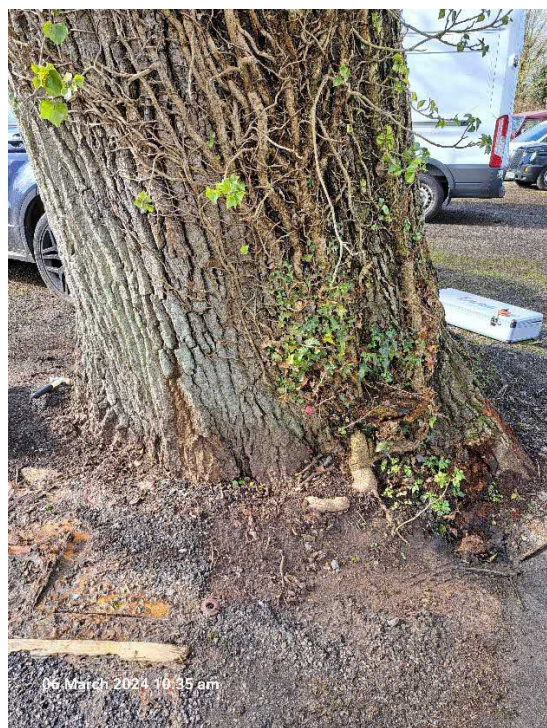
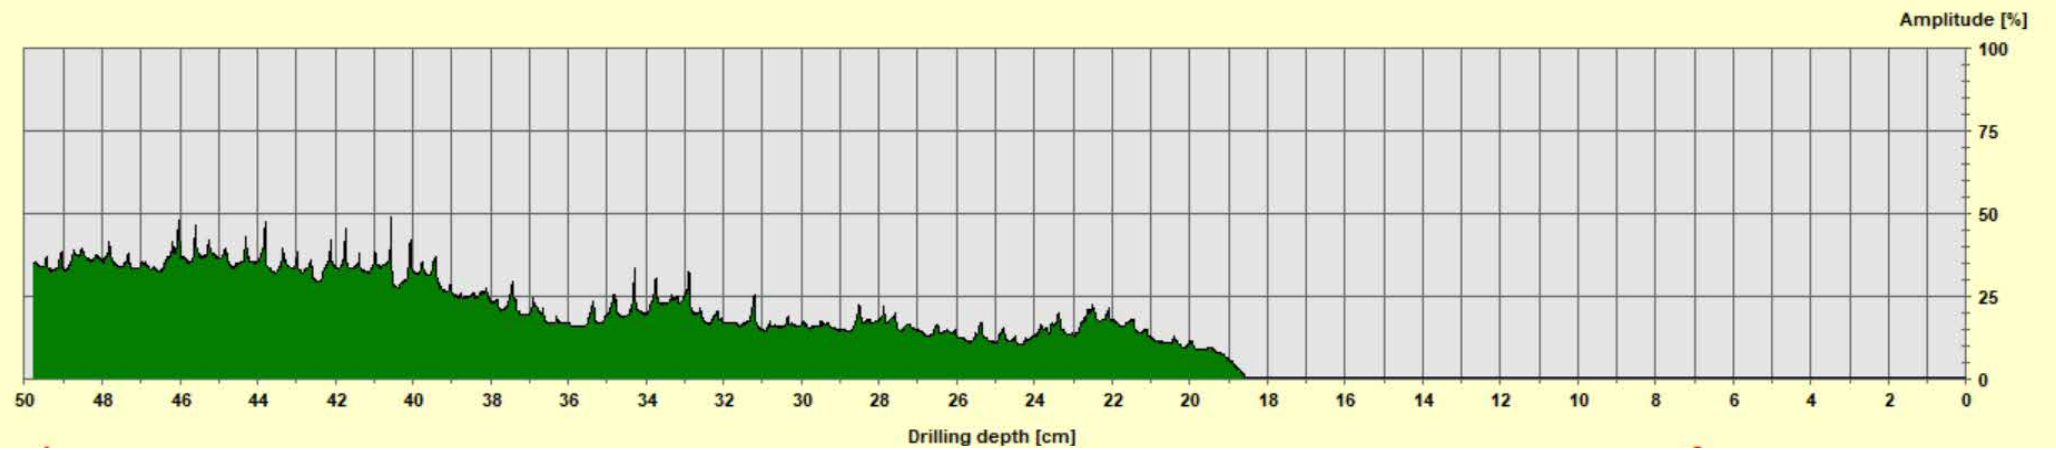
Drill point: East

- 5.8.2 Eastern aspect: A drill shot was taken from the eastern aspect of the stem at a point immediately adjacent to a site of fungal association (*Pseudoinonotus dryadeus*). Fungal fruiting bodies were no longer present, with only evidence of heavily degraded tissue remaining. The drill shot was taken at a section devoid of buttressing, however a minor root flare form is visible where the tree's lean and expected reaction wood formation is observed. The reading showed no resistance from 0-190mm depth, indicating complete degradation of bark, cambium and sapwood to this depth. Normal readings were observed from 190mm depth, with pronounced early/late wood peaks and troughs as expected of *Q. robur*. The extent and location of degraded wood observed corresponds with the mode of decay associated with *Ganoderma* sp., i.e., degradation of lignin, leaving a soft white rot and little in the way of resistance when a micro-drill is employed. The pronounced peaks/troughs and good amplitude observed from 190mm depth onwards, indicates the presence of sound heartwood on the eastern side of the stem. It

should be noted that *Ganoderma* sp. associate with below-ground portions of the tree as well as the lower stem, such that decay may potentially have spread from roots to the test site.

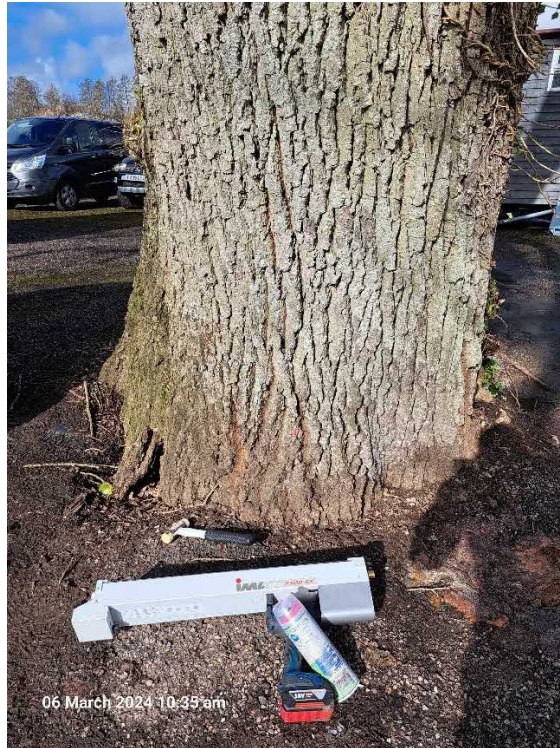
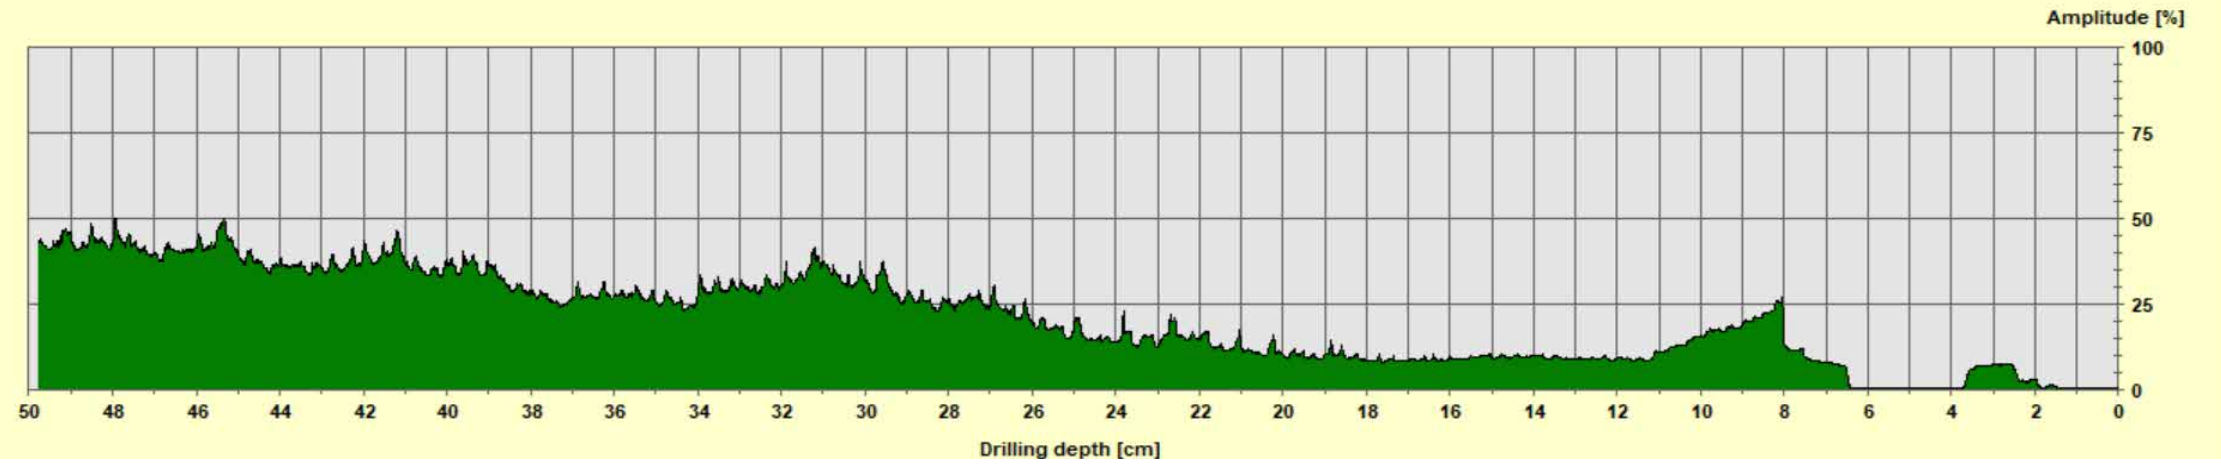
Drill point: South

- 5.8.3 Southern aspect: The southern aspect of the stem shows minimal flare, as expected of an oak on a pronounced lean in the same direction. Reaction wood typically develops on the tension side of broadleaf trees, as observed in T001. The comparatively flat surface of the test site showed no external symptoms of internal decay, and no visible ffb present at the time of test, or at the initial inspection in January 2024. Resistance readings showed good amplitude from 60mm depth (after initial low amplitude at the bark and fissures). A gradual reduction in amplitude is observed between 80mm and 220mm depth, however adequate resistance remains as well as defined early and late wood peaks/troughs respectively. Resistance readings from 220mm depth to the full 500mm showed good wood quality with no cause for concern, indicating sound heartwood.

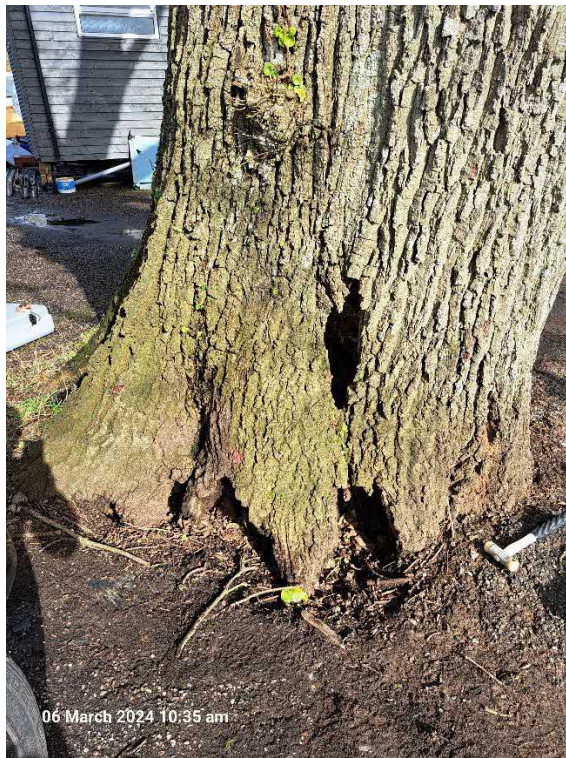
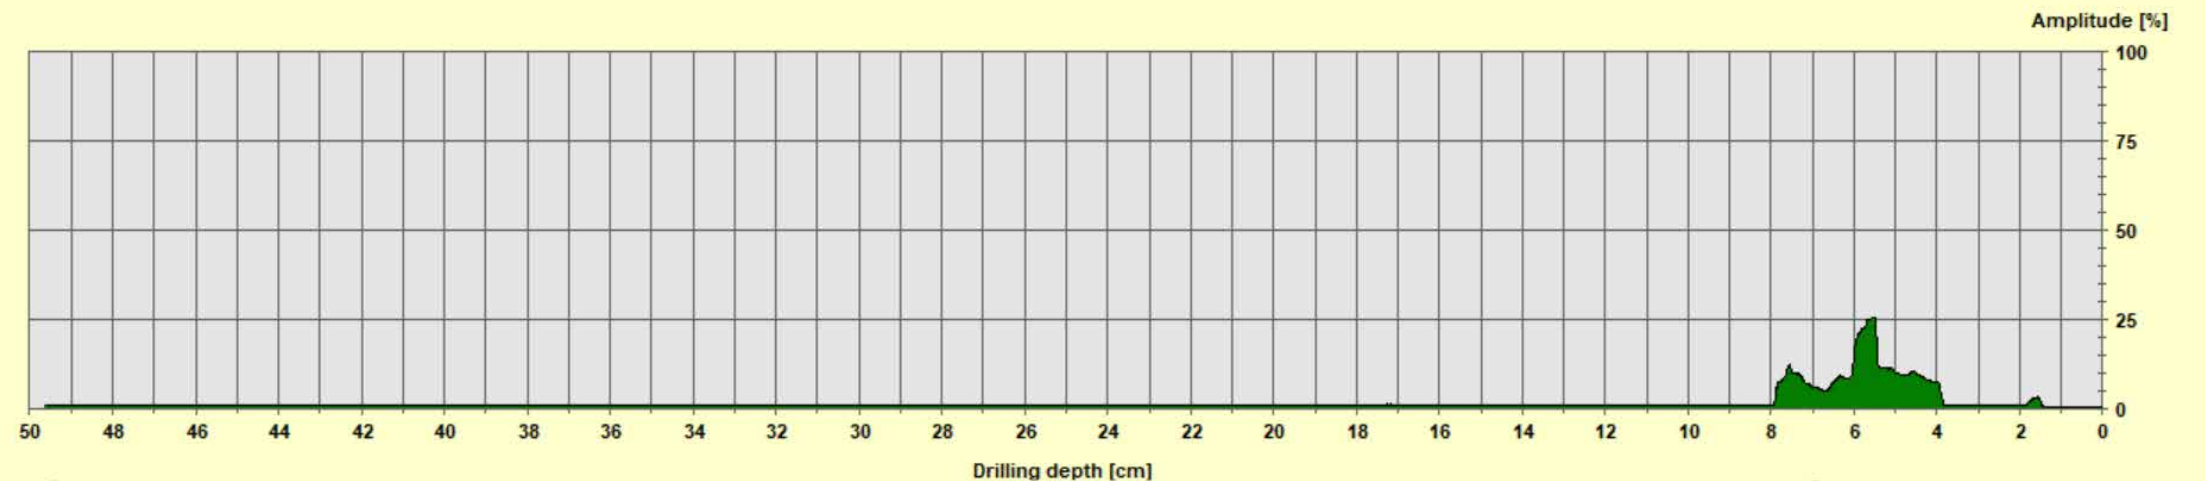
Drill point: West

- 5.8.4 Western aspect: The western side of the stem shows an open cavity with significant sapwood and heartwood decay. Potentially initially caused by a vehicle strike (as the area was formerly used as a train station carpark), this large section of the stem exhibits a near complete lack of structural integrity. Resistance readings demonstrated this, with amplitude remaining at zero beyond the bark layer to the full 500mm depth. The lack of support provided by the near entire western aspect of the basal area indicates the importance of sound wood on the north, east and southern aspects.

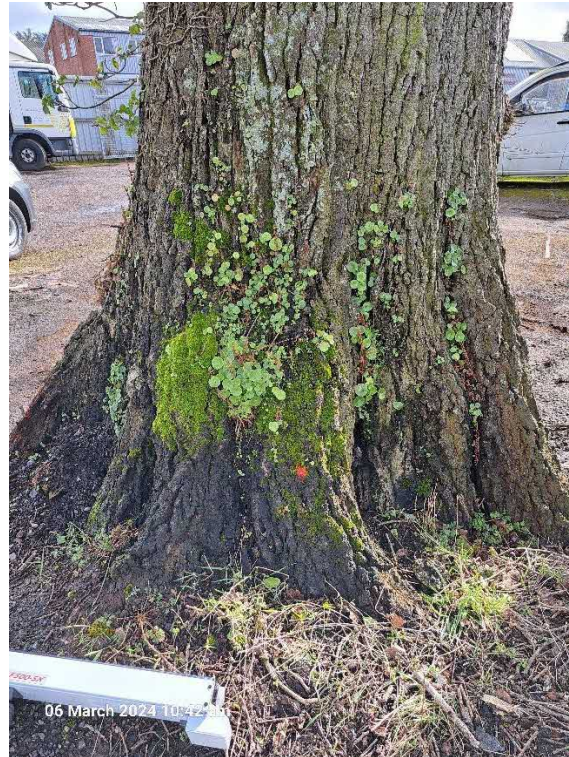
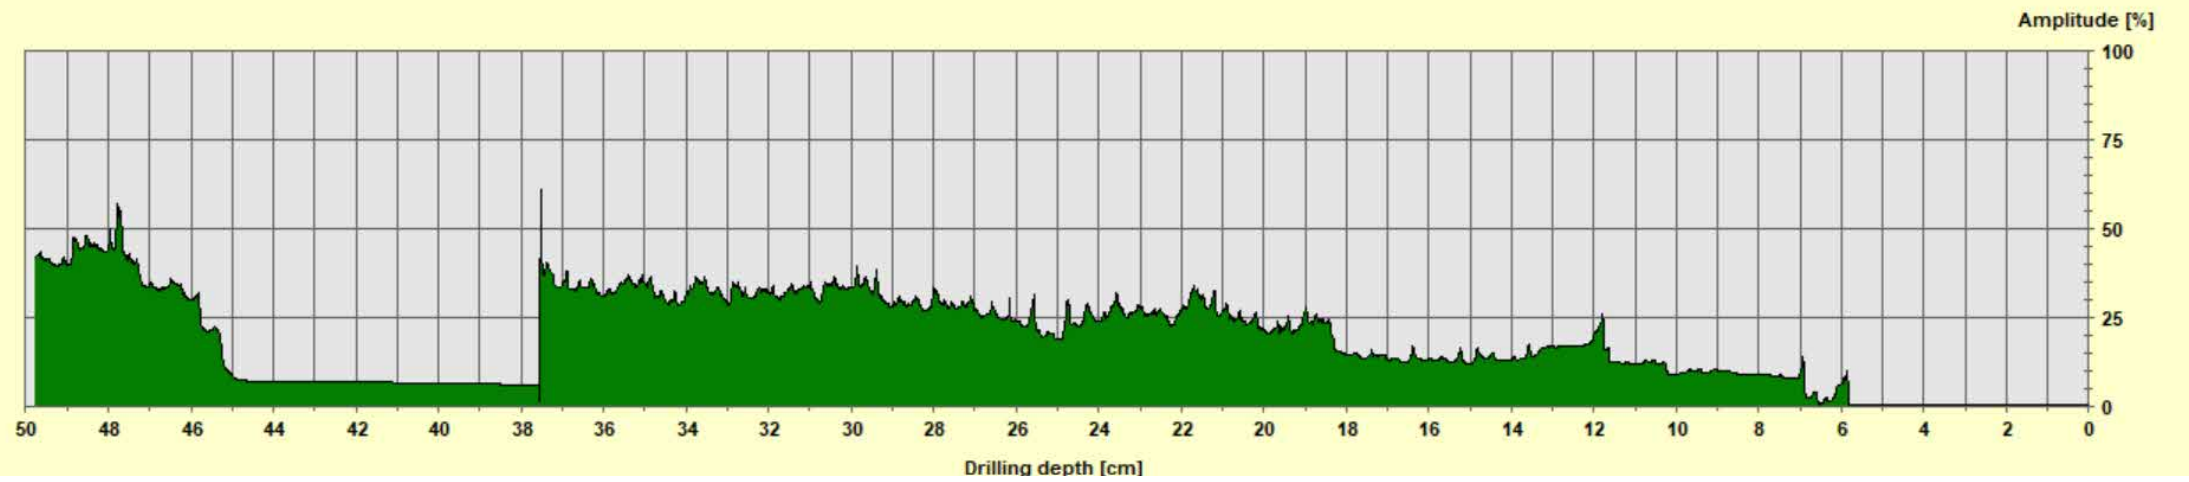
Drill point: North West

- 5.8.5 Northwestern aspect: The northwestern drill shot was taken from a buttress root on the tension side of the south-leaning stem. This root is considered to be structurally significant for this reason, and more so due to the compromised support provided by other points around the circumference of the tree's basal area. Resistance readings showed pronounced peaks and troughs associated with sound early/late wood to approximately 380mm depth, where amplitude peaked then troughed, dramatically. This reading is likely to indicate the point at which the drill needle breached a reaction zone (peak) and entered an area of decay behind the buttress root. The area of decay appears to be that of a soft/white rot, as no indication of late wood is shown. Amplitude increases at 450mm depth for the remaining 50mm, indicating the presence of sound heartwood. This suggests the buttress root appears to be of sound quality, whereas decay behind the root is present and developing. This is often seen in oak, whereby buttresses remain as stand-alone supporting structures whilst heartwood decays, leaving an 'Eiffel Tower' form, as is associated with *Pseudoinonotus dryadeus*; hence its commonly used name, Eiffel Tower fungus.

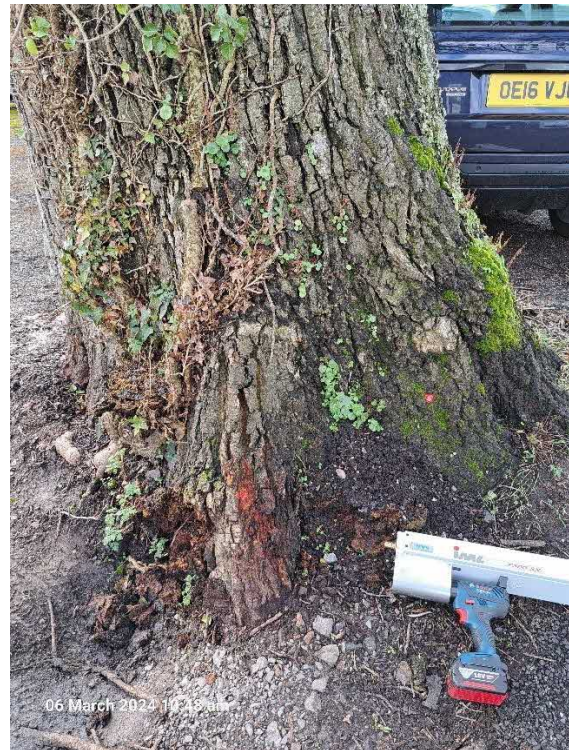
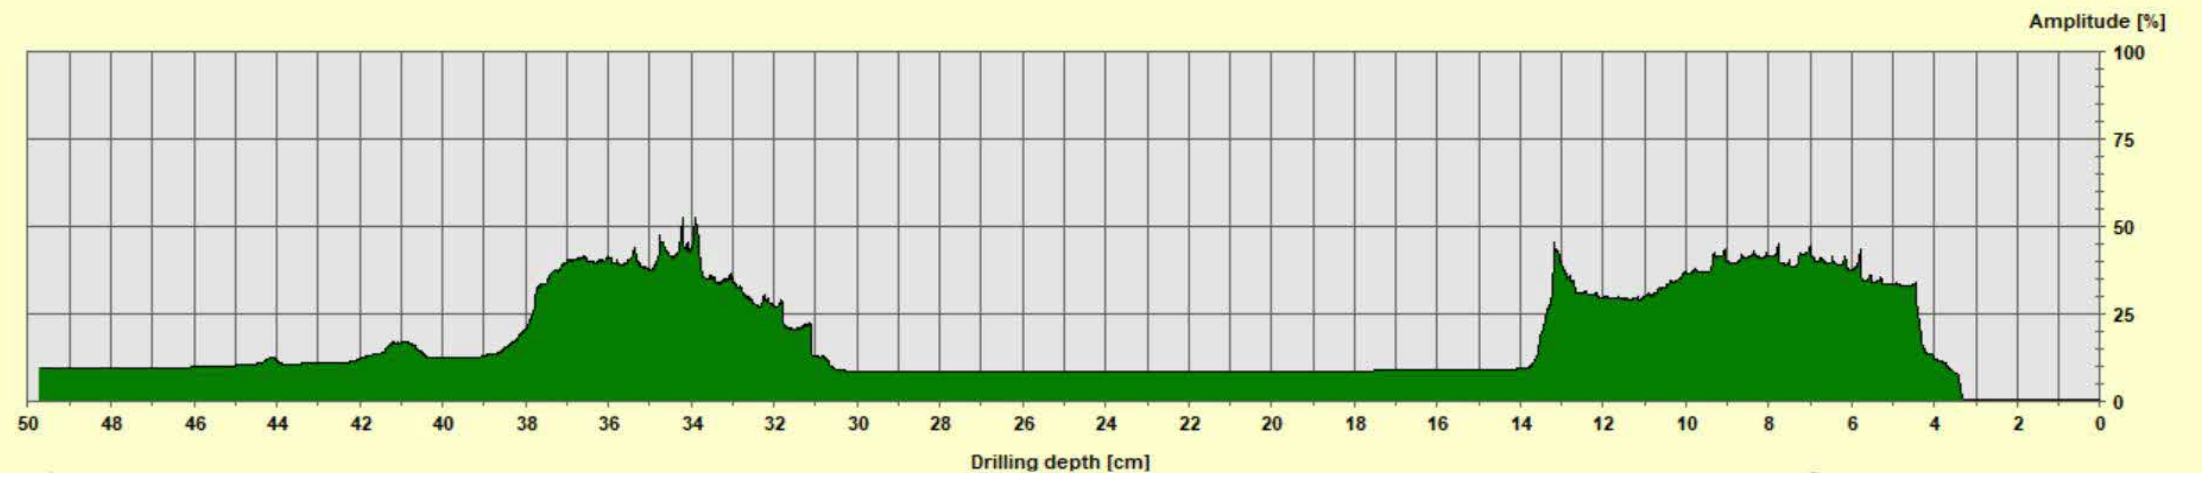
Drill point: North East

- 5.8.6 Northeastern aspect: The northeastern drill shot was taken from a buttress root located immediately adjacent to a site of fungal association by *Pseudoinonotus dryadeus* – (on the opposing side of the buttress to the northern test site). This buttress location is considered to be structurally significant, as with that of the

northwestern site, as it also is on the tension side of the south-leaning stem. Amplitude readings initially show sound wood from 35mm depth to 130mm, however resistance drops significantly and shows a lack of early/late wood peaks and troughs until 320mm, and again after 380mm depth. The troughs indicate an area of significant strength loss due to the presence of a white rot, commensurate with the mode of decay caused by *Pseudoinonotus dryadeus* and *Ganoderma resinaceum*. The advanced spread of fungal fruiting bodies (degraded) at this location, coupled with the presence of decay on the tension side of the stem, gives rise to the possibility that the below-ground areas of the rootplate may also be structurally compromised.

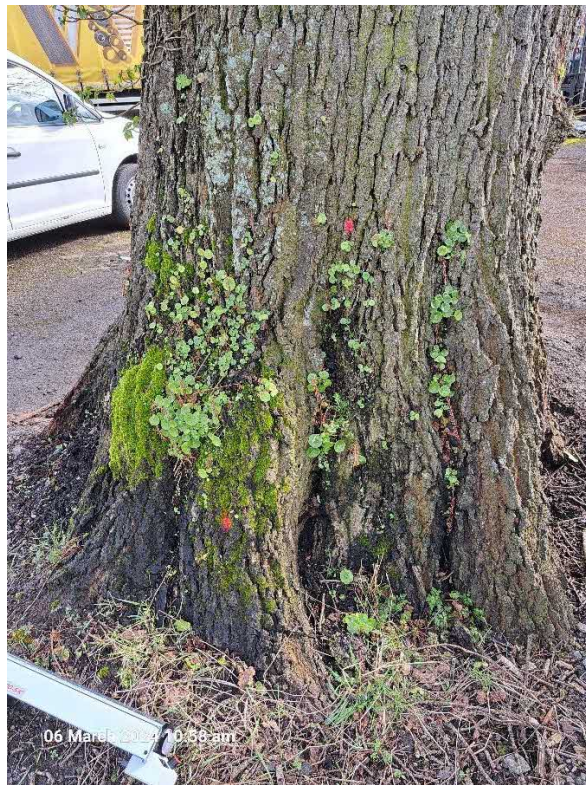
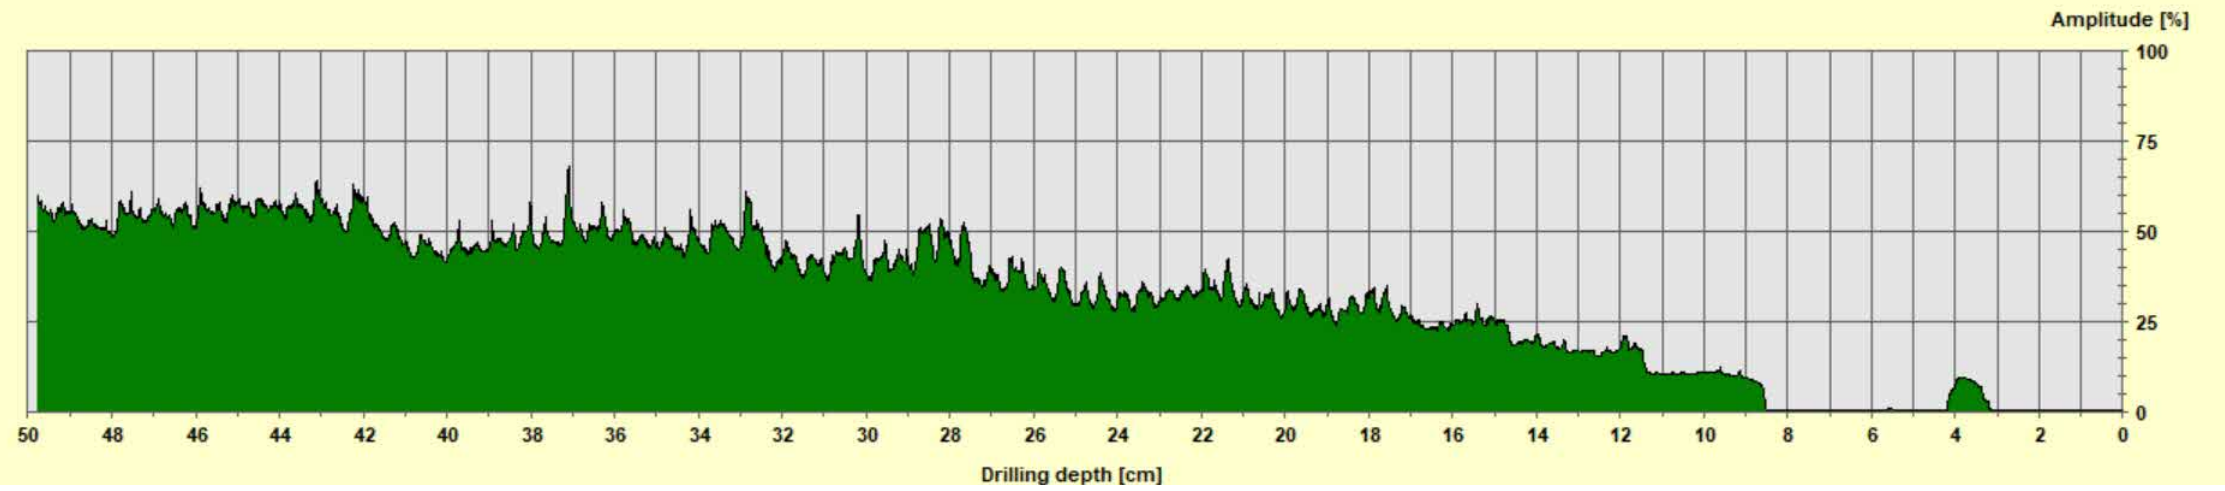
Drill point: North West, 1m above ground level

- 5.8.7 Northwestern aspect, 1m above ground level: The reading at this test site showed a steady increase in resistance and very pronounced early/late wood peaks and troughs. This should be used as a comparative reading, with amplitude and pattern exemplifying that of a healthy example of the species.
