# Verification Report

Client: Greene King

Emersons Green, Bristol

Report No: 938.04.01

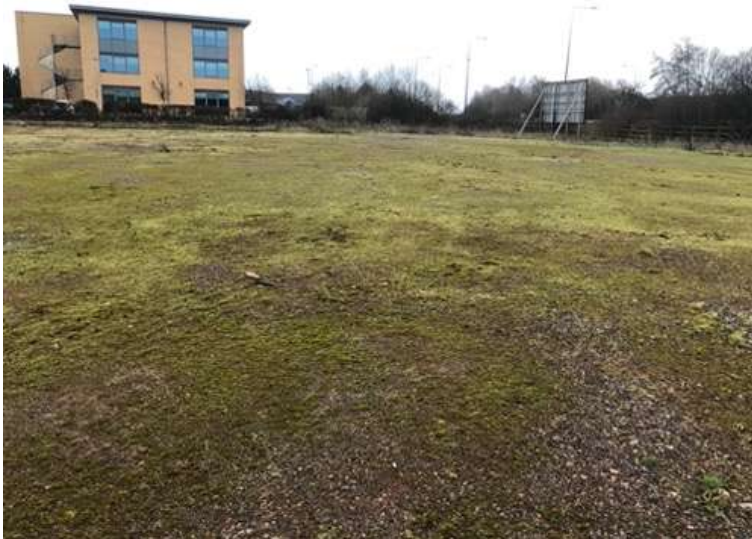
**Photo 1:** The southern and eastern site boundaries marked by wooden fencing and shrubs. The majority of the site consists of a compacted clay surface covered with a thin layer of vegetation.

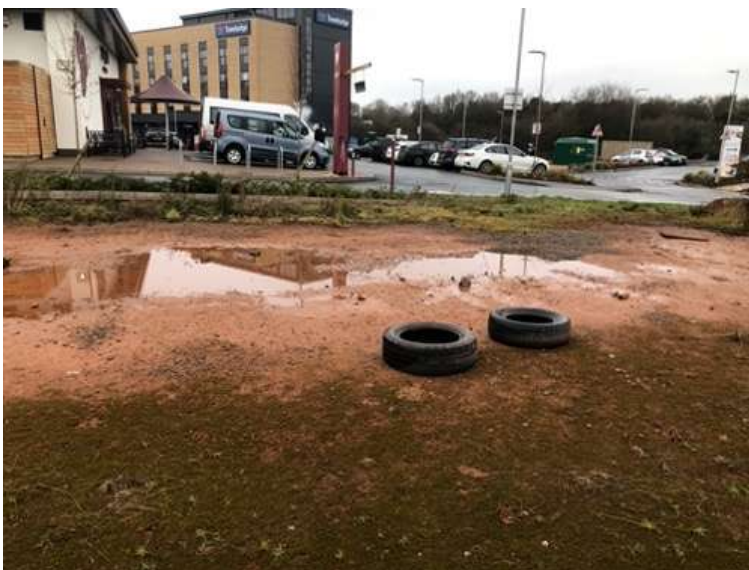
**Photo 2:** A view towards the north-western corner of the site. Some standing water was present during the site investigation as well as softer ground.

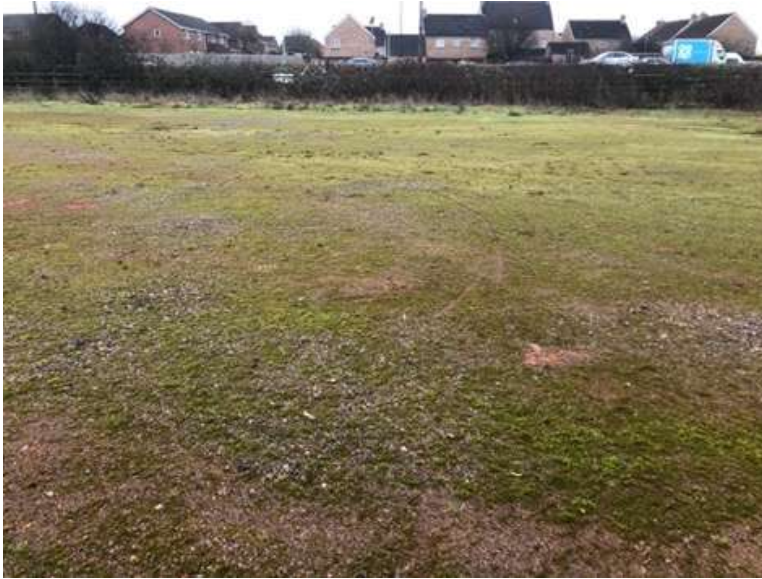
**Photo 3:** Looking south-west across the site showing the hedge forming the southern site boundary and the A4174 beyond.

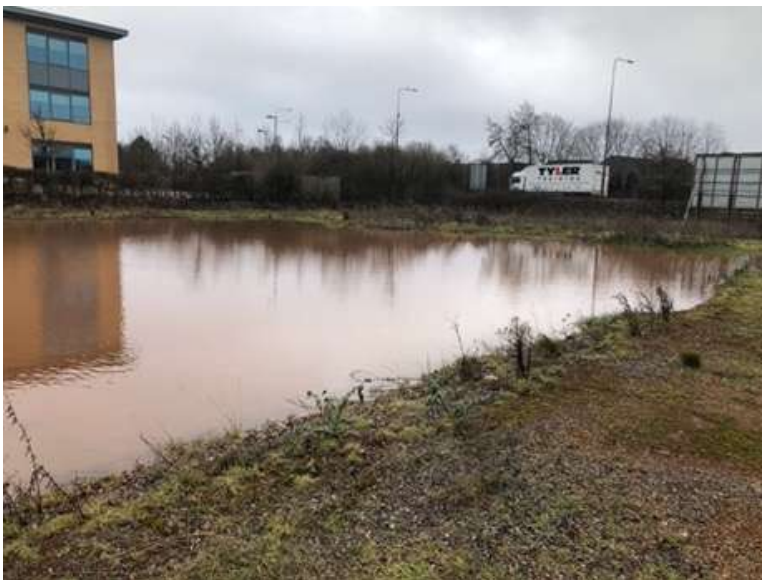
**Photo 4:** A view eastwards along the eastern zone of the site, the majority of this area consisted of standing water circa 0.25m deep.

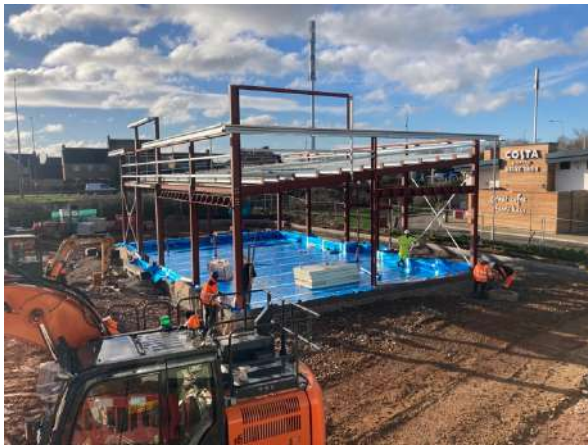
**Photo 5:** View south-westwards towards Greggs retail unit on 10<sup>th</sup> January 2024.

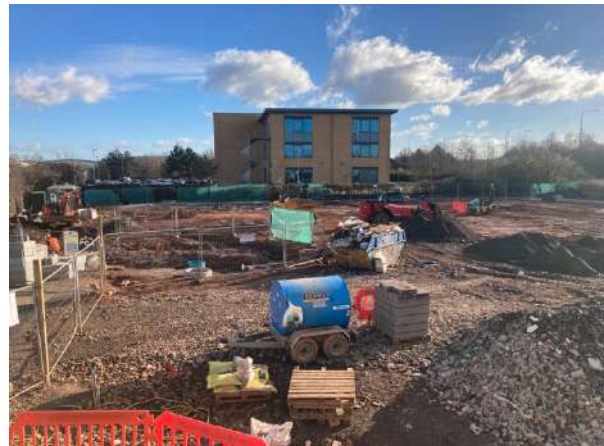
**Photo 6:** View eastwards across the site, with the site entrance shown on the immediate left on 10<sup>th</sup> January 2024.

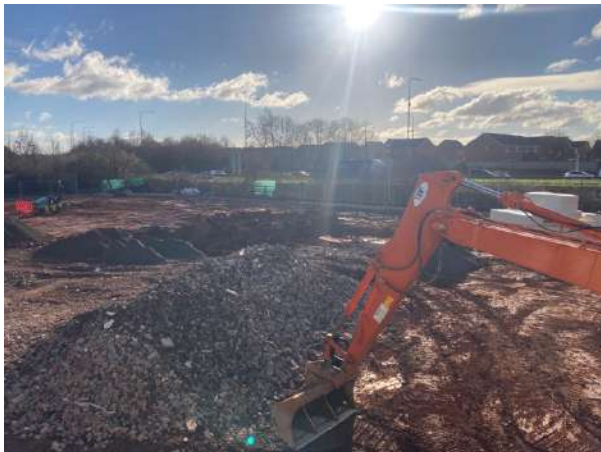
**Photo 7:** View southwards across the site on 10<sup>th</sup> January 2024.

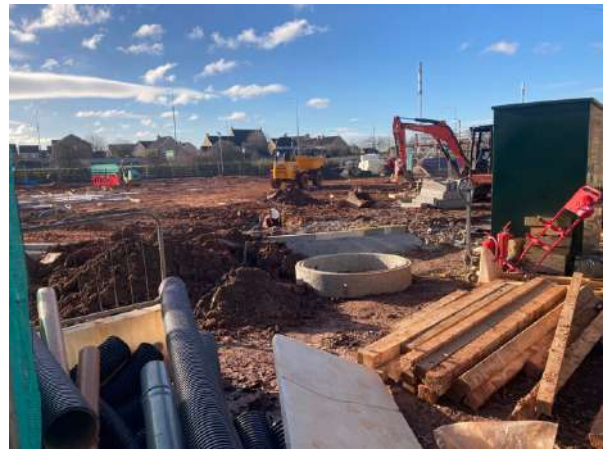
**Photo 8:** View from the northern boundary of the site across the footprint of the proposed McDonalds retail unit on 10<sup>th</sup> January 2024.

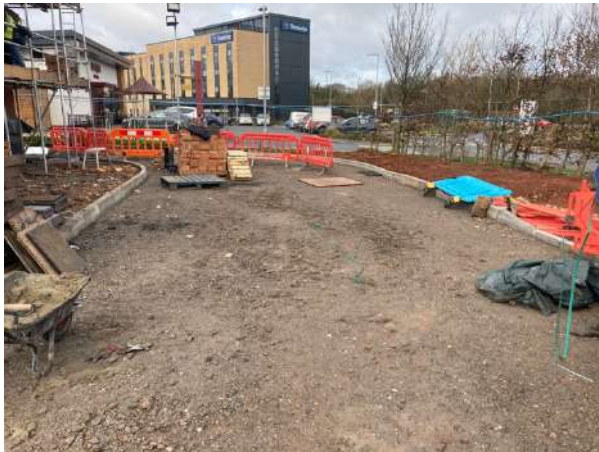
**Photo 9:** Construction of roadway around Greggs unit on 16<sup>th</sup> February 2024

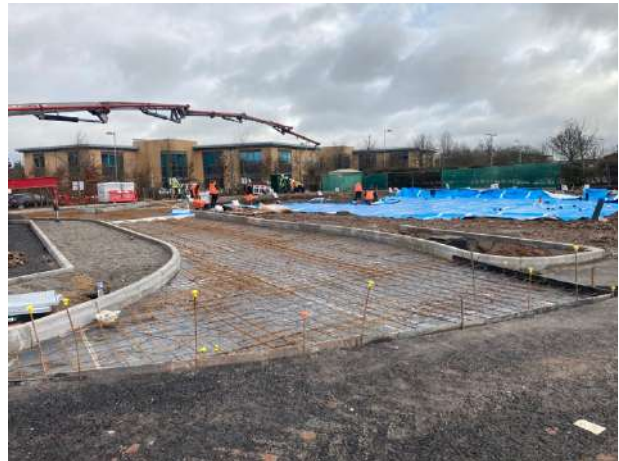
**Photo 10:** Access road around McDonalds unit in the process of receiving concrete on 16<sup>th</sup> February 2024.

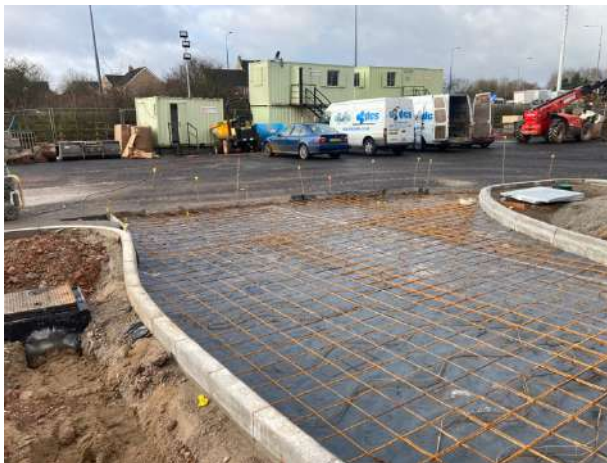
**Photo 11:** Similar view to Photo 10.

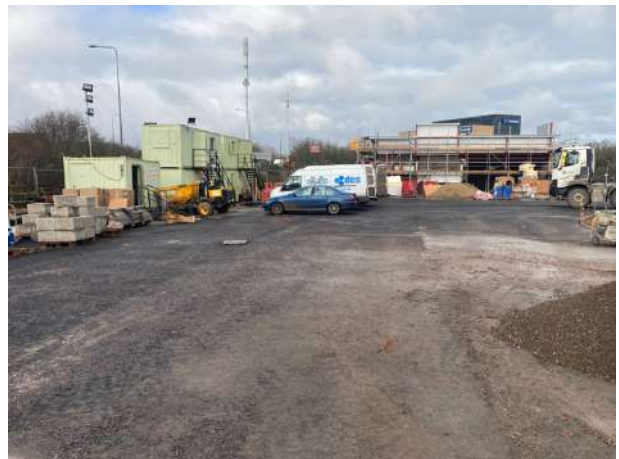
**Photo 12:** View westwards towards the Greggs unit.

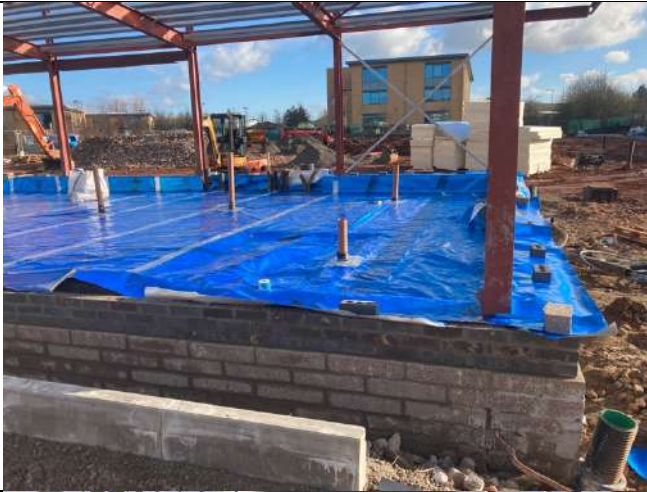
2

Visqueen membrane installed within footprint of Gregg's unit.

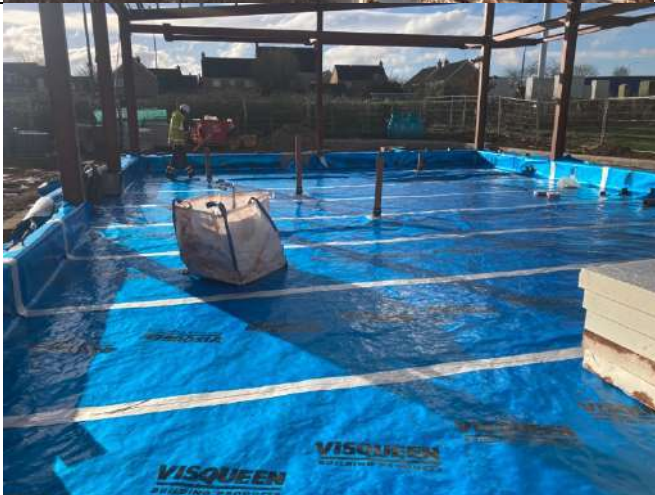
3

Visqueen membrane installed within footprint of Gregg's unit, with majority of joints taped.

At the time of writing, some service entries and one joint still required sealing. PCA have provided Remada with photographic evidence to show that this work was completed on the 10<sup>th</sup> January 2024. A selection of these photographs is presented below:

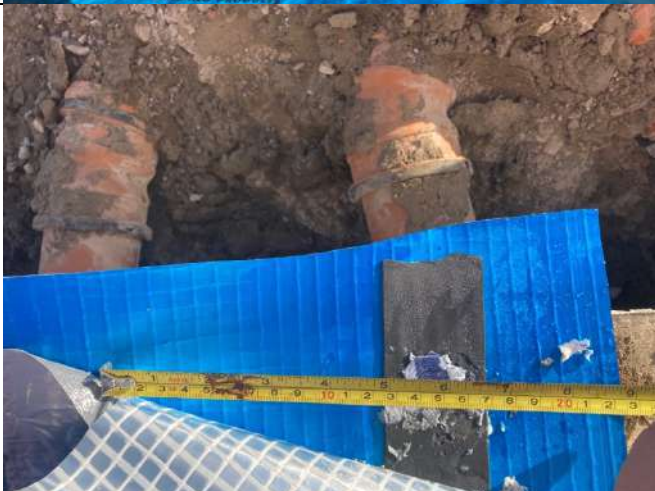
4

Overlap measured between individual sheets, with double-taping visible.

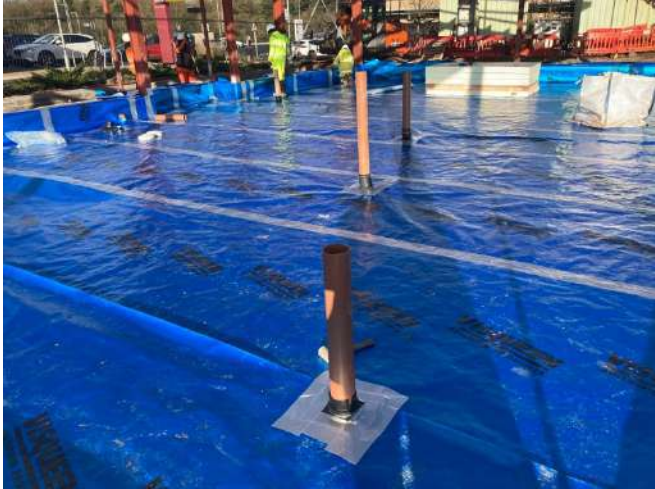
Top hat covers around service entry, sealed with tape and metal clip present.
6

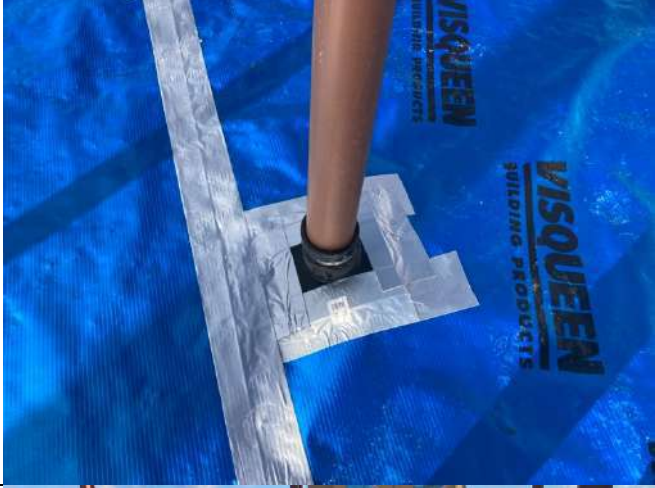
Top hat cover around service entry, sealed with tape.
7

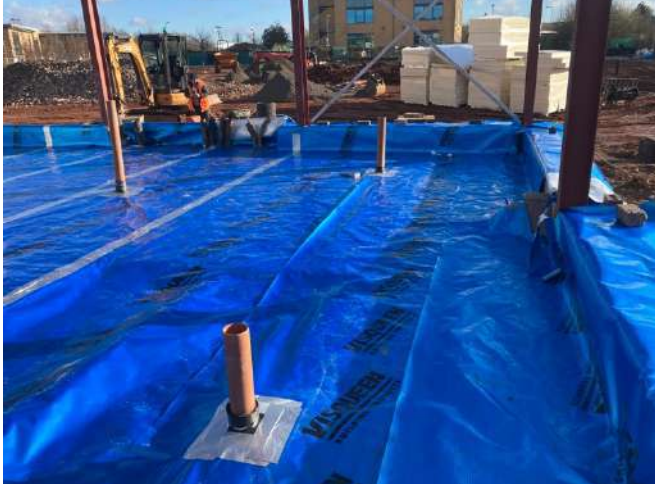
Top hat covers around service entry, sealed with tape and metal clip present.

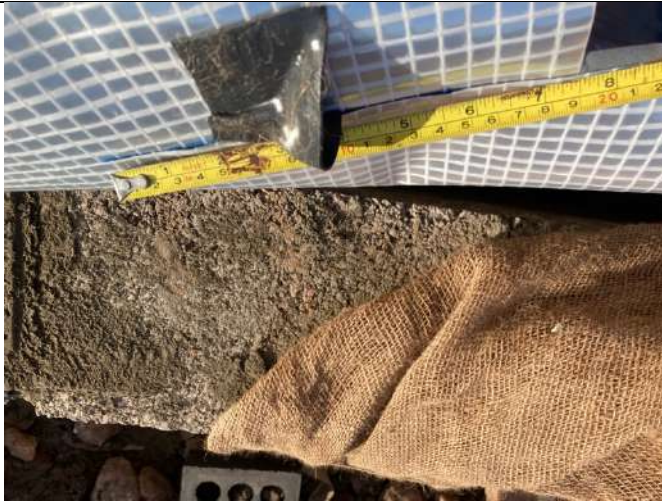
8

190mm overlap noted along joints.

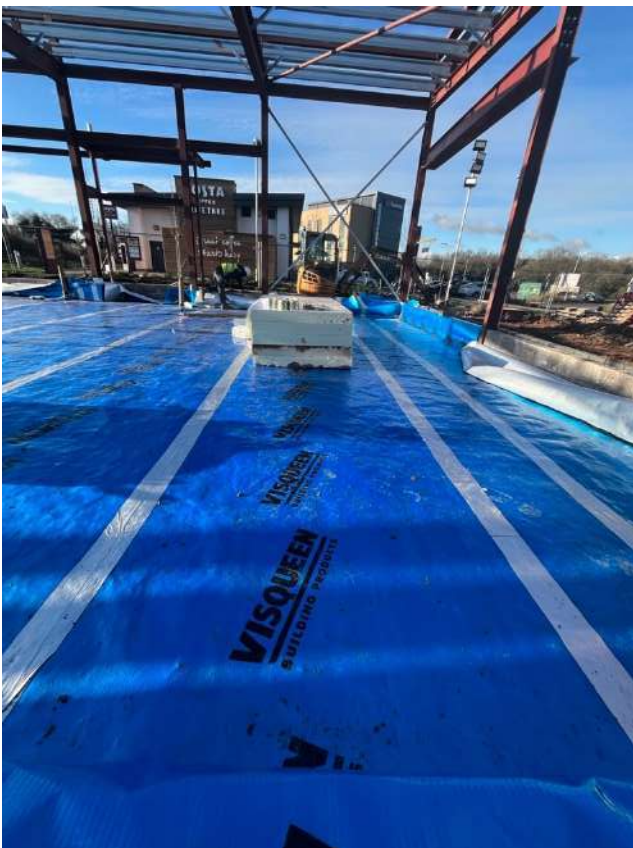
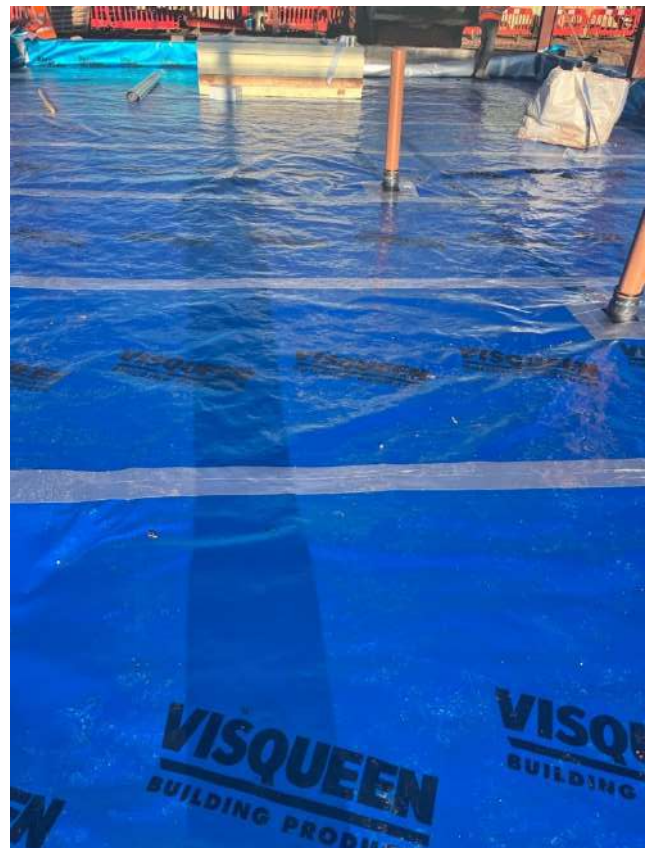
Photos 9 and 10 – PCA supplied photo showing all joints to have been sealed.

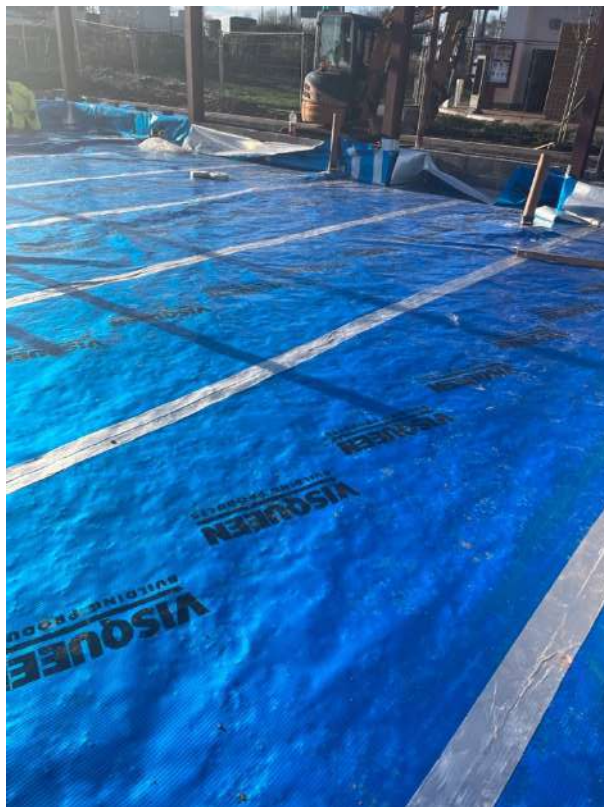
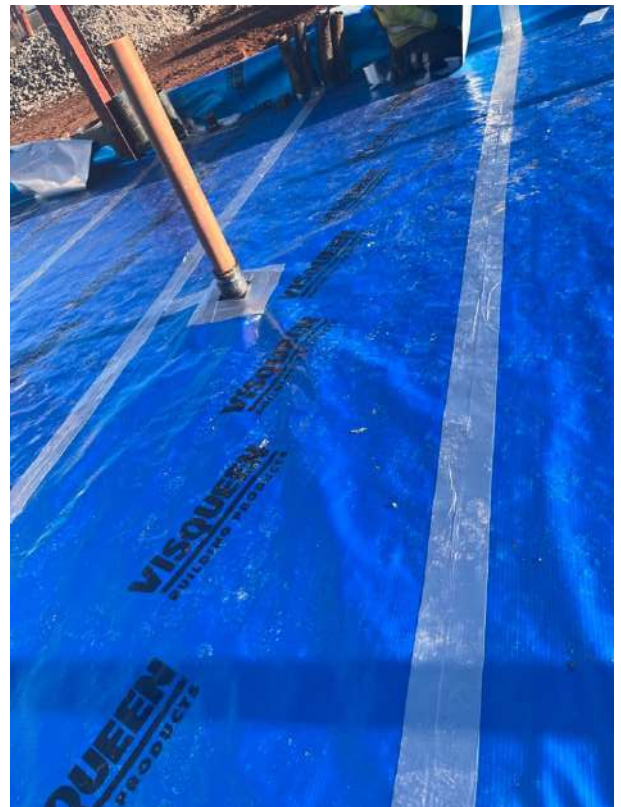
Photos 11 and 12 – PCA supplied photo showing all joints to have been sealed, and top hat covers installed.

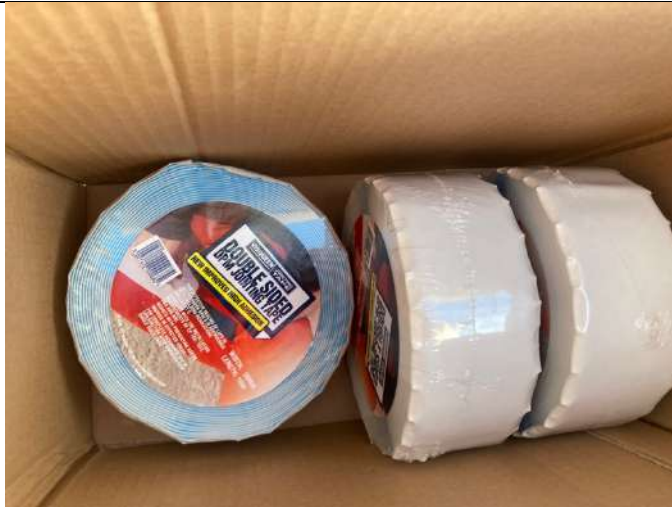
5

Product details of double-sided tape

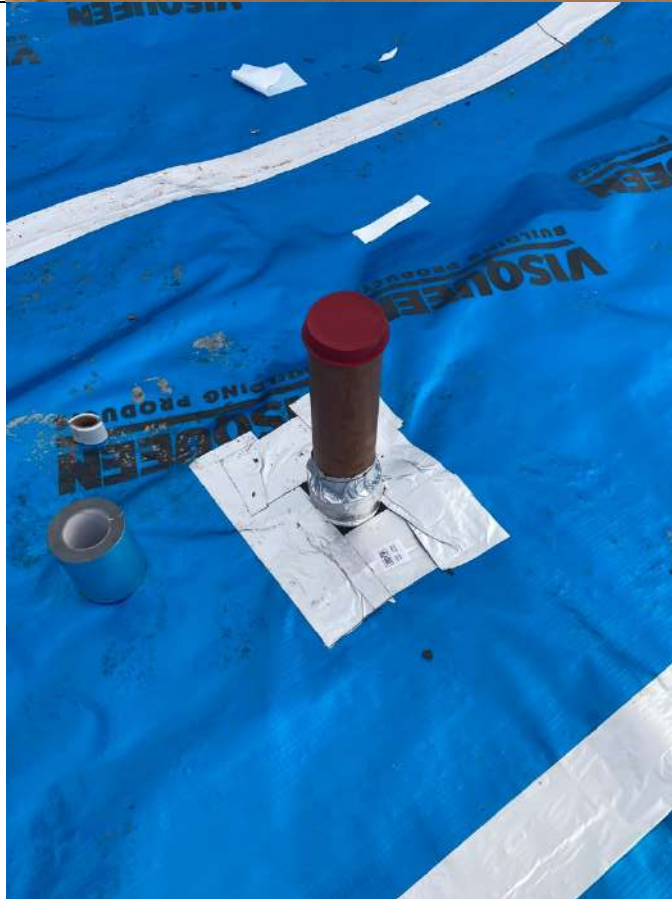
6

Top hat cover around service entry,  
sealed with tape.

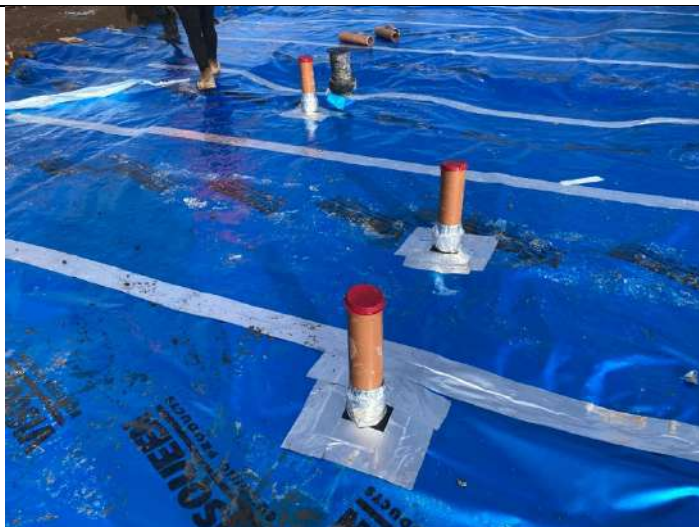
7

Top hat cover around service entries,  
sealed with tape.

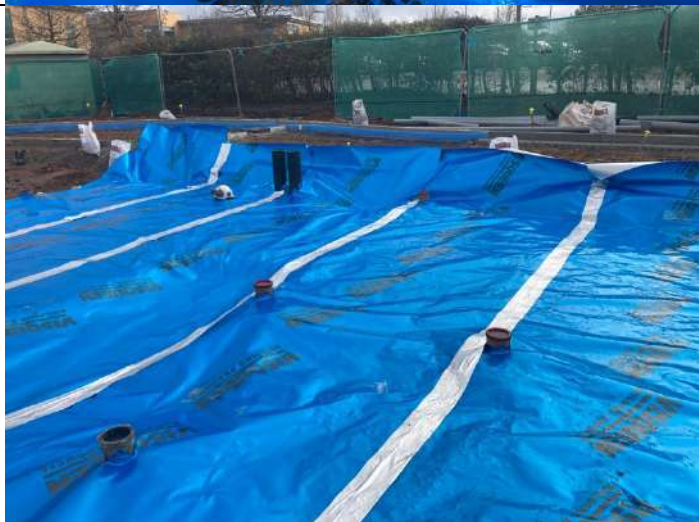
8

Service entries still requiring top hat  
covers at the time of Remada's visit.

At the time of Remada's inspection, some service entries and some joints still required sealing. PCA have provided Remada with photographic evidence to show that this work was completed on the 16<sup>th</sup> February 2024.

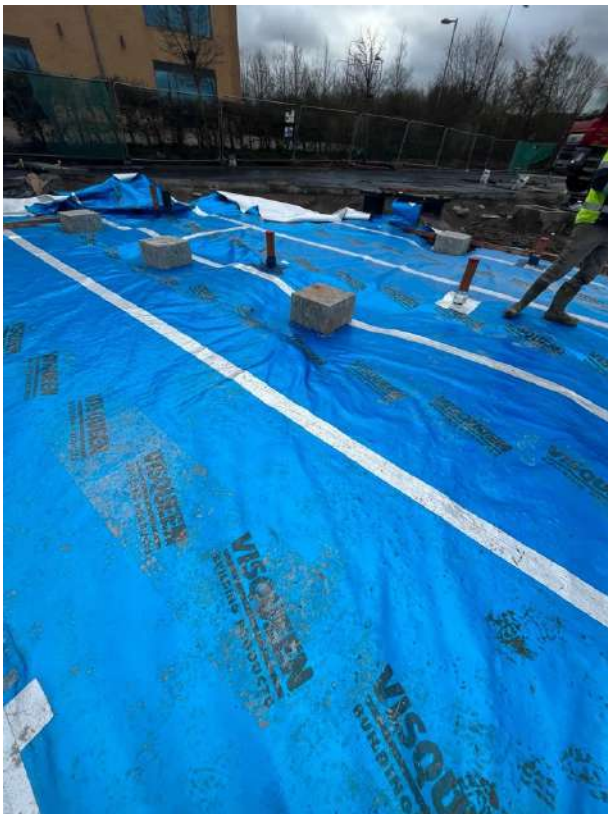
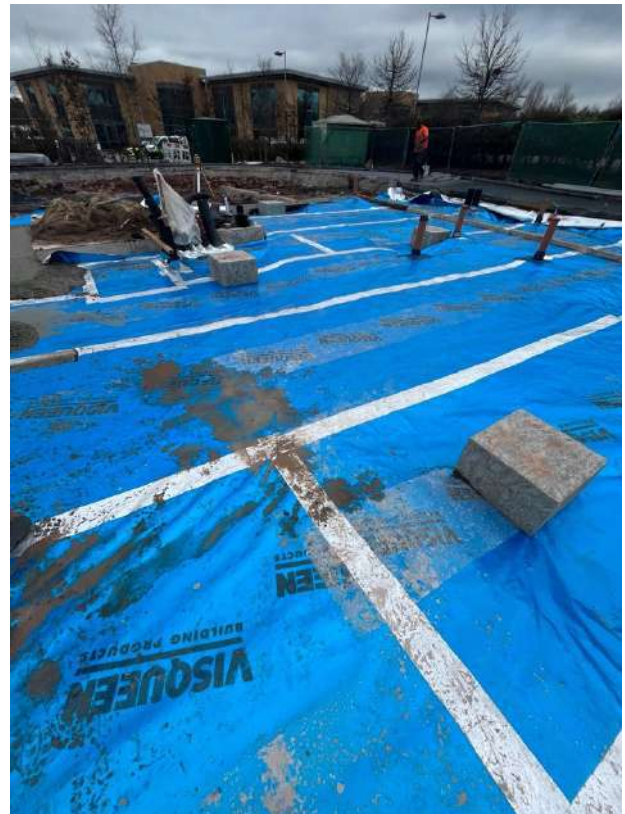
**Photos 9 & 10** – PCA supplied photos showing all joints and service entries have been sealed.
