**Arboricultural Survey Report:
Trees to the frontage of 9 Burnley Road, Hempstead, Bacup,
Lancashire, OL13 8AB**

Document reference: 843/23, Revision 0

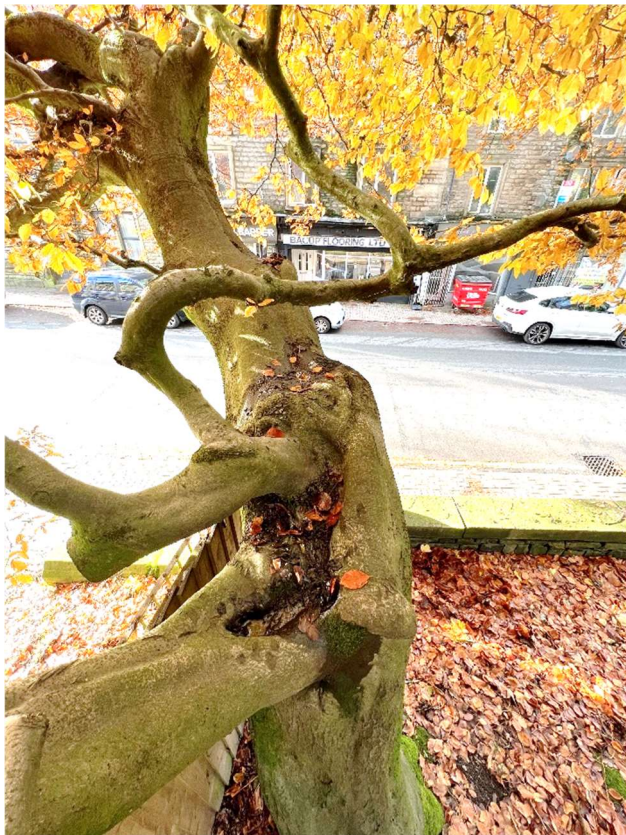
- 2.7 The tree is of an unusual habit with a short stout trunk extending to around 1.8m before the first point of branching. The largest of these lower branches is around 250mm in diameter and features outer growth that brushes up against the face of the adjacent building, including balustrading, stonework and windows at second storey level. To the road side, the main stem continues almost in the manner of a side limb (extending over the road at an approximate angle of 20–30°). Looking down upon this part of the primary structure, there were minor sunken pockets which were water-filled at the time of assessment. However, there was no indication of deep-penetrating decay.

Photograph 5: Looking down upon the spring of the crown of tree 1.

- 2.11 **Recommendation:** Lateral branch growth extending towards the neighbouring building should be pruned back to give at least 2m and preferably 3m clearance. Such works have been done previously, resulting in some internodal pruning stubs. Wherever possible, these should be reduced back to a stronger natural growth point, limiting future dysfunction.
- 2.12 The remaining crown growth to the road side should also be selectively reduced, primarily to reduce end weight given the observed defects to the upper side of limbs. The typical extent of reduction should be 3–4m. At which point, any minor compensatory branch reduction pruning should be carried out to retain the crown in as pleasing a shape as possible when viewed from the road frontage. Minor remaining growth over the lawn is to be crown lifted to give 2m clearance.

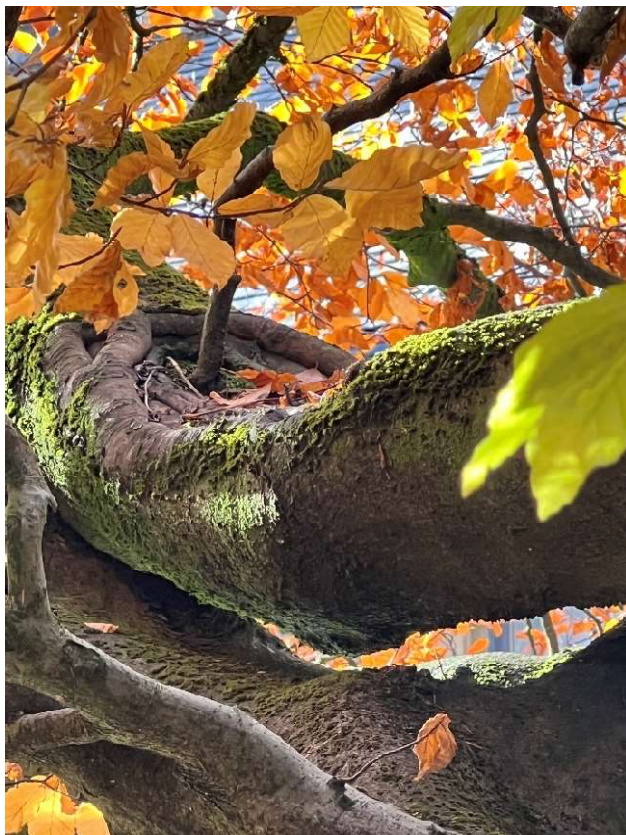
- 2.10 Evident from ladders was the fact that the upper side of a number of these branches features substantial old bark wounds which has given way to localised decay, almost certainly caused by previous bark stripping damage by grey squirrels. This is clearly longstanding as there has been some adventitious new growth which appears to be rooting into pockets of organic detritus. The tree maintains fair vigour with a reasonable crown density being observed at the time of inspection.

Photograph 6: Showing old wounds to the upper side of limbs of tree 1 over the road.

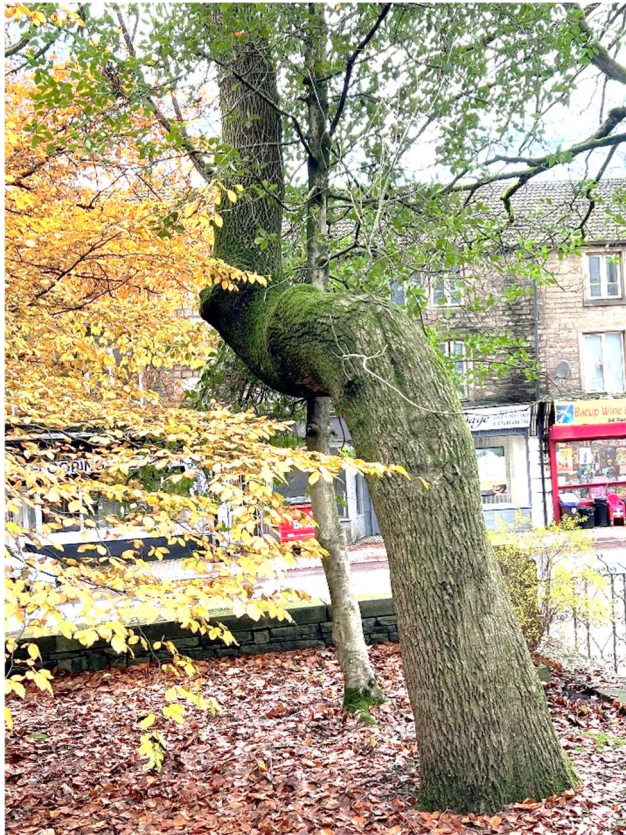
- 2.16 The tree stands at an approximate height of 18m and has a trunk diameter of 610mm.
- 2.17 At the time of inspection, all of the leaves had cast. However, looking at the buds on lower live growth plus remnants of cast leaves, it appears to be a plain ash tree, albeit its location indicates that it was intentionally planted.
- 2.18 The tree is of unusual form with a heavily swept lower trunk extending vertically for around 2.5m before there is a major elbow offsetting the crown to the side of Burnley Road (at around 2m from the trunk centre) before reverting to near vertical growth, albeit with a general bias over the road. In all, the tree has an estimated radial spread of around 11–12m on the road side.

Photograph 7: Showing the swept form of tree 3.

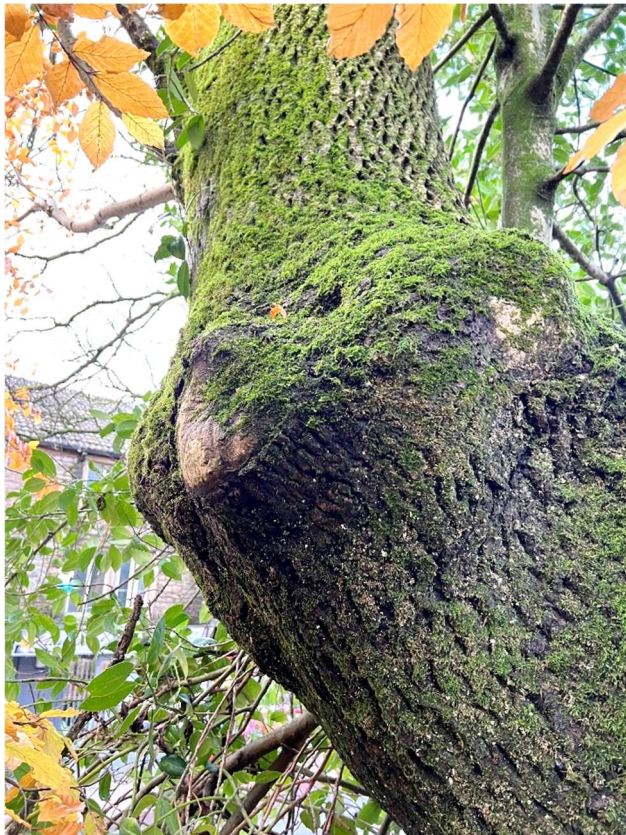
- 2.19 Just at the point where the stem regains vertical alignment (beyond the elbow), there are a group of closely aligned old pruning wounds, giving rise to the potential of possible coalesced decay.

- 2.21 At this point of the structure of the tree, it is heavily clad in moss and bryophytes, slightly hindering visual inspection and interpretation of biomechanical symptoms. Due to the mechanical forces, such an area is susceptible to delamination cracking, informing as so-called hazard beam.

Photograph 8: Showing the closely aligned old pruning wounds just at the point where the stem of tree 3 regains vertical alignment.

- 2.22 The upper crown features some substantial dead branches of up to 110mm in diameter by 6–7m in length which, should they fall, may potentially do so onto the pavement. Other minor deadwood was noted overhanging the road.
- 2.23 Going by bud set, the tree appears to have reasonable vigour and there are no indications of substantial crown decline associated with ash dieback disorder at this stage.
- 2.24 **Recommendation:** Deadwood is to be removed from the crown of the tree. The tree is to be paid particular attention during future monitoring.

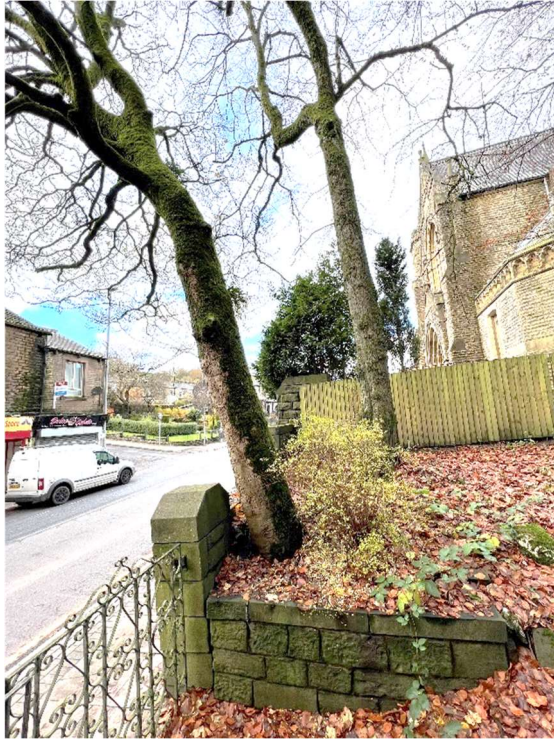
Photograph 9: Showing sycamore tree 4 next to the wall with lime tree 5 to the rear.

- 2.26 The tree has an estimated total height of around 19m and a trunk diameter of 580mm. The radial crown spread extends for a maximum of around 8m, overhanging the full width of Burnley Road. There is at least 5m clearance over the carriageway with only minor sucker growth at a lower level. The trunk is clad in moss and bryophytes, including ferns, and is part suppressed by the crown of an adjacent lime.

- 2.27 The tree is in fair physiological vigour. Given the location of a contemporary lime adjacent, it is almost certain that this tree has opportunistically self-seeded. It is clearly responsible for the displacement of the adjacent wall, likely due to a combination of both direct and indirect growth pressure (including the flexing of roots when the tree sways in the wind). The tree still has significant trunk increment potential, which undoubtedly would cause further conflict with the wall. There is no indication of the crown subsiding away from that of the adjacent lime at present. Small sized deadwood was noted, including overhanging the road.

- 2.29 **Recommendation:** Ongoing damage to the wall cannot be mitigated so long as the tree remains. Should such damage worsen significantly, the wall may need to be reconstructed in the future, itself having a potential negative impact upon the adjacent lime tree. On this basis, it is recommended to carefully dismantle the sycamore to a low stump which should be chemically treated to abate regrowth, noting it may take multiple applications to achieve this.

- 2.30 If the tree is to be retained in the short term, deadwood should be removed from its crown.

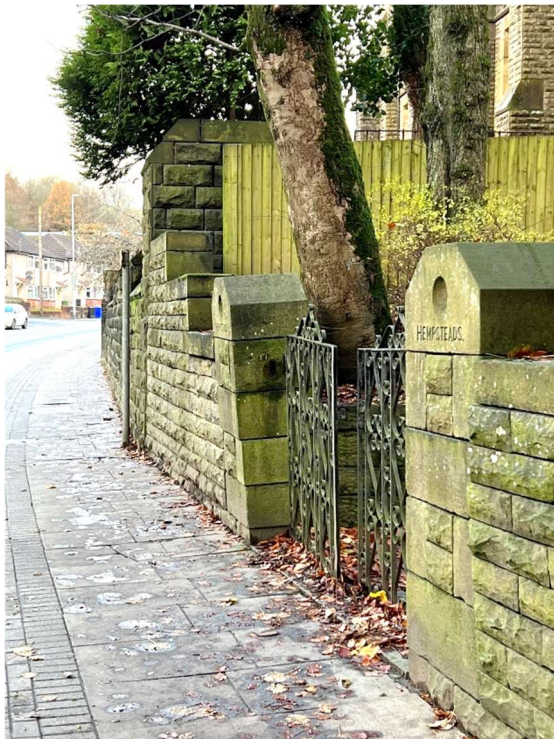
Photograph 10: Showing displacement of the wall and gate pier adjacent to tree 4.

- 2.25 The tree is in mid-maturity and grows immediately to the rear of the frontage stone retaining wall. It is responsible for the gate pier listing and historic displacement to the internal section of the retaining wall leading to the steps (the returning section from the frontage).

- 2.28 From a layman's perspective, the wall does not appear unsafe at present. However, it will inevitably be subject to future displacement if the tree is retained. Intrinsicly, the tree has a very short acceptable life expectancy in this respect. Although a significant tree in terms of the visual amenity of the street scene, a high quality lime tree remains within a few metres which was clearly an original component of the planting scheme, offering substantial mitigation.

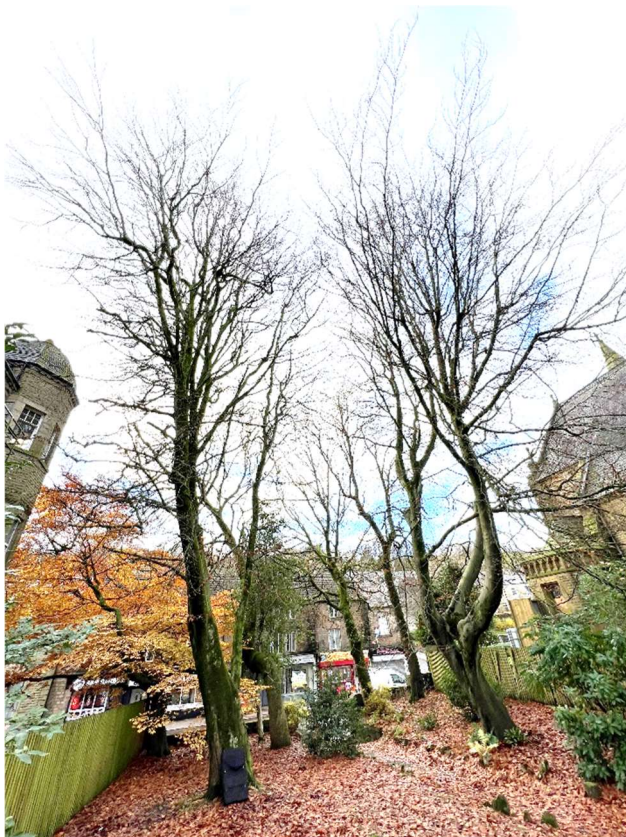
Photograph 11: Showing previously reduced beech trees with tree 6 to the right and tree 7 to the left.

- 2.34 There are co-dominant stems above 2.1m with that to the house side further dividing at 3.3m above ground level, meaning that the crown is borne from three main stems, giving it a somewhat congested structure. The fork at around 3m was accessed off ladders and appears acceptable in its configuration. The upper crown has clearly been reduced but now features substantial growth beyond of up to around 140mm in diameter. Growth is now extending into contact with the verge of the adjacent church roof and lowest level growth on the property side is of horizontal habit and features minimal clearance off the porch.

- 2.39 At around 2m on the path side, a side branch has an upswept nature, maintaining dominance up into the high crown structure. However, in the main, the crown has a strong bias to the south east, overhanging the neighbouring property. Previous lateral branch reduction has been internodal, resulting in some stubs that have died back.

- 2.35 **Recommendation:** Selectively reduce the crown to a post-pruning height of around 16m (typically 1m higher than previous points of pruning). The crown is heavily asymmetric. However, side growth should be selectively shortened so that there is at least 3m clearance off the church and back from the report property frontage.
- 2.36 Any deadwood should also be removed from the remaining crown. Post-pruning, there should be around 4m clearance above the lawn height, to be effected only by the selective shortening of low pendulous secondary growth.
- 2.37 The tree remains in good physiological vigour and is predicted to respond positively to such pruning.

- 2.42 **Recommendation:** The tree should be further reduced to a post-pruning height of around 17m, ensuring that the section of contiguous crown with the previous beech remain at the same height. Previous branch pruning stubs should be, where appropriate, further reduced back to a natural growth point. From the remaining crown, any significant deadwood should be removed.

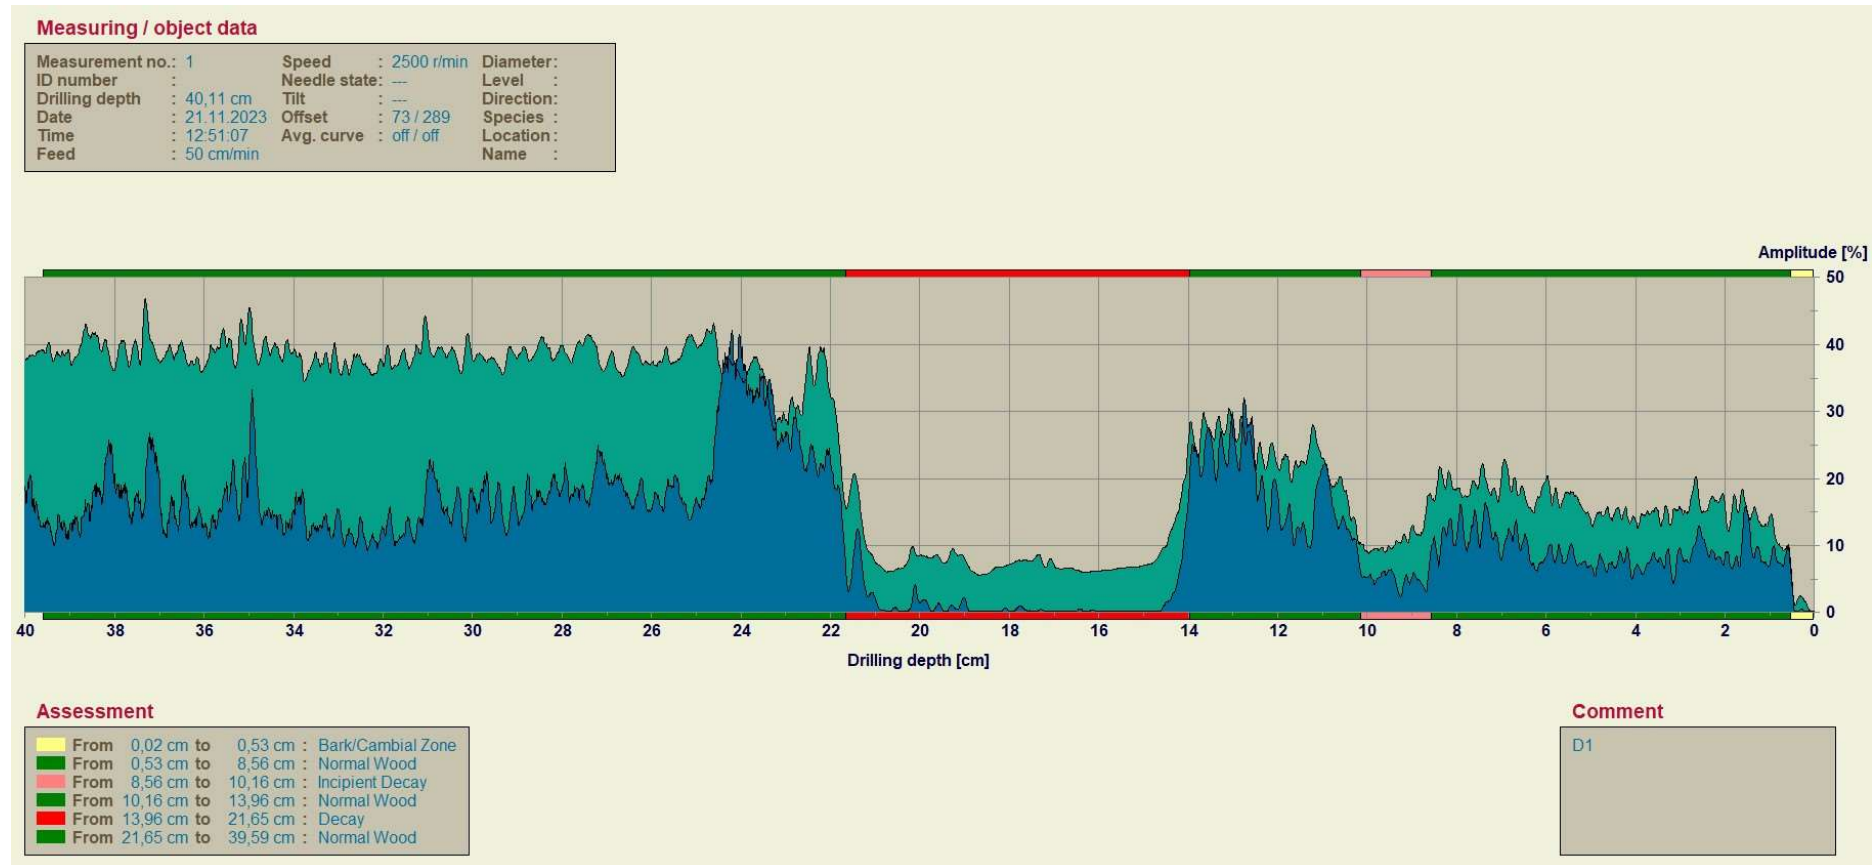
Test drilling D1

- 2.8 In terms of the stem extending to the road side, there is an opening at around 1m distance from the trunk and a slight rib formation running back from the opening towards the main stem. There is clearly some decay associated with this point and I made a test drilling D1 at around 200mm to the main stem side of the opening. This noted some insipient decay within outer wood ahead of a cavity extending between 14cm and 21cm (which I predict runs back close to the main stem itself). In terms of the residual sound wood thickness to the boundary side of this limb, this appeared acceptable to me. The tested section of stem itself had a diameter of around 500mm.

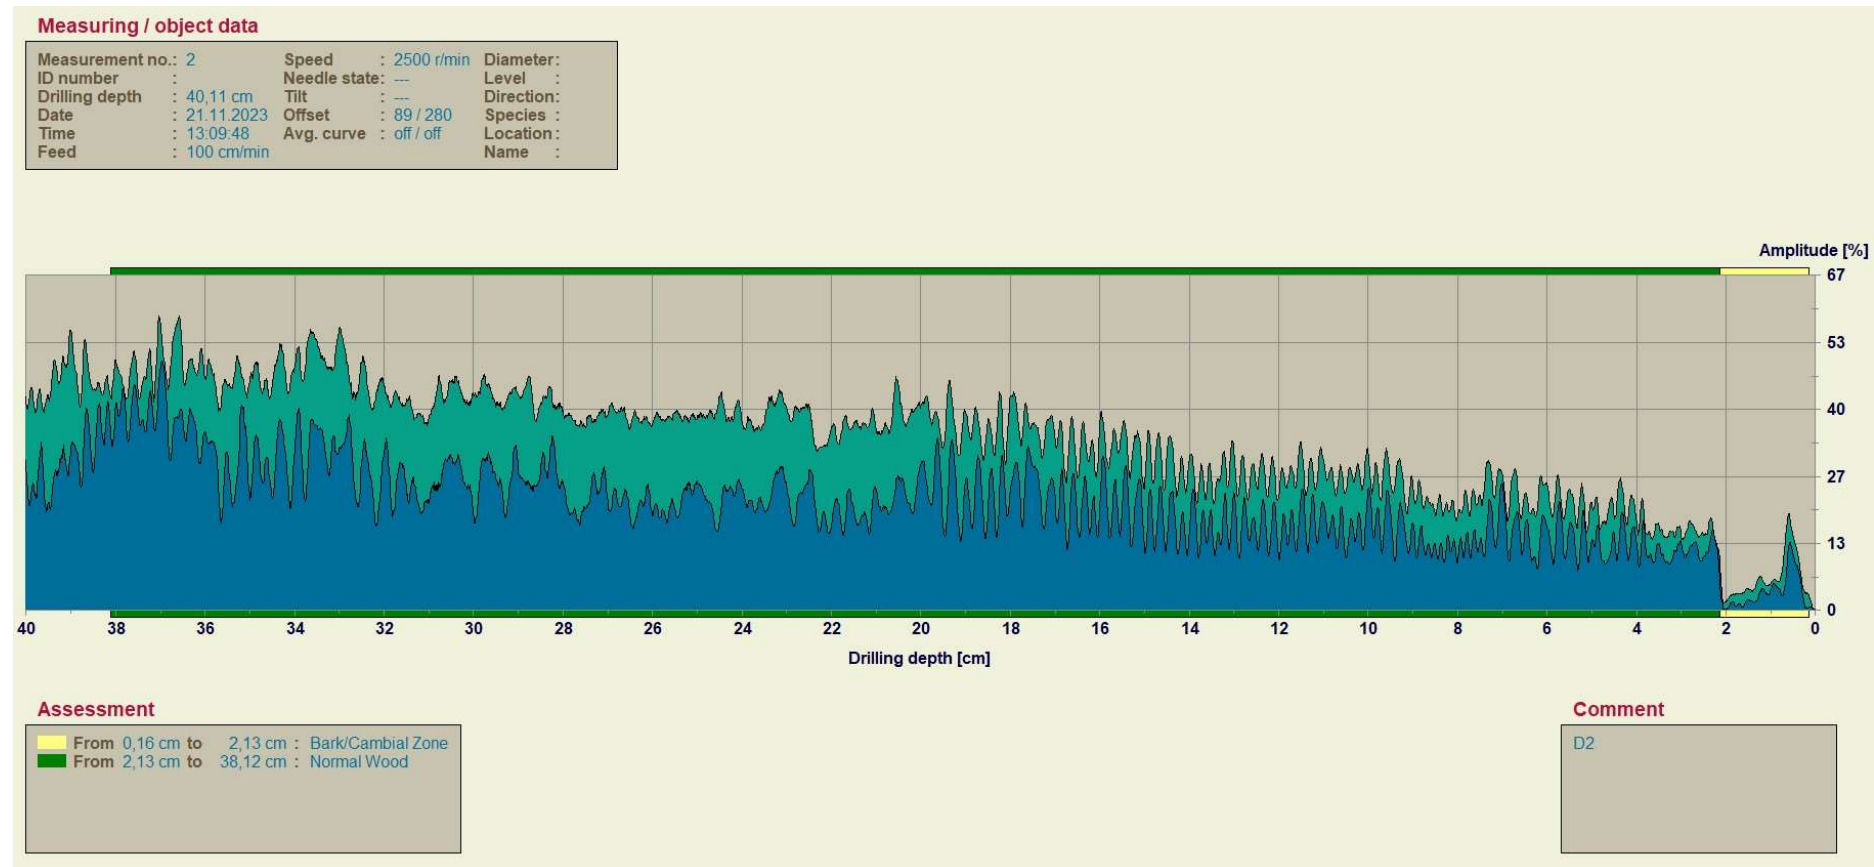
- 2.20 Test drilling D2 was made sideways into the main stem just beneath this point. However, it revealed entirely normal wood patterns. Due to the significant mechanical forces being placed upon the horizontal elbow section of the trunk, a further test drilling D3 was made into the middle of the horizontal section at around mid-stem height. This indicated some minor insipient decay alteration between 24cm and 30cm penetration. However, there was no clear degradation as to the wood quality.
