Application to undertake works to trees subject to Tree Preservation Order

The owners of 507 Holcombe Road, Helmshore, Mr and Mrs Howard, have instructed Birtle Tree Services to undertake a condition survey of a number of trees that are located within the boundary of their property. The Local Planning Authority have confirmed that Tree Preservation Order Hollin Bank District T2/F/G4, T2/F/W2, T2/F/G5 are located within the boundary of the property. All of the TPOs are either Group or Woodland categories.

Ref 1 – 507 Holcombe Road, Helmshore BB4 4LX 100224

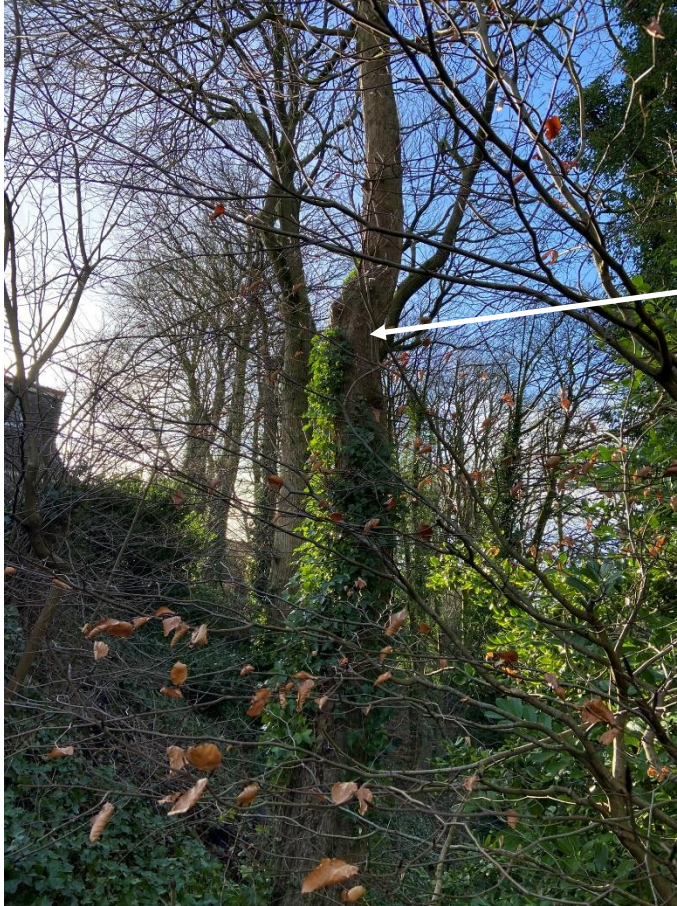
Image 1 - T1 to be crown thinned

Tree Reference, species and details	Specification of Work Requested	Reasons for work
<p>T1 Horse Chestnut <i>(Aesculus hippocastanum)</i></p>	<p>a. Crown thin 30% b. Ring bark ivy c. Remove deadwood from canopy</p>	<p>a. To increase natural light into residential property which will reduce the current need for internal artificial light b. Removal of ivy to prevent kiting in the future if the ivy is allowed to colonise the canopy c. Good arboricultural management</p>
<p>T2 Horse Chestnut <i>(Aesculus hippocastanum)</i></p>	<p>a. Crown lift lower branches that are overhanging the decking area and crown thin 30% b. Remove branch which is poorly formed c. Remove deadwood from canopy</p>	<p>a. To increase natural light into residential property which will reduce the current need for internal artificial light b. Good arboricultural management c. Good arboricultural management</p>
<p>T3 Horse Chestnut <i>(Aesculus hippocastanum)</i></p> <p><i>Note – Wound area to north of stem is callusing well and no evidence of decay</i></p>	<p>a. Crown lift lower branches that are overhanging the decking area and crown thin 30% b. Remove deadwood from canopy</p>	<p>a. To increase natural light into residential property which will reduce the current need for internal artificial light b. Good arboricultural management</p>

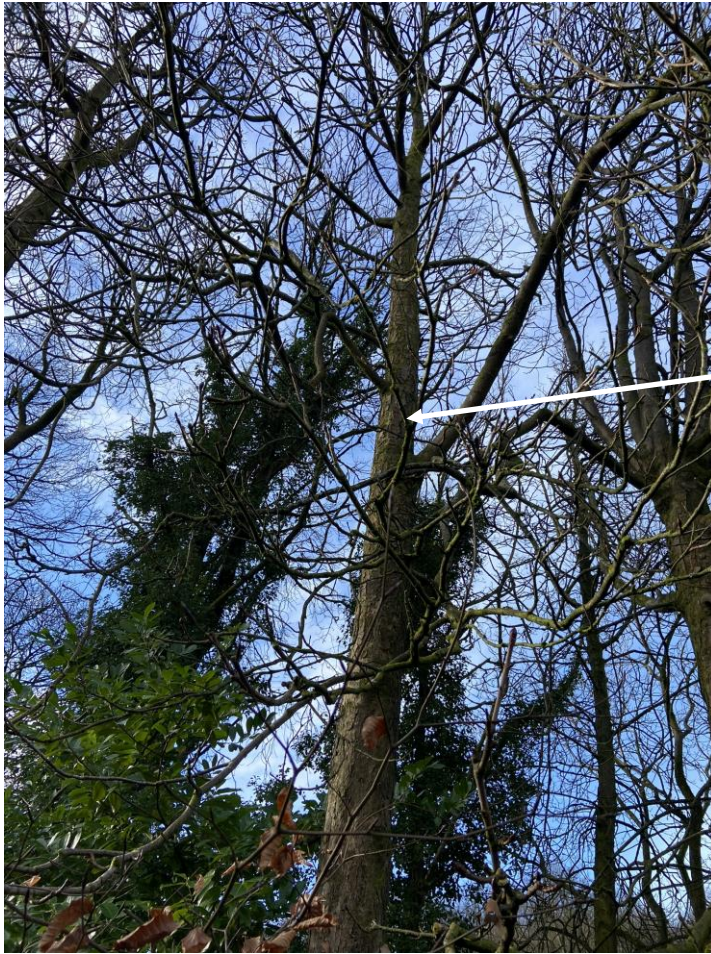
Image 2 - T2 to be crown lifted and thinned

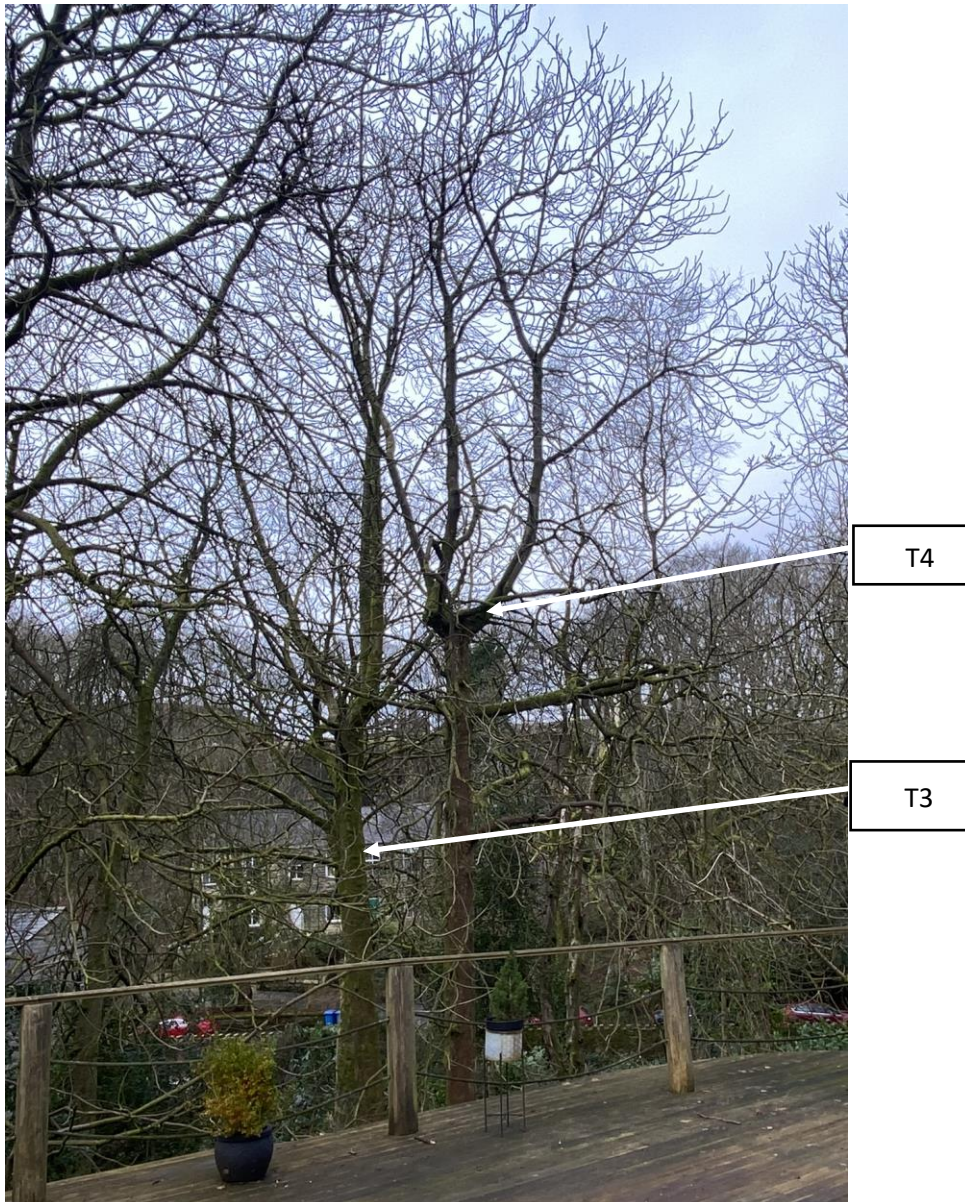
Image 3 - T3 and T4 to be crown lifted and thinned

<p>T4 Horse Chestnut <i>(Aesculus hippocastanum)</i></p> <p><i>Note – small cavity at base of tree but no evidence of decay</i></p>	<p>a. Crown lift lower branches that are overhanging the decking area and crown thin 30% b. Remove two branches which are poorly formed c. Remove deadwood from canopy</p>	<p>a. To increase natural light into residential property which will reduce the current need for internal artificial light b. Good arboricultural management c. Good arboricultural management</p>
<p>T5 Ash <i>(Fraxinus)</i></p>	<p>Section fell to ground level</p> <p>Replacement to be the saplings already growing in the woodland area</p>	<p>Evidence indicates that T5 is dead or dying due to Ash Dieback. A residential property (1.5m from tree), garage (0.5m from tree) and busy public highway (1m from tree) are within the fell zone and therefore removal is recommended to mitigate the risk of harm to people or damage to property.</p>

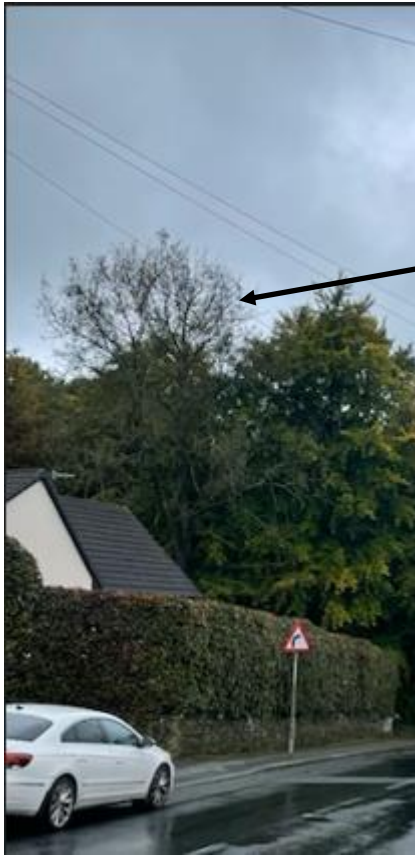
T5 (Ash) is located in very close proximity to the north of the property, to the west of a garage and the public highway (Holcombe Road) beyond. It is unclear from the TPO map provided by the Local Planning Authority whether T5 is actually included within the TPO as it appears to be outside of both G5 and W1 however to prevent any possible infringement an application for T5 has been included. Evidence from the survey and also from photographs provided by Mr and Mrs Howard confirm that T5 has symptoms indicative of Ash Dieback (*Hymenoscyphus fraxineus*) indeed the images from summer 2023 show very little leaf cover. It is therefore recommended that T5 is section felled to ground level in order to mitigate the risk of damage to property and harm to people within the property and/or using the pathway and highway to the east of the tree and within the fell zone of the tree if it fails in that direction. There are a significant number of saplings within the woodland, most of which are beech (*Fagus*) and are thriving in the understorey of the canopies of the other trees within the woodland, which are sufficient as replacements for T5.

Image 4 – T5 (to be removed) taken summer 2023 showing proximity to highway and evidence of Ash Dieback

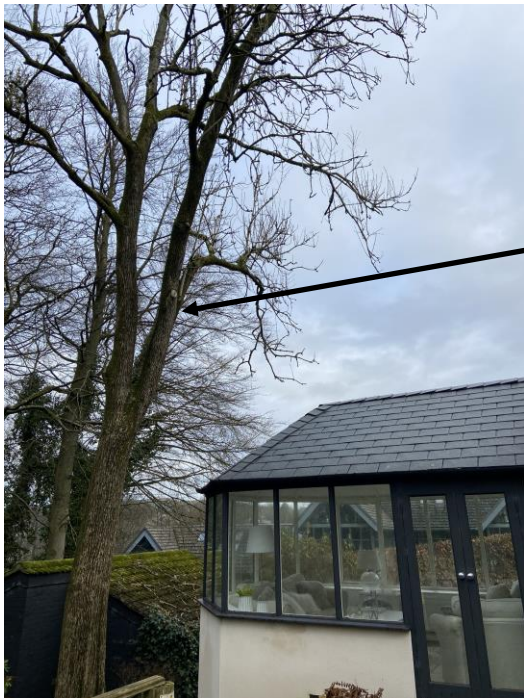
Image 5 - showing proximity of T5 to residential property and garage

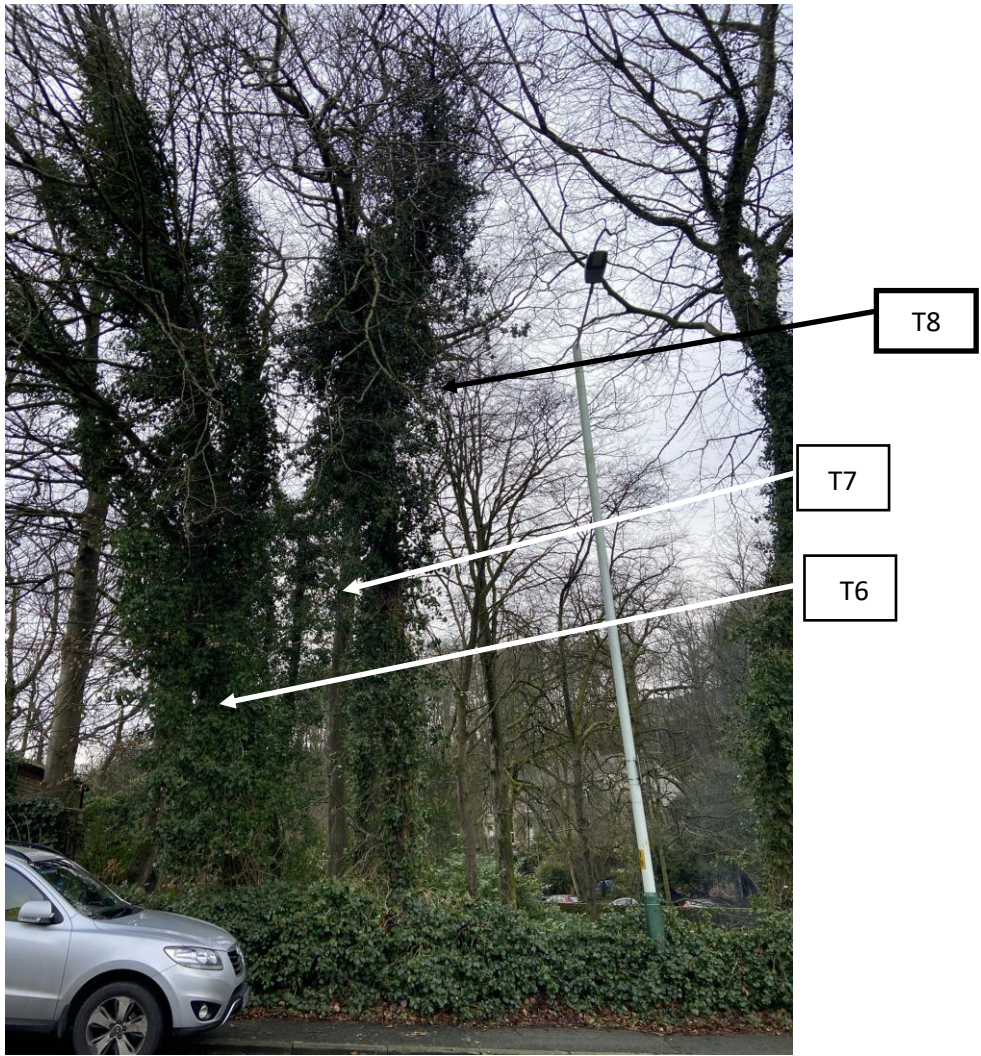
<p>T6 Beech <i>(Fagus)</i></p> <p><i>It is noted that T6 has a lean to the east over the highway of approximately 20° and re-inspection should observe if this is increasing</i></p>	<p>a. Crown lift to create clearance of 5m to east of tree over highway b. Ring bark ivy c. Remove deadwood from canopy</p>	<p>a. To ensure sufficient vehicular clearance to avoid damage to vehicles by the tree and damage to the tree from the vehicles – reducing the weight of the canopy may reduce the potential for the lean to the east to increase over time b. Removal of ivy to prevent kiting in the future if the ivy is allowed to colonise the canopy c. Good arboricultural management</p>

<p>T7 Ash (<i>Fraxinus</i>)</p> <p>It is noted that T7 currently does not appear to have any symptoms of Ash Dieback but future inspections should confirm continued health</p>	<p>a. No work required b. Remove deadwood from canopy</p>	<p>a. Currently T7 appears to be in a health condition and has sufficient clearance over the highway b. Good arboricultural management</p>
<p>T8 Beech (<i>Fagus</i>)</p> <p><i>It is noted that T8 has a lean to the east over the highway of approximately 30° and re-inspection should observe if this is increasing</i></p>	<p>a. Crown lift to create clearance of 5m to east of tree over highway b. Ring bark ivy c. Remove deadwood from canopy</p>	<p>a. To ensure sufficient vehicular clearance to avoid damage to vehicles by the tree and damage to the tree from the vehicles – reducing the weight of the canopy may reduce the potential for the lean to the east to increase over time b. Removal of ivy to prevent kiting in the future if the ivy is allowed to colonise the canopy c. Good arboricultural management</p>

Image 6 - T6, T7 and T8 – T6 and T8 to be crown lifted

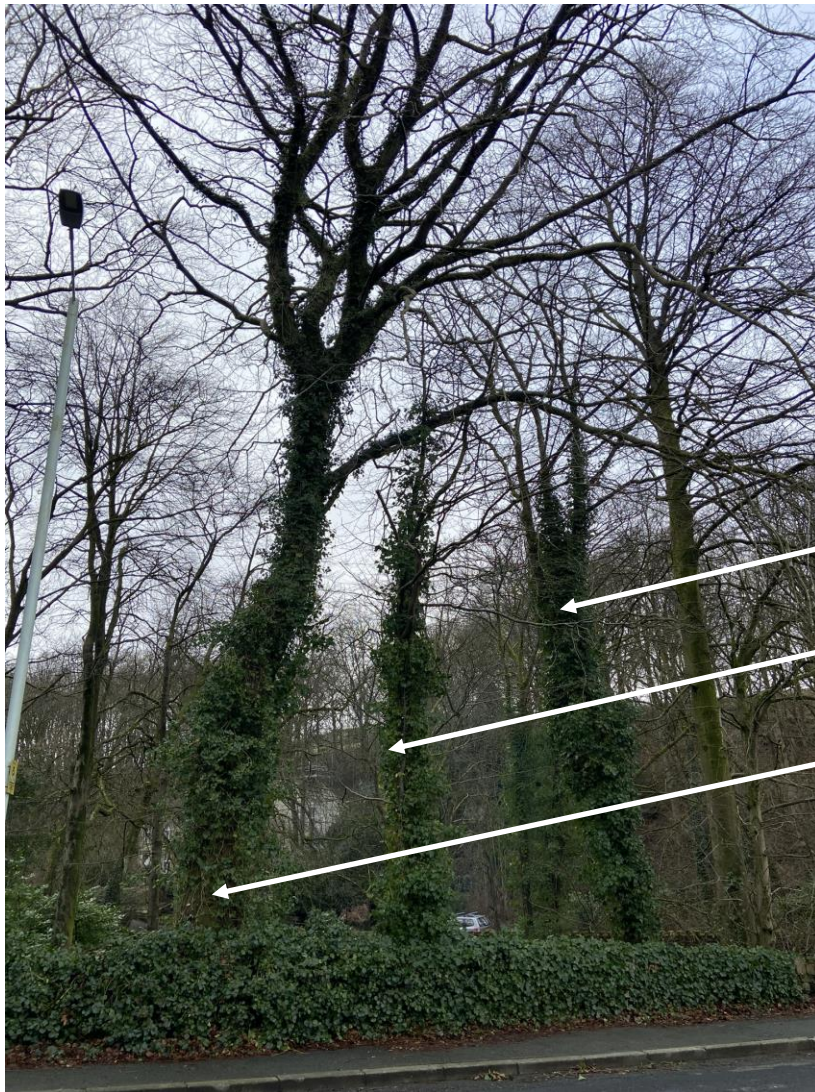
Image 7 - T9, T10, T11 to be crown lifted

<p>T9 Beech (<i>Fagus</i>)</p>	<p>a. Remove two lower branches to achieve 5m clearance to east of tree over highway b. Ring bark ivy c. Remove deadwood from canopy</p>	<p>a. To ensure sufficient vehicular clearance to avoid damage to vehicles by the tree and damage to the tree from the vehicles b. Removal of ivy to prevent kiting in the future if the ivy is allowed to colonise the canopy c. Good arboricultural management</p>
<p>T10 Beech (<i>Fagus</i>)</p>	<p>a. Crown lift to create clearance of 5m to east of tree over highway b. Ring bark ivy c. Remove deadwood from canopy</p>	<p>a. To ensure sufficient vehicular clearance to avoid damage to vehicles by the tree and damage to the tree from the vehicles b. Removal of ivy to prevent kiting in the future if the ivy is allowed to colonise the canopy c. Good arboricultural management</p>
<p>T11 Sycamore (<i>Acer pseudoplatanus</i>)</p> <p><i>It is noted that T11 has a lean to the east over the highway of approximately 20° and re-inspection should observe if this is increasing</i></p>	<p>a. Remove epicormic growth from previous pruning sites to create clearance from pathway b. Ring bark ivy c. Remove deadwood from canopy</p>	<p>a. To ensure sufficient pedestrian clearance b. Removal of ivy to prevent kiting in the future if the ivy is allowed to colonise the canopy c. Good arboricultural management</p>

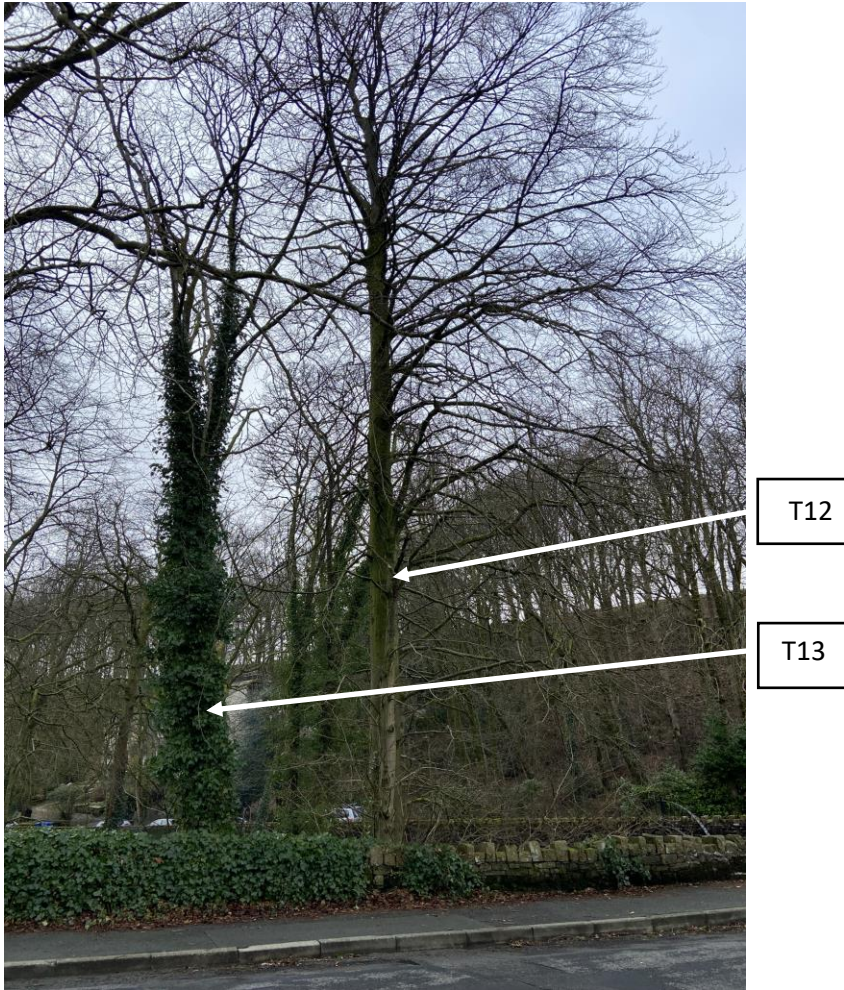
Image 8 - T12 and T13 to be crown lifted

<p>T12 Elm (<i>Ulmus</i>)</p>	<p>a. Crown lift to create clearance of 5m to east of tree over highway – epicormic growth removal included in the crown lift</p>	<p>a. To ensure sufficient vehicular clearance to avoid damage to vehicles by the tree and damage to the tree from the vehicles b. Good arboricultural management</p>

b. Remove deadwood from canopy	
T13 Beech (<i>Fagus</i>)	a. Crown lift to create clearance of 5m to east of tree over highway b. Remove deadwood from canopy	a. To ensure sufficient vehicular clearance to avoid damage to vehicles by the tree and damage to the tree from the vehicles b. Good arboricultural management

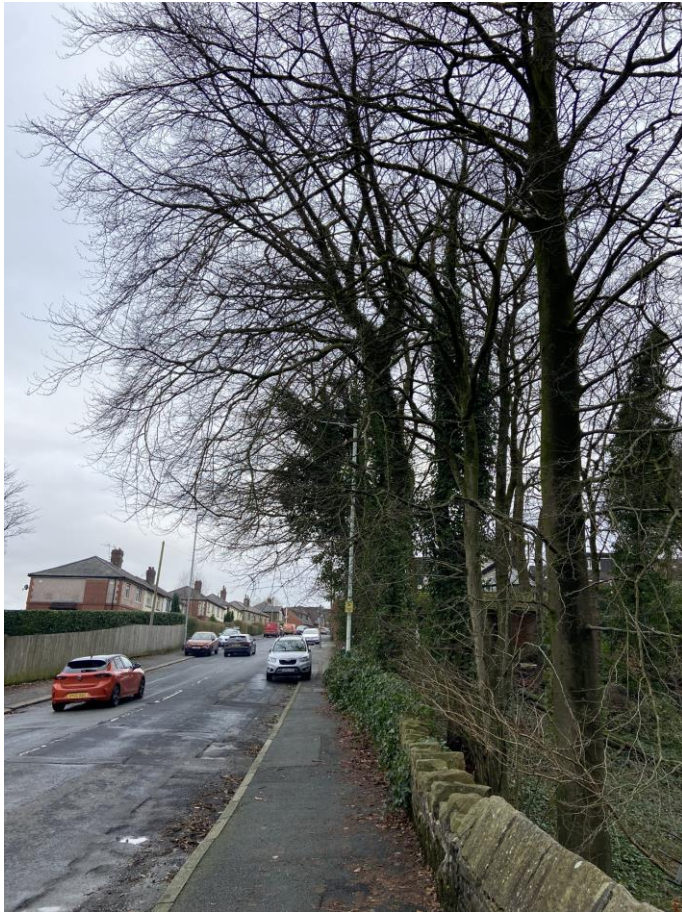
T6 to T13 are located on the eastern boundary of the property along the public pathway and highway (Holcombe Road). The trees are, in the main in good health and appear to be structurally sound, however in order to maintain sufficient vehicular clearance, crown lifting to create a 5m clearance is recommended for some of the trees together with the removal of a small number of scaffold branches which are either crossing or have poor form. The work is recommended to prevent damage to vehicles and to ensure good arboricultural management by preventing the trees being damaged by vehicles.

Image 9 – indicating T6 – T13 overhanging highway and pathway – request for crown lift to create sufficient vehicular and pedestrian clearance

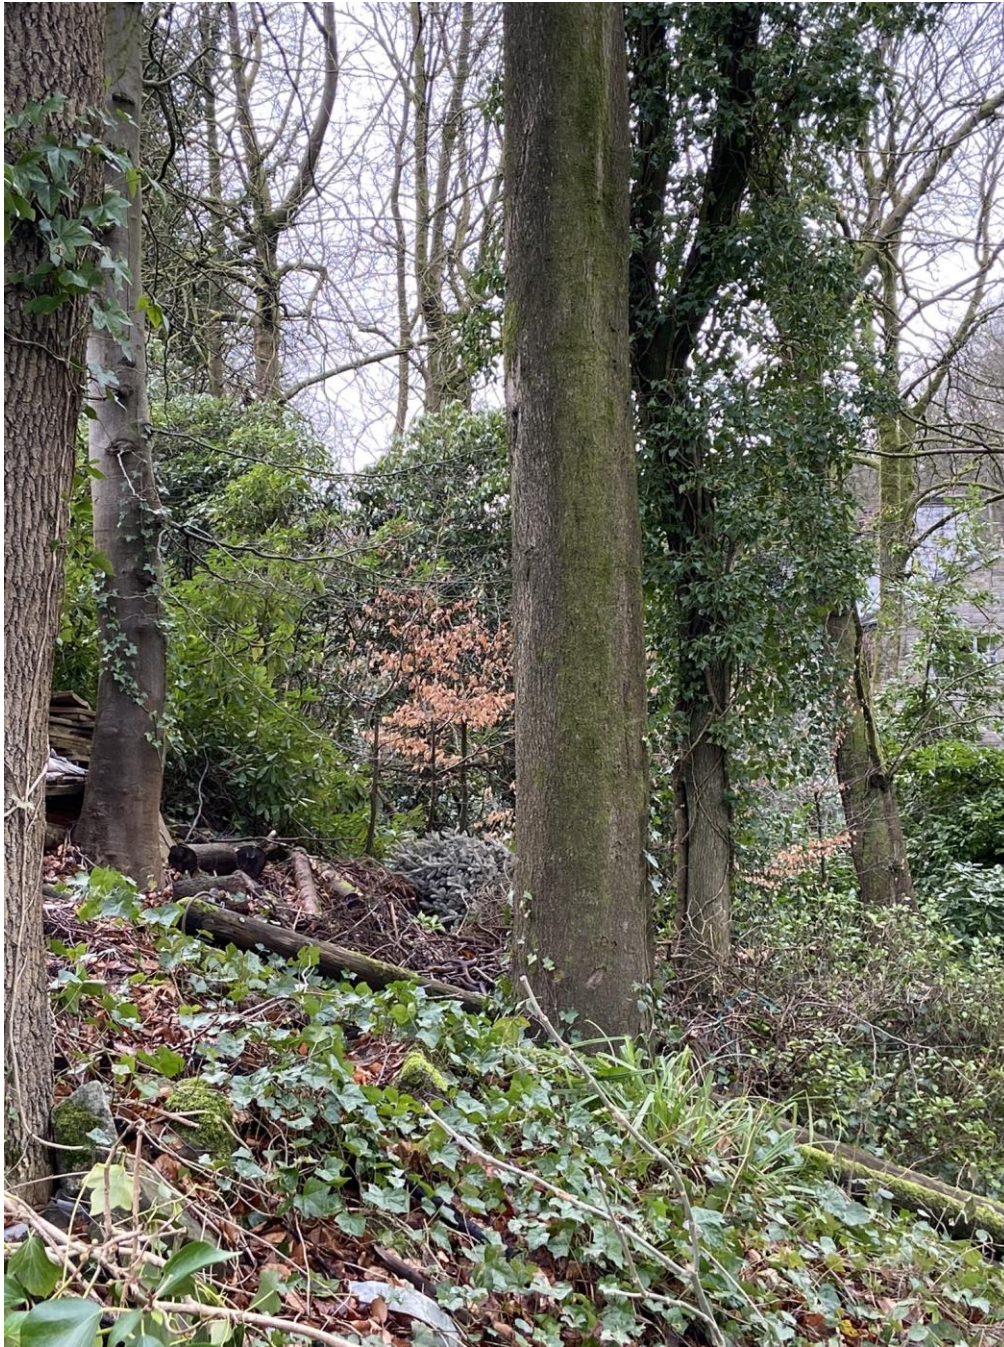
Image 10 – indicating multiple saplings within woodland
