JP Chick & Partners Ltd
Consulting Civil & Structural Engineers

Newtown Meadow Nissen Huts

Structural Inspection Report

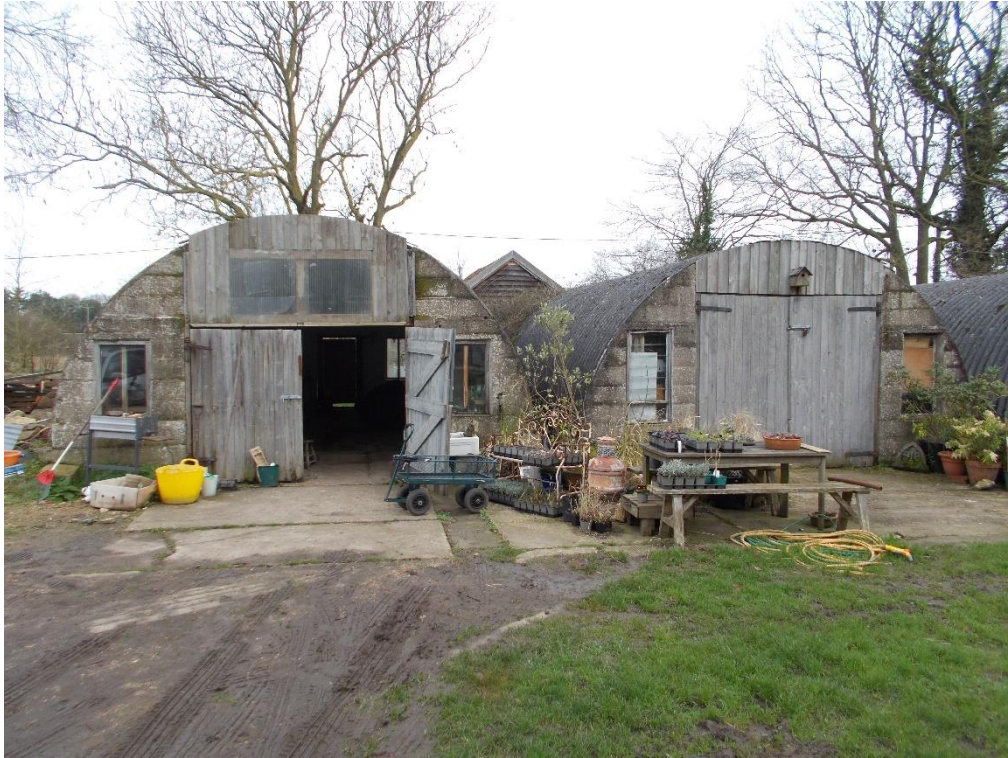
- 4.1 The south elevation presents the gable ends, which are infilled with blockwork. The blockwork presents in fair to good condition, with modest signs of weathering. The gable ends are in good alignment and good verticality.

Photograph 1 – South gable ends

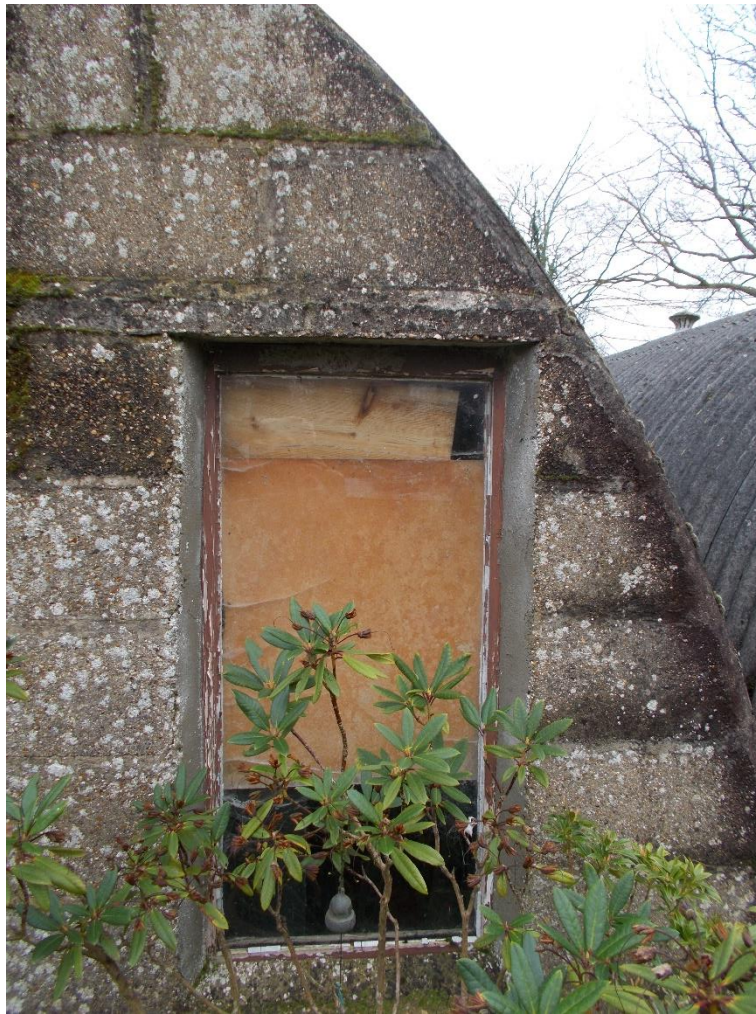
- 4.3 The window openings are abridged with a concrete lintel. The bearing length of the lintel is generally relatively short where it abuts the curved roof line, being approximately 50mm, however, this does not appear to have adversely affected the performance, as the loading is modest.

Photograph 2 – Lintel bearing

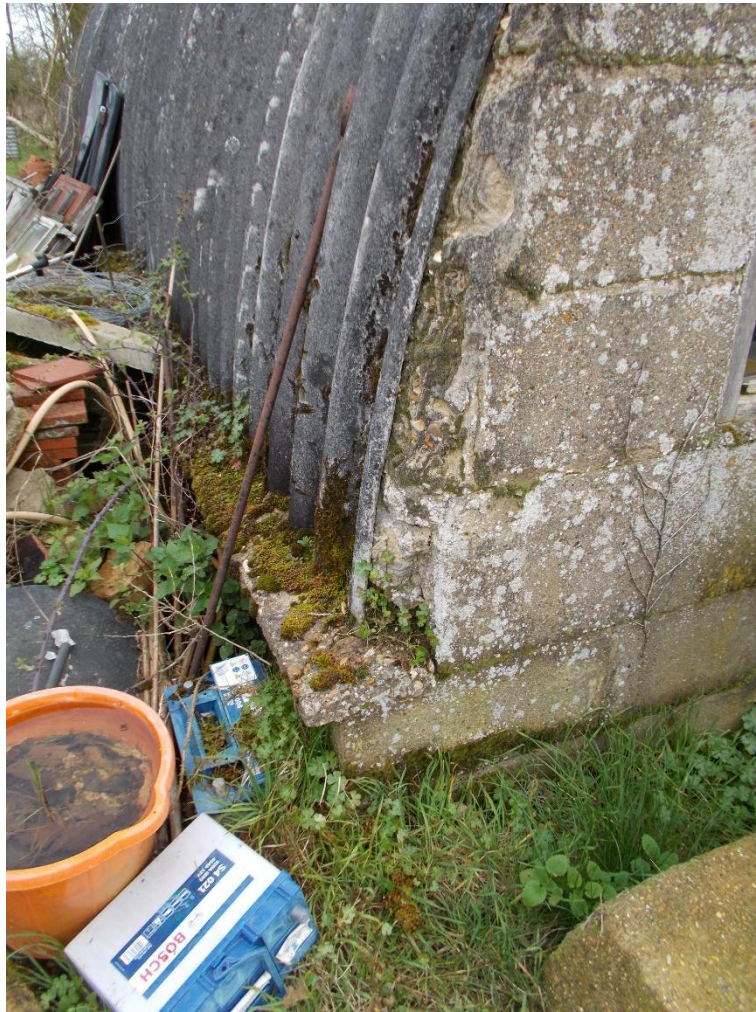
- 4.9 At springing point, the roof sheeting is supported on shallow plinth walls, approximately 150mm thick blockwork and with outward thrust of the sheeting appearing to be resisted by a cast concrete sill, supported on the blockwork itself. The sill also sheds surface water from the roof onto the adjacent ground.

Photograph 3 – 'Springing point' concrete block plinth

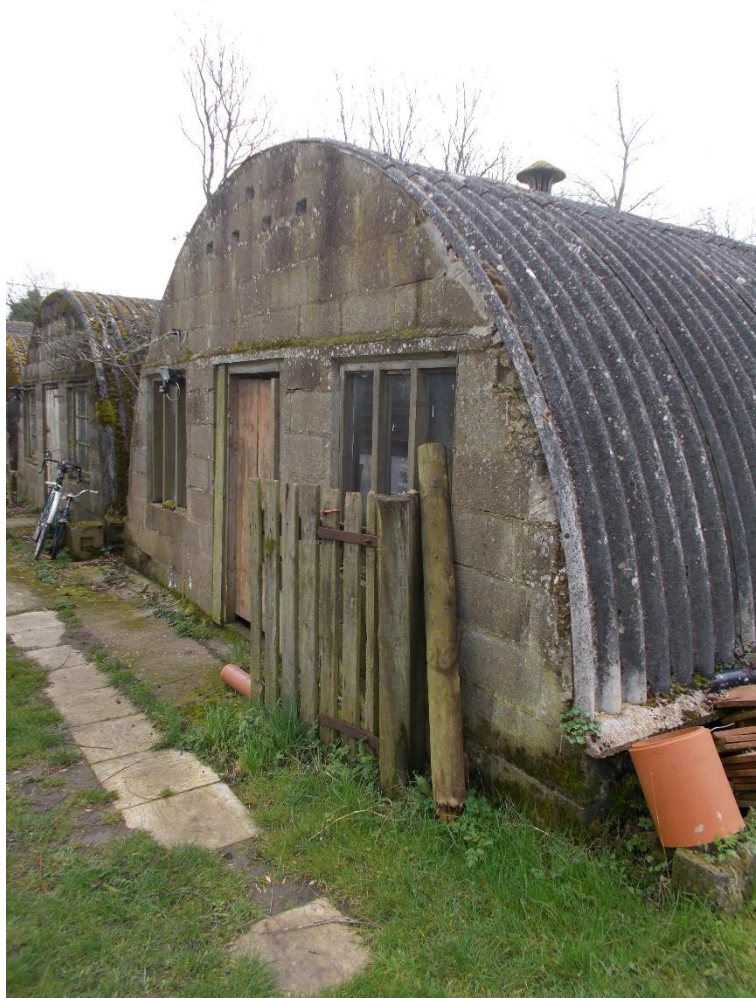
- 4.5 The north gable ends are of a similar construction to the south, although feature single personnel door openings with windows each side. The blockwork is again in fair to good condition with no significant signs of substantial weathering.

Photograph 4 – North gable ends

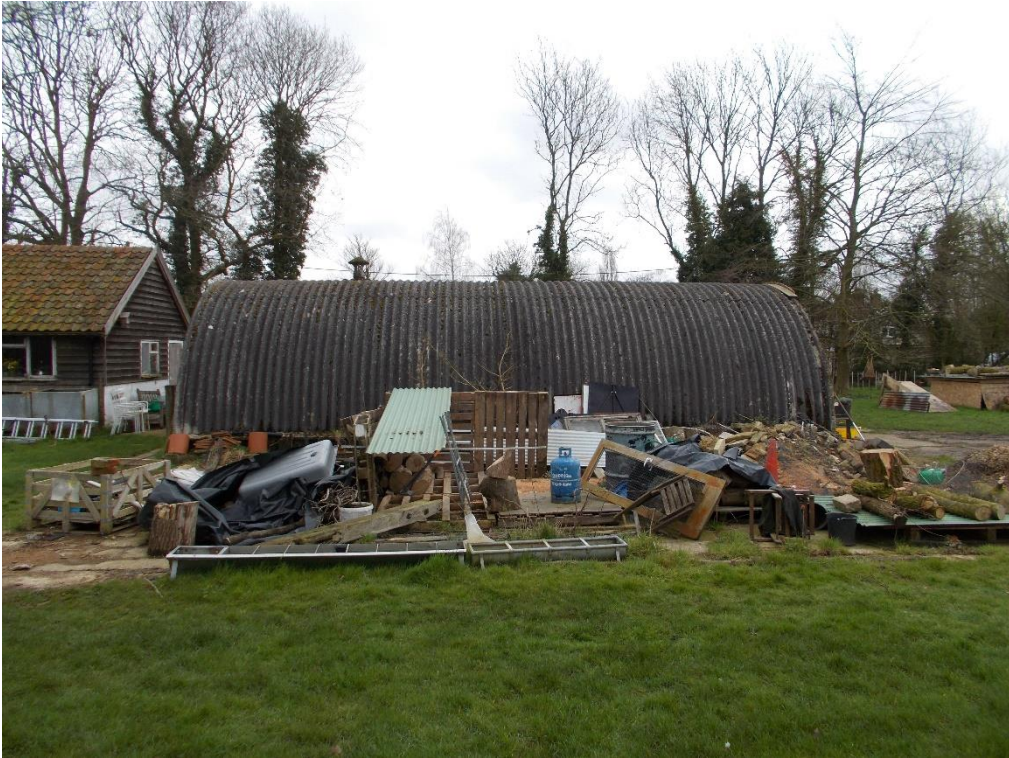
Photograph 5 – Western elevations

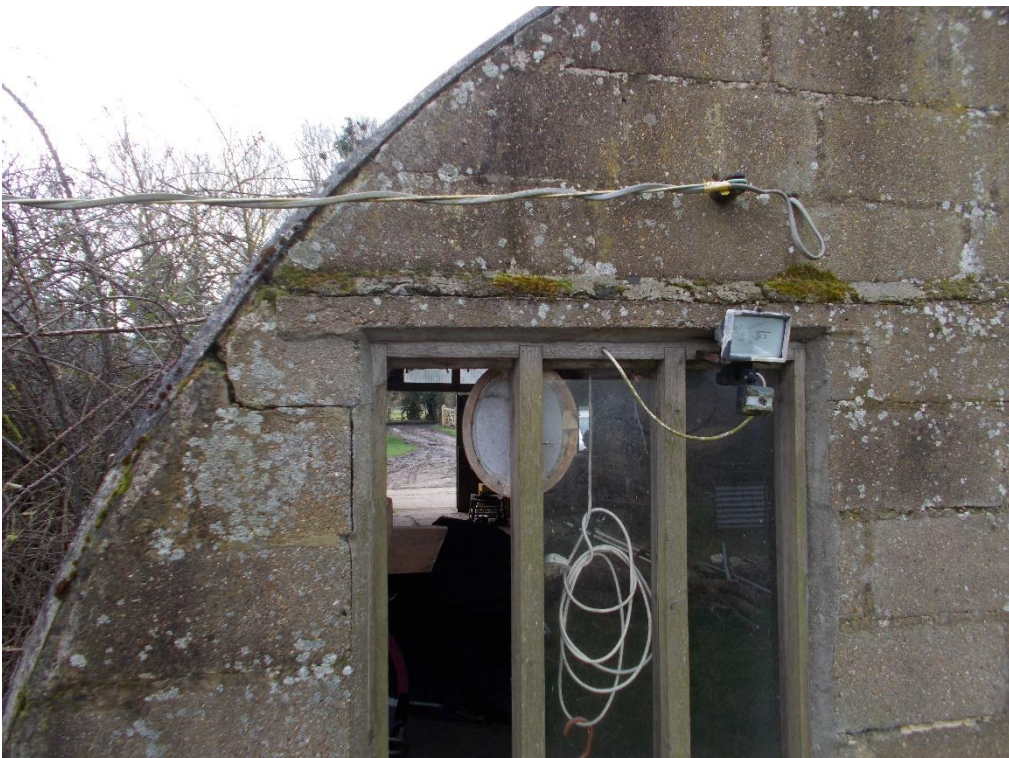
- 4.6 Concrete lintels traverse the window and door openings and appear to be performing generally satisfactory. There is evidence of minor settlement towards the western end, requiring a small degree of repointing of blockwork joints above, however, this is relatively minor. The alignment and verticality of gable ends are both good. As before, these appear to be constructed on 450mm wide concrete foundations cast flush with the floor slab within.

Photograph 6 – Minor lintel movement

- 7.6.3 Undertake repointing to open joints in blockwork walling.
 - 7.6.4 Remove vegetation growing between the units, remove silt and ensure that drainage is provided and can discharge freely away from the units.

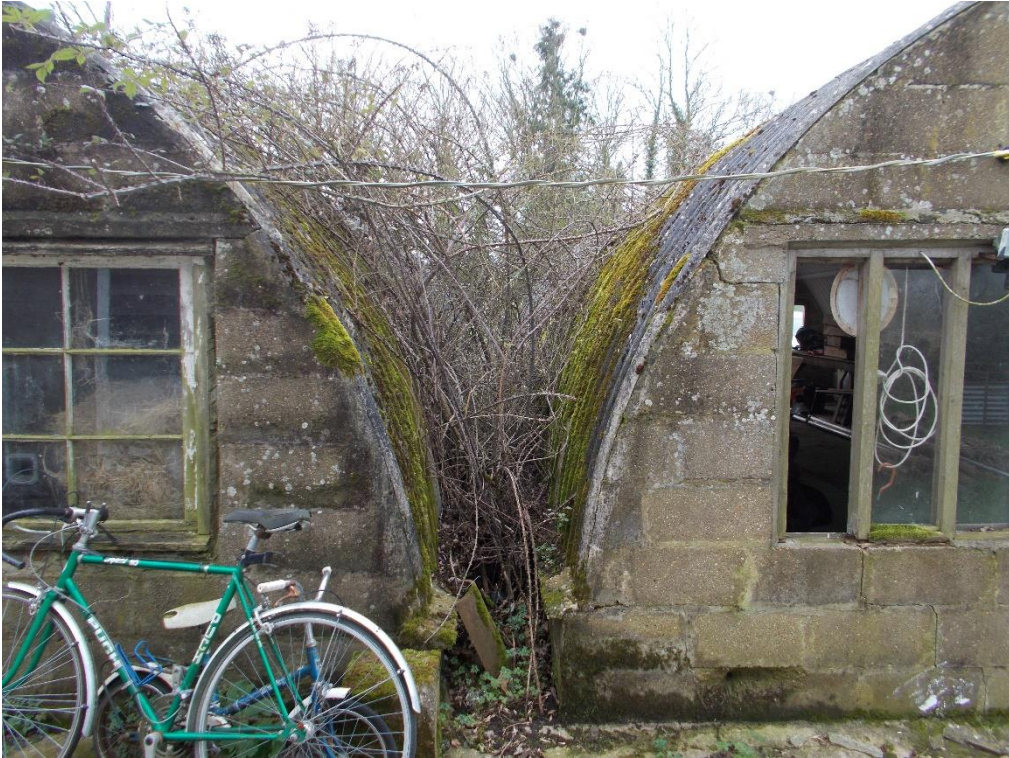
- 4.10 The external ground is generally level surrounding each units. The units are relatively close to one another, being spaced by 450mm, and this has enabled silt and soil to build up, permitting the growth of vegetation in the small gap between the two units.

Photograph 7 – Vegetation in 'valley'

- 4.11 It is recommended that this be cleared and cleaned to ensure that debris does not build up and further that surface water can be disposed of in a positive way.

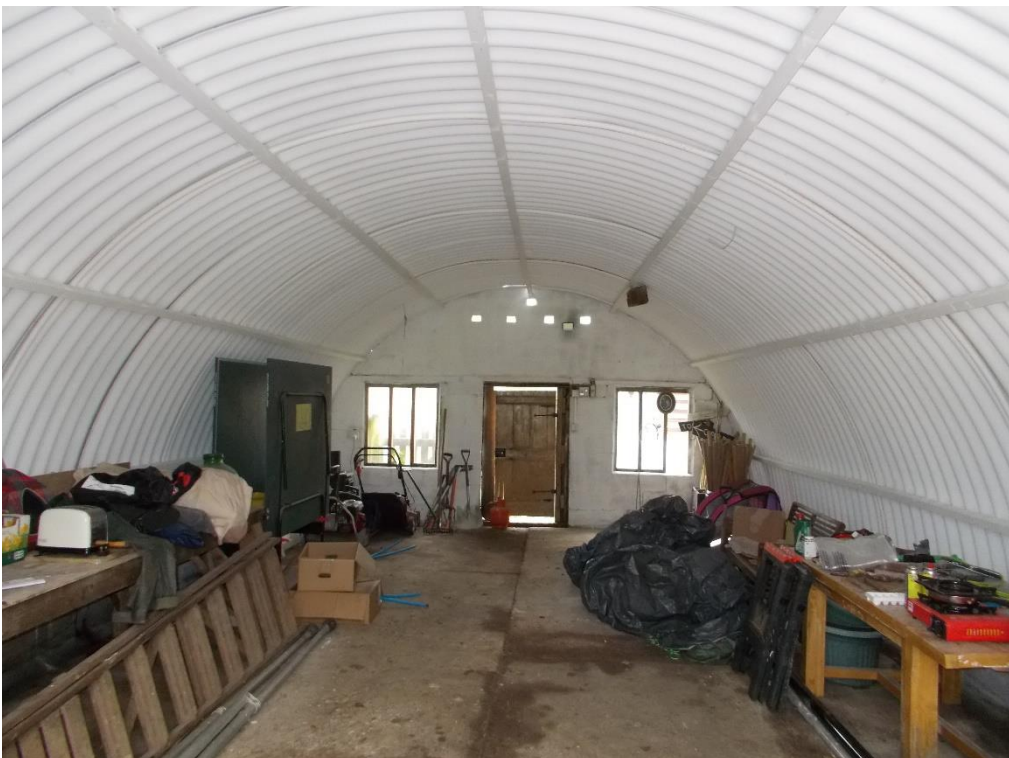
Photograph 8 – General interior

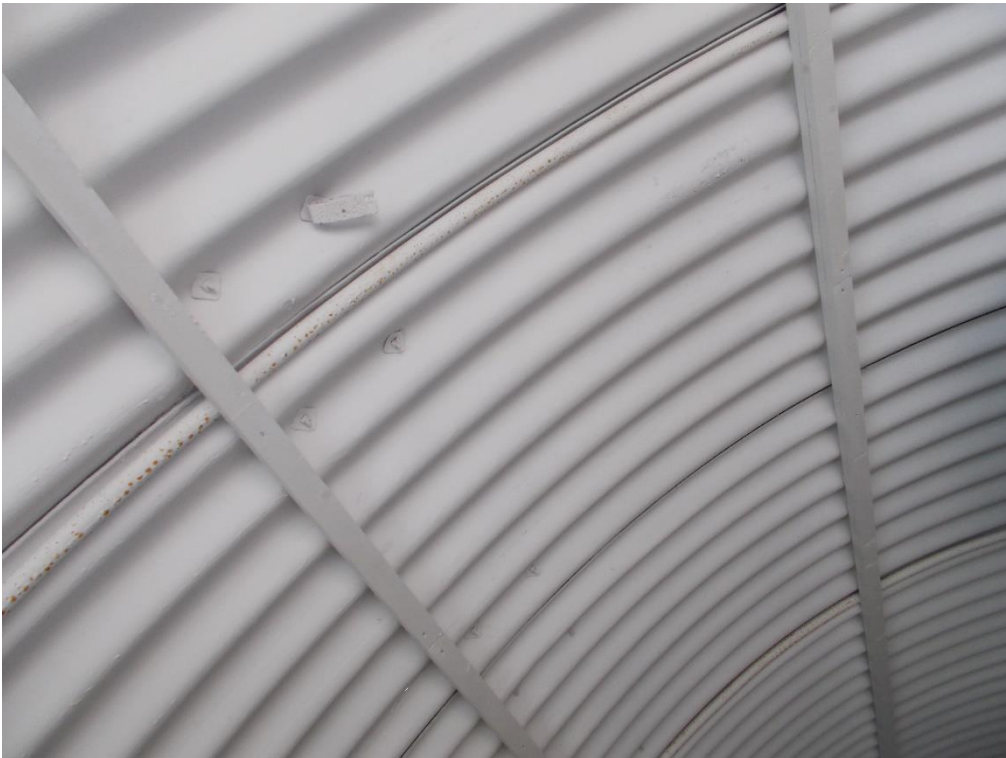
- 5.4 Intermediate structural support to the roofing is being provided by longitudinal timber purlins of which, 2 No. are present to each 'side walls' of the curved roof, with 3 No. being present being towards the 'crown' of the roof. The purlins are formed of pairs of 50mm wide x 25mm deep timber battens, which form a composite section. These gain support from the semi circular ribs, formed from 35mm diameter tubular steel sections. These sections are spaced at regular centres along the building varying from 1800mm to 2000mm.

- 5.5 There are 6 No. tubular steel ribs along the length of each structure. These are embedded into the concrete at the tops of the blockwork plinth walls.

- 5.6 At the time of the inspection, the structural timber purlins and tubular steel ribs appeared to be supporting the current loading regime satisfactorily, without obvious deflection or distortion.

Photograph 9 – Steel rib and purlins

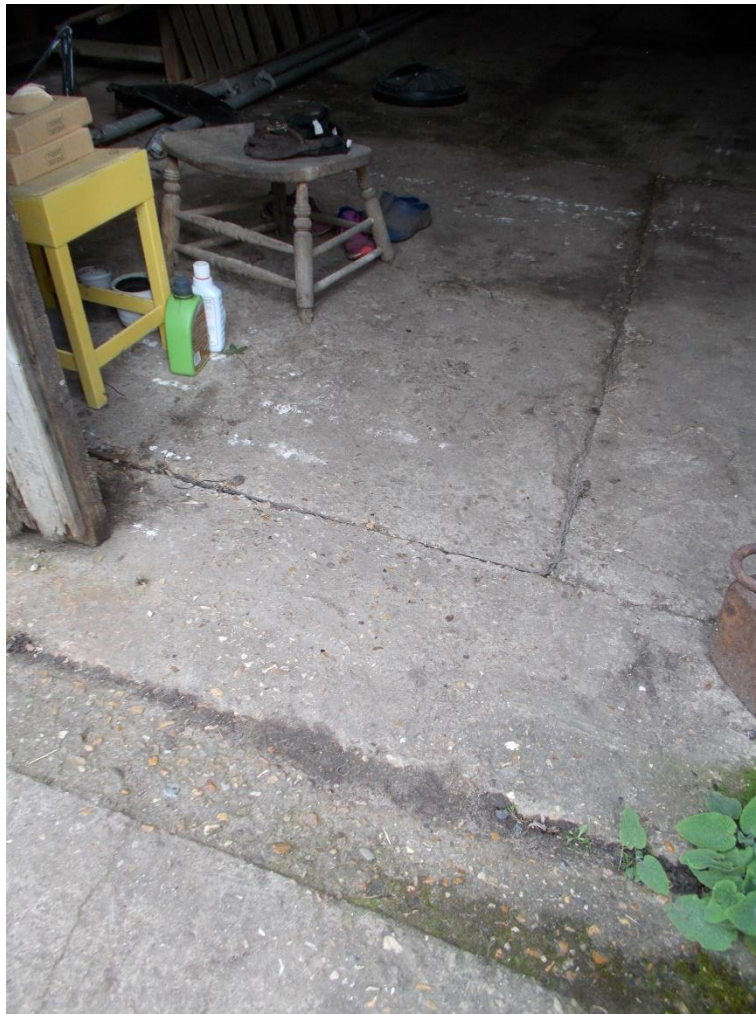
- 4.2 The block walls appear to be constructed on a 450mm wide concrete foundation, the finished level of which is flush with the internal concrete floor slabs.

- 5.1 A concrete ground floor is present within each unit. This appears to be a ground bearing concrete floor slab cast in individual bays of various sizes. The floor presents as reasonably level

Photograph 10 – Foundation and slab details
