# DESIGN, ACCESS & HERITAGE STATEMENT

## BRICK HOUSE BRICKHOUSE HILL EVERSLEY

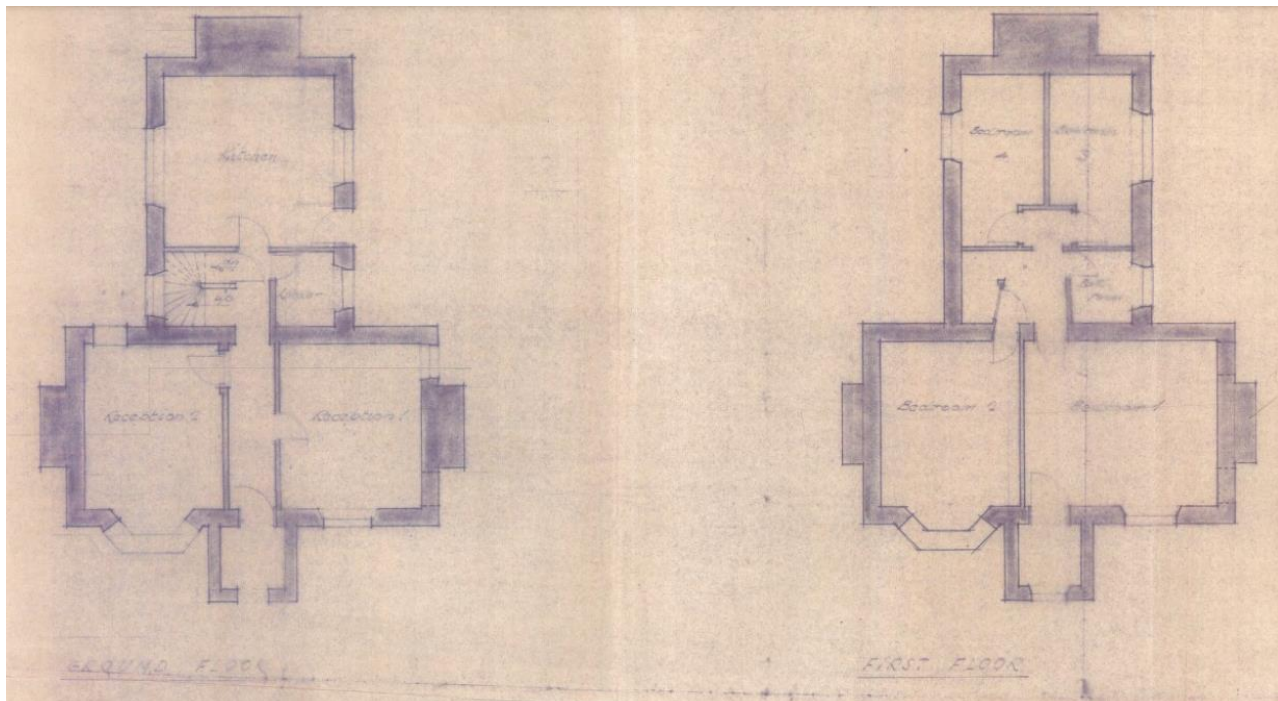
The listing describes the house as:

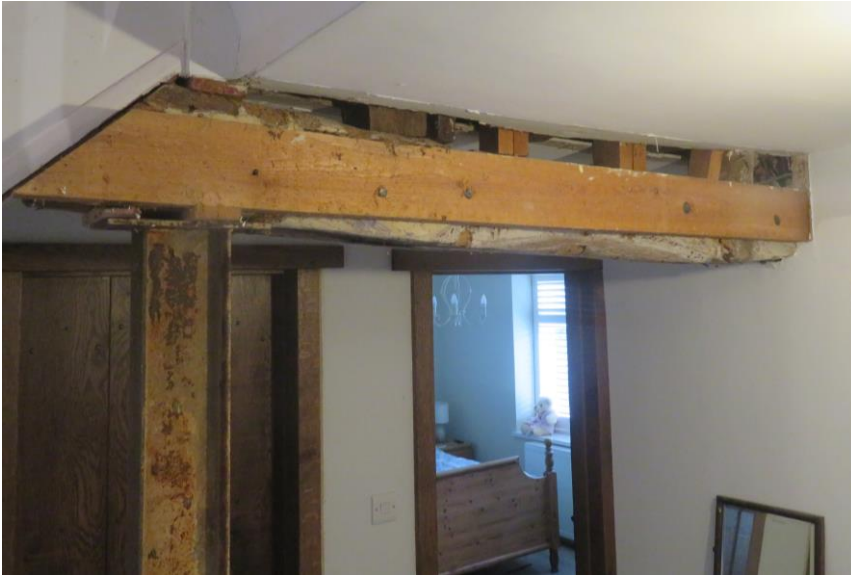
The dropped tie beam cut to accommodate the stairs, is supported on a metal post and repaired using pine flitch plates.

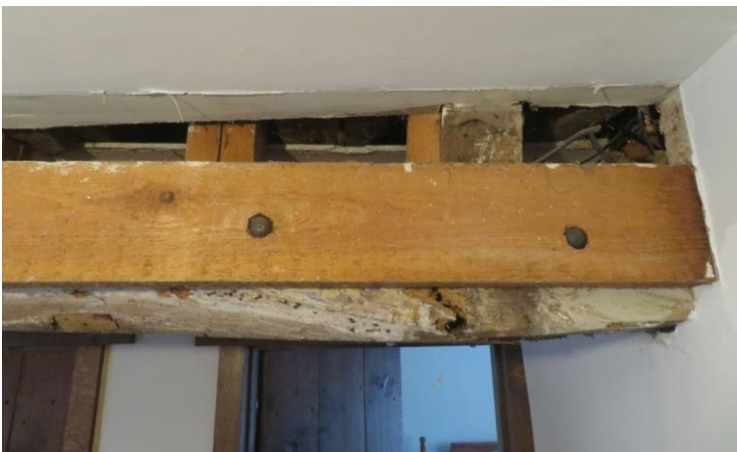
Vertical crack in beam

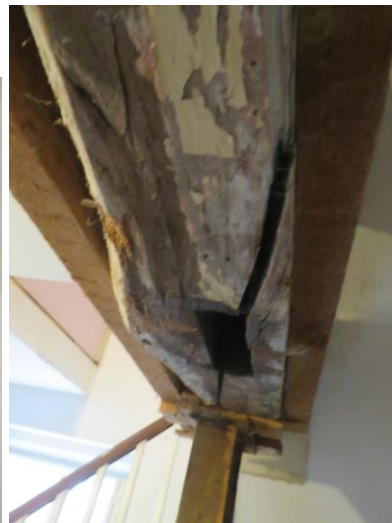
diagonal crack in beam, seen from below

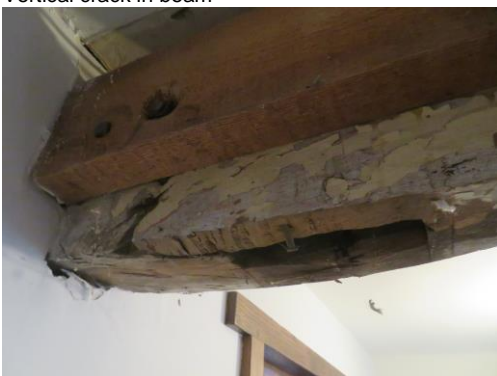
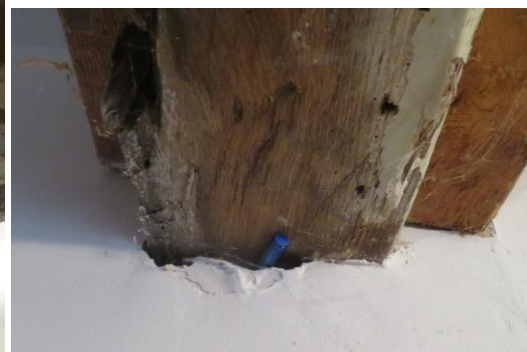
5mm gap under beam where it pass through the partition

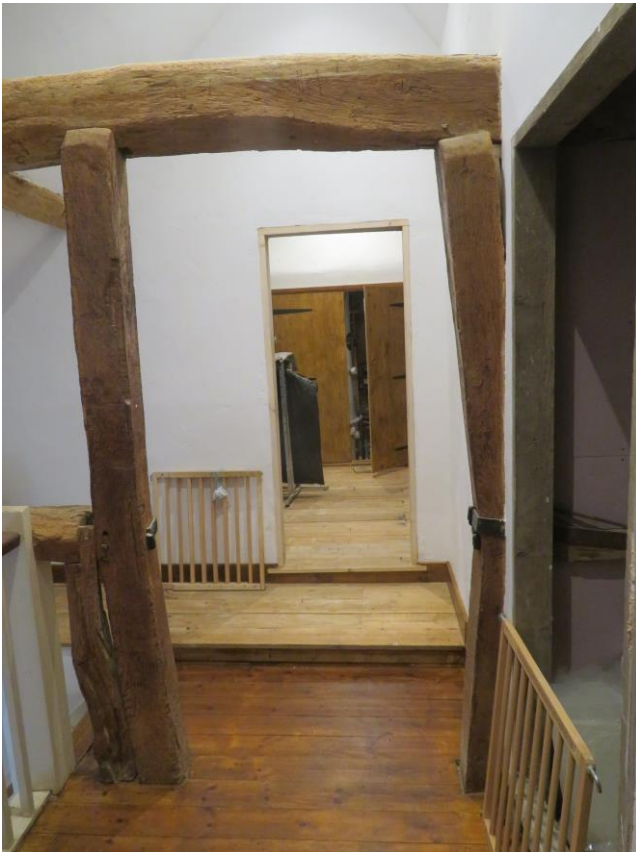
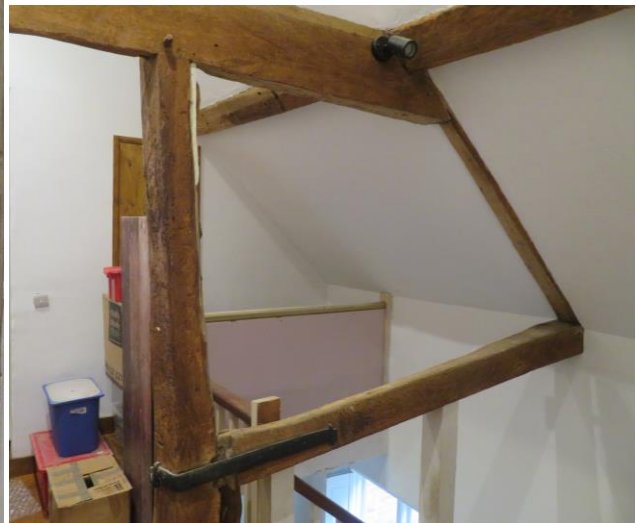
cracked right hand post where the stub tie beam joins it

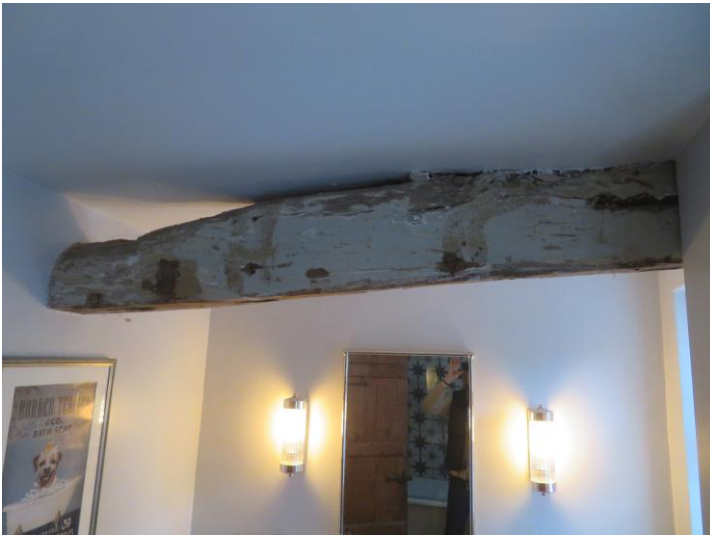
View of beam in bathroom

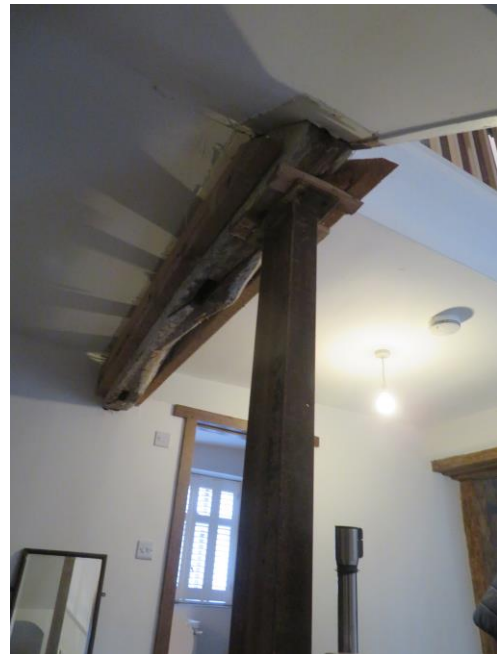
View of beam from below
