21 Bargrove Close, London, SE20 8DU IFS-LBG-SUB-20-0088174

LEVEL MONITORING for Subsidence Management Services

21 Bargrove Close, London, SE20 8DU

Client:	Subsidence Management Services		
Client Contact:	lan Domigan		
Claim Number:	102309871		
Client Reference:	IFS-LBG-SUB-20-0088174		
Policy Holder:	Mrs Iryna Kotsur		
Report Date:	26 February 2024		
Our Ref:	M17806

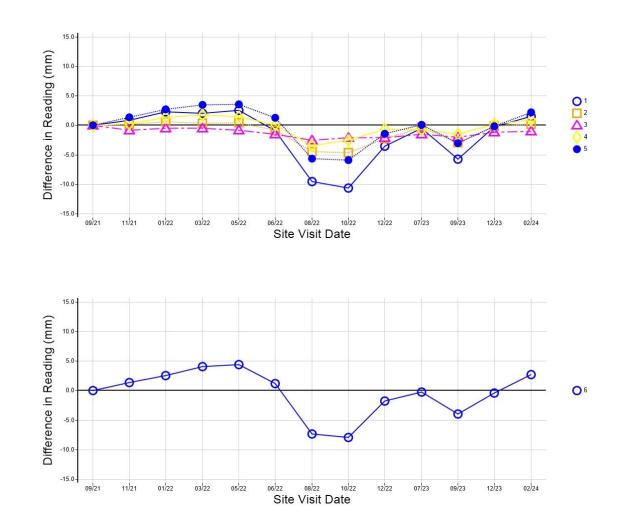
Level Monitoring Difference Graphs

The following graphs display the progressive movement that each Level Monitoring Station recorded at each separate site visit date to give an overall look at how much the property is moving.

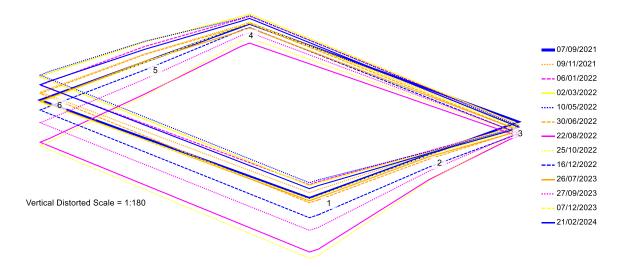
Level Monitoring Displacement Map

The following image shows an isometric representation of the movement of the property, based on the Level Monitoring Stations that were installed.
