# Arboricultural Consultancy for Lloyds Bank

Insured	Mrs Iryna Kotsur	Address	21 Bargrove Close, London, SE20 8DU		
Client	Subsidence Management Services	Contact	Kyza Derby	Claim No.	IFS-LBG-SUB-20-0088174
ES Ref	SA-246851	Consultant	Giles Mercer	Contact No.	0330 380 1036
Report Date	06/11/2020

# GEOTECHNICAL

# ROOT IDENTIFICATION

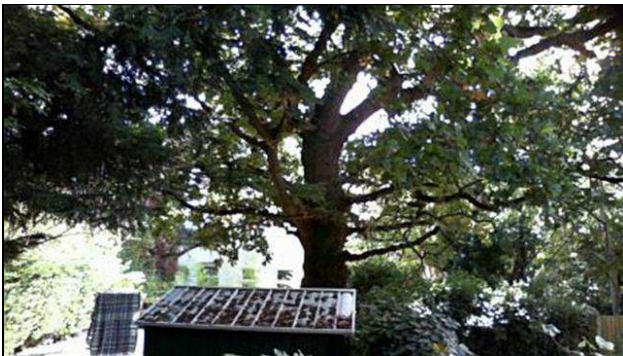
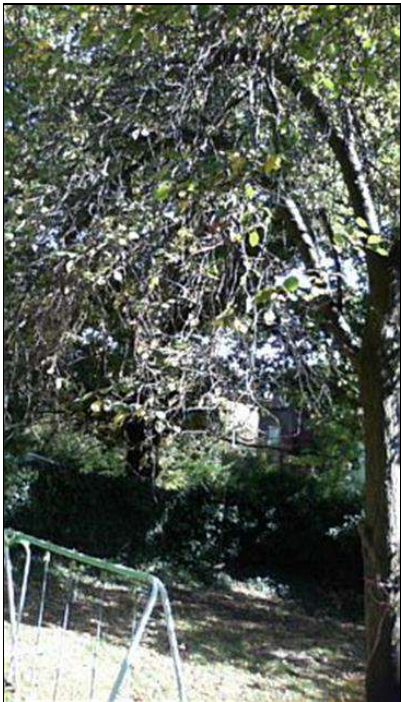
T5 - Oak

Our survey of the site identified the Oak (T5), Laurel (T7) and Cypress trees (TG2), given their position relative to the damage it is our opinion that these trees are the dominant features proximate to the area of movement and accordingly we have identified their collective / cohesive influence as the primary cause of the subsidence damage.

Consequently, complete removal of the Plum (T3), the Oak ( T5), Cypress (T6), Bay Laurel (T7) and components of TG2 (as detailed) will offer the most certain arboricultural solution likely to restore long-term stability.

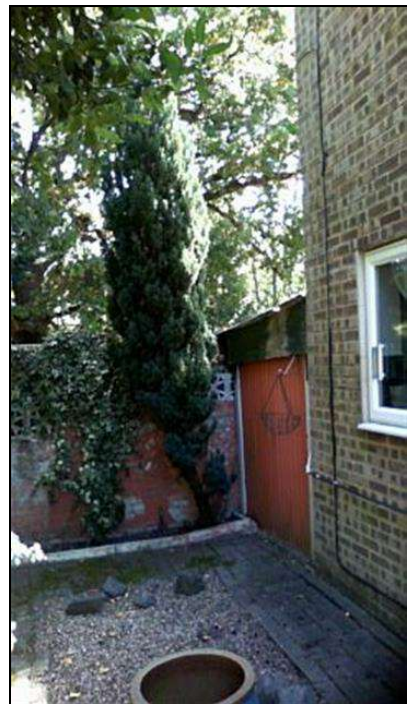
T6 - Cypress

However, the Plum (T3) & Cypress (T6) cannot be discounted as contributing to the overall level of soil drying proximate to the area of damage and are therefore also considered to retain a contributory influence, albeit in a limited / secondary capacity when compared to the above.

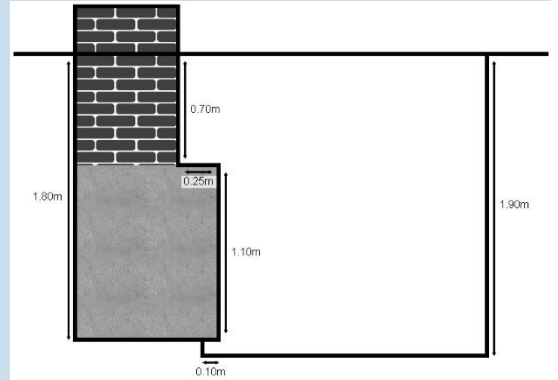
## TP/BH1 Foundation Detail and Borehole Log

House foundation comprised of brick wall to 700mm bgl, bearing on concrete to 1800mm bgl, with a total projection of 250mm from the elevation. Underside of foundation (USF) was exposed to 100mm back from the face of the foundation and probed 500mm back from the face of the foundation.

House foundation was exposed and the underside of foundation (USF) recorded to be 1.8m bgl (TP/BH 1).

Roots encountered to 2.9m bgl (TP/BH 1).
