**G.D.A. Design Associates Limited**

**Methodology Statement and Specification for Rectifying Damage to Side Elevation  
Brickwork Due to Unauthorized Works and the requirements of Condition 5 attached to  
Planning Permission Ref - DC/080135.**

**The Vicarage, 5 Robins Lane, Bramhall, Stockport. SK7 2PE**

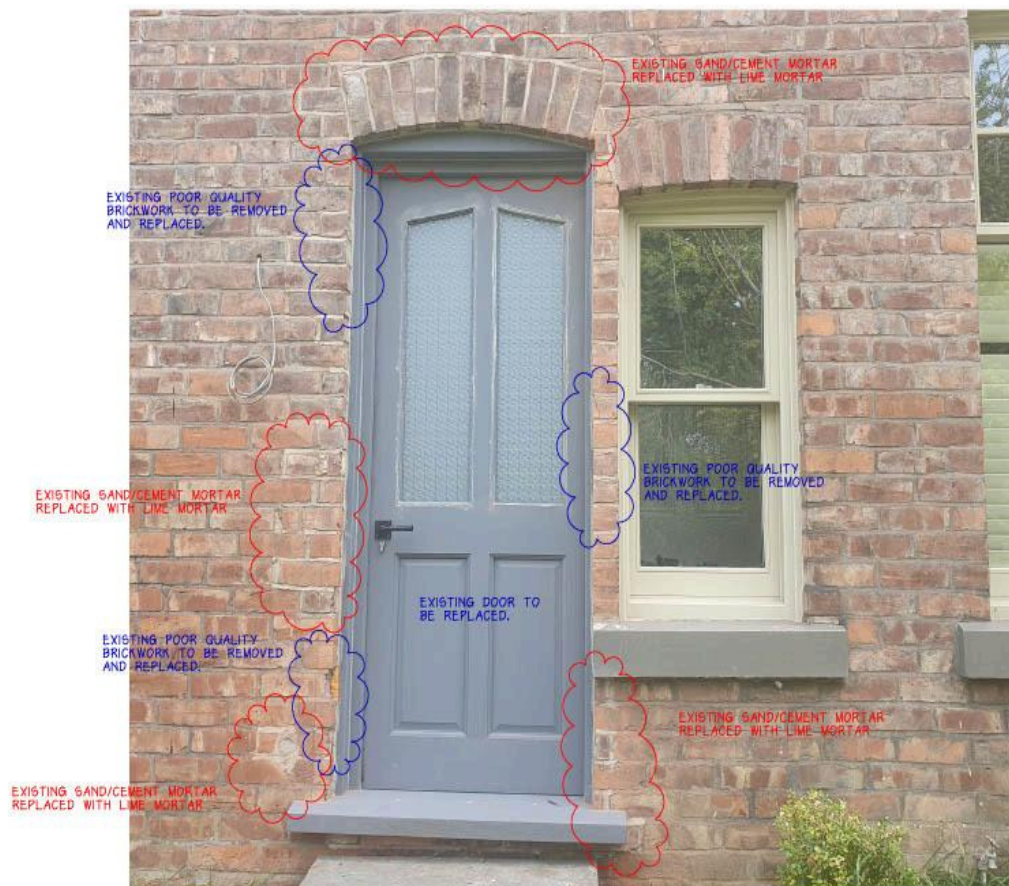
#### **Image 1 - inserted door opening.**

The areas highlighted are not a comprehensive indication of all remedial work required.

Damaged bricks will be carefully removed and replaced with either matching bricks or the reuse of the existing bricks placed suitably to restore structural integrity and aesthetic appeal.

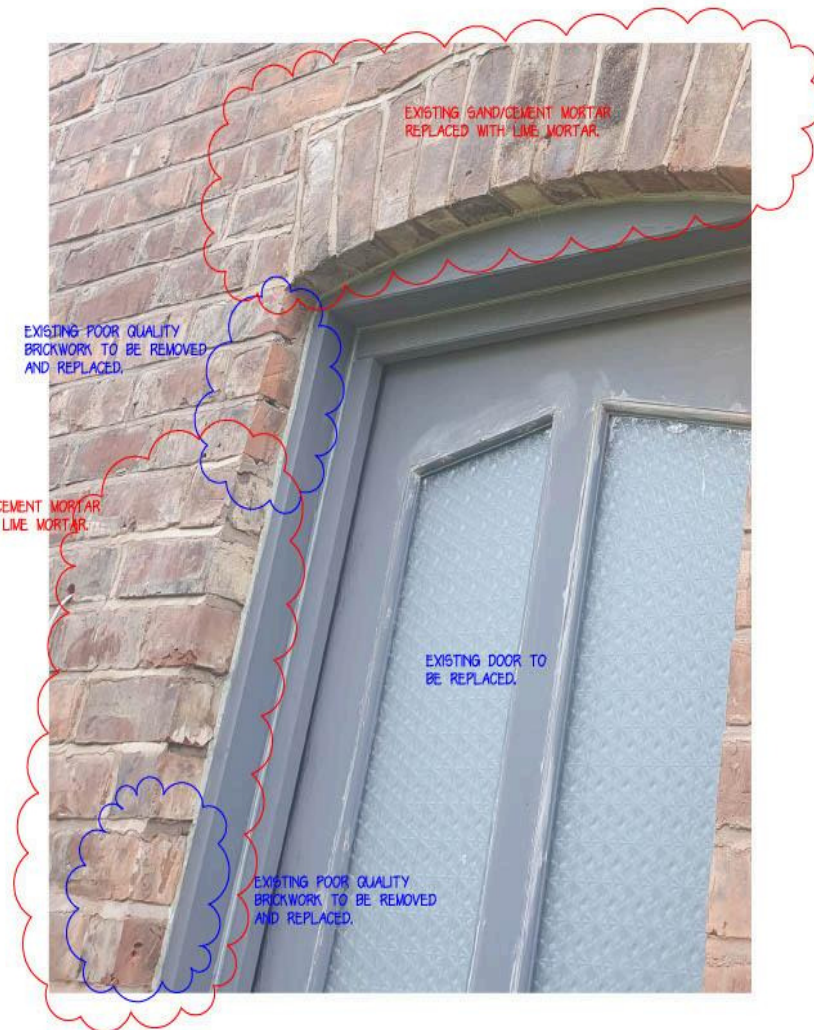
### **Image 2 - inserted door opening.**

The areas highlighted are not a comprehensive indication of all remedial work required.

Existing mortar will be carefully chiselled out by hand tools and not cut mechanically. Replacement mortar will be lime mortar with added pitch to colour match ensuring compatibility with existing mortar.
