Email: info@hermitagewindows.co.uk

STATEMENT OF PROPOSED REPAIR AND REPLACEMENT OF EXISTING WINDOWS.

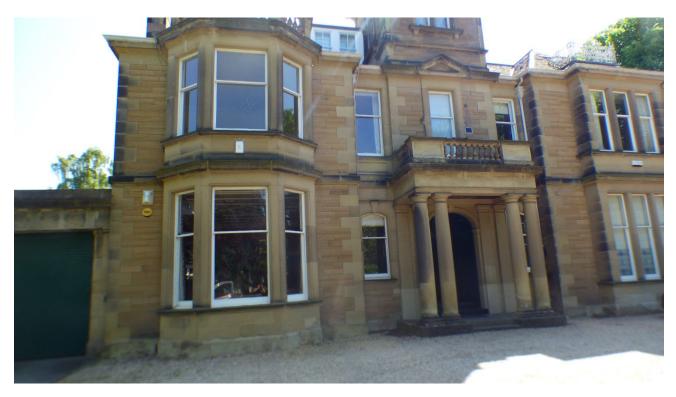
Photograph 1: Showing Front Elevation of 27/3 South Oswald Road, Edinburgh, EH9 2HH.

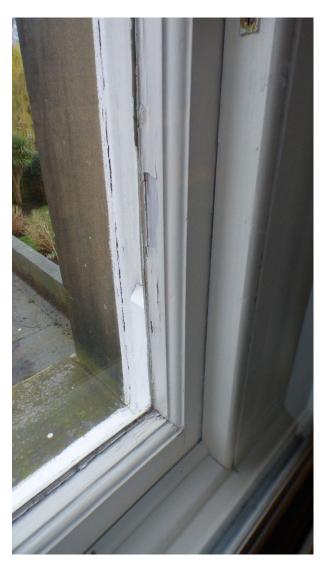
Photograph 4: Showing Window 1 with evidence of a rotten bottom rail section. Due to water ingress this section has become beyond repair and requires a replacement sash.

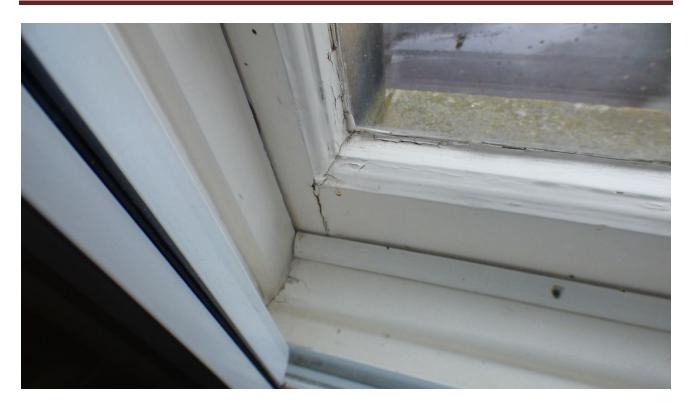
Photograph 5: Showing Window 1 with evidence of a rotten bottom rail section. Due to water ingress this section has become beyond repair and requires a replacement sash.

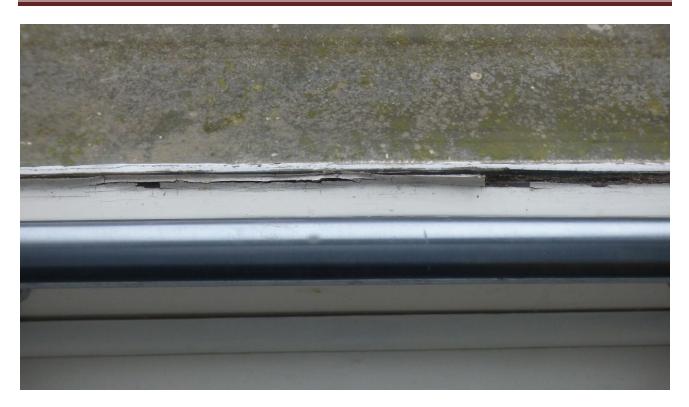
Photograph 6: Showing Window 1 with evidence of a rotten bottom rail section. Due to water ingress this section has become beyond repair and requires a replacement sash.

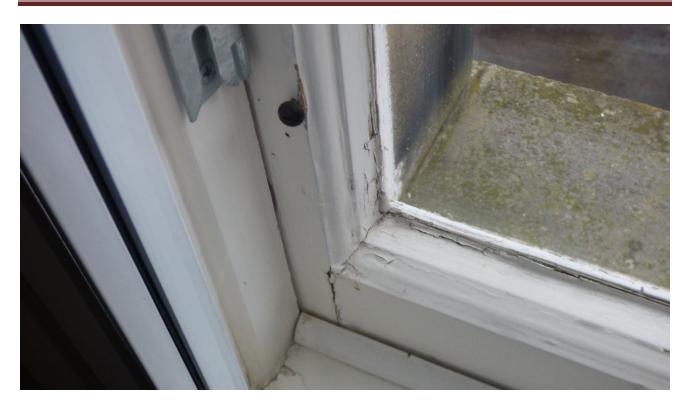
Photograph 7: Showing Window 1 with evidence of soft and rotten bottom rail timbers. Due to water ingress this section has become beyond repair and requires a replacement sash.

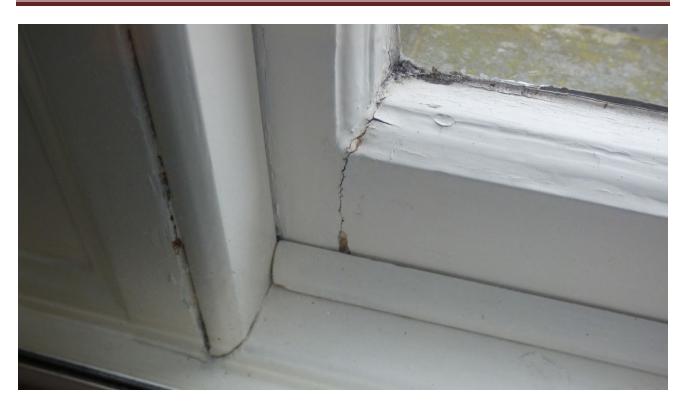
Photograph 8: Showing Window 2 with evidence of soft and rotten bottom rail timbers. Due to water ingress this section has become beyond repair and requires a replacement sash.

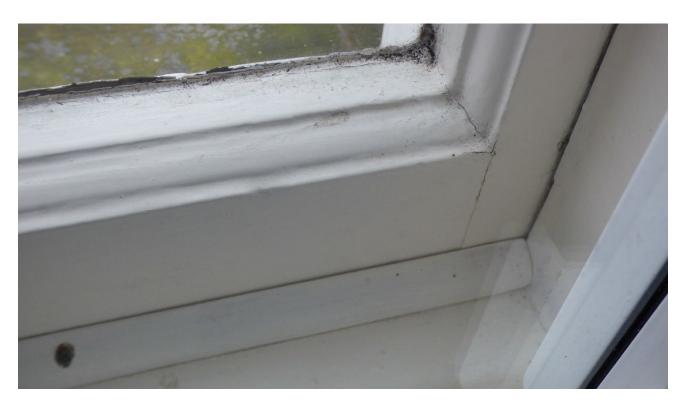
Photograph 9: Showing Window 2 with evidence of soft and rotten bottom rail timbers. Due to water ingress this section has become beyond repair and requires a replacement sash.

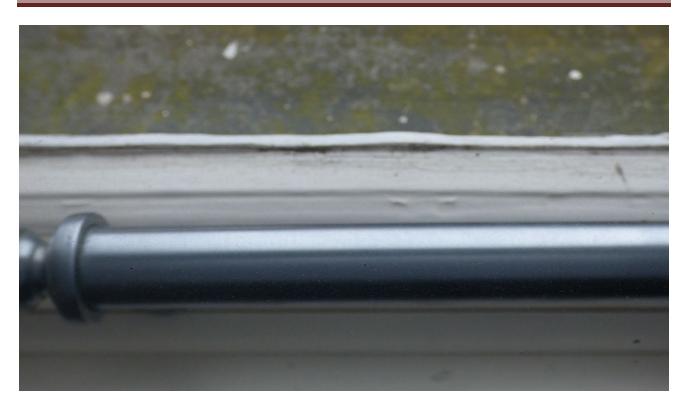
Photograph 10: Showing Window 2 with evidence of soft and rotten bottom rail timbers. Due to water ingress this section has become beyond repair and requires a replacement sash.

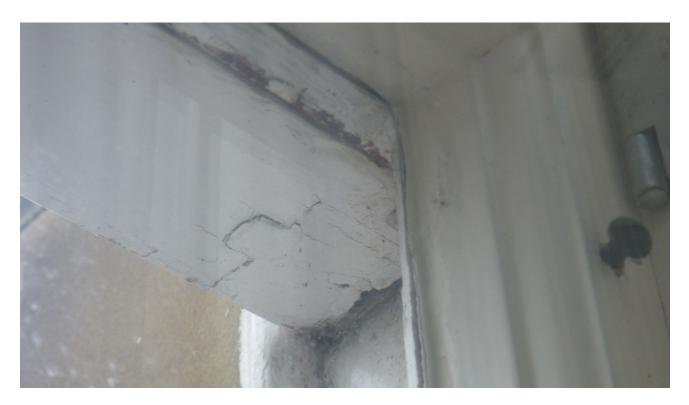
Photograph 11: Showing Window 2 with evidence of a rotten midrail section. Due to water ingress this section has become beyond repair and requires a replacement sash.

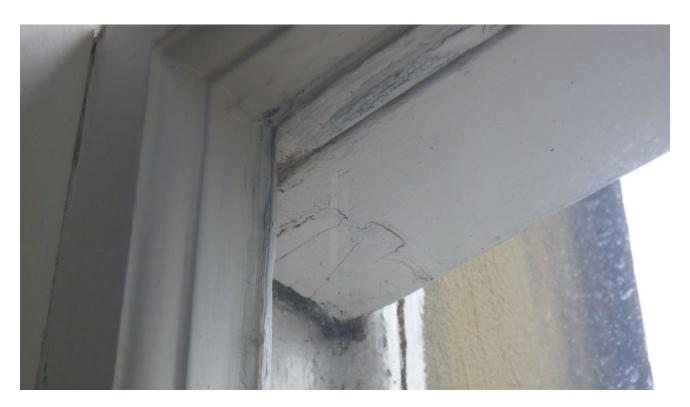
Photograph 12: Showing Window 2 with evidence of a rotten midrail section. Due to water ingress this section has become beyond repair and requires a replacement sash.

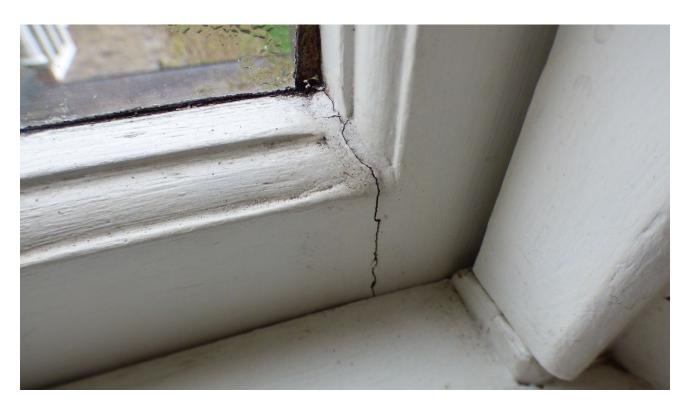
Photograph 14: Showing Window 3 with evidence of a rotten bottom rail section. Due to water ingress this section has become beyond repair and requires a replacement sash.

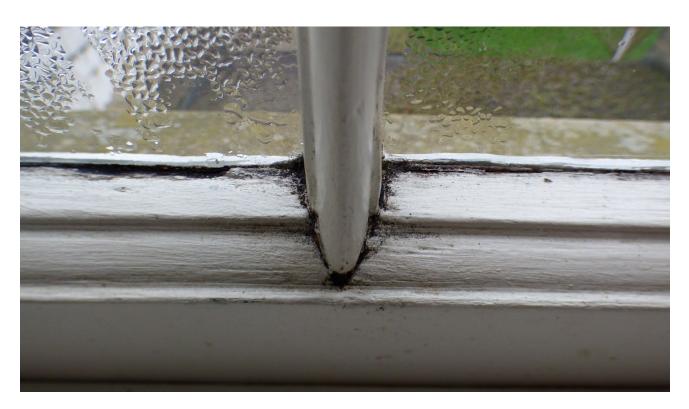
Photograph 15: Showing Window 3 with evidence of a rotten bottom rail and astragal section. Due to water ingress this section has become beyond repair and requires a replacement sash.

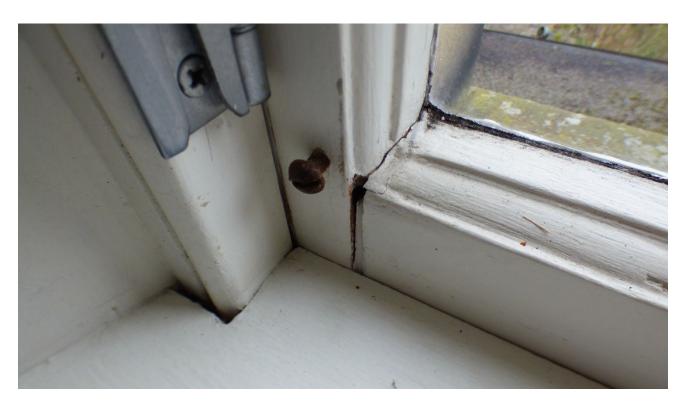
Photograph 16: Showing Window 3 with evidence of a rotten bottom rail section. Due to water ingress the mortice and tenon joint has become rotten and requires a replacement sash.

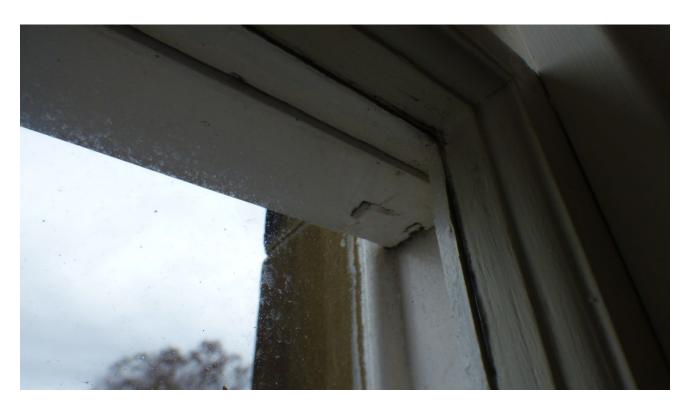
Photograph 17: Showing Window 3 with evidence of a rotten midrail section. Due to water ingress this section has become beyond repair and requires a replacement sash.

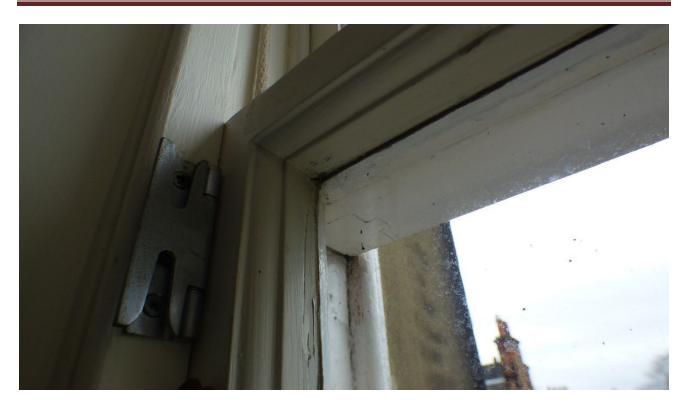
Photograph 18: Showing Window 3 with evidence of a rotten midrail section. Due to water ingress this section has become beyond repair and requires a replacement sash.

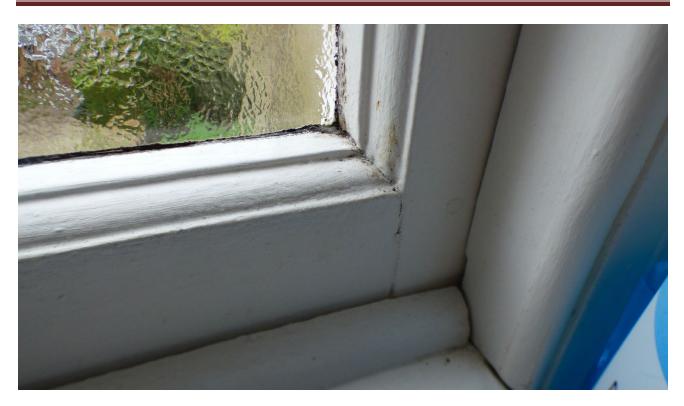
Photograph 20: Showing Window 4 with evidence of a rotten bottom rail section. Due to water ingress this section has become beyond repair and requires a replacement sash.

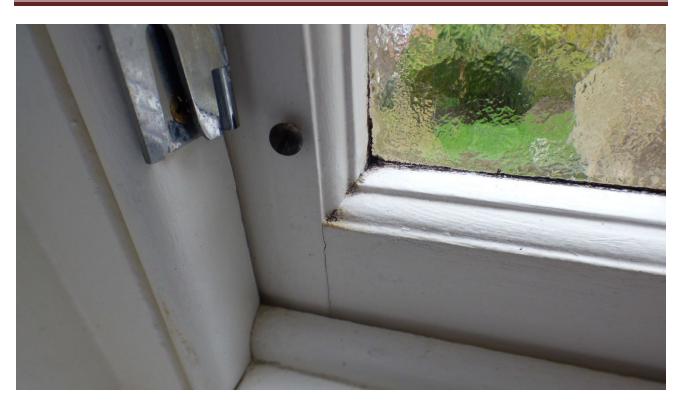
Photograph 21: Showing Window 4 with evidence of a rotten bottom rail section. Due to water ingress this section has become beyond repair and requires a replacement sash.

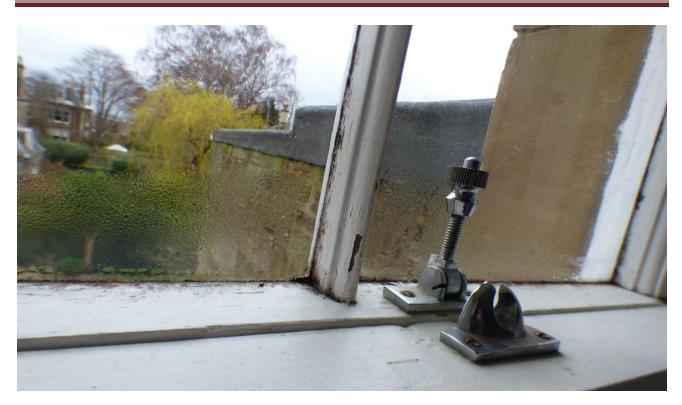
Photograph 22: Showing Window 4 with evidence of a rotten midrail and astragal section. Due to water ingress this section has become beyond repair and requires a replacement sash.
