LORD OF THE TREES

12 Mansionhouse Road.

22 March 2024

Visual tree assessment

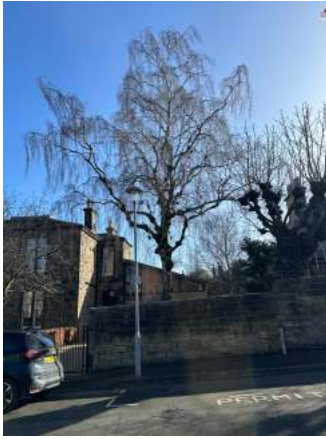
The Birch is a prominent tree on the street with a high amenity value, there is evidence of historic pruning - although these wounds appear to be occluding well.

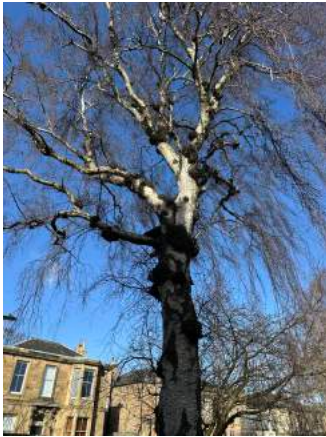
Some limbs to the North and South have been lions tailed, and are some what etiolated. There is a large rot pocket on the tension side of the lower Southern limb.

Any future risk can be mitigated by reducing the north and south etiolated limbs by 1m, this should ideally be completed with 12months.

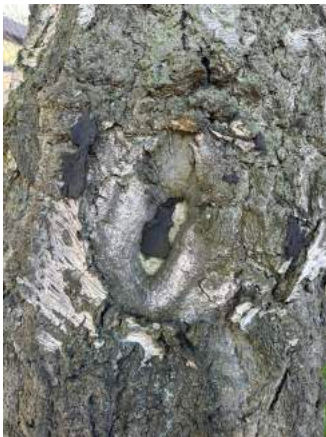
The stem has been filled with concrete at some point in the past 20-30 years. The extent of the decay and volume of sound wood is impossible to measure as a result.

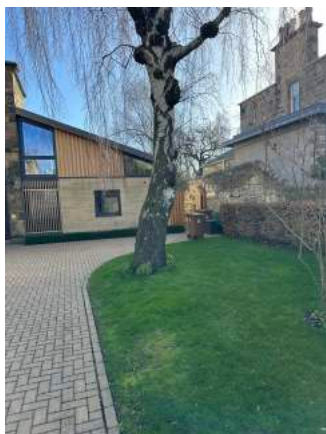
There is a slight dog leg at 1m, with a slight swelling of the trunk, no parasitic decay fungi were observed, although these are seasonal in nature.
