**EMERGENCY WORKS – REPLACE FAILED  
CHIPBOARD ROOF DECKS & LEAD ROOF  
COVERINGS**

**NORTH RANGE, OLD QUAD  
BRASENOSE COLLEGE  
OXFORD  
OX1 4AJ**

**DESIGN AND ACCESS STATEMENT, HERITAGE ASSESSMENT,  
AND NOTES IN SUPPORT OF  
APPLICATIONS FOR LISTED BUILDING CONSENT**

Updated March 2024

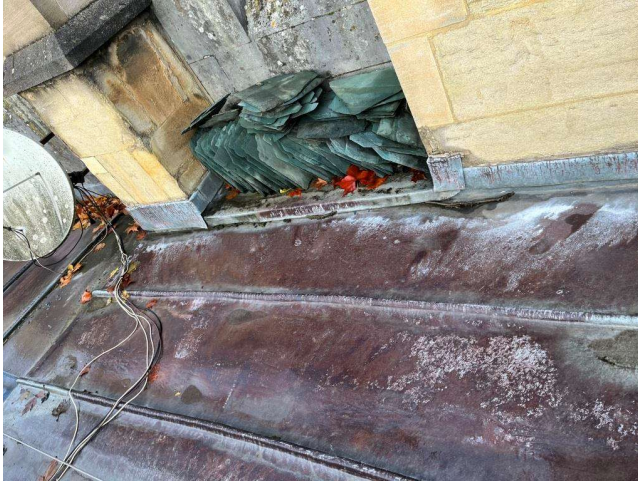
Photograph No 1

General view – Area 3 – Stair 5 – towards chimneys

See evidence of previous running repairs and deformed small diameter hollow leaded rolls.

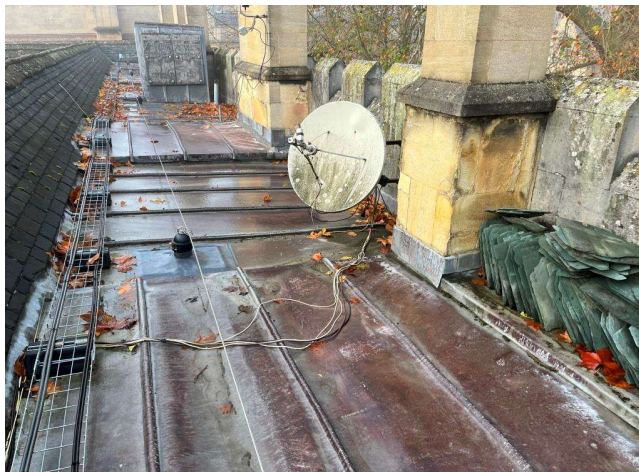
Photograph No 2

General view – Area 3 – Stair 5 – towards Stair 4

See deformations in bays, deformed small diameter hollow leaded rolls and standing water.

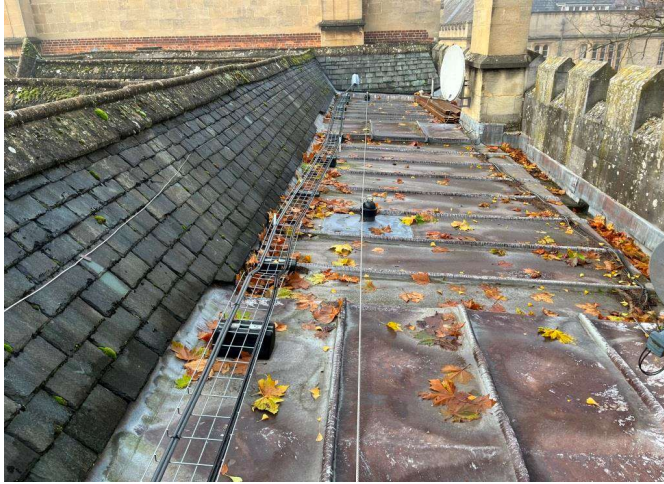
Photograph No 3 – Area 2 – Stair 4 - towards Stair 3

See deformed bays, deformed small diameter hollow leaded rolls and standing water.

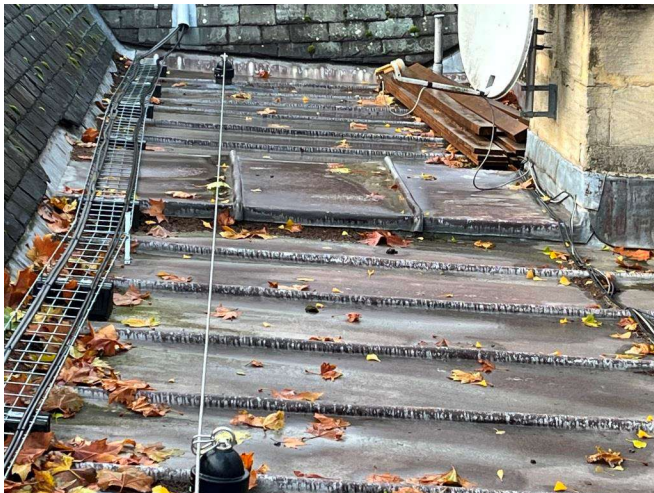
Photograph No 4 – Area 1 – Stair 3

See deformed bays and evidence of standing water.

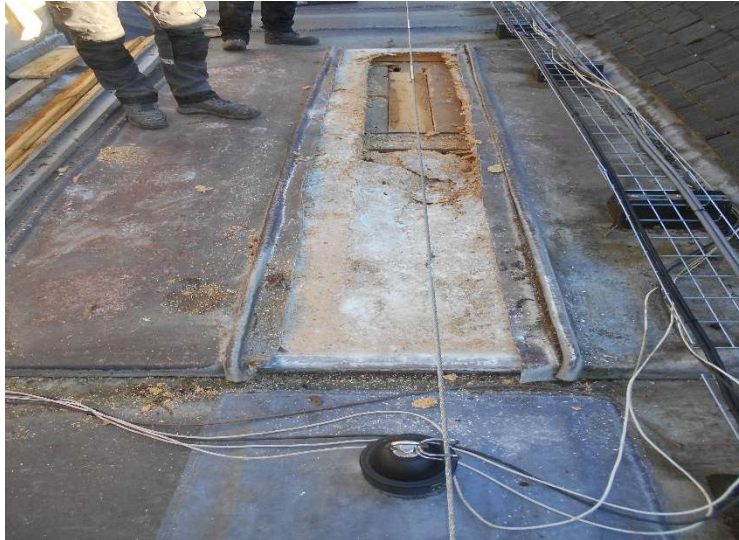
Photograph No 5 – Investigation – Raised Bay a)

- 5.03 A bay of lead (one of the bays aligning with a chimney stack), where the deflection is currently most severe was carefully taken up. It revealed that the deck below the lead is formed from chipboard, which having become wet from leaks, has disintegrated and the deck has failed. The investigation also revealed that the raised decks had been built up above the previously existing roof boarding\*

- 5.05 The chipboard roof decking material is not a fit for purpose material. It is an outmoded hazardous composite, and it breaks down when subject to moisture. As the chipboard gets wet it breaks down, the roof deflects and holds water, water passes lead cracks/splits, and the cycle continues until failure.
- 5.06 Chipboard is not an appropriate material for using as roof decking. Wherever it has been exposed so far, it is wet and damaged/breaking down or disintegrating. There is an urgent need for the material to be removed/replaced using a material which is fit for purpose, not least on a listed historic building.
- 5.07 The existing roofs serving the buildings have no current provision for protection against lightning strike(s).

From south, indicating chipboard deck exposed – composite material is part broken down. Also indicates deformed and splitting small diameter lead rolls.

- 6.03 Existing failed wet chipboard decking used on the raised bays and also on the other bays is all to be replaced in line with the typical details identified.

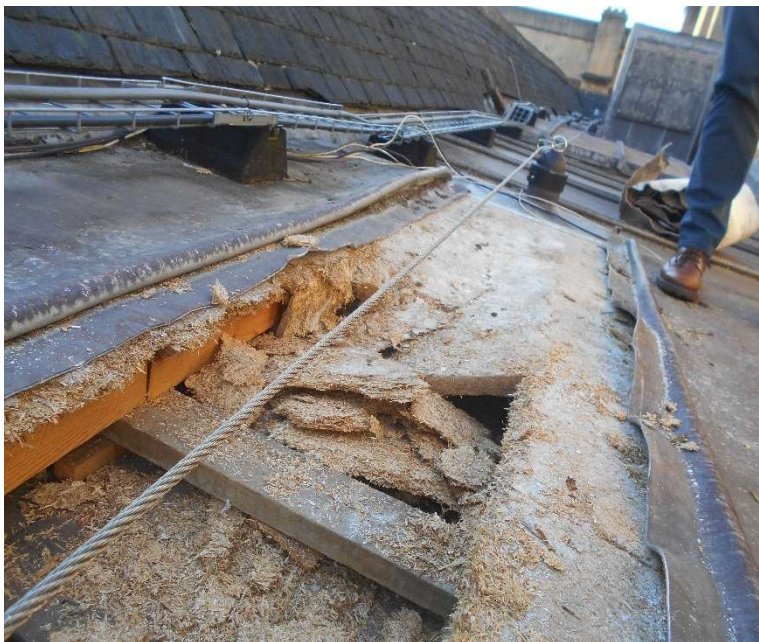
Photograph No 6 – Investigation – Raised Bay b)

From north, indicating disintegrated chipboard debris sitting on the previous roof covering timber roofing boards.

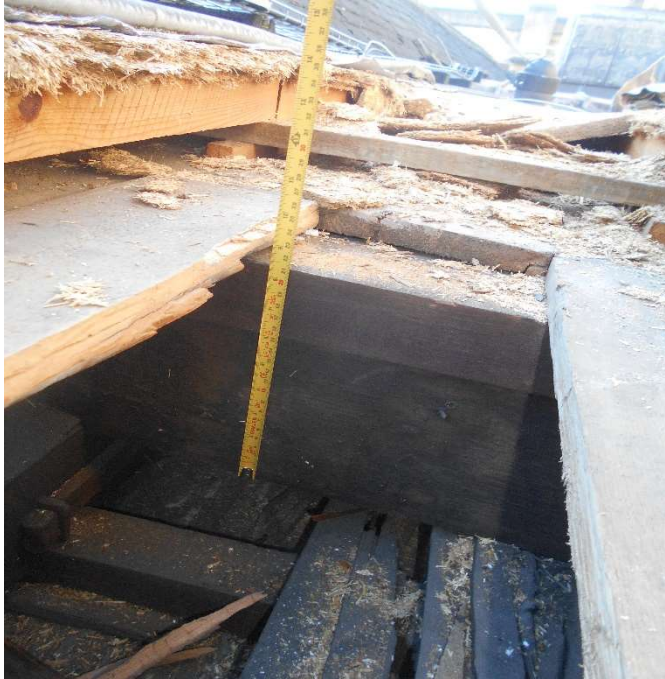
Photograph No 7 – Investigation – Raised Bay c)

\* Raising up the decks aligned with stacks, and re-routing water from the back of stacks to each side is envisaged to be the previous remedial measure to address a lack of fall and cracking/splitting in the previous lead gutters. The lead failure would most likely have been caused by the stack projections which would constrain thermal movement of the lead.

Build-up of raised chipboard bay above previous boarded roof. Timber roof boards and two previous ceilings can be seen.

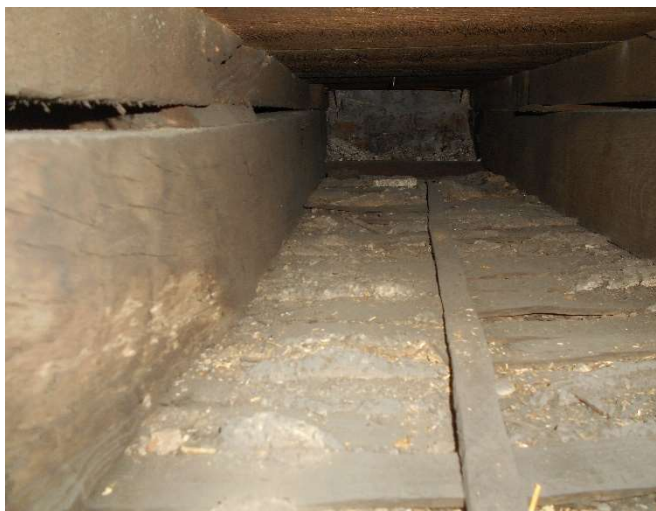
Photograph No 8 – Investigation – Raised Bay d)

View from below previous roof boarding – lathing from a previous ceiling can be seen.

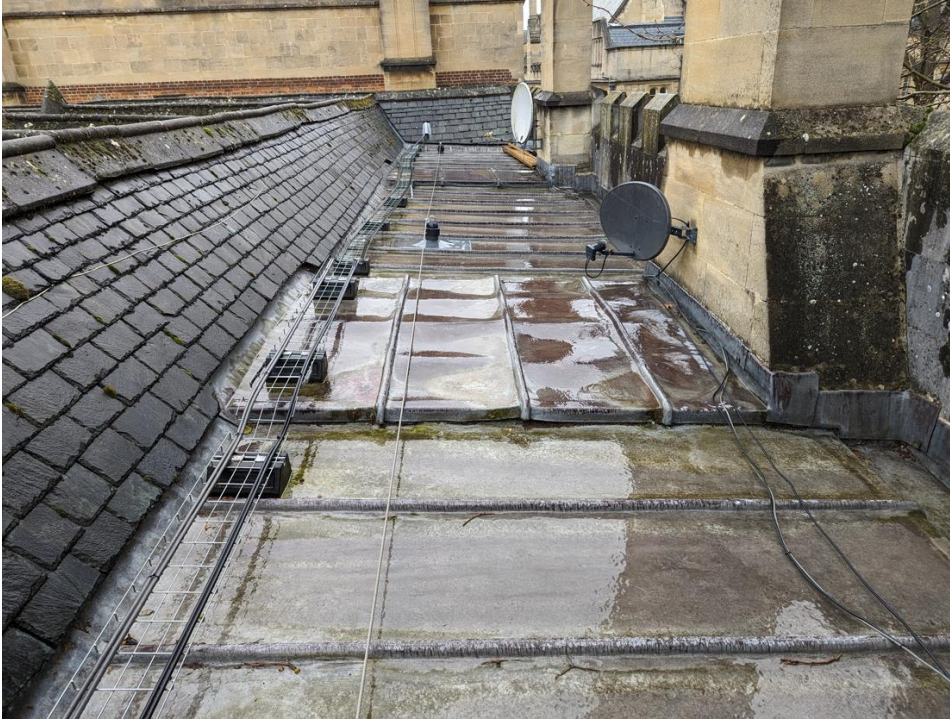
Figure 1: View from roof access door looking West

It was raining during the site visit and it could be seen that water is not running off the flat roof effectively and there are areas where the lead coverings appear distorted.

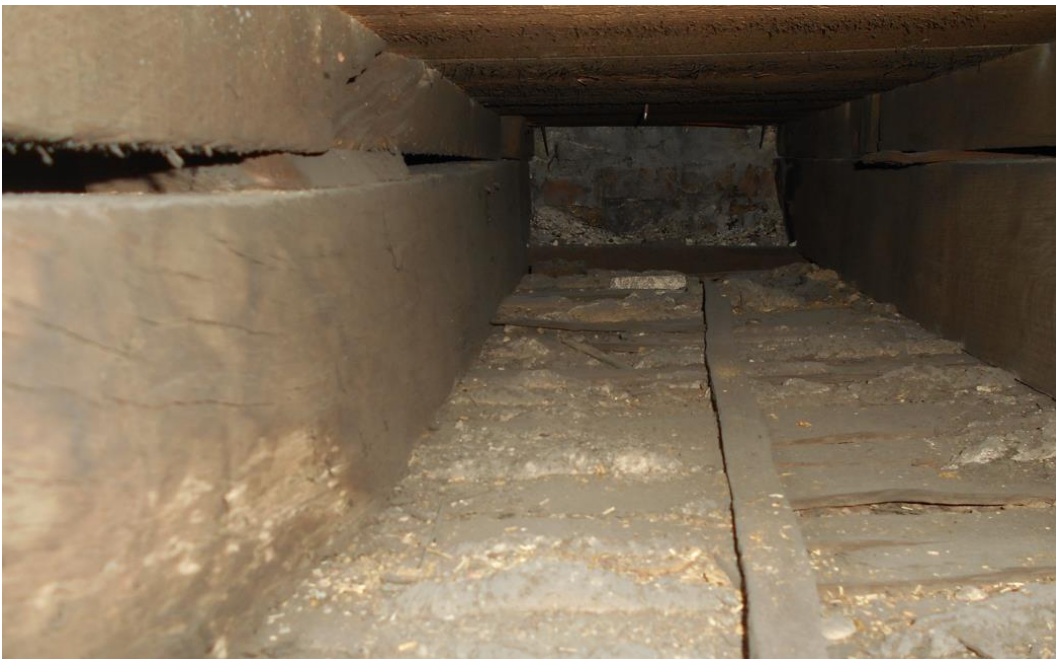
Figure 2: Photo provided by Sidleys showing flat roof structure

The photos that have been sent through by Sidleys show the roof build up has been altered in the past. With the chipboard having been placed on top of timber boarding. There are also photos that show the structure below the boarding to be firring on timber rafters, supporting a lath and plaster ceiling.

PM were not present when the investigations were carried out but have been told that the roof structure itself did not appear to be suffering from decay in these locations.

However, given the issues with the lead and the fact that water is ponding, and in some cases getting through to the boarding under, there is a risk that there could be local areas where water has gotten through to the timber structure and caused it to decay. PM recommend that as the works are carried out the condition of the roof structure is reviewed and PM notified if the timber is found to be questionable.
