**REF CONDITION REPORT ON EXISTING WINDOW AND DOORS AT DEAN COTTAGE DIPPENHALL STREET CRONDALL FARNHAM SURREY GU10 5NY**

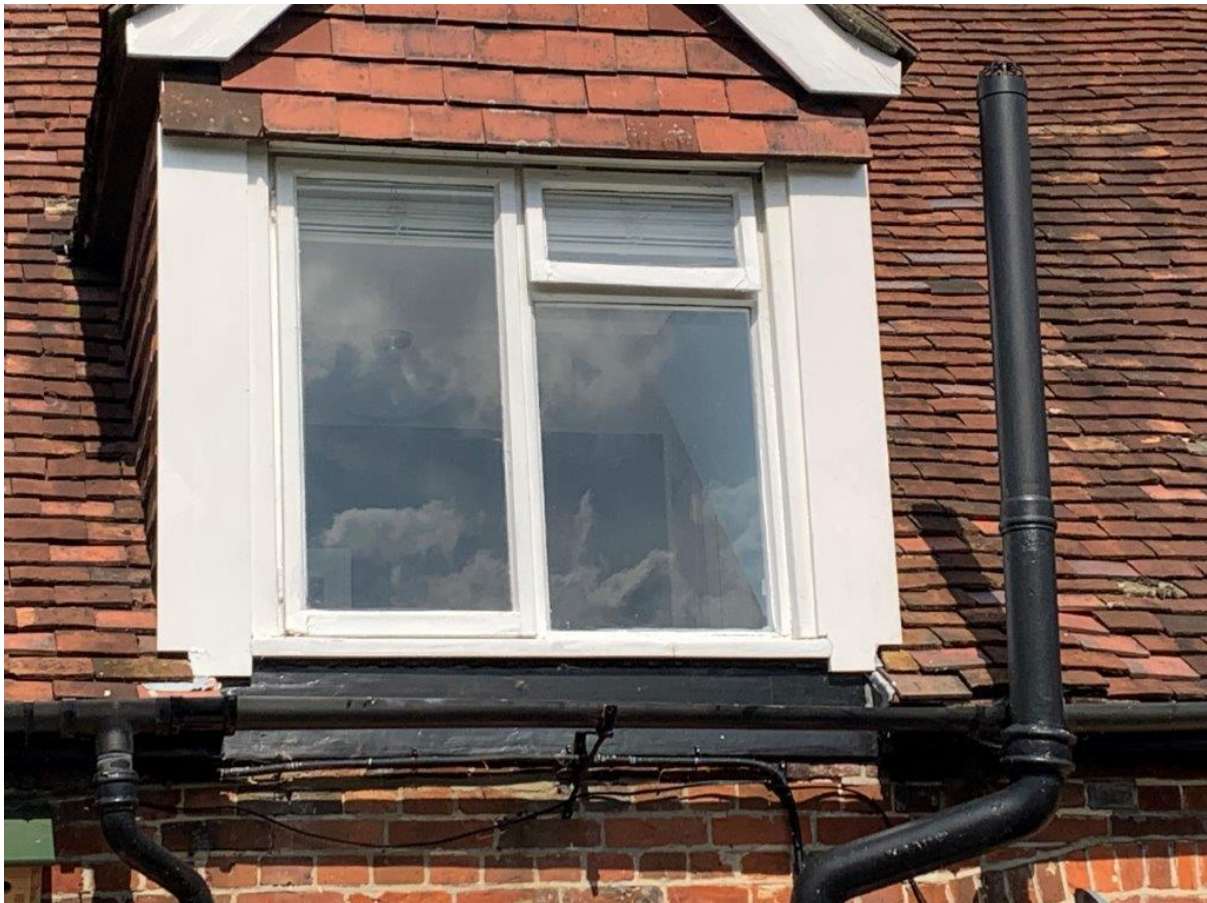
**BATHROOM DORMER:**

Has been replaced at some point with a stock size modern joinery frame and packed out to suit the opening. This is highlighted by the timber cheek boards outside running down past the cill. The bottom of the window opener and frame are showing signs of rot and opener is poor fit.

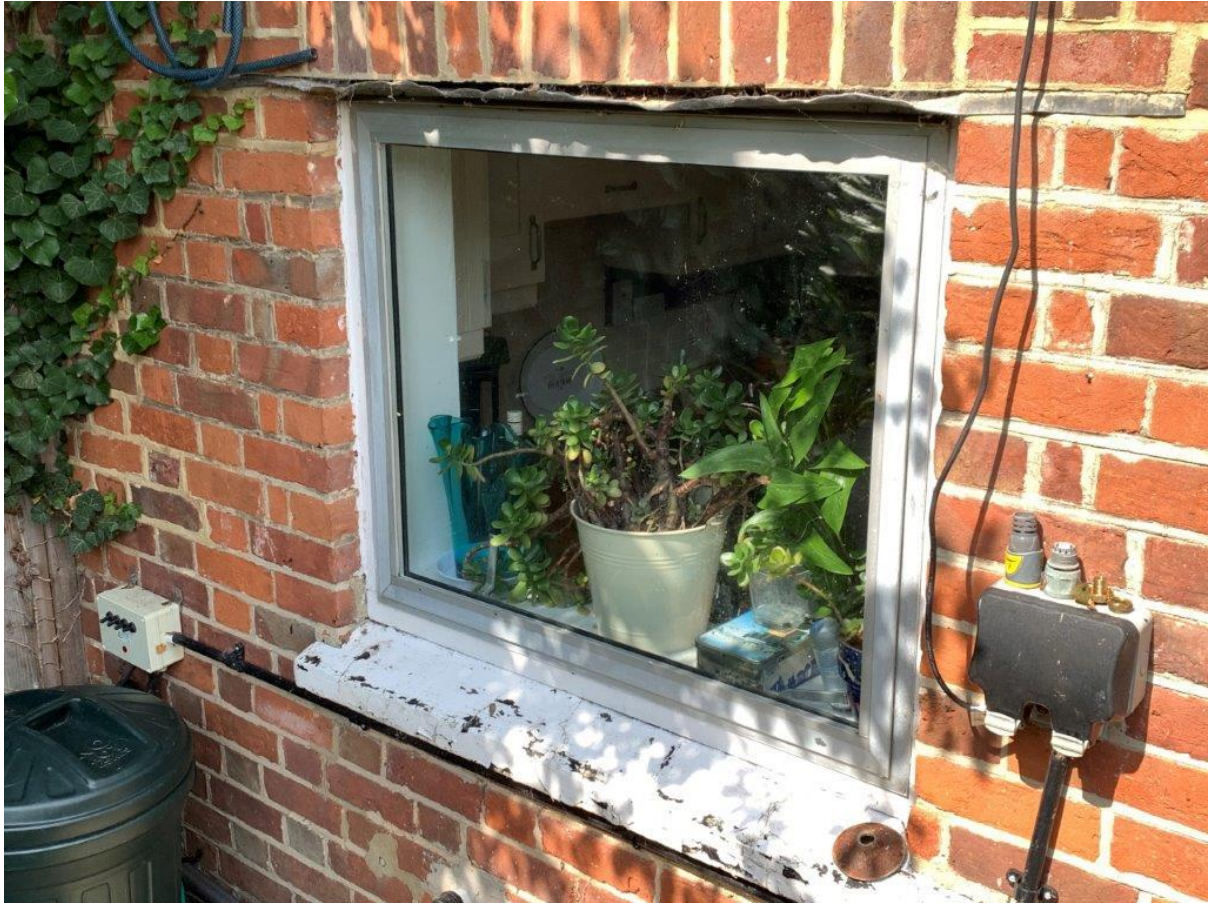
**KITCHEN (REAR):**

Existing window is a timber sub-frame with an aluminium insert. This is not the original window but a replacement fitted during re-modelling works. The window, while in a reasonable state of repair appears to be out of place against the other windows.

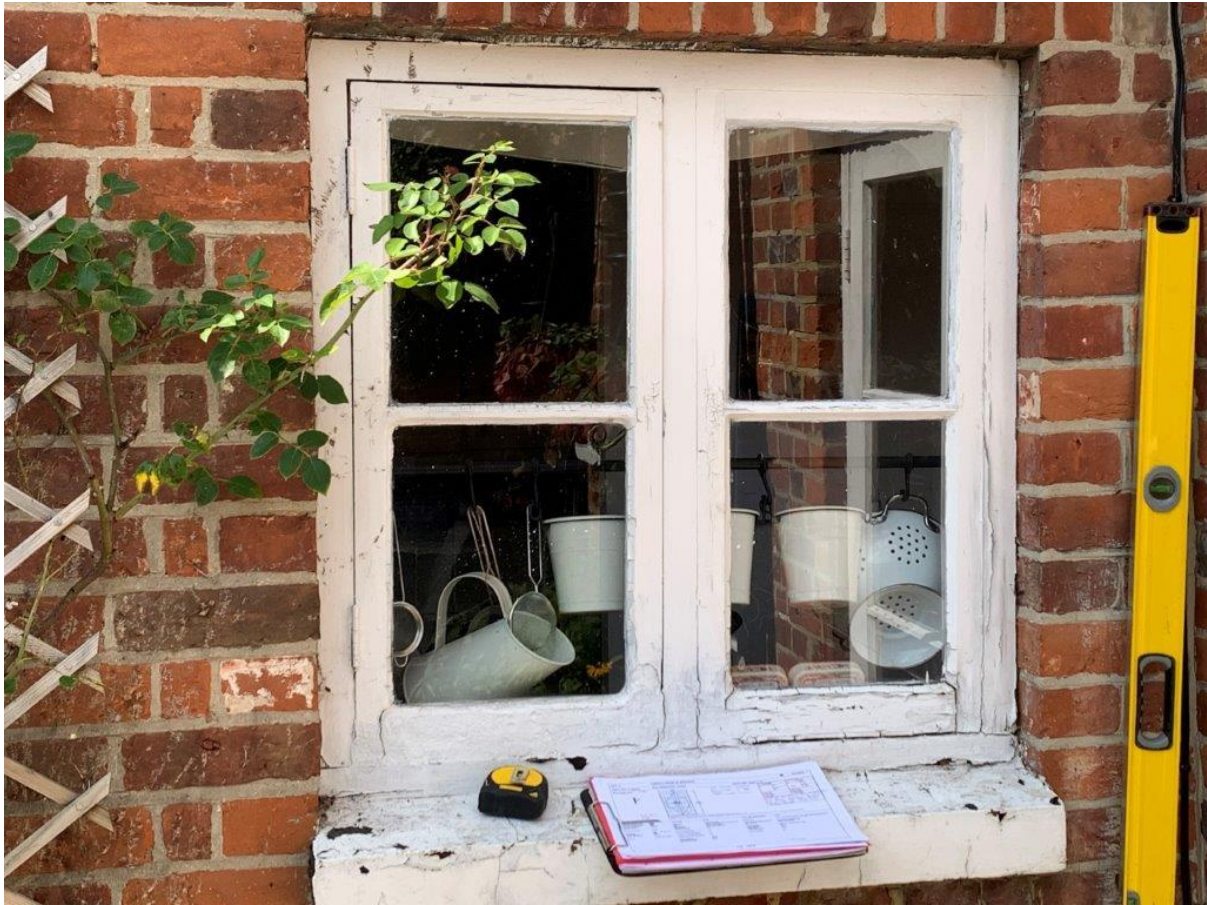
**KITCHEN (SIDE):**

Window but is showing a large amount of rot, The bottom of the L/H opener looks like it has been heavily repaired in the past.

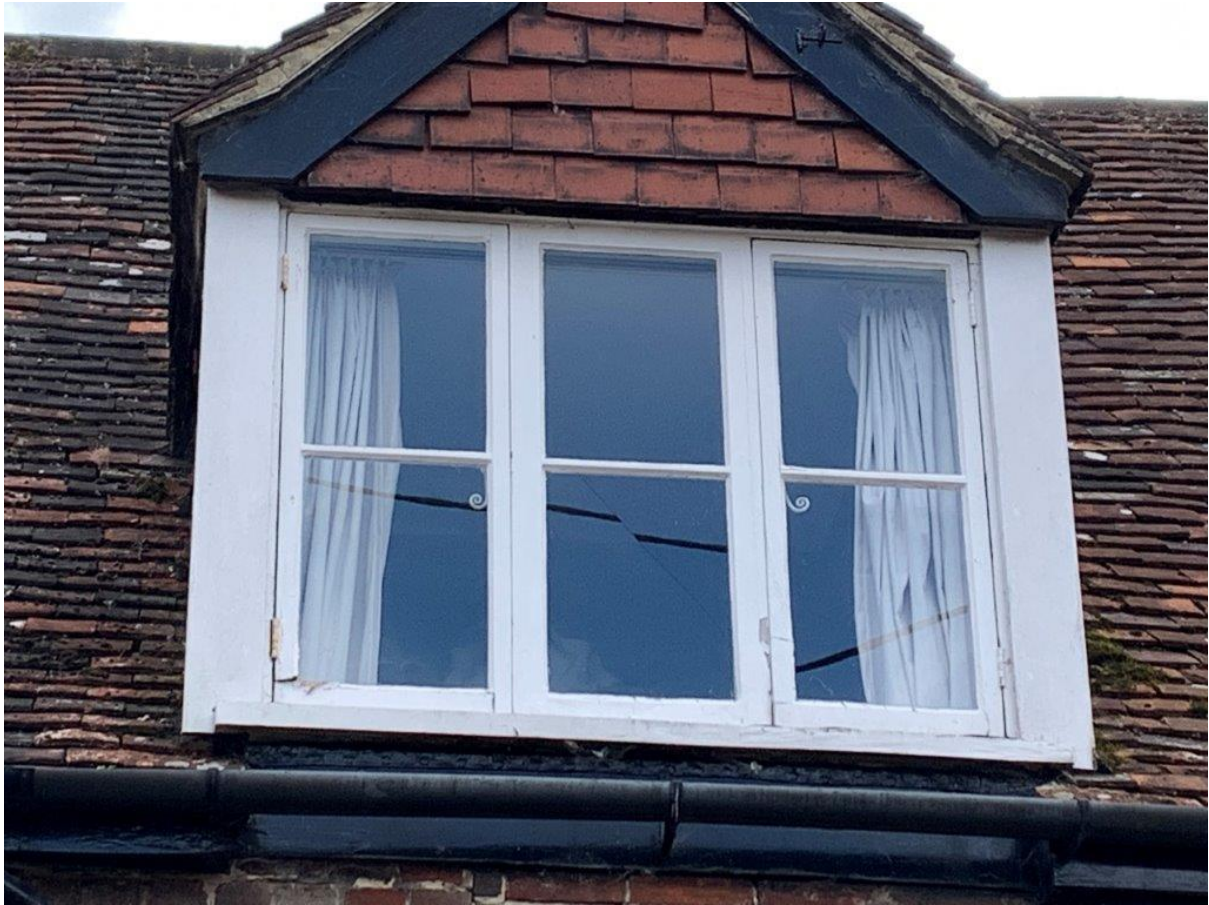
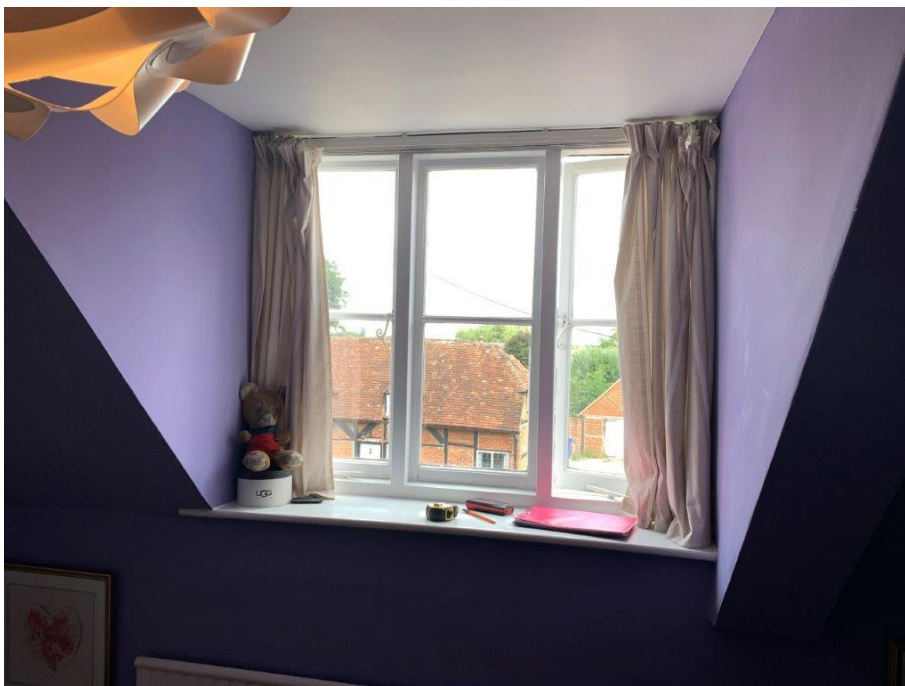
**FRONT BEDROOM DORMER:**

Showing considerable amounts of rot causing the joints on the opener to open up. The lower central single glazed window is cracked.

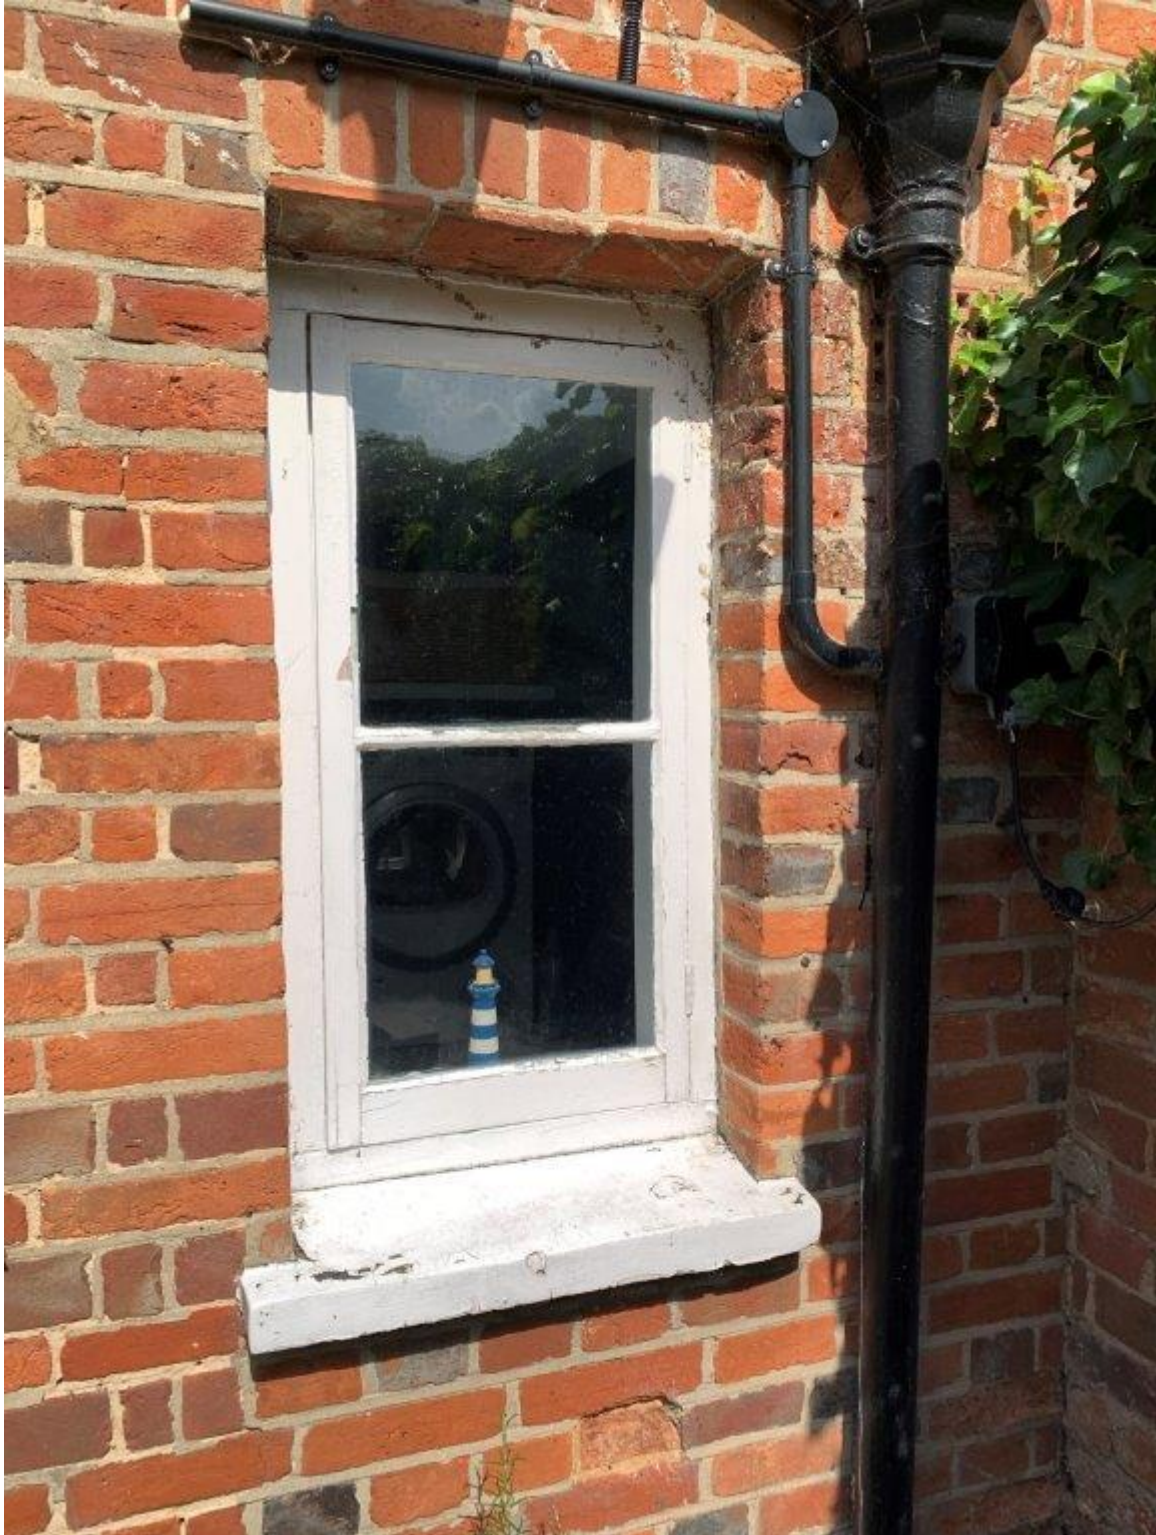
**SMALL GROUND FLOOR BATHROOM WINDOW :**

Showing signs of rot between the bottom of the frame and the stone cill. The joints on the opener are starting to come apart, and the opener is a poor fit in the frame with large gaps at the top causing draughts.

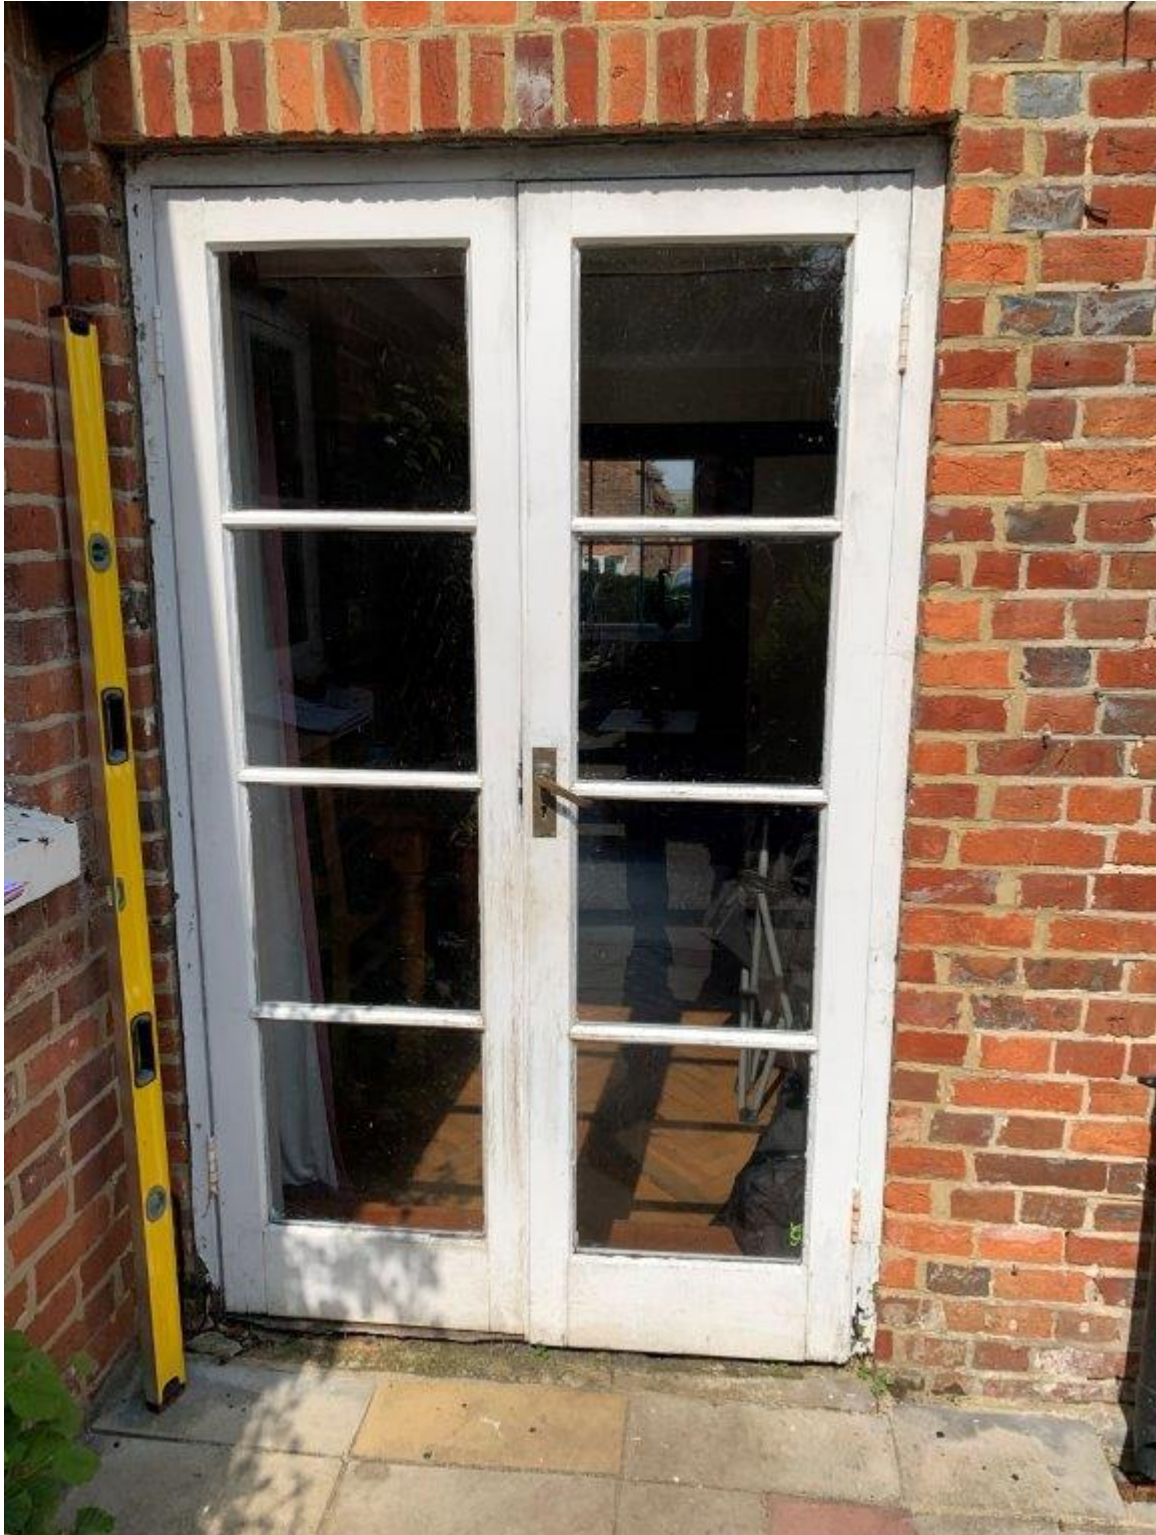
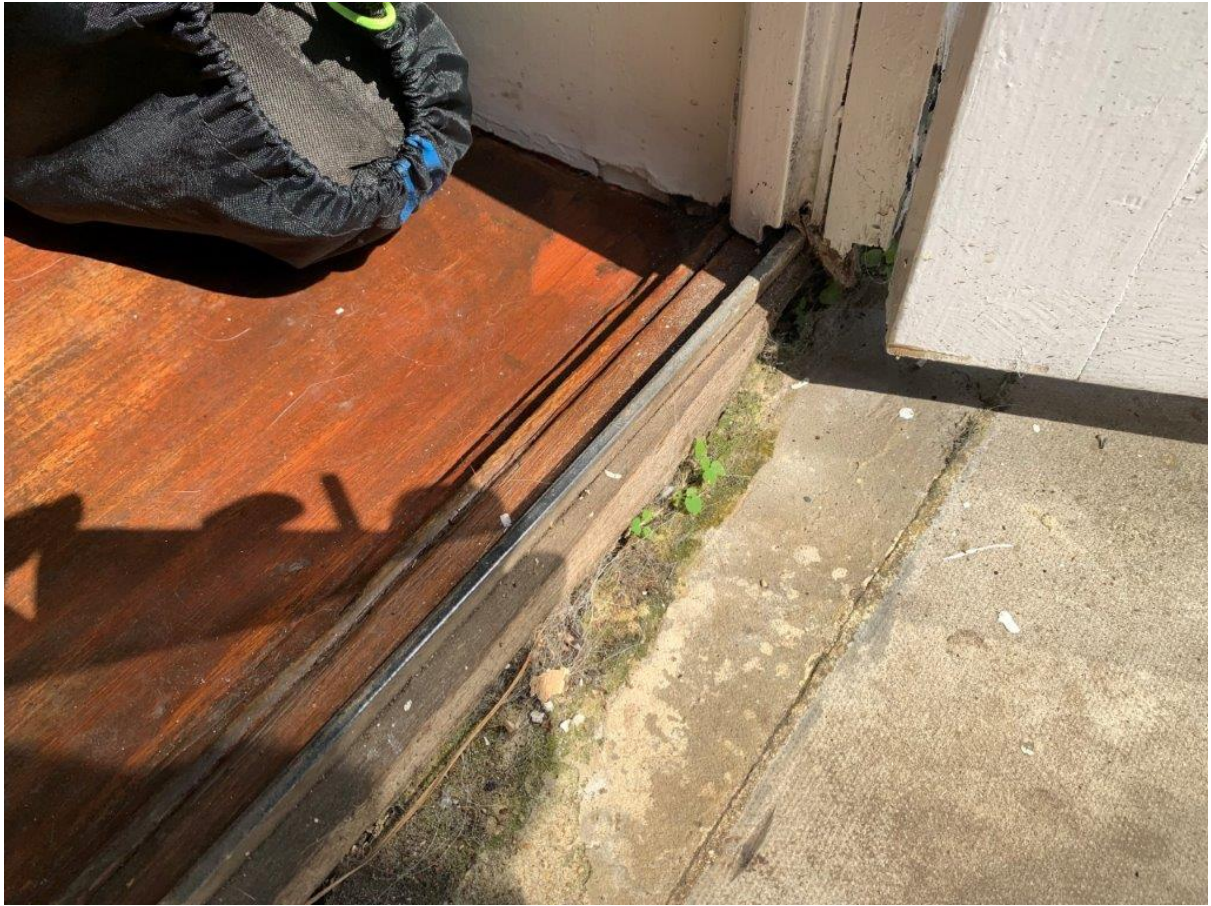
### REAR GROUND FLOOR FRENCH DOORS:

The front of the cill has completely rotted away and there is rot in the bottom of the frame. The L/H door has large gaps and the frame is badly out of level. This is causing draughts and a door that is difficult to lock.

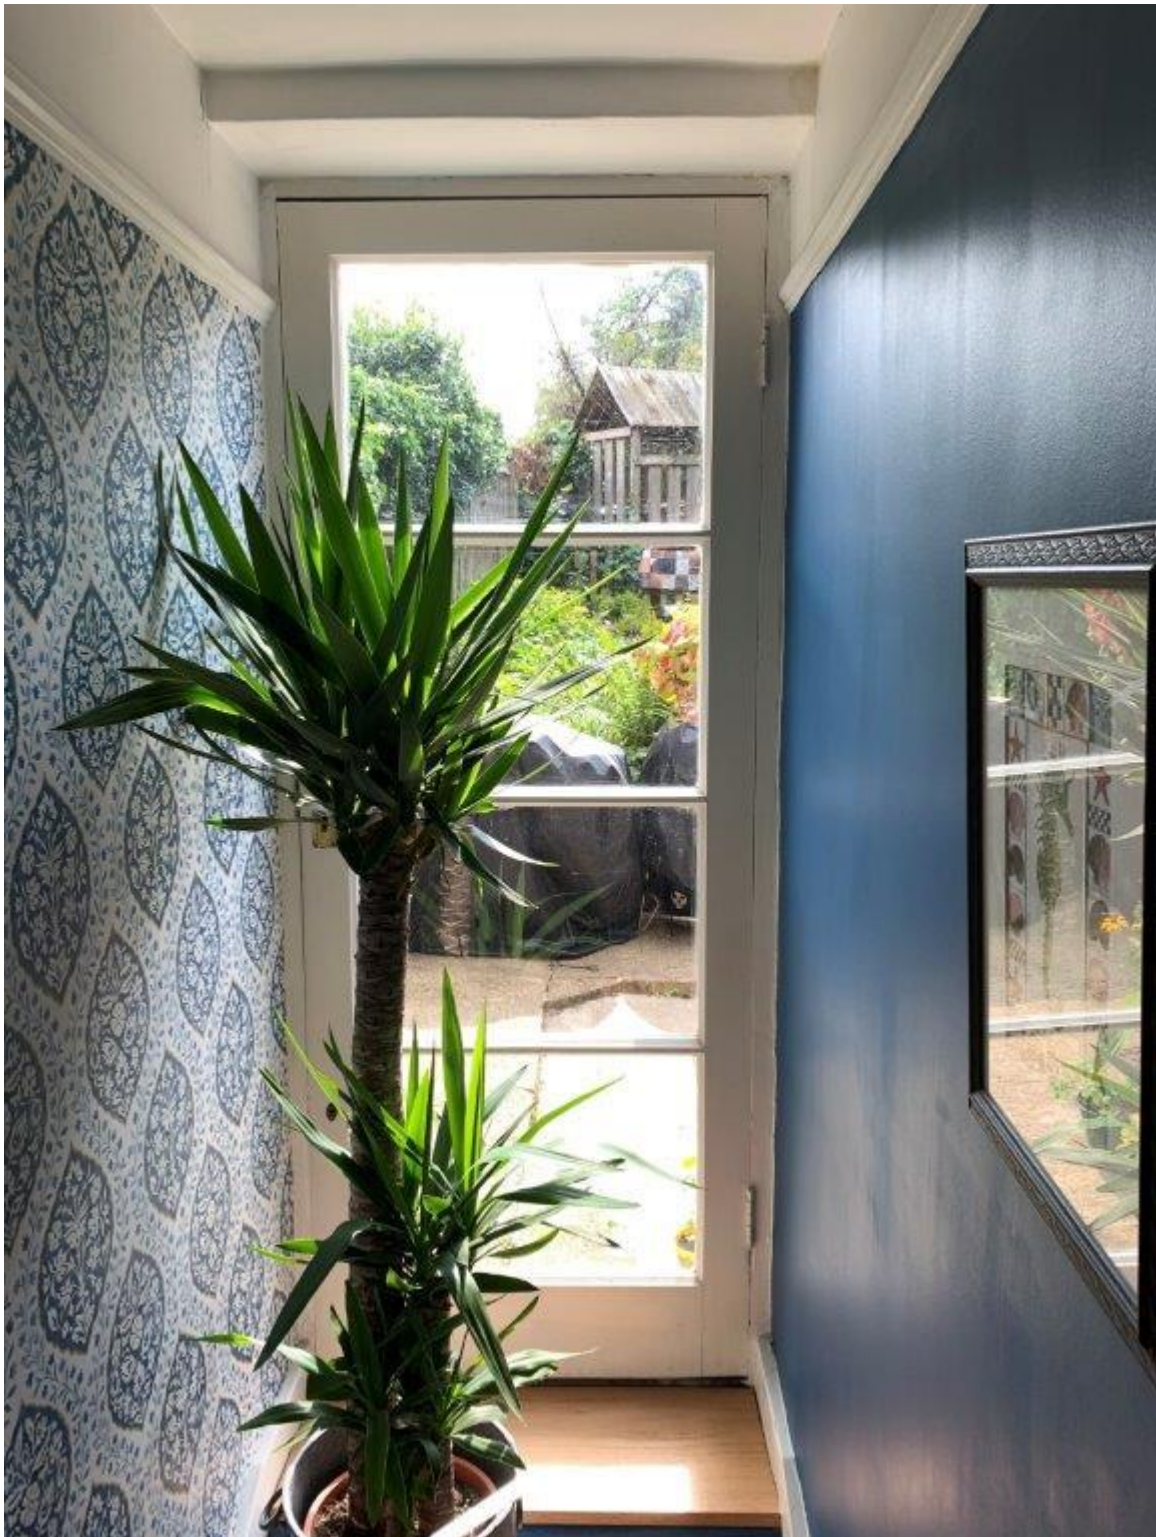
**REAR GROUND FLOOR SINGLE DOOR:**

Rot in the bottom of the frame and cill.
