Dean Cottage, Crondall

Conservation guidance Note

Dean Cottage
Dippenhall Street
Crondall
Farnham
Surrey GU10 5NY

15.04.2024

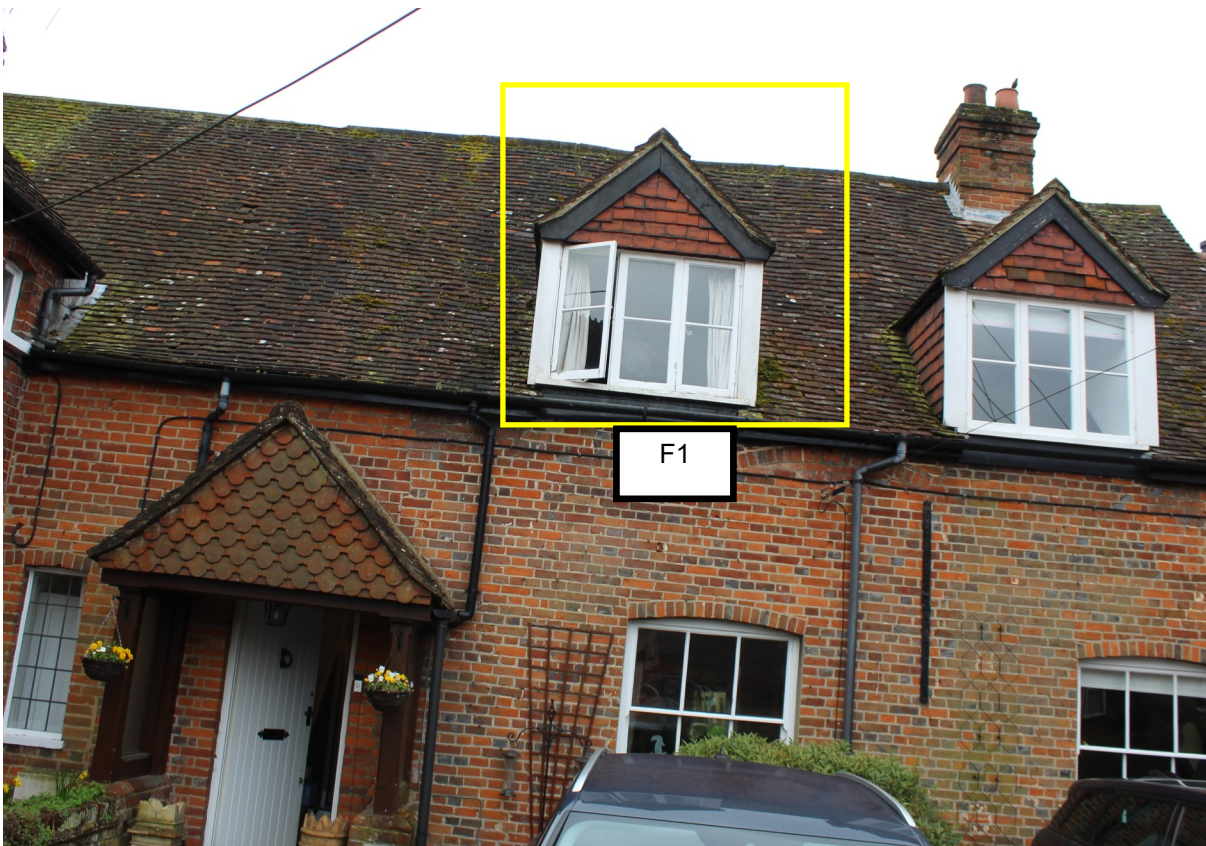
3.1 Item F1

Item F1 is a window - a triple casement window, with two openers and fixed central. The casements are subdivided into two large panes, and the window which is proposed for replacement is of a type with the corresponding one next door.

The window style does not match the more formal sash windows of the Ground Floor, and it is not clear when the dormers may date from. The style of the window in question is not sufficiently distinct to be able to confidently give it an age. There were no mouldings or other distinguishing features, and the joinery furniture was nondescript.

The gable style matches those on the rear elevation - but the window style does not. It is likely that these are the earliest of any of the windows included in the proposal. The significance of this window might be considered “moderate”.

The condition overall was found to be poor.

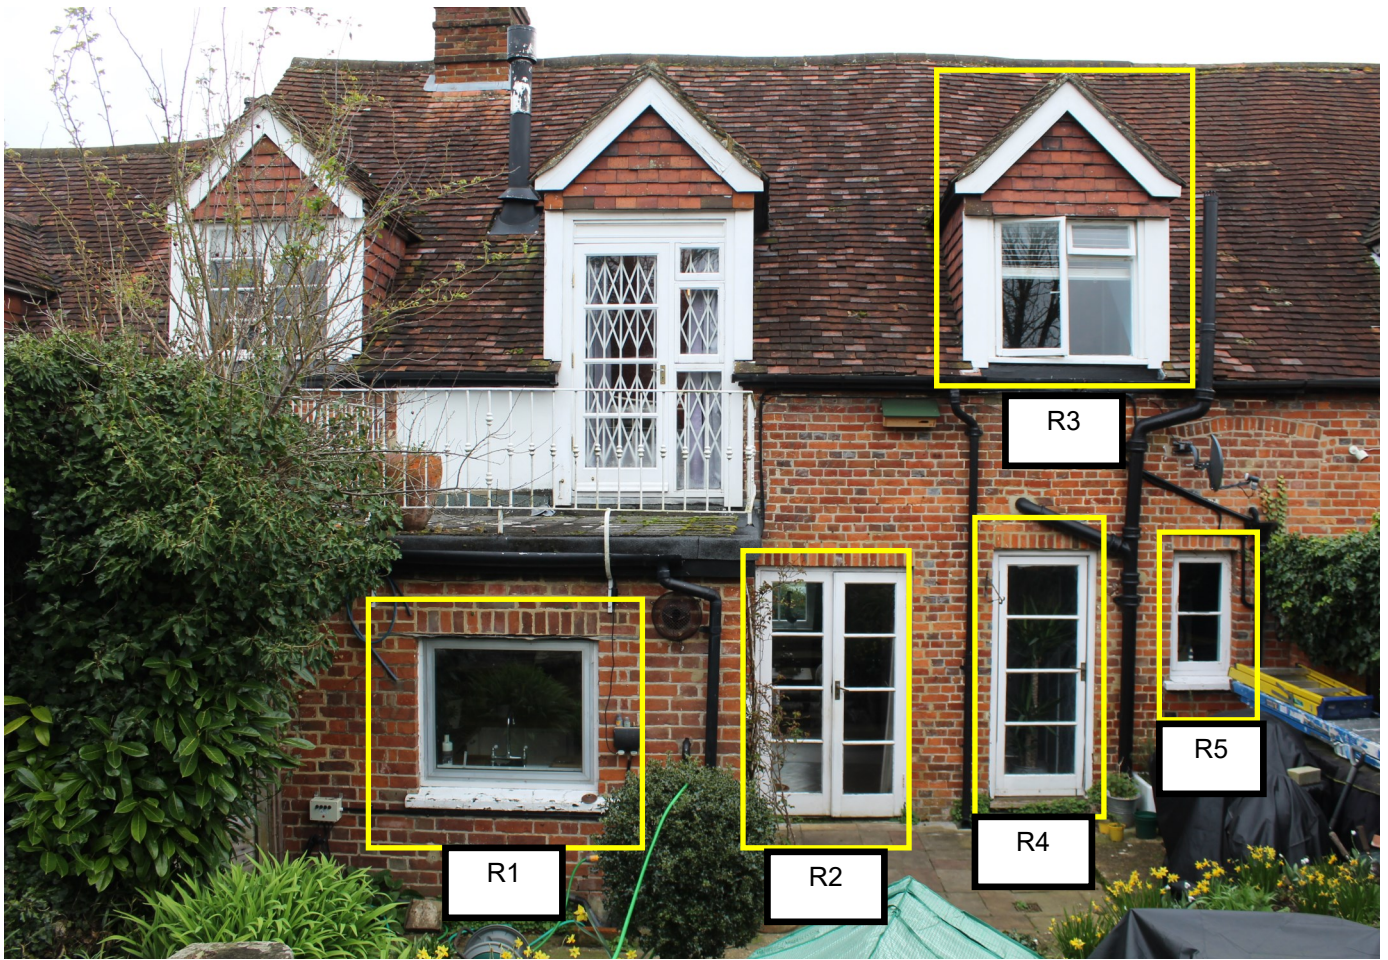
3.2 ***Items R1- R5***

This window is a fixed pane, aluminium window. It sits on a concrete sill, and may well date from the 1960s when this type of aluminium glazing was popular.

The window is of no significance and it is actually harmful to the building as a whole. Replacement would benefit the building.

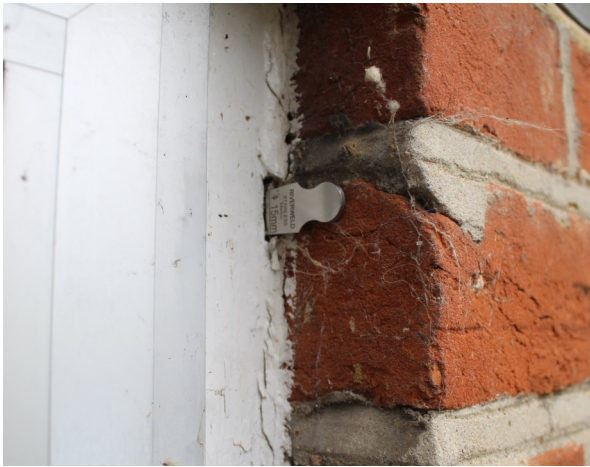
Silicone mastic, smeared over the frame and the masonry - with nothing behind. The taper gauge makes it clear there was a void of at least 150 mm behind the silicone - this shows the poor installation.

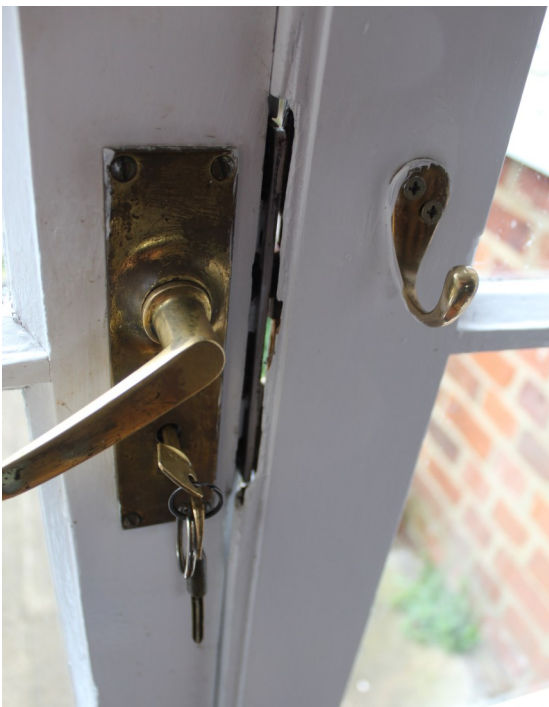
These French Doors were found to be non-closing owing to their poor condition. Significant issues with the installation also noted, as well as cracked glazing. These sit in a much-altered opening and are a modern insertion, which is now in poor condition.

Even closed, there was such warping of these doors that they could not be closed. When timber has warped like this it is not only a sign of a poorly made item, but also it is extremely difficult to rectify.

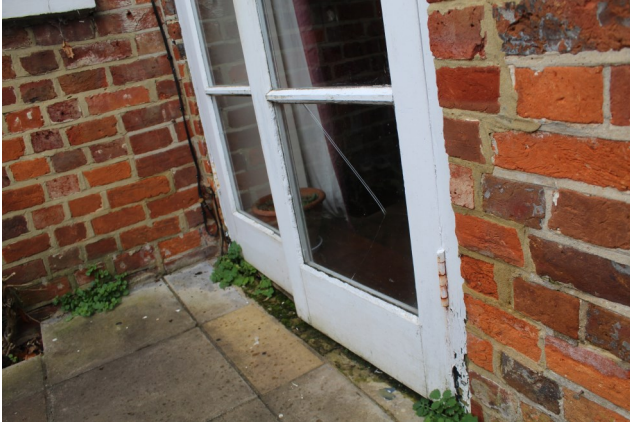
Item R2

Left - cracked glass, lack of weather bar or any projecting cill. Rusting hinges.

This window is within a later opening and is a relatively modern design. It is of Little significance and its condition may be viewed as harmful to the Listed Building.

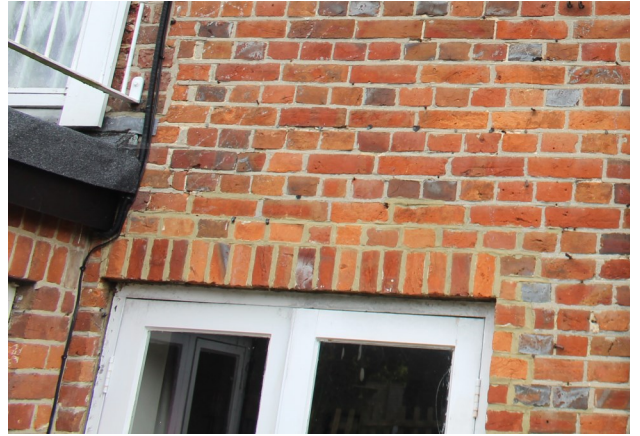
Right - showing the difference in the brickwork and the pointing which identifies this as a later insertion. Additionally, the lead drip above helps record the modification.

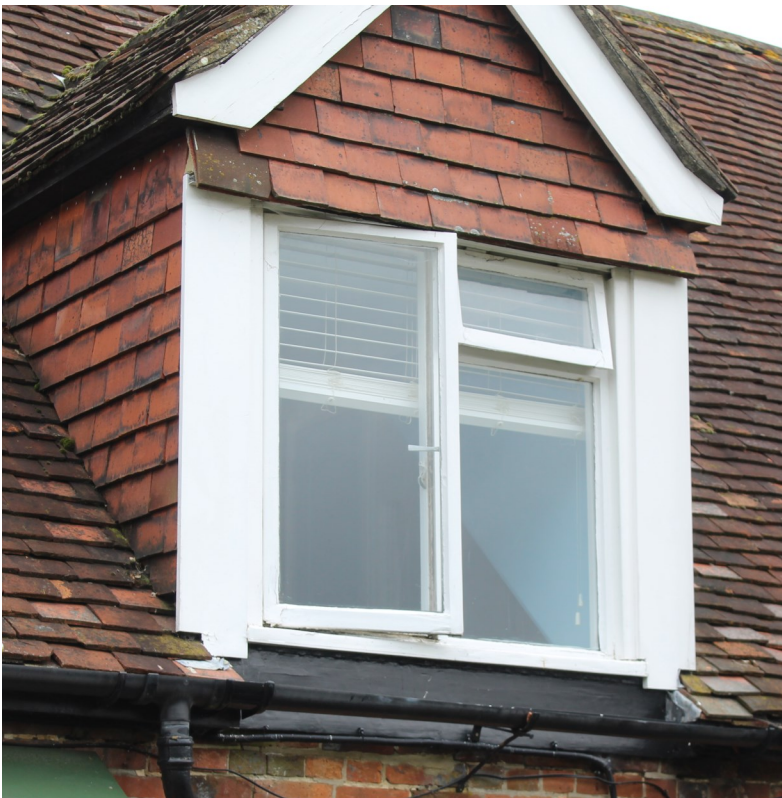
During the survey the window was found to only partially operational owing to swelling of the timber. Whilst it is possible that this could be repaired, there is no reasoning to do so from a conservation point of view. The window itself is not important - and the benefit to the building to having a high quality casement put in far outweighs any potential or inferred harm created through its replacement.

Item R3 is a poor-quality window and is of no real value.

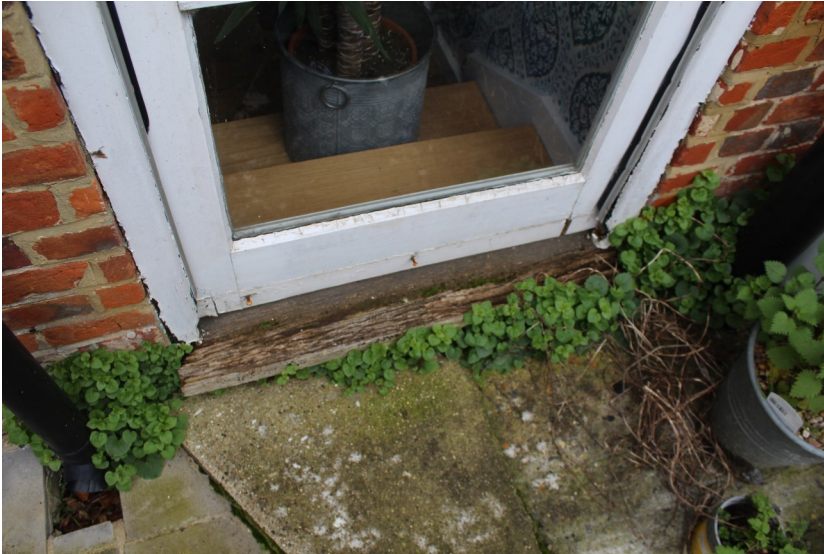
The cill is in poor condition and would require wholesale replacement.
Cutting out and jointing the cill would require a specialist joiner repair (i.e. the SPAB style joinery repair) which is not appropriate for a modest door of little significance which is in poor condition.

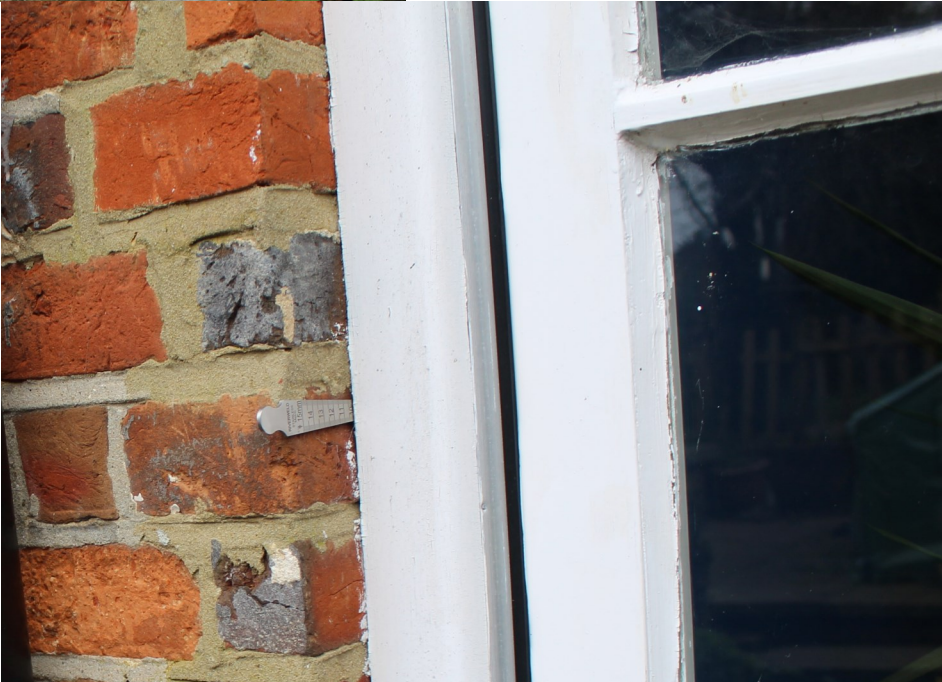
The taper gauge showing the lack of any appropriate jointing material between frame and masonry.

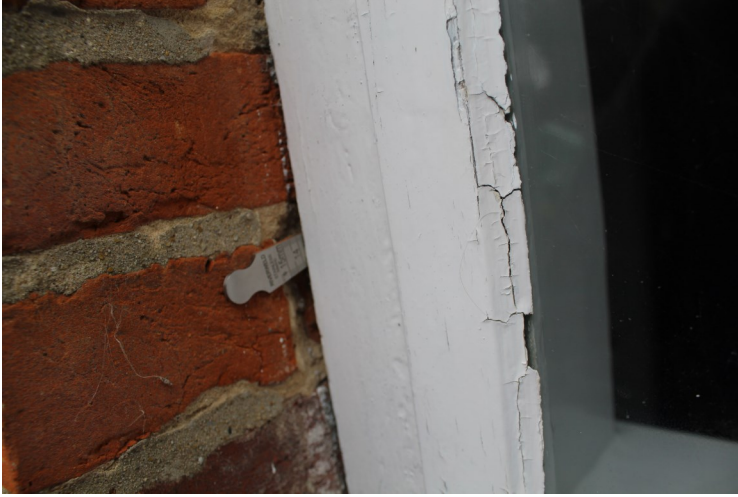
Significant voids between the frame and the masonry. Also, poor condition of the putty

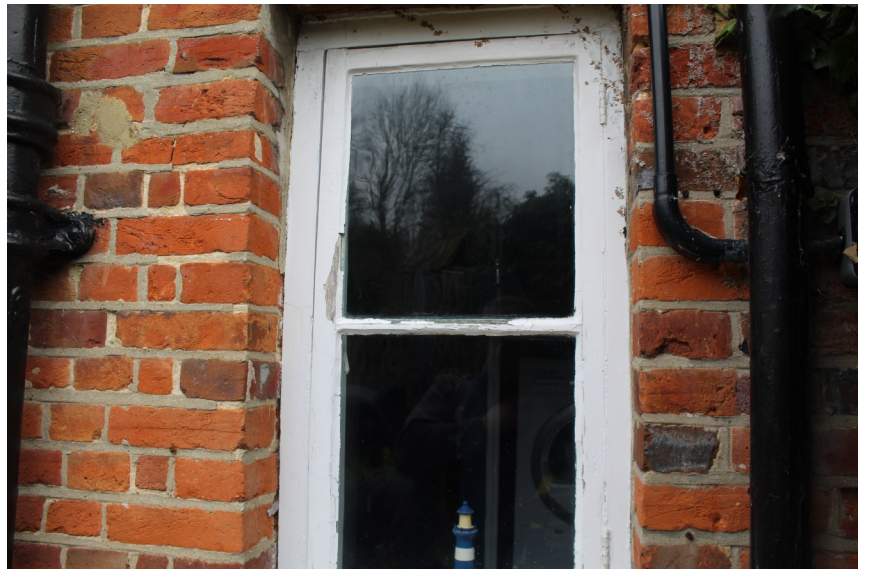
General view of the poor condition.

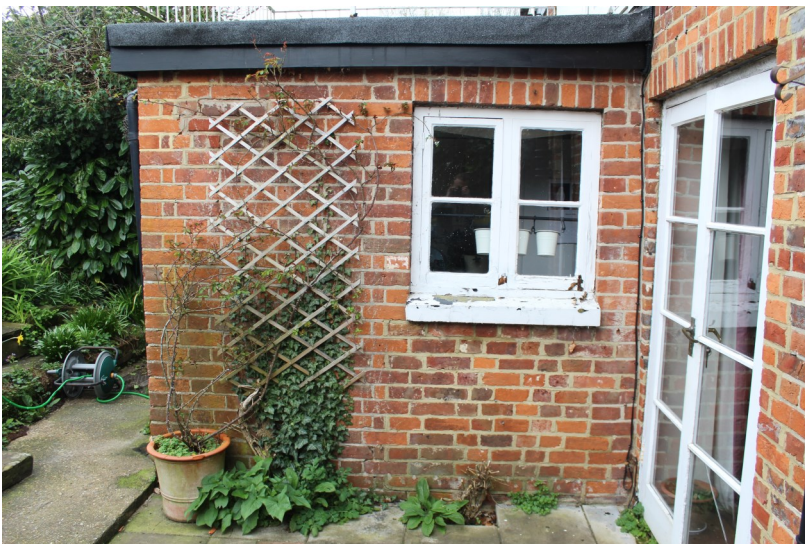
2.4 **Item S1**

General view of the poor condition. The window is within what was once a doorway.

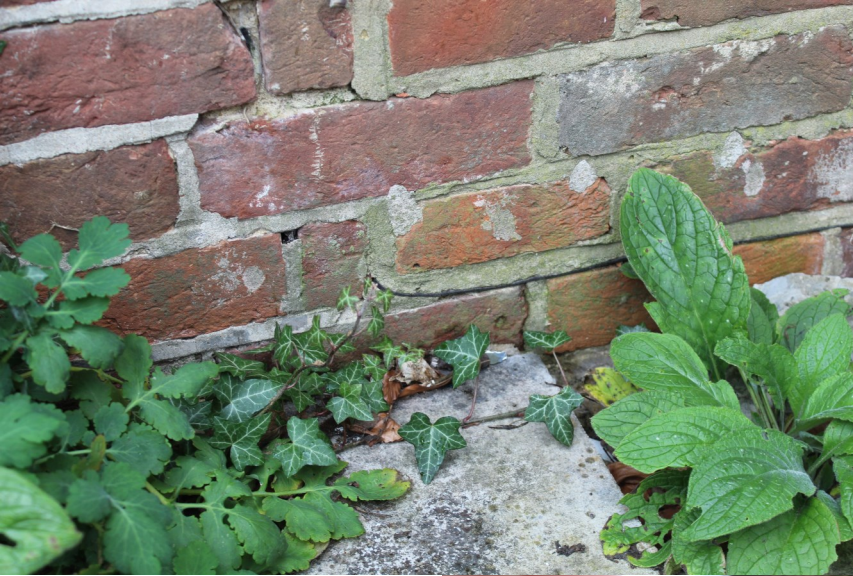
2.4 ***Item S1***

The presence of the plastic “DPC” helps date when this doorway was infilled - likely post 1960. The reasoning for this being that the plastic DPC was uncommon prior to this, and the aluminium window (R1) is thought probably circa 1960.

This doorway is probably the entrance into the outhouse.

Concrete cill with poorly-formed (but correctly positioned) drip detail

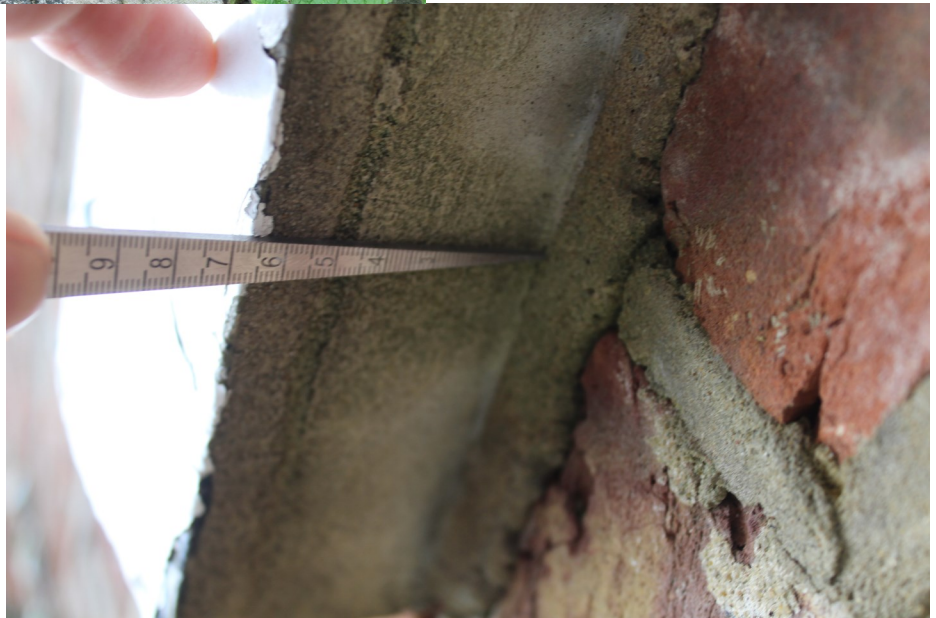
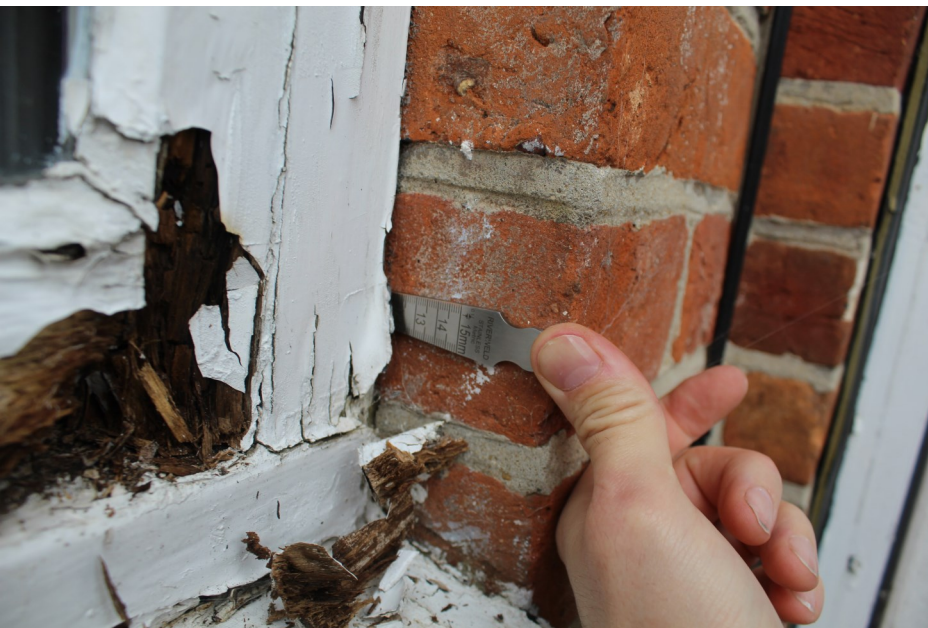
Item S1

As elsewhere, significant voids between the masonry and the timber frame. This is a major contributor to the poor condition.

The wet rot has compromised the opening casements at the junction - while it may be physically possible to repair, the time and cost would not justify it for a window of little - to no - significance.

Our assessment of the window is that it may date from after 1960, given the patterns viewable at the property. It is a modern and commonplace design, and we find it hard to attribute any particular significance to it. It is poorly fitted, and would require wholesale removal, modification and a full SPAB repair. This sort of treatment is usually reserved for items of joinery of High significance - and we cannot reasonably attribute that level of importance to this window.

Its replacement would benefit the building's significance overall.
