Title:
Picus® Sonic Tomograph
Tree Investigation

Date:
24 August 2023

Site Address:
9 Mountbatten Road
Poole
BH13 6JE

Ref:
PI/78123/AC

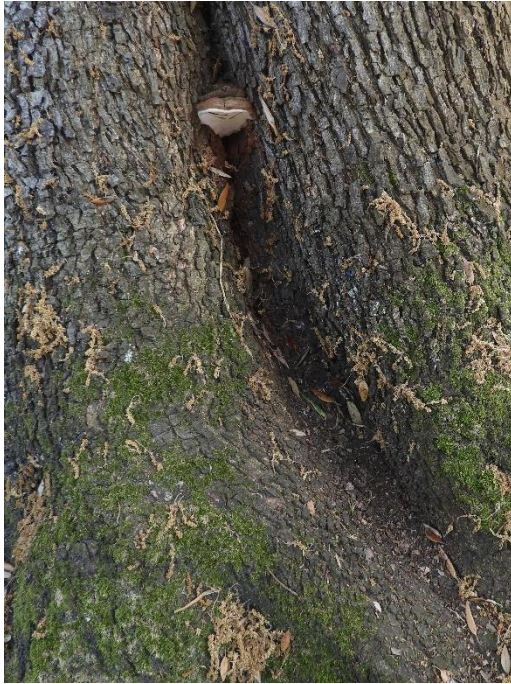
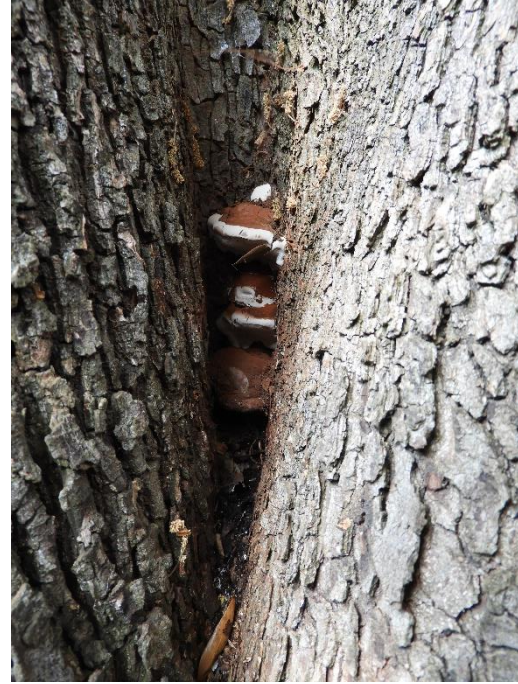
- 5.1.1 The tree is twin stemmed from ground level with the two stems touching up to 2m. The west stem divides again at 2.5m. The combined stem diameter at 1.5m above ground level is 115cm, with the west stem measuring around 70cm and the east around 50cm. The tree is 15m tall with a radial crown spread of 8m. There is an old stub left from the removal of a low branch above the root flare on the west side and large exposed roots spiralling anticlockwise. There is a single fungal fruit body in the fissure between the two stems on the north side and a column of five fruit bodies in the fissure on the south side. Crown vitality appears to be normal.

Fungal fruit bodies on north (left) and south (right)

- 6.3 Although *Ganoderma* are a group of fungi that can cause extensive decay in trees, often leading to stem failure, this tree does not appear to be significantly affected at present. Holm oak has a high resistance to decay and where fungi do colonise their progress through the wood is generally slow. It is therefore unlikely that the situation will quickly develop into one where it is necessary to prune or fell the tree for safety reasons.

- 7.1.1 No tree work is recommended at present.

- 7.2.1 Tree health and condition can change over time and be affected by the environment; therefore, regular periodic inspections are needed to ensure any changes are identified and appropriate, timely action taken.
- 7.2.2 The tree subject of this report is recommended to be re-inspected in autumn 2025. This can be a visual inspection initially and this may prompt further internal testing, but it may not be considered necessary.

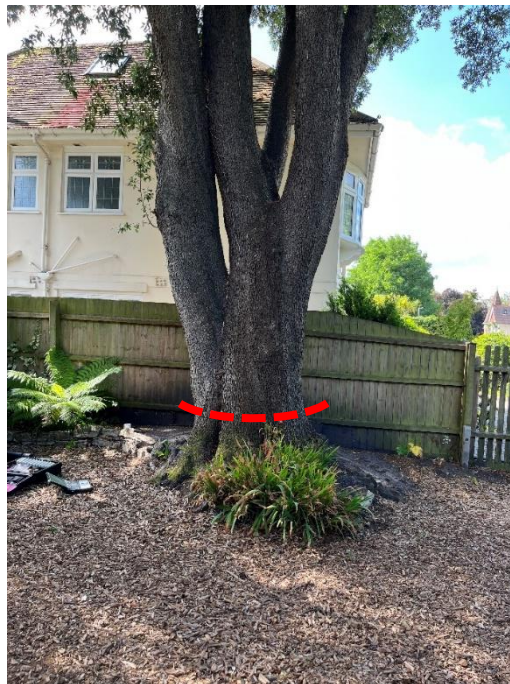
5.2.1 One reading was taken at 75cm above ground level. A total of twelve sensors were used with sensors 1-7 placed on the west stem and 8-12 on the east stem. The sensors were arranged in such a way that the individual stems could be analysed in isolation as well as viewing the combined cross-section.

Height of tomograph reading on stem

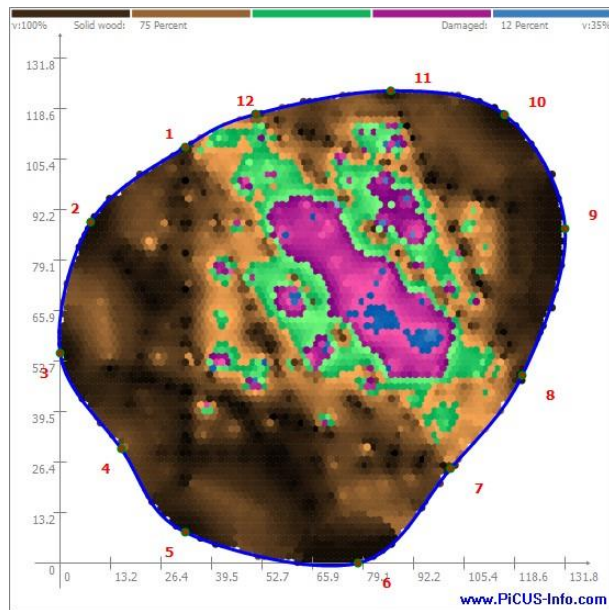
5.2.2 The combined tomogram shows a main area of decay in the centre of the tree – where the two stems meet – with smaller areas of decay in both stems to the east and west. The decay shown amounts to approximately 12% of the total cross-sectional area of the stems.

- 6.1 There is clearly some discrepancy between the extent of decay shown in the combined tomogram and in the tomograms for the two individual stems. As it was not possible to place any sensors between the stems the individual tomograms do not have any data for the central region, so this area is effectively absent from the individual images. However, they also do not show the same decay further into the stems where data was available. This is likely to be because in the combined tomogram the sound waves crossing from one stem to another were impeded by the stem union and this slower transit time erroneously shows up as decay when the wood is actually sound. As the individual tomograms are generated using only the sound waves passing between the sensors on the same stem, this issue does not arise.

- 6.2 Whilst there are deficiencies in both the combined and individual tomograms described above, it is still possible to infer a reasonable picture of the situation within the tree. It seems likely that there is a central area of decay at the stem union, as shown in the combined tomogram between sensor points 1, 6, 7, & 12 – which is what one would expect given the presence of the fungal fruit bodies in this area – but it is probably less extensive. The individual tomograms will be a more accurate representation of the interior of the stems in showing no significant decay so the areas shown either side of the central region shown in the combined tomogram can safely be discounted. Overall the amount of decay is probably no more than 10% of the cross-section of the tree stems.

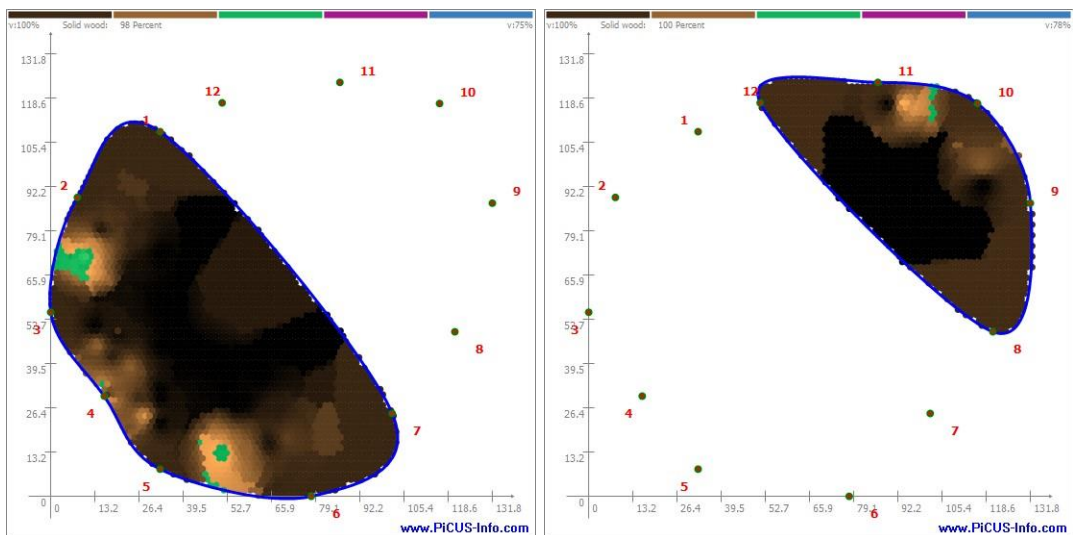
5.2.3 However, when the data from the two stems is separated out by only including the measuring points on each stem individually, almost no decay is shown within the majority of each stem cross-section.
