Our ref: SMS/24022

RE: CONVERSION OF PIG BARN AT BOWERS FARM, SO51 6EH

Further to your request to carry out an inspection of the pig barn, I report as follows.

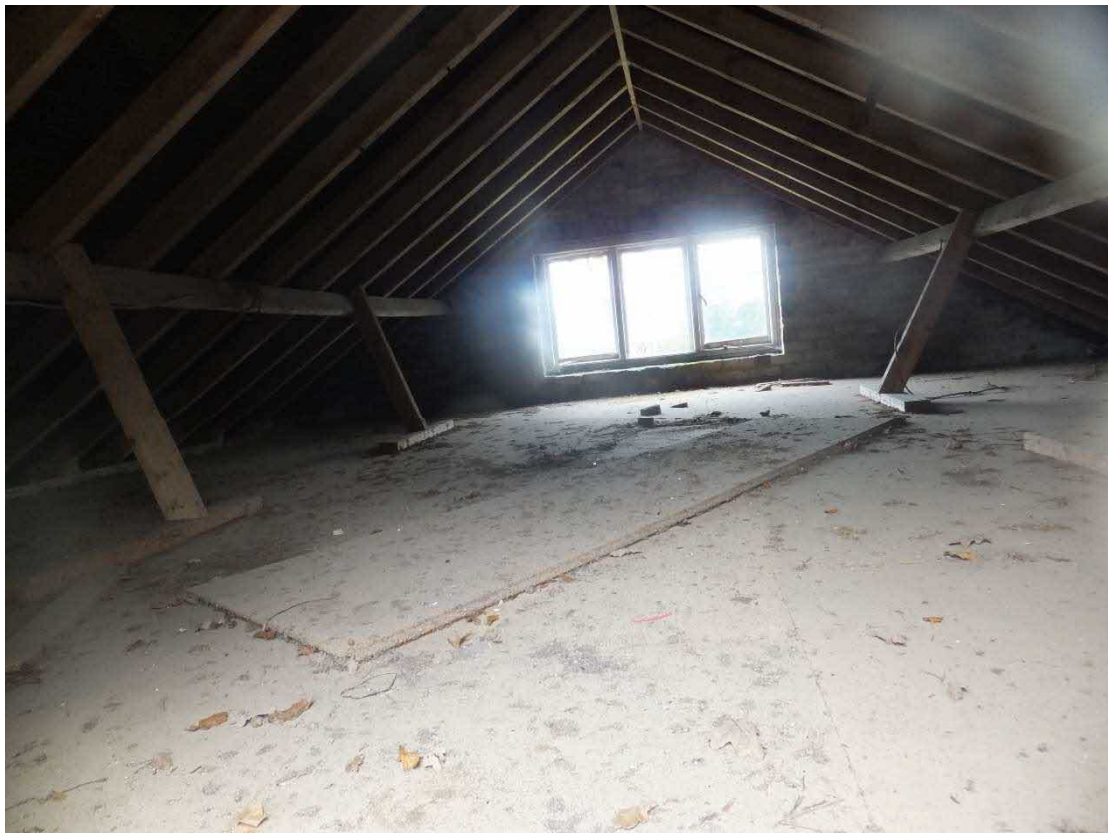
- 3.1 CENTRAL SECTION: The structure of the central section appears to be in good condition. The rafters and joists appear to be in very good condition, and appear to be relatively modern. The purlins do appear to have deflected, likely due to the inadequate propping arrangements. The timber beam supporting the floor joists seems to be modern, as are the masonry piers which support it. It was difficult to fully inspect the condition of the walls internally due to the presence of logs being stored, but generally no concerns were noted.

Fig 6 Central Section –First floor and roof

- 4.1 Roof Structure: Calculations will have to be carried out on the existing timber rafters and purlins to ensure they can support the proposed roof build-up.

- 4.3 First floor: The first floor structure within the central section is in good condition. Calculations will have to be carried out to confirm that the timber joists and central support beam are able to support the proposed loading

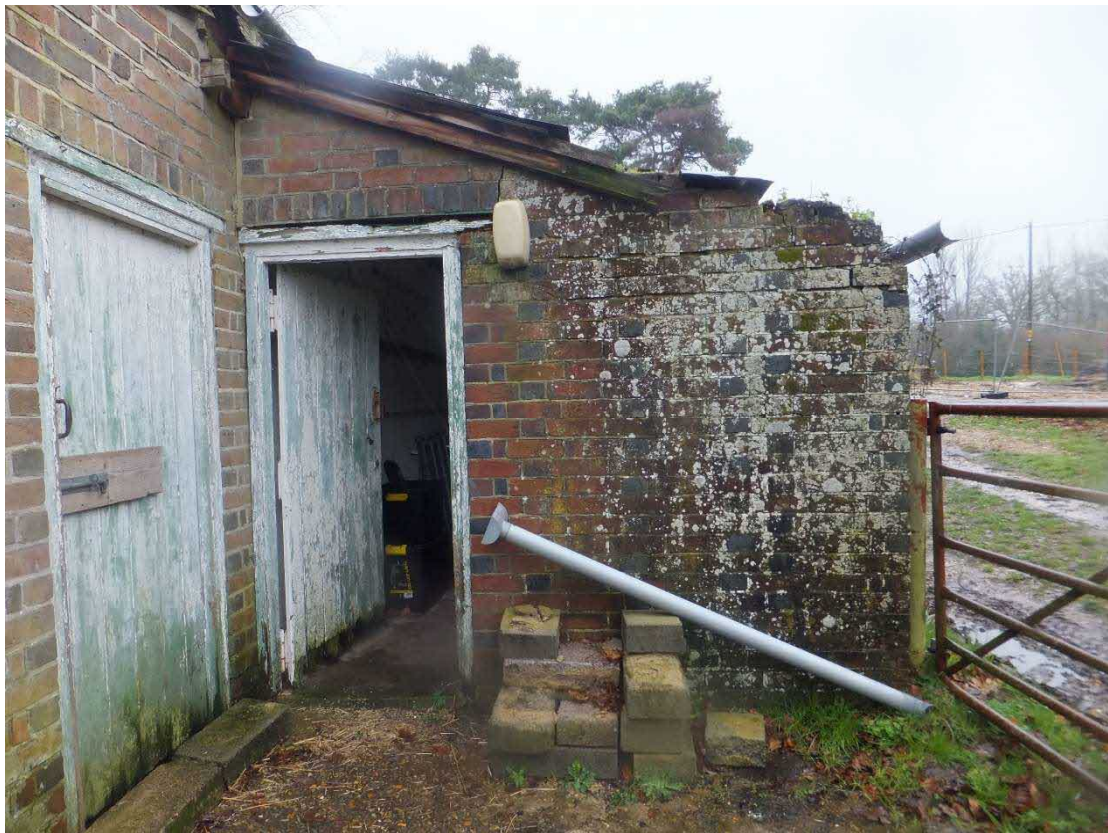
- 3.3 EAST LEAN-TO: The rafters and purlin are rotten at the south east corner of the roof due to water ingress (Figs 12 & 26). The timber lintel over the doorway into the lean-to is also rotten from the same water leak. This has led to cracking within the masonry above the lintel (Fig 27).

Fig 12 Rear elevation of East lean-to

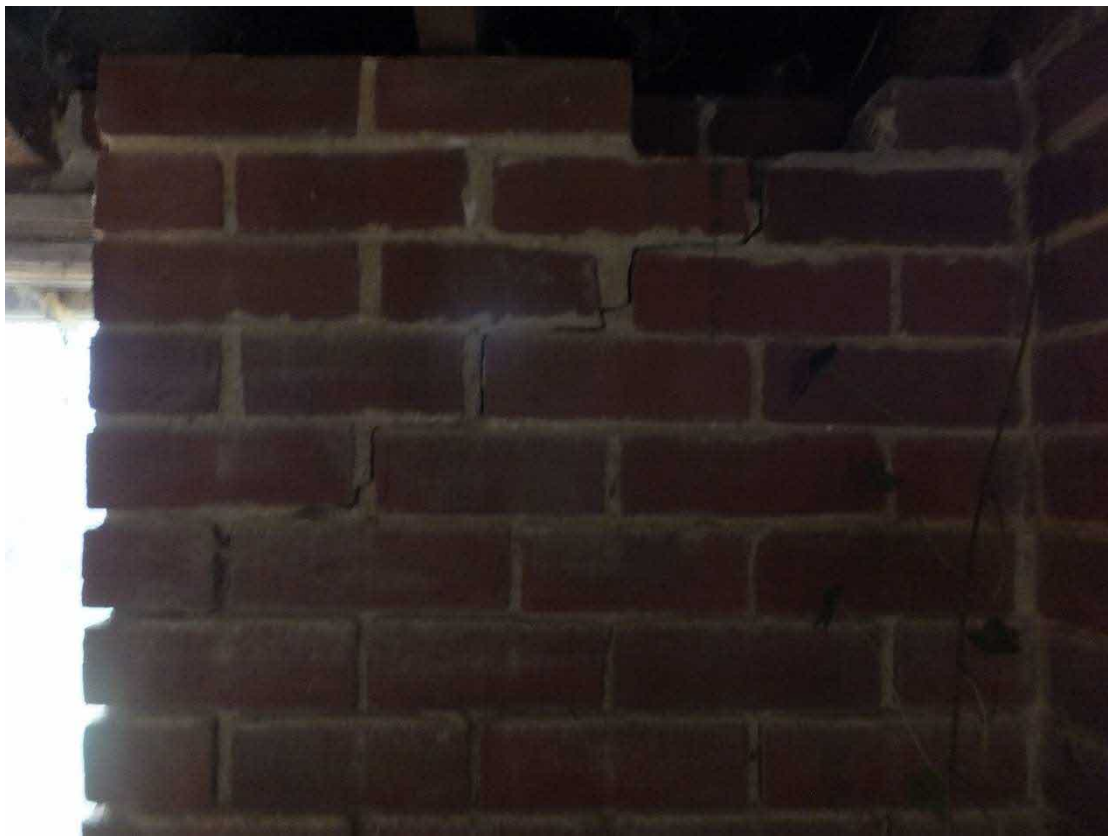
- 3.2 WEST LEAN-TO: The rafters and internal walls to this area appear to be quite modern, and are generally in good condition. It is possible that the inner leaf has been added to this area at a later date than the external leaf, therefore the presence of wall ties should be confirmed. A crack is present internally to the pier on the right hand side of the window (Fig 21). Externally the masonry is covered with ivy in this area (Fig 22). The external timber, including wall plates on the outer leaf, fascia boards and window frames, are all in poor condition due to exposure to the elements (Fig 21-23). The side wall to the South West lean-to was toothed in every 4th brick when it was added. A crack is present at the bottom of the wall at this joint (Fig 24) likely due to differential shrinkage between the newer and older masonry. A gap is present at the vertical joint between the rear wall of the west lean-to and the central section wall (Fig. 25) likely due to inadequate tying.

Fig 21 West lean-to –cracking to inner leaf

- 4.2 Walls: The walls are generally either 100 brick/100 brick cavity or 215 brick solid walls. They are generally sound and able to be retained. The rotten and failed lintels should be replaced and the associated cracking repaired. The vertical joints between perpendicular walls may require strengthening with remedial ties and a polysulphide mastic

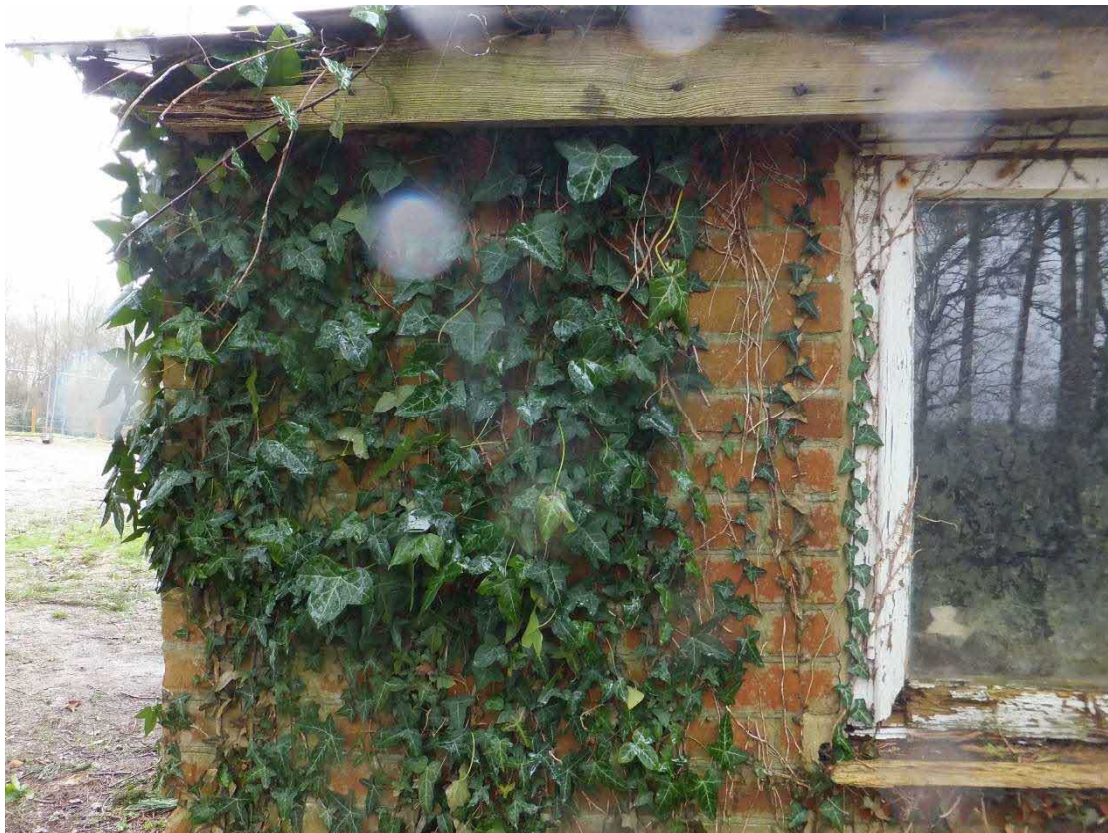
Fig 22 West lean-to –external view

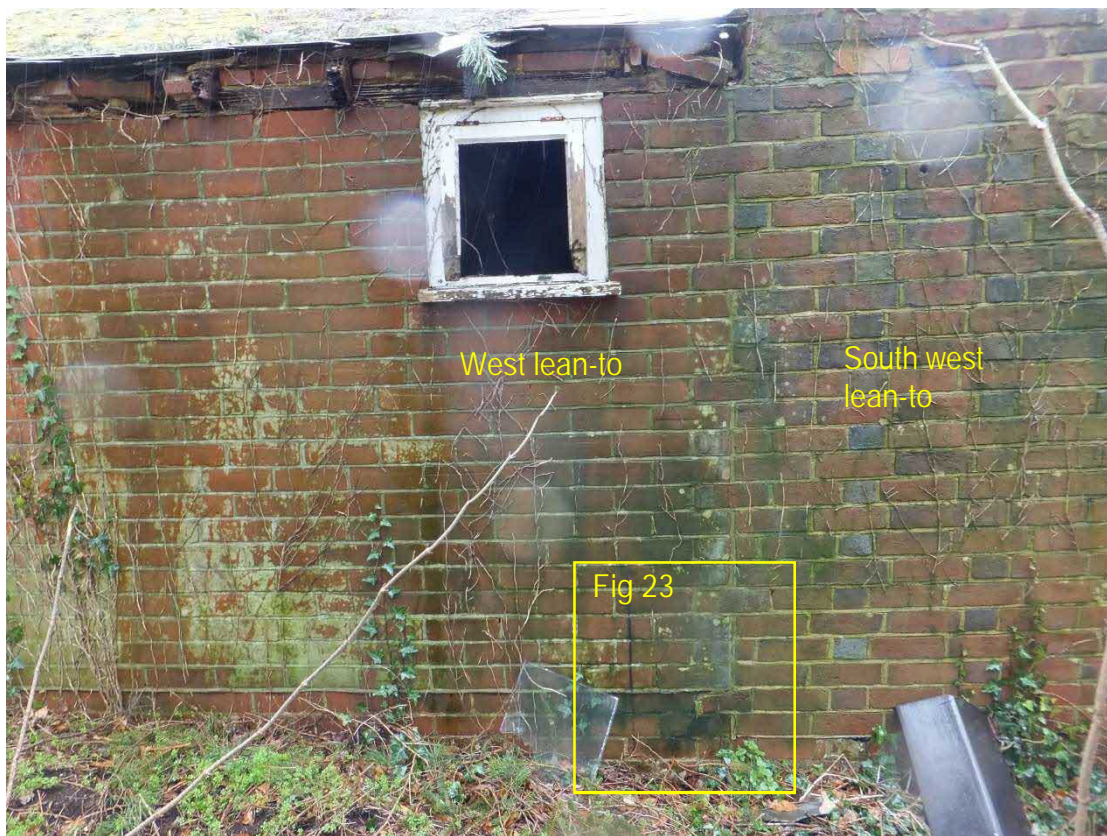
Fig 23 West lean-to –external view

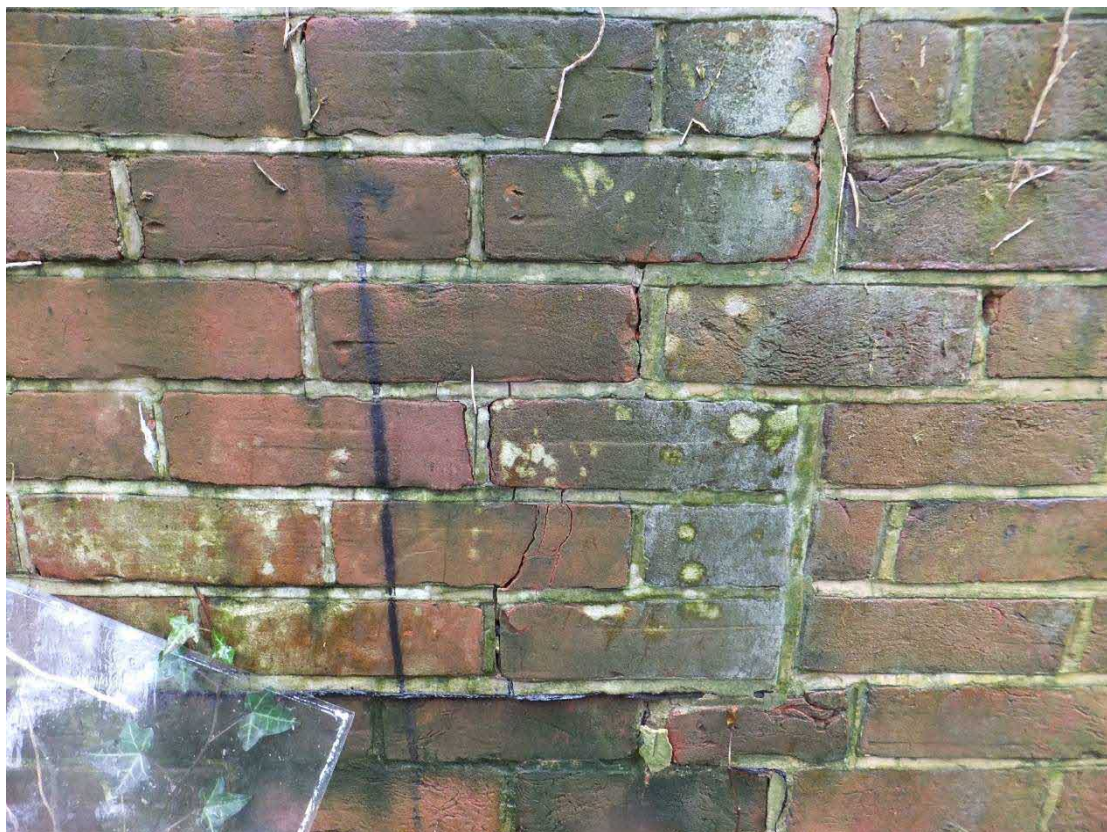
Fig 24 West lean-to –cracking to base of wall

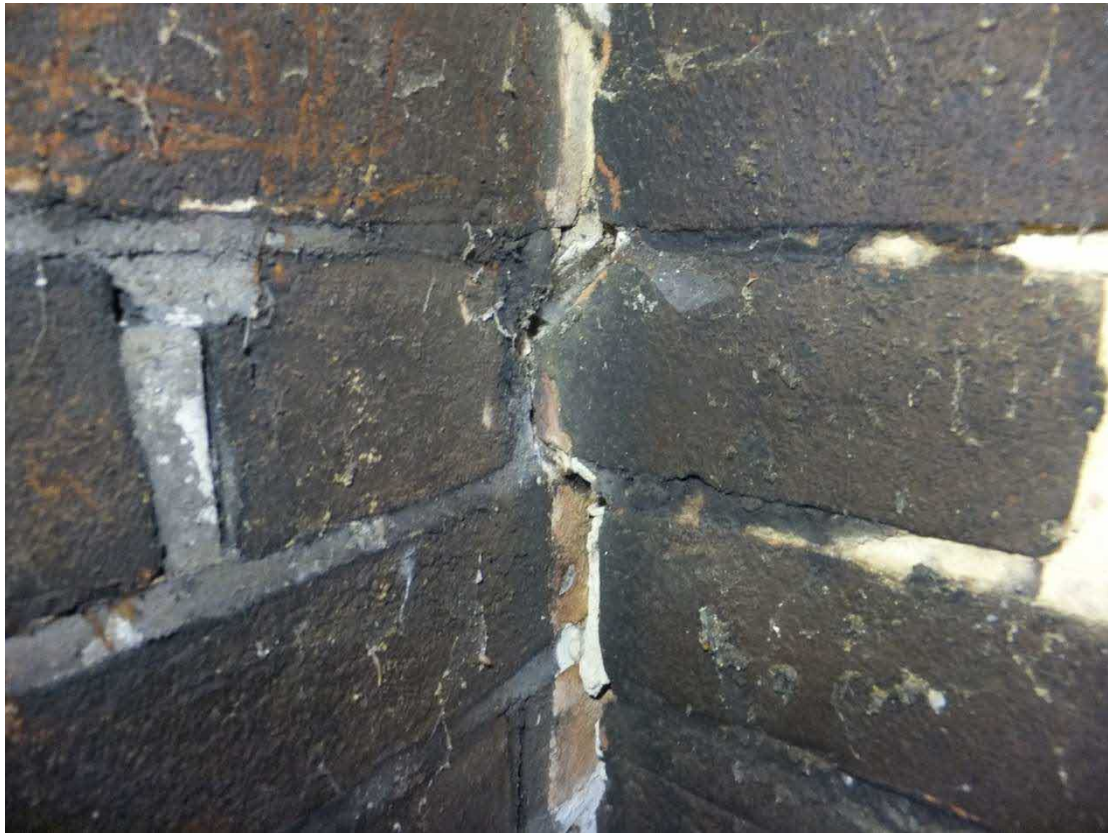
Fig 25 West lean-to –gapping to wall between west lean-to & central section

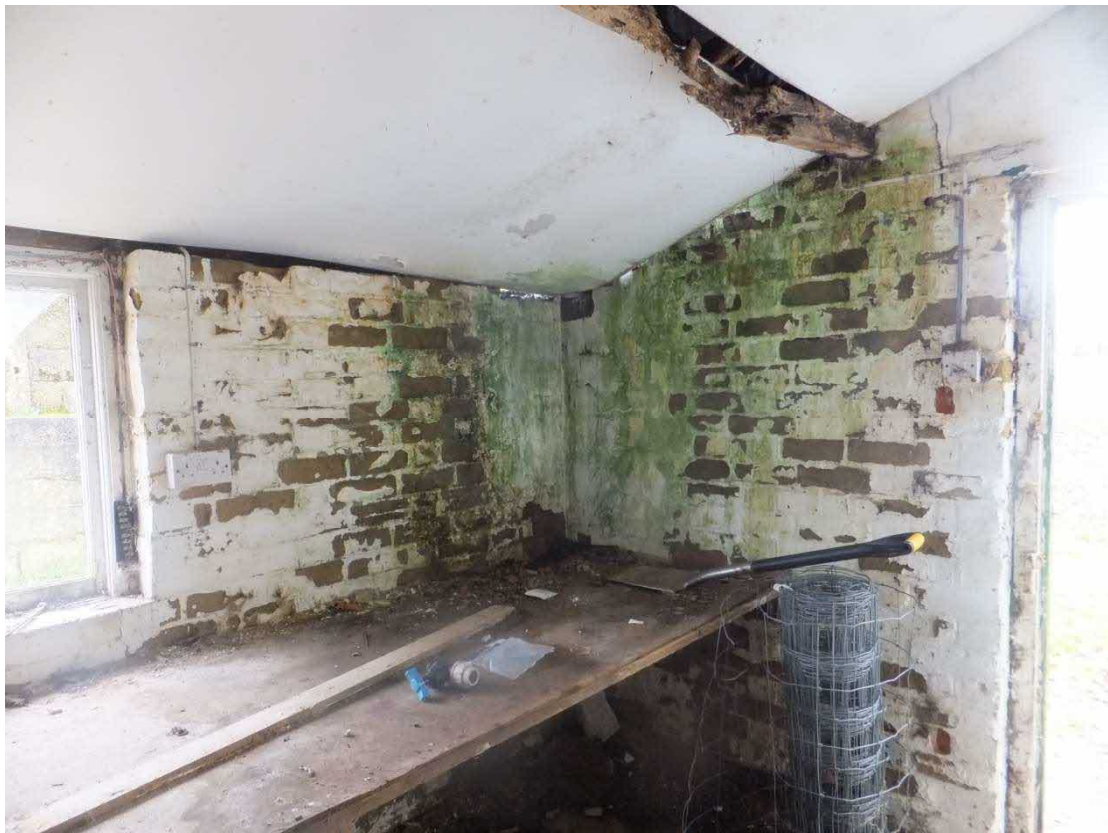
Fig 26 East lean-to –rotten purlin and corner of roof

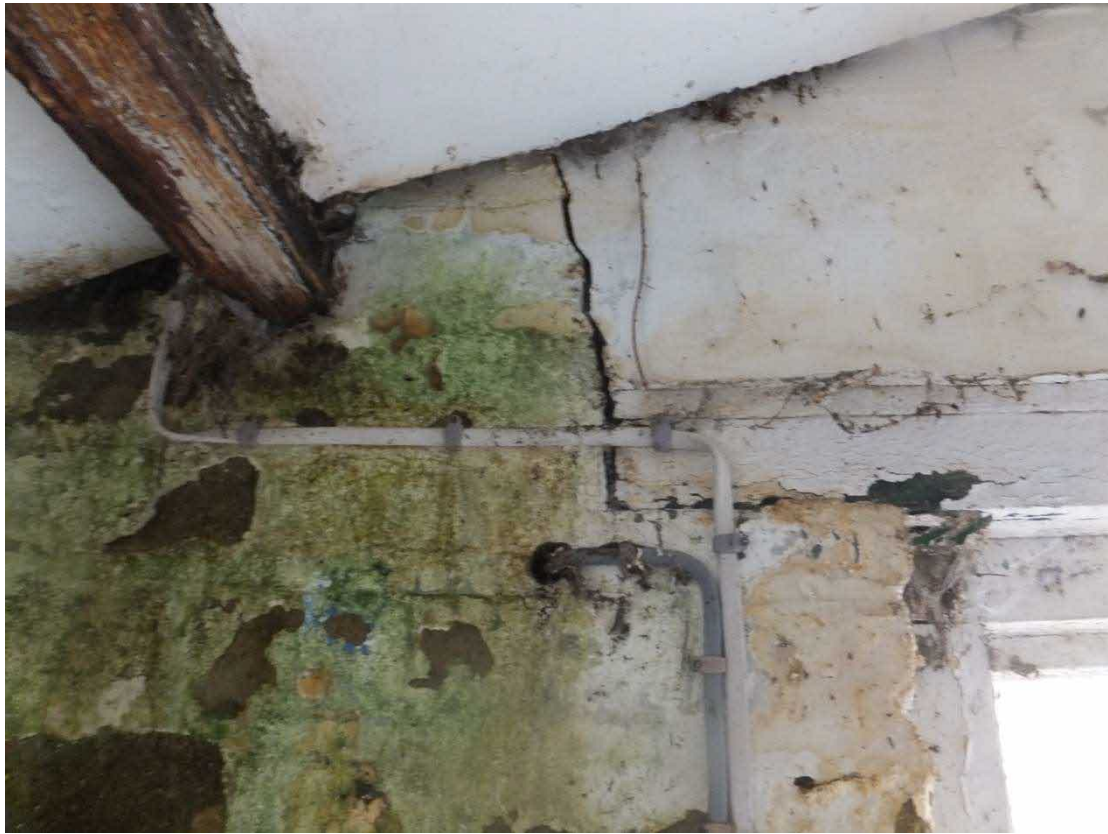
Fig 27 East lean-to –rotten purlin and crack to masonry over lintel

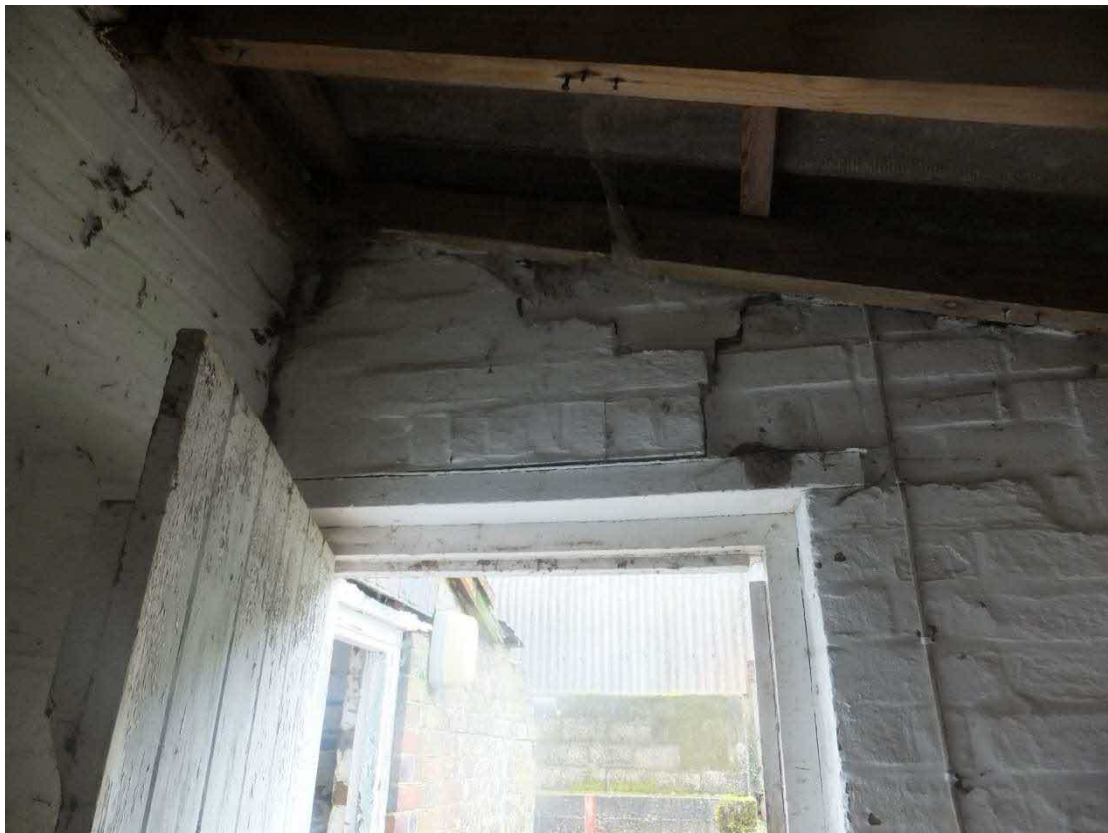
- 3.4 SOUTH/REAR LEAN-TO: The rafters and purlin appear to be in good condition. The roof sheeting is in good condition, however, it should be noted that this may contain asbestos which has implications for its removal. Cracking is present to the masonry over the main door entrance indicating that the timber lintel is inadequate.

Fig 28 South lean-to –crack to masonry over lintel
