Project Name: Manor Court Farm_ TN3 9TB

Project Description: Condition Check

Project Number: JSD6982

Section Inspection - 01/02/2024 - OutfallX

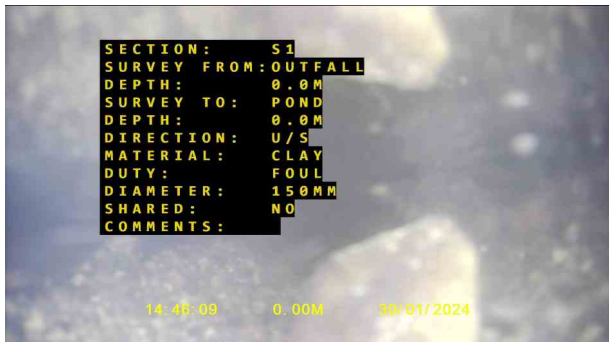
OutfallX_7bb3e1a5-d594-400f-be6f-e0dbcecb17b2_20240207_143910_338.jpg, 00:00:12, 0.00 m
Start node, major connection without manhole, reference:
Outfall

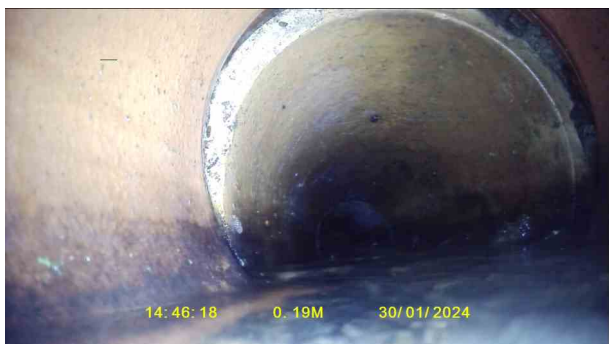
OutfallX_d92b1d45-cb27-433e-9e1c-a9e2ea572757_20240207_144003_208.jpg, 00:00:21, 0.19 m
Water level, 15% of the vertical dimension

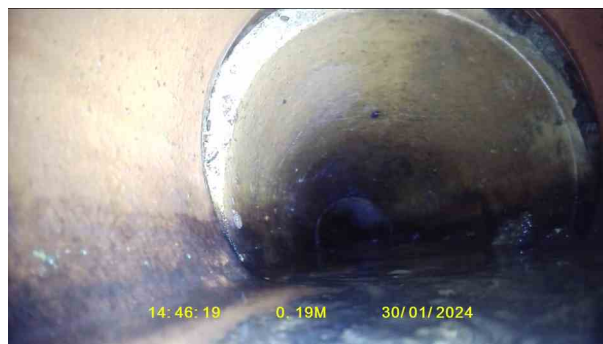
<table><tr> <td style="width: 10%; text-align: right;">0.00</td> <td style="width: 10%;">BR</td> <td style="width: 40%;">Start node, major connection without manhole, reference: Outfall</td> <td style="width: 10%;">00:00:12</td> <td style="width: 10%;">OutfallX_7 bb3e1a5-d 594-400f-b</td> <td></td> </tr><tr> <td style="text-align: right;">0.19</td> <td>OJM</td> <td>Open joint, medium</td> <td>00:00:22</td> <td>OutfallX_6 e46a544-d 1a2-496c-</td> <td style="text-align: center;">1</td> </tr></table>

OutfallX_6e46a544-d1a2-496c-aa92-881a1830dace_20240207_144035_842.jpg, 00:00:22, 0.19 m
Open joint, medium

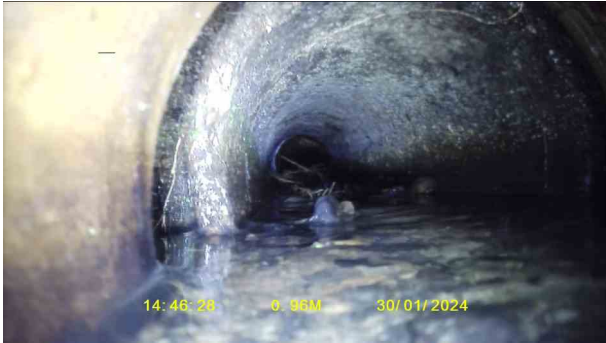
<table><tr> <td style="width: 10%; text-align: right;">0.00</td> <td style="width: 10%;">BR</td> <td style="width: 40%;">Start node, major connection without manhole, reference: Outfall</td> <td style="width: 10%;">00:00:12</td> <td style="width: 10%;">OutfallX_7 bb3e1a5-d 594-400f-b</td> <td></td> </tr><tr> <td style="text-align: right;">0.96</td> <td>OJL</td> <td>Open joint, large</td> <td>00:00:31</td> <td>OutfallX_5 3a77deb-2 f96-47fd-8</td> <td style="text-align: center;">1</td> </tr></table>

OutfallX_53a77deb-2f96-47fd-89da-481b2703d1a5_20240207_144107_204.jpg, 00:00:31, 0.96 m
Open joint, large

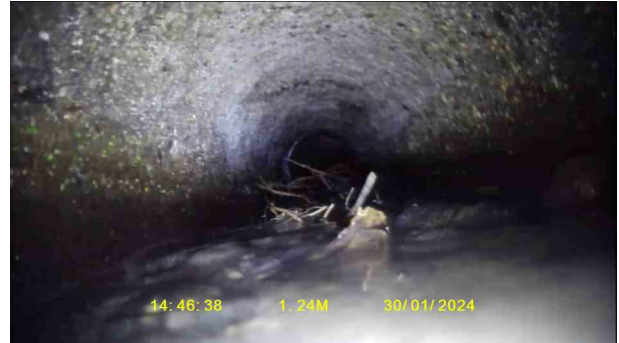
<table><tr> <td style="width: 10%; text-align: right;">0.00</td> <td style="width: 10%;">BR</td> <td style="width: 40%;">Start node, major connection without manhole, reference: Outfall</td> <td style="width: 10%;">00:00:12</td> <td style="width: 10%;">OutfallX_7 bb3e1a5-d 594-400f-b</td> <td></td> </tr><tr> <td style="text-align: right;">1.24</td> <td>DER</td> <td>Settled deposits, coarse, 15% cross-sectional area loss</td> <td>00:00:40</td> <td>OutfallX_3 0ab77ca-0 060-4b10-</td> <td style="text-align: center;">3</td> </tr></table>

OutfallX_30ab77ca-0060-4b10-8d18-56899995f9c8_20240207_144134_623.jpg, 00:00:40, 1.24 m
Settled deposits, coarse, 15% cross-sectional area loss

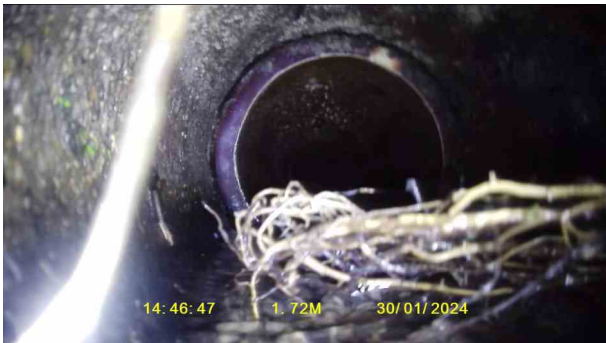
<table><tr> <td style="width: 10%; text-align: right;">0.00</td> <td style="width: 10%;">BR</td> <td style="width: 40%;">Start node, major connection without manhole, reference: Outfall</td> <td style="width: 10%;">00:00:12</td> <td style="width: 10%;">OutfallX_7 bb3e1a5-d 594-400f-b</td> <td></td> </tr><tr> <td style="text-align: right;">1.72</td> <td>RM</td> <td>Roots, mass, 15% cross-sectional area loss</td> <td>00:00:49</td> <td>OutfallX_1 bfe1504-e 6ec-4b6d-</td> <td style="text-align: center;">3</td> </tr></table>

OutfallX_1bfe1504-e6ec-4b6d-a041-c26e970ff7de_20240207_144209_986.jpg, 00:00:49, 1.72 m
Roots, mass, 15% cross-sectional area loss

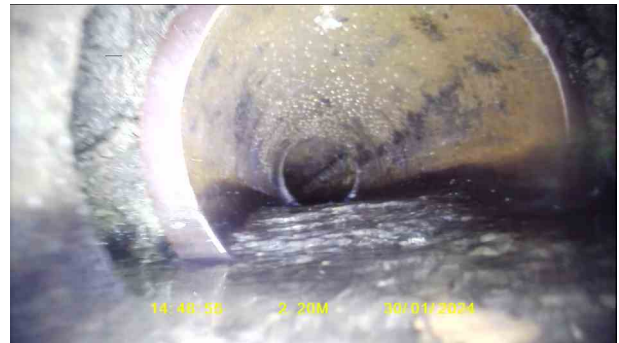
<table><tr> <td style="width: 10%; text-align: right;">0.00</td> <td style="width: 10%;">BR</td> <td style="width: 40%;">Start node, major connection without manhole, reference: Outfall</td> <td style="width: 10%;">00:00:12</td> <td style="width: 10%;">OutfallX_7 bb3e1a5-d 594-400f-b</td> <td></td> </tr><tr> <td style="text-align: right;">2.20</td> <td>OJL</td> <td>Open joint, large</td> <td>00:00:58</td> <td>OutfallX_1 9960c97-f 2a0-46d1-</td> <td style="text-align: center;">1</td> </tr></table>

OutfallX_19960c97-f2a0-46d1-bf83-6b4e618f12e7_20240207_144247_636.jpg, 00:00:58, 2.20 m
Open joint, large

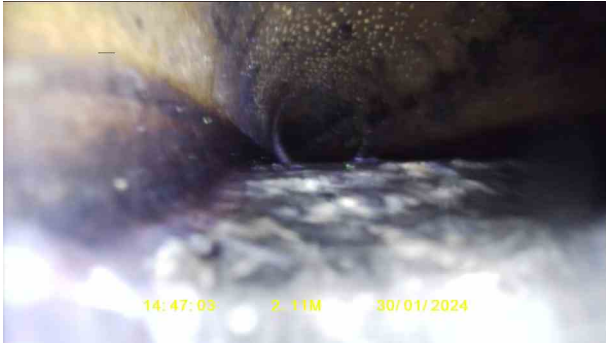
<table><tr> <td style="width: 10%; text-align: right;">0.00</td> <td style="width: 10%;">BR</td> <td style="width: 40%;">Start node, major connection without manhole, reference: Outfall</td> <td style="width: 10%;">00:00:12</td> <td style="width: 10%;">OutfallX_7 bb3e1a5-d 594-400f-b</td> <td></td> </tr><tr> <td style="text-align: right;">2.21</td> <td>DER</td> <td>Settled deposits, coarse, 15% cross-sectional area loss</td> <td>00:01:06</td> <td>OutfallX_b 7b1b047-8 d08-4d7e-</td> <td style="text-align: center;">3</td> </tr></table>

OutfallX_b7b1b047-8d08-4d7e-bbb0-a86f977c5ef5_20240207_144325_629.jpg, 00:01:06, 2.21 m
Settled deposits, coarse, 15% cross-sectional area loss

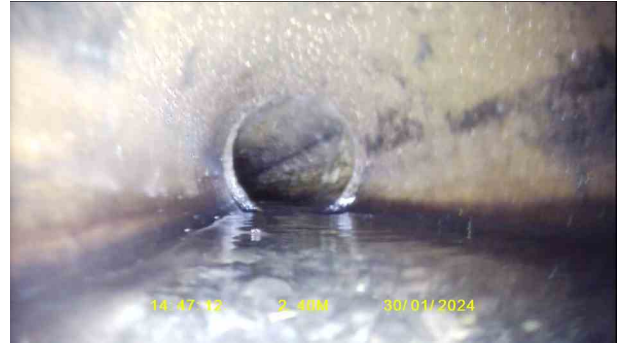
OutfallX_dde5996b-ca2e-464c-99b4-c6b34a127b1e_20240207_144404_242.jpg, 00:01:15, 2.40 m
Water level, 10% of the vertical dimension

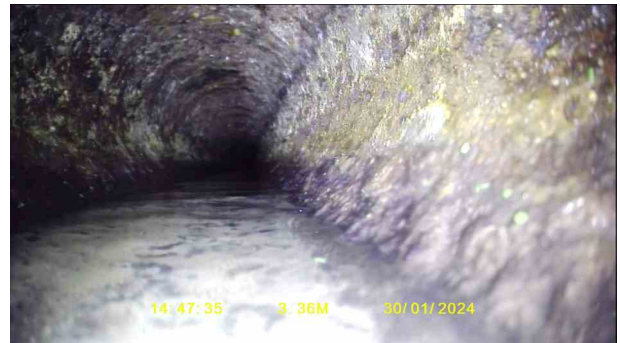
OutfallX_246864a4-b2f7-4295-a372-02a29c3854e8_20240207_144823_669.jpg, 00:01:38, 3.36 m
Water level, 10% of the vertical dimension

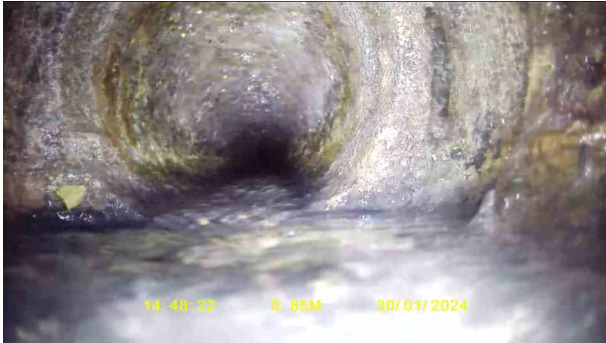
<table><tr> <td style="width: 10%; text-align: right;">0.00</td> <td style="width: 10%;">BR</td> <td style="width: 40%;">Start node, major connection without manhole, reference: Outfall</td> <td style="width: 10%;">00:00:12</td> <td style="width: 10%;">OutfallX_7 bb3e1a5-d 594-400f-b</td> <td></td> </tr><tr> <td style="text-align: right;">5.85</td> <td>JDL</td> <td>Joint displaced, large</td> <td>00:02:24</td> <td>OutfallX_9 3d762f8-1 2f5-469f-9</td> <td style="text-align: center;">1</td> </tr></table>

OutfallX_93d762f8-12f5-469f-9b86-62ada8c01128_20240207_144937_656.jpg, 00:02:24, 5.85 m
Joint displaced, large

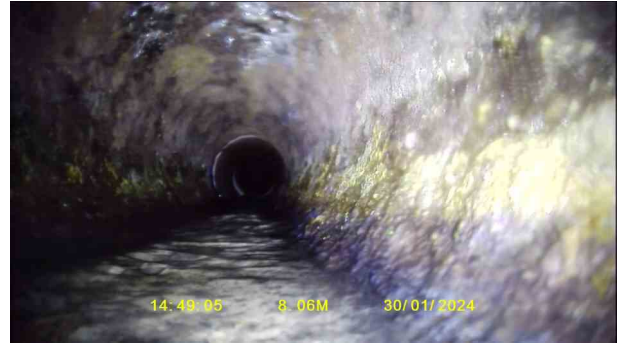
<table><tr> <td style="width: 10%; text-align: right;">0.00</td> <td style="width: 10%;">BR</td> <td style="width: 40%;">Start node, major connection without manhole, reference: Outfall</td> <td style="width: 10%;">00:00:12</td> <td style="width: 10%;">OutfallX_7 bb3e1a5-d 594-400f-b</td> <td></td> </tr><tr> <td style="text-align: right;">8.06</td> <td>DEE</td> <td>Attached deposits, encrustation from 4 o'clock to 8 o'clock, 15% cross-sectional area loss</td> <td>00:03:07</td> <td>OutfallX_8 39c829b-a 3ec-4679-</td> <td style="text-align: center;">3</td> </tr></table>

OutfallX_839c829b-a3ec-4679-a72c-4b693fa7b2f7_20240207_145047_743.jpg, 00:03:07, 8.06 m
Attached deposits, encrustation from 4 o'clock to 8 o'clock, 15% cross-sectional area loss

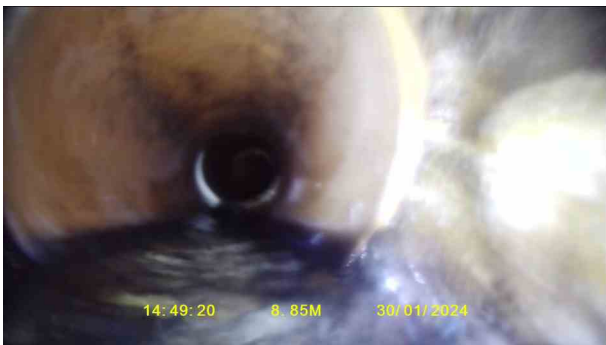
OutfallX_cc939559-63db-41a0-8284-c877ea8fd997_20240207_145139_401.jpg, 00:03:22, 8.85 m
Material changes to vitrified clay

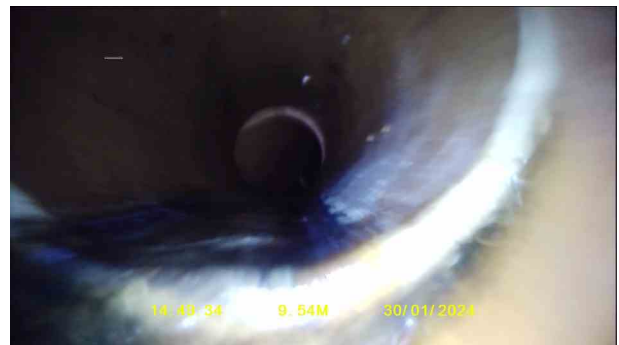
OutfallX_584051a2-19b7-493d-b747-bf505a6b9380_20240207_145213_981.jpg, 00:03:36, 9.54 m
Open joint, medium

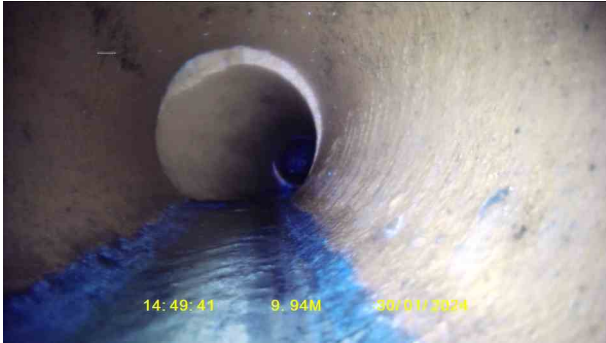
OutfallX_f18fb4c6-9445-4a2d-9f39-cc3abc9c69c4_20240207_145323_863.jpg, 00:03:43, 9.94 m
Attached deposits, encrustation from 5 o'clock to 8 o'clock, 10% cross-sectional area loss

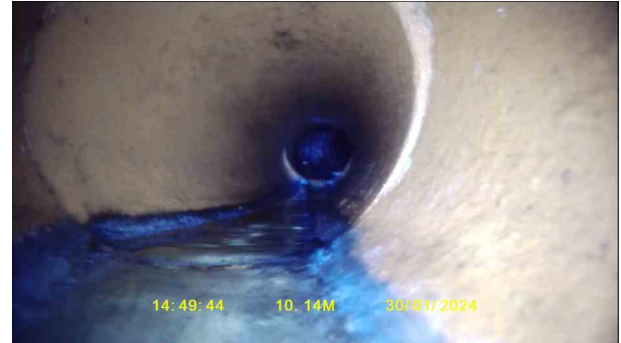
OutfallX_4b33bde6-c209-4661-8d7c-b70650424308_20240207_145338_985.jpg, 00:03:46, 10.14 m
Line deviates right

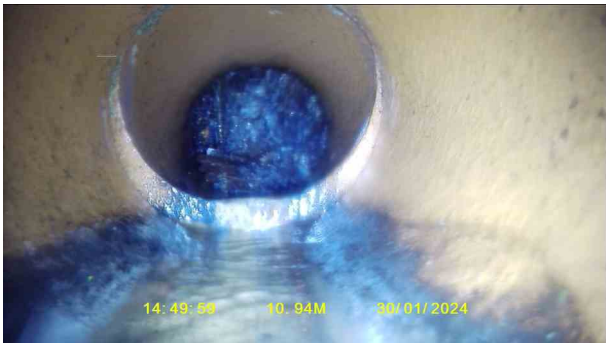
OutfallX_ed11f62a-18ae-4772-9a8b-e352e785c667_20240207_145434_852.jpg, 00:04:01, 10.94 m
Joint displaced, large

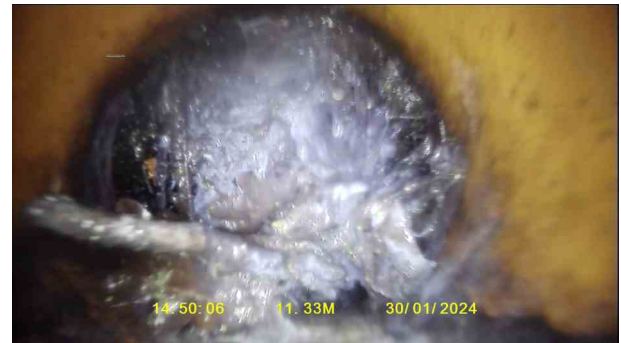
OutfallX_abab79a8-452f-415d-887c-8d16a97969ea_20240207_145517_824.jpg, 00:04:08, 11.33 m
Survey abandoned, Line completely blocked
