STRUCTURAL INSPECTION REPORT.

Visual Structural Inspection in Relation to Proposed Conversion of Existing Barn at Bell House, Humble Green, Little Waldingfield, Suffolk, CO10 0TB .

Mr T. Miller.

Job No: C278

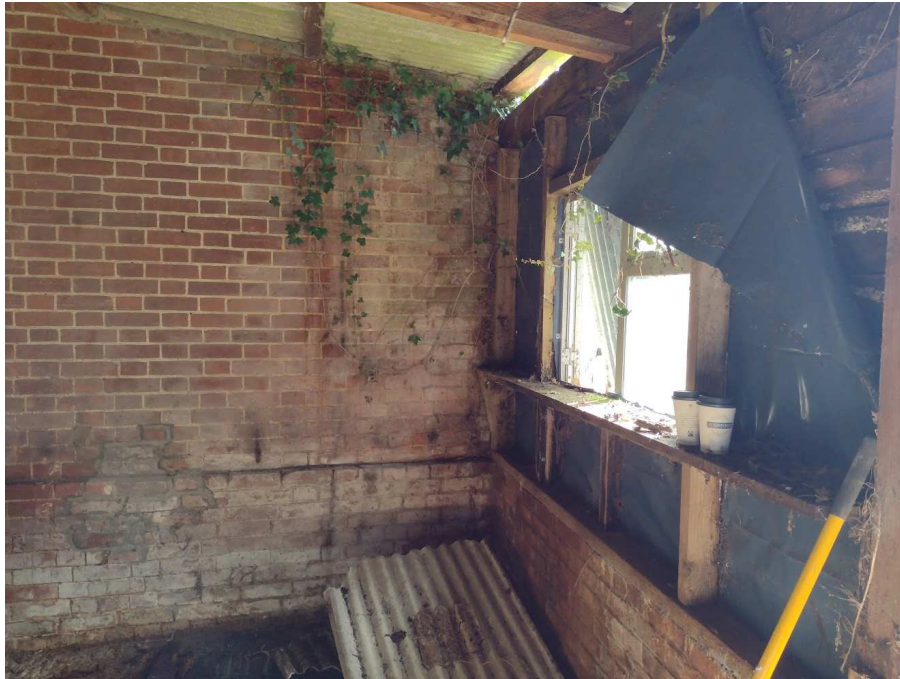
PHOTOGRAPH A – SECTION 1

Section 1 : 4” Soft Red Brick work plinth to the external wall with plastic sheeted and boarded timber frame above plinth. The roof is timbered with Asbestos corrugated Roofing Sheets. The floor to the area is a ground bearing concrete slab in sound condition. Refer to Photograph A.

The roofs and walls to each section of the barn building are generally in good condition and currently performing adequately, there was evidence of previous repairs where a tree branch had gone through the roof some time ago to section 1. There were rotten timbers to some areas of roof which will need replacement.

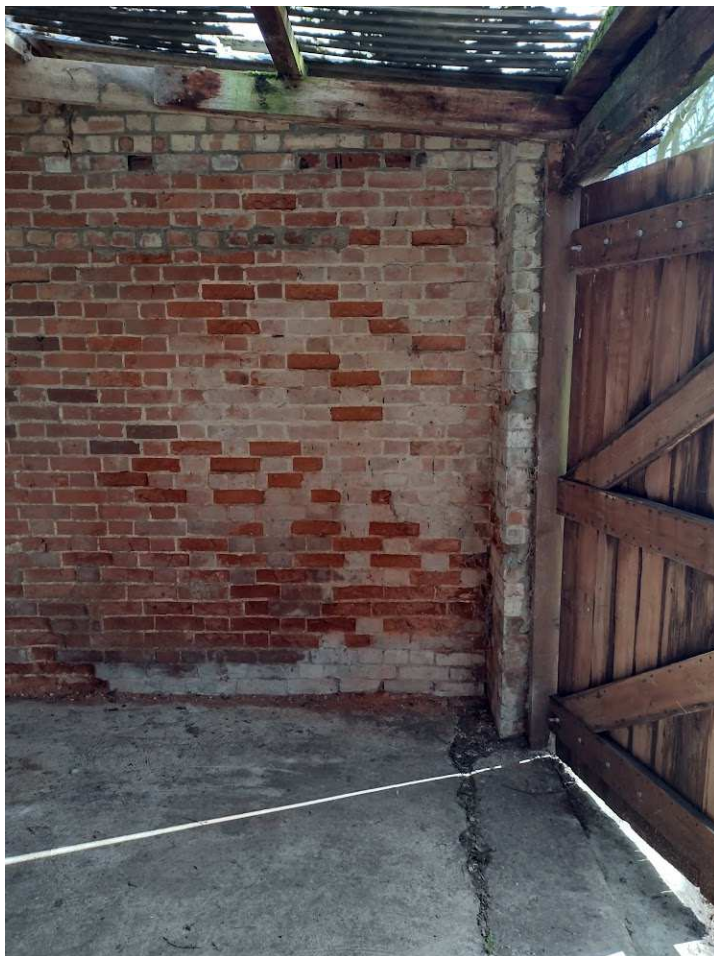
PHOTOGRAPH B – SECTION 2

Section 2 : The external walls are 9” brick work with timber purlin roof covered using asbestos corrugated sheeting. The floor to the area is a ground bearing concrete slab in sound condition. Refer to Photograph B.

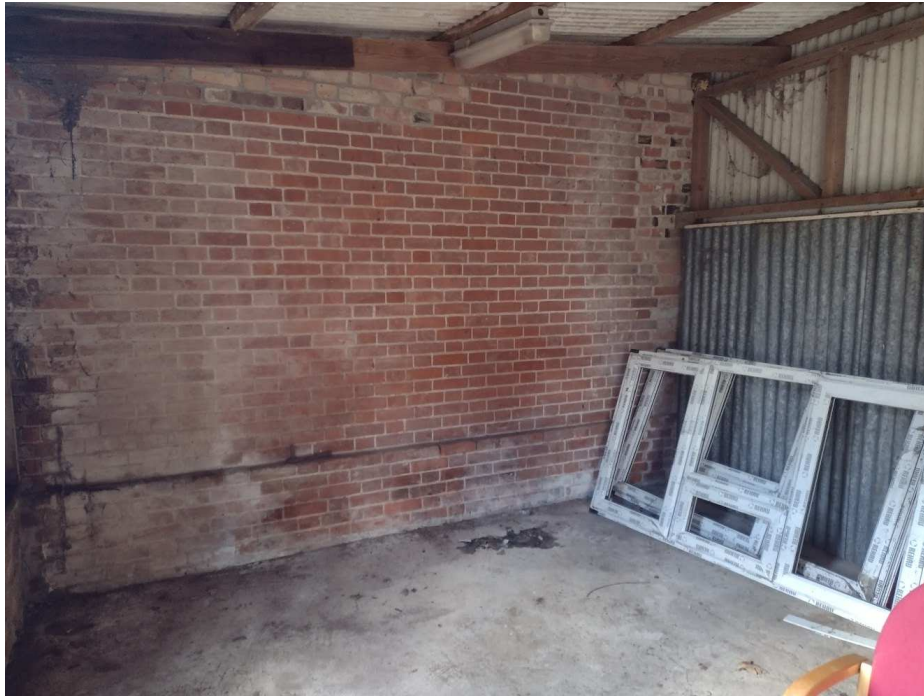
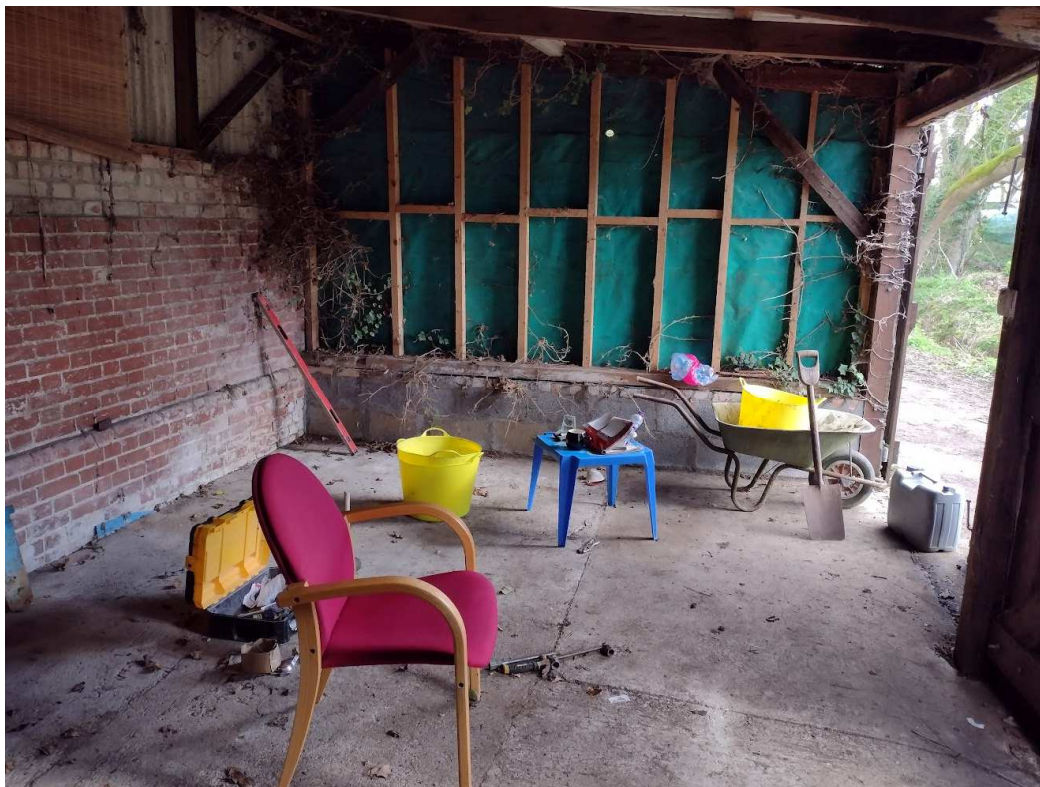
Section 3 : The external walls are 9” brick work and blockwork plinth to the external gable wall with timber framing over the plinth with a timber boarded finish. It has a timber purlin roof covered using asbestos corrugated sheeting. The floor to the area is a ground bearing concrete slab in sound condition. Refer to Photographs C & D.

PHOTOGRAPH C – SECTION 3

PHOTOGRAPH D – SECTION 3

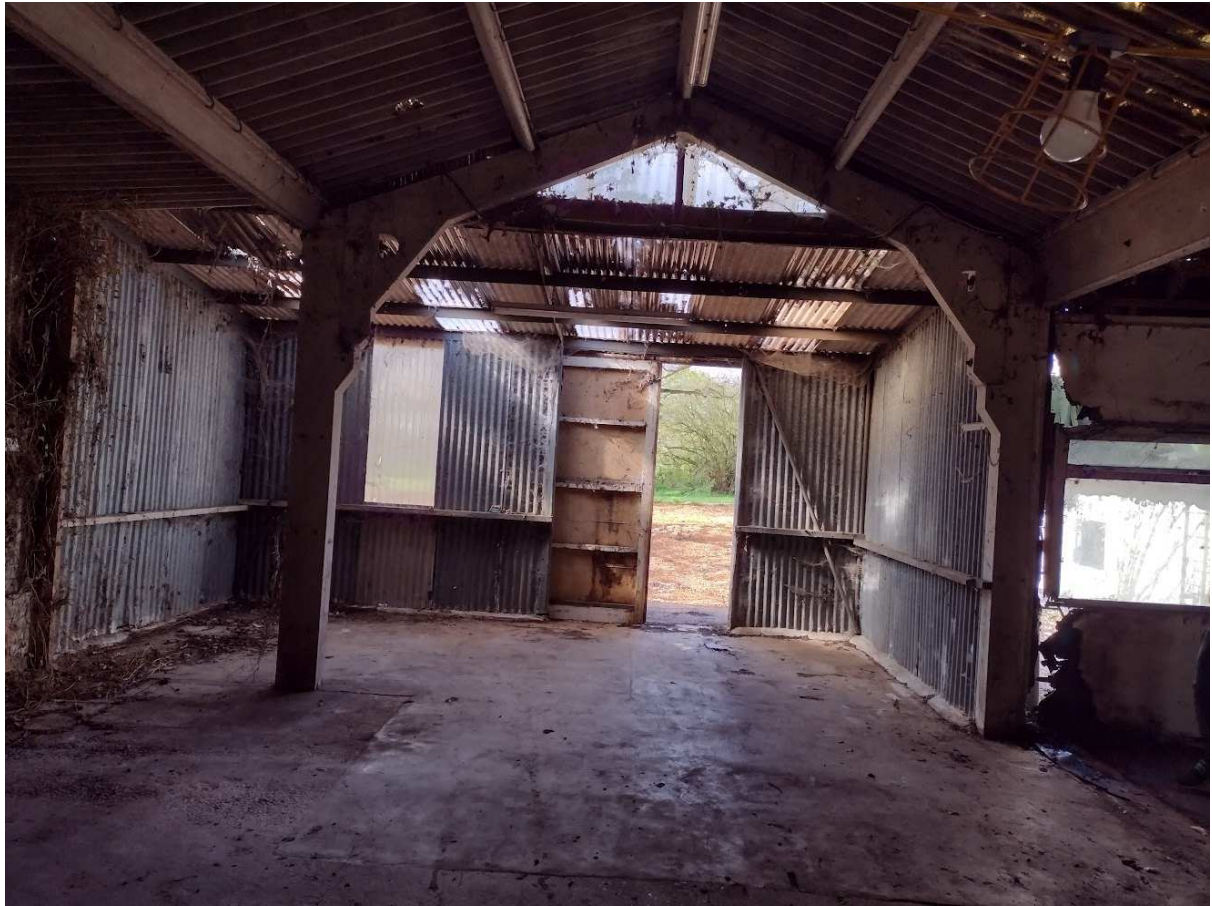
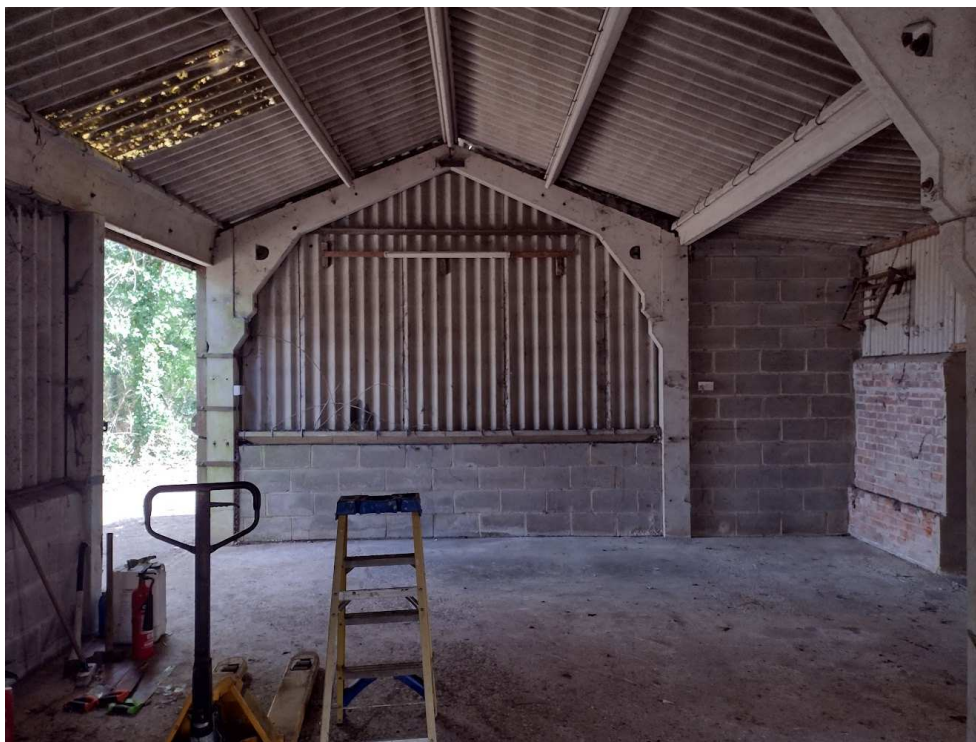
Section 4 : (Side & Rear Lean-to)Blockwork & asbestos sheet cladding with timber & angle side rails to external walls to each end with asbestos corrugated walls & an asbestos corrugated roofing sheet roof over. Supported by the wall plate of rear internal walls to areas 1 to 3. Concrete ground bearing slab throughout in sound condition. Refer to Photographs E & F.

Section 5: Blockwork & asbestos sheet cladding with angle side rails to external wall to one end with Precast Concrete Portal Frames with PCC Purlins supporting an asbestos corrugated roofing sheets with occasional glassfibre sheet corrugated rooflights, there is a lean-to element to one end of the portal with timber structure and metal corrugated walls with an asbestos corrugated roofing sheet roof over. Concrete ground bearing slab throughout in sound condition. Refer to Photographs E & F.

PHOTOGRAPH E – SECTION 4 & 5

PHOTOGRAPH F – SECTION 4 & 5

Some localised areas of brick/blockwork walls will need rebuilding/repair/strengthening. Any original timber which is in a sound condition, should be retained and restored. Any cracks in masonry should receive a helical bar crack stitch repair to restore integrity. The introduction of damp proof course and membranes will be required by specialist. The existing PCC frame should be closely inspected for any reinforcement corrosion or spalling of concrete.

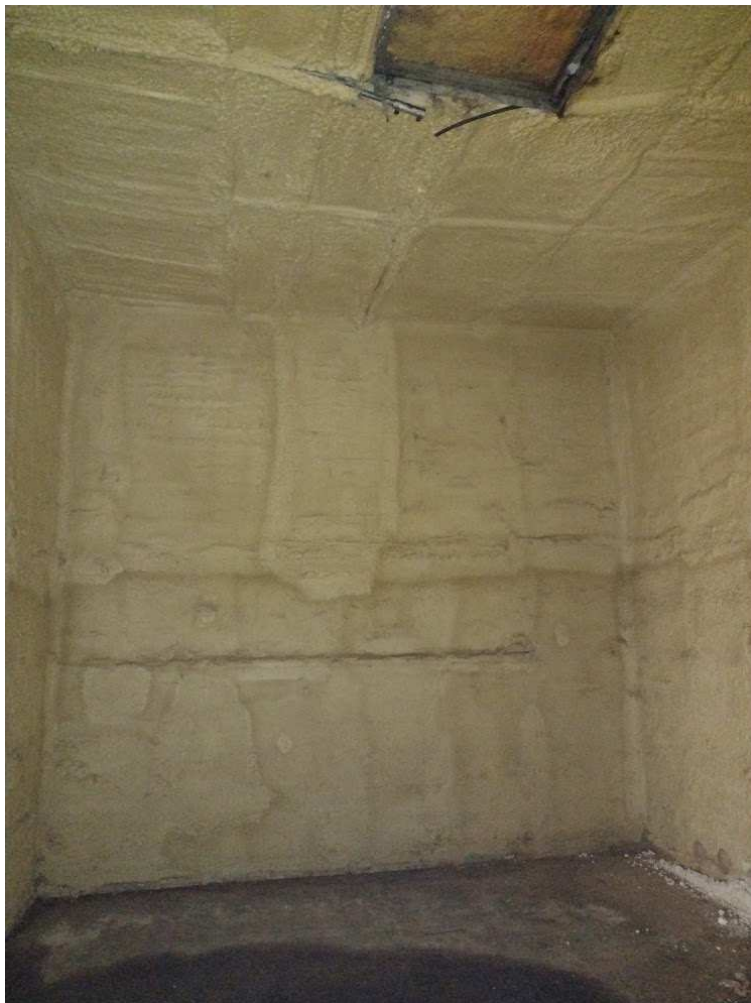
PHOTOGRAPH H - SECTION 6

Section 6: Timber Battens fixed onto brickwork walls with timber roof supports and asbestos corrugated sheeting with sprayed on insulation, blockwork internal wall with is a ground bearing concrete slab in sound condition. Refer to Photograph H.

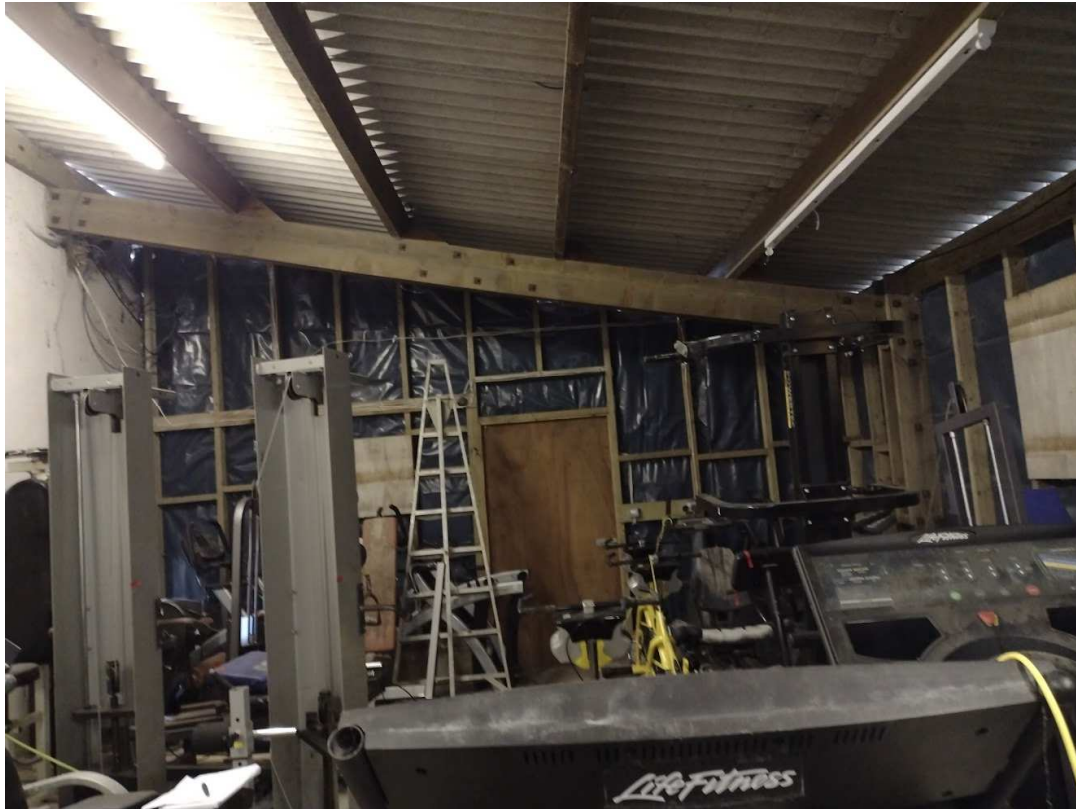
PHOTOGRAPH J – SECTION 8

Section 8: Timber frame boarded walls on 3 sides with membrane against stud work (no sheathing ply seen) with timber beams spanning across onto Section 6 wall and onto t/f external wall with timber purlins all in very good condition with a ground bearing concrete slab in sound condition.

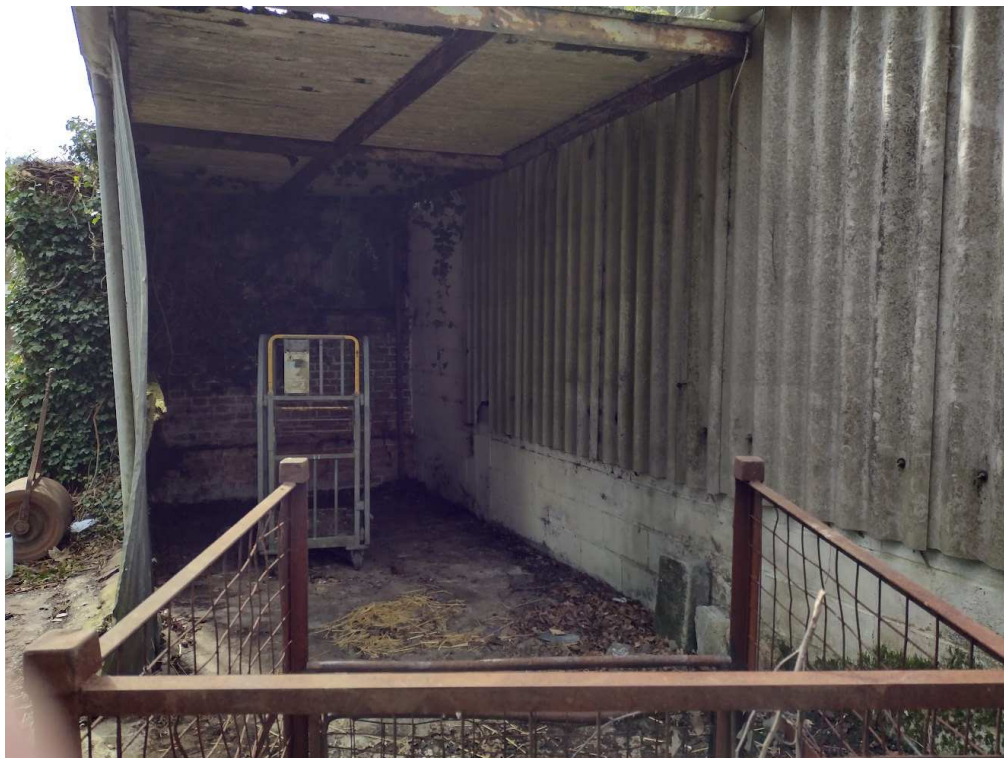
PHOTOGRAPH K – SECTION 9

Section 9: Carport area with an asbestos corrugated sheet roof with timber purlin supports and a corrugated metal sheet side wall and solid brick wall to rear, there is a ground bearing concrete slab in sound condition. Refer to photograph J.

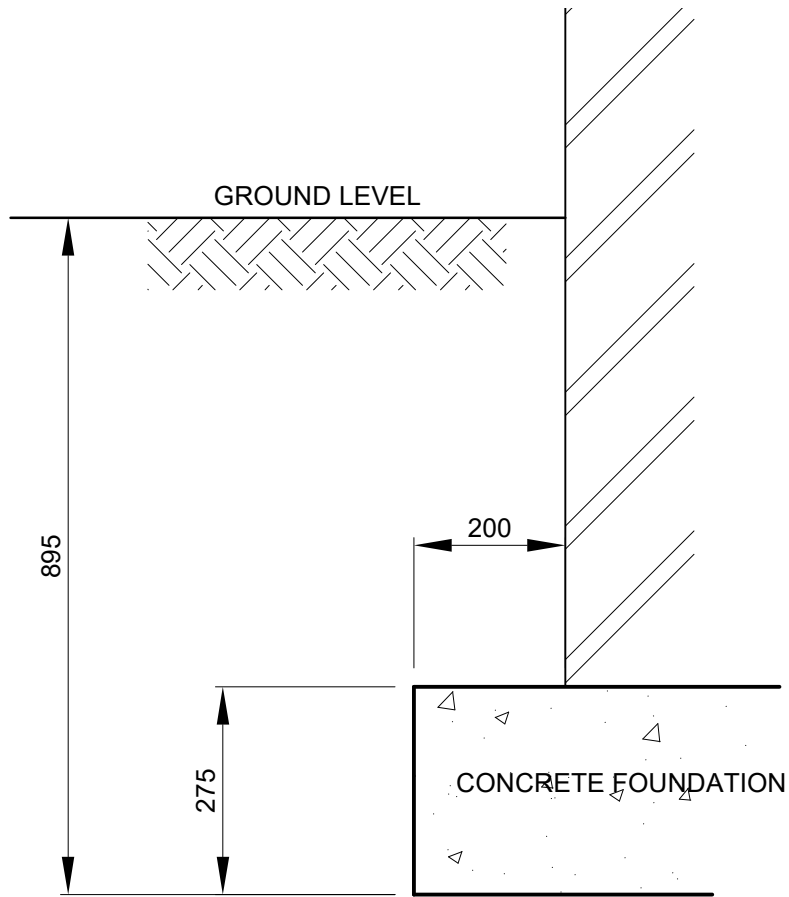
TRIAL HOLE 1 (TP1) INFO.

Generally, there is no significant evidence of foundation movement and if levels are maintained similar to the existing levels we do not consider general improvement to the foundations will be warranted. We base this on the trial pit information however other conditions may exist on site.

FIRM BOULDER CLAY STRATUM
