River Wall Survey

**Red Lion Court
46-48 Park Street
London
SE1 9EQ**

1.1.1 This report describes a river wall survey carried out as part of investigations for a proposed development at Red Lion Court, Park Street, London.

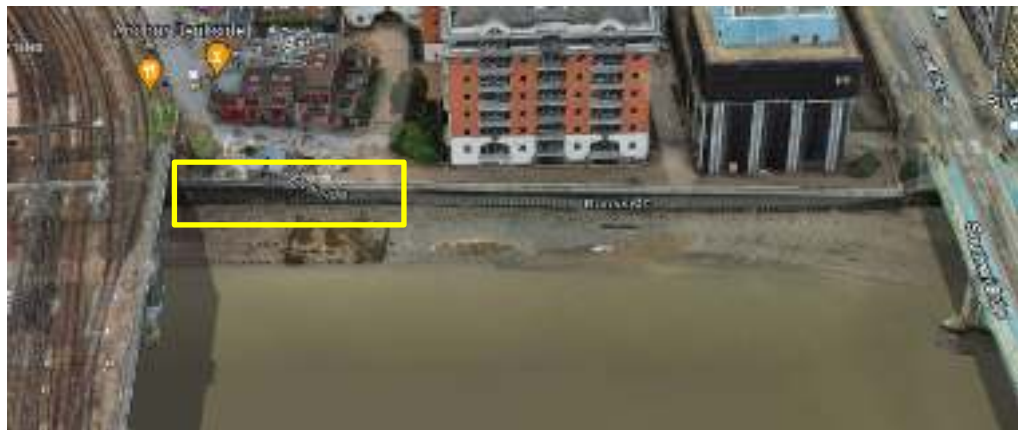
3.1.1 The river wall is formed of steel sheet piles. Anchor tie rod ends are present in all recessed piles from the west (Southwark Bridge) for approximately two thirds of the wall length. No tie rods were visible in the eastern section approximately as below.

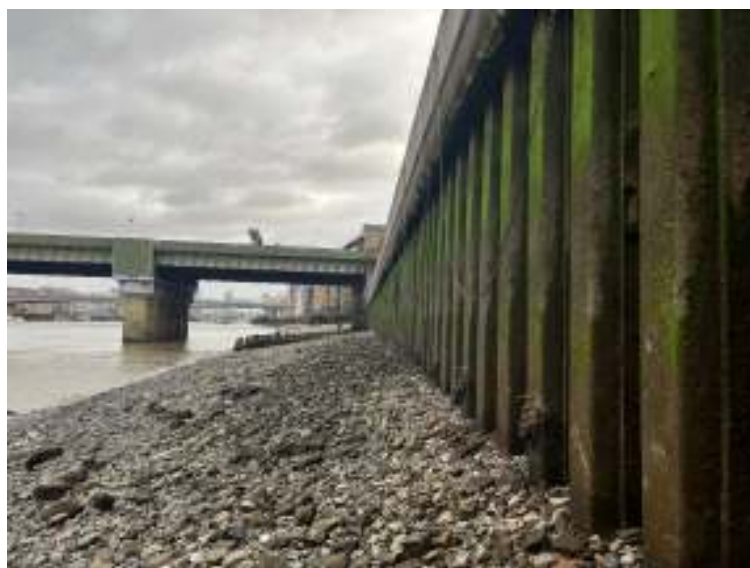
Photograph 3.1 – General view along the sheet piled wall

3.1.2 A general view along the wall looking west is shown below.

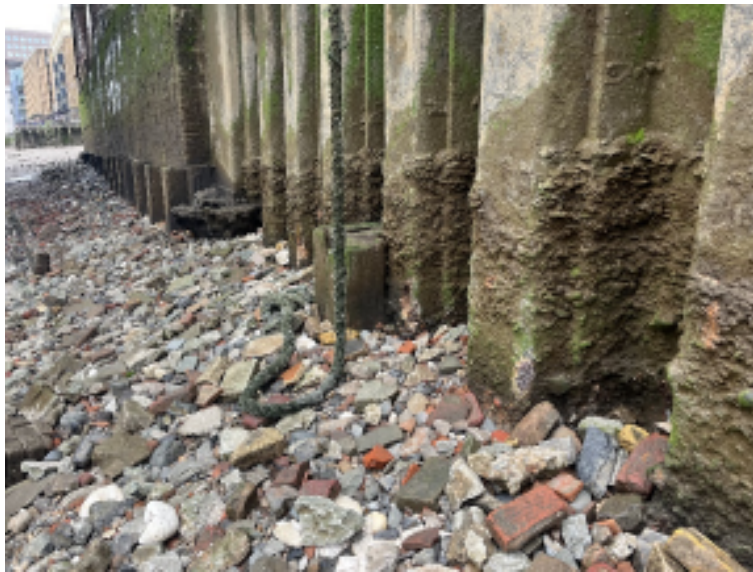
3.2.2.1 Piles were generally slightly corroded with algae as expected. To the east, piles were slightly more visibly corroded, particularly at the base as pictured below.

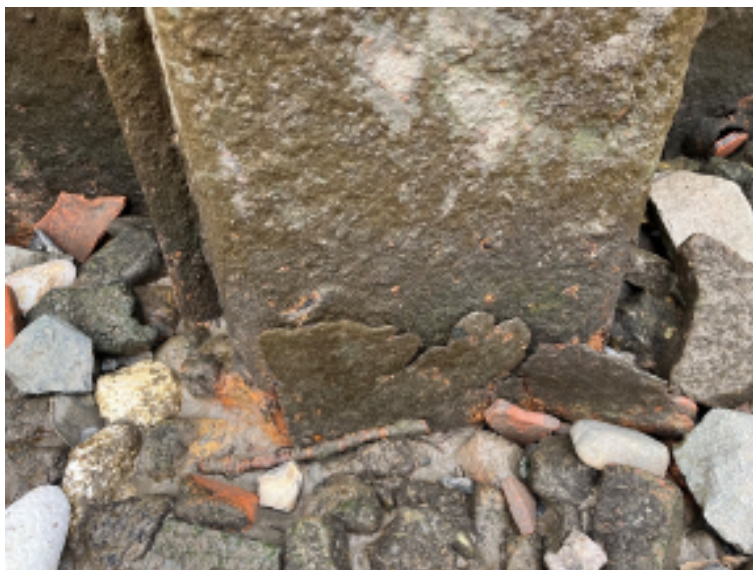
3.2.3.1 Small areas of delamination (loss of outer layer of steel) as pictured below:

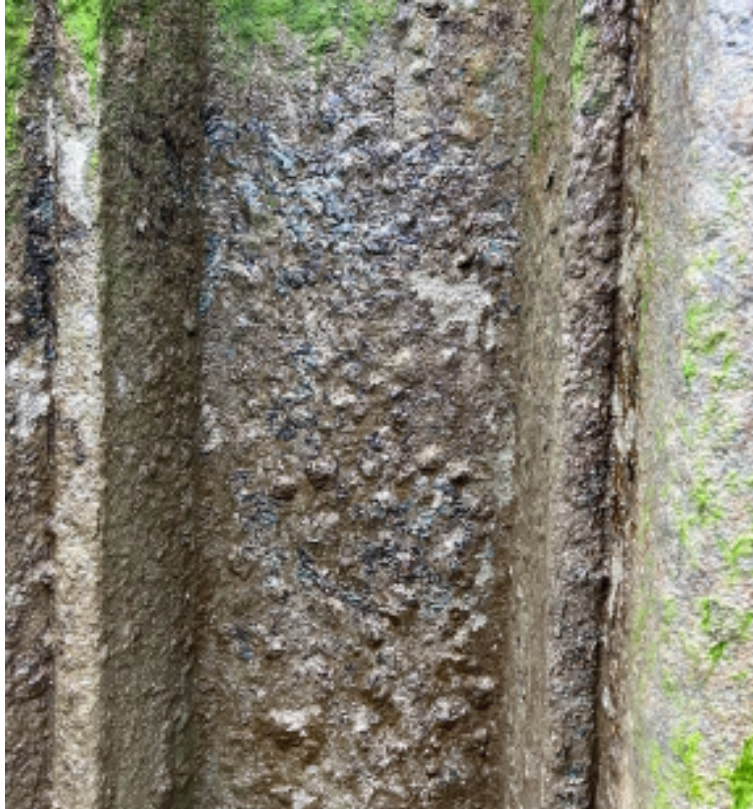
- 3.2.4.1 Bubbling at the surface, suggestive of possible sub surface corrosion/expansion, was observed within lower sections of piles particularly to the east of the site as pictured below.

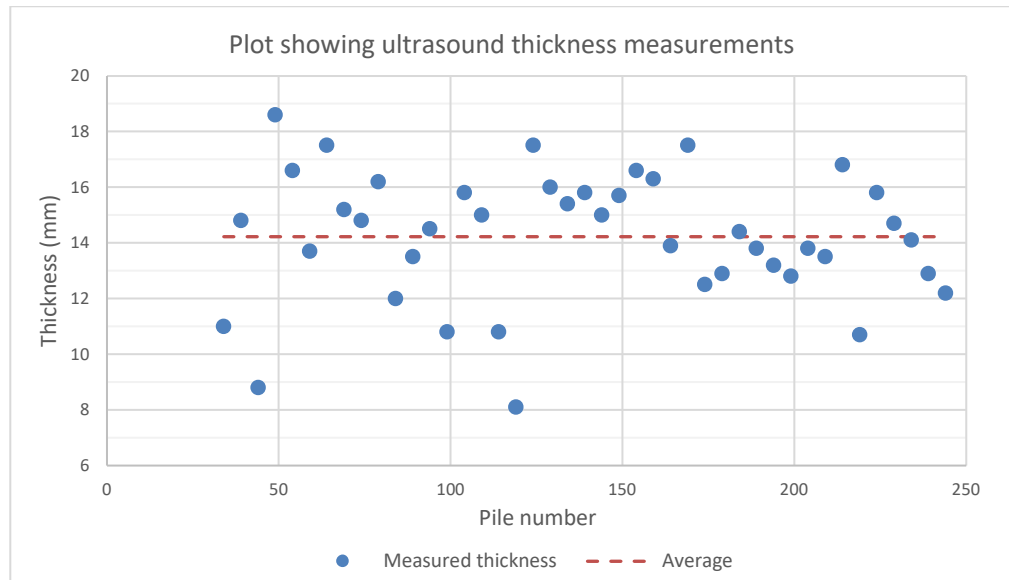
3.3.2 The average measured steel thickness onsite was 14.2mm, with a range of 8.1mm – 18.6mm. Test results are represented graphically below.
