Red Lion Court
46-48 Park Street
London

River Wall Survey

1.1.1 This report describes a river wall survey carried out as part of investigations for a proposed development at Red Lion Court, Park Street, London.

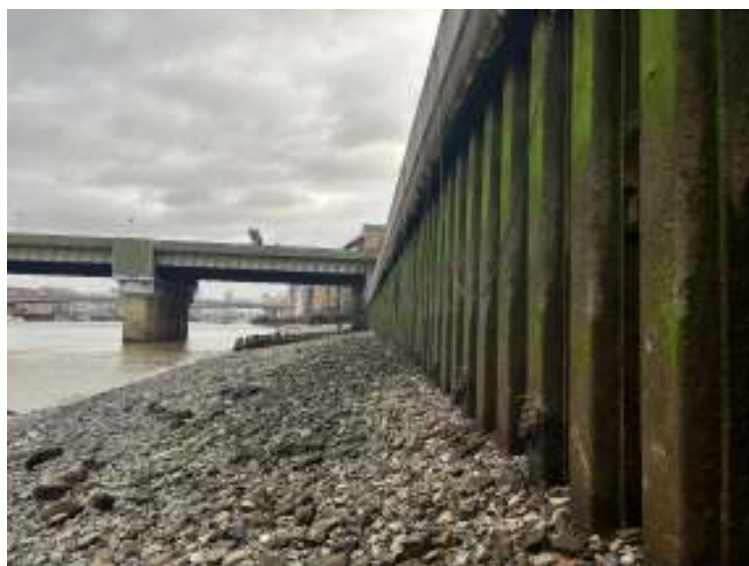
3.1.2 A general view along the wall looking west is shown below.

Photograph 3.1 – General view along the sheet piled wall

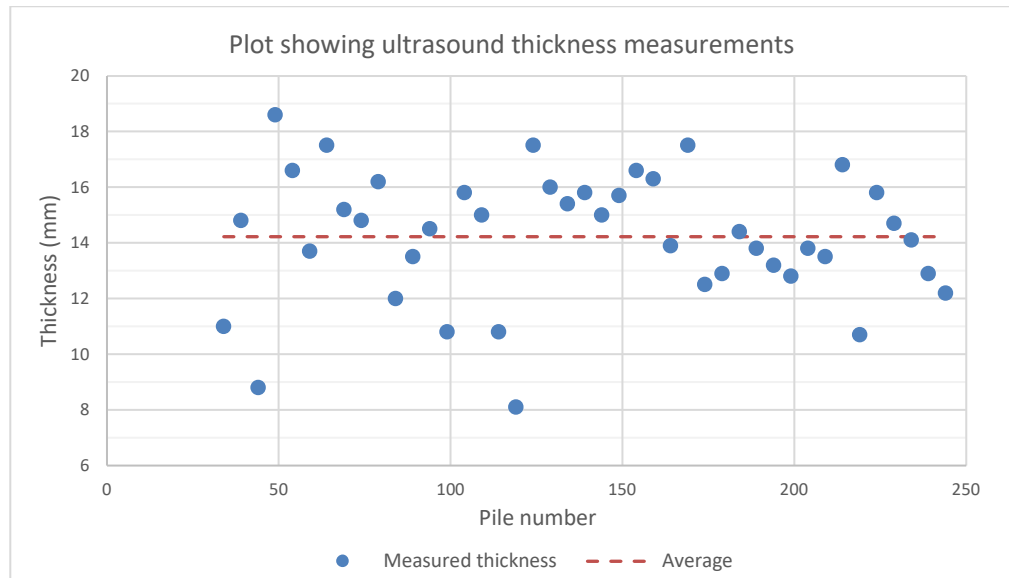
3.3.2 The average measured steel thickness onsite was 14.2mm, with a range of 8.1mm – 18.6mm. Test results are represented graphically below.
