A	First issue	AM	GL	KB	18.03.2022
REV	DESCRIPTION	PREP	CHKD	APPD	DATE
 environmental • geotechnical • building fabric					
PROJECT					
Red Lion Court, London					
TITLE					
Exploratory hole plan (current layout)					
PROJECT NO.	SCALE AT A3	DRAWING NO.			
STT5486	1:500	02

APPENDIX 04

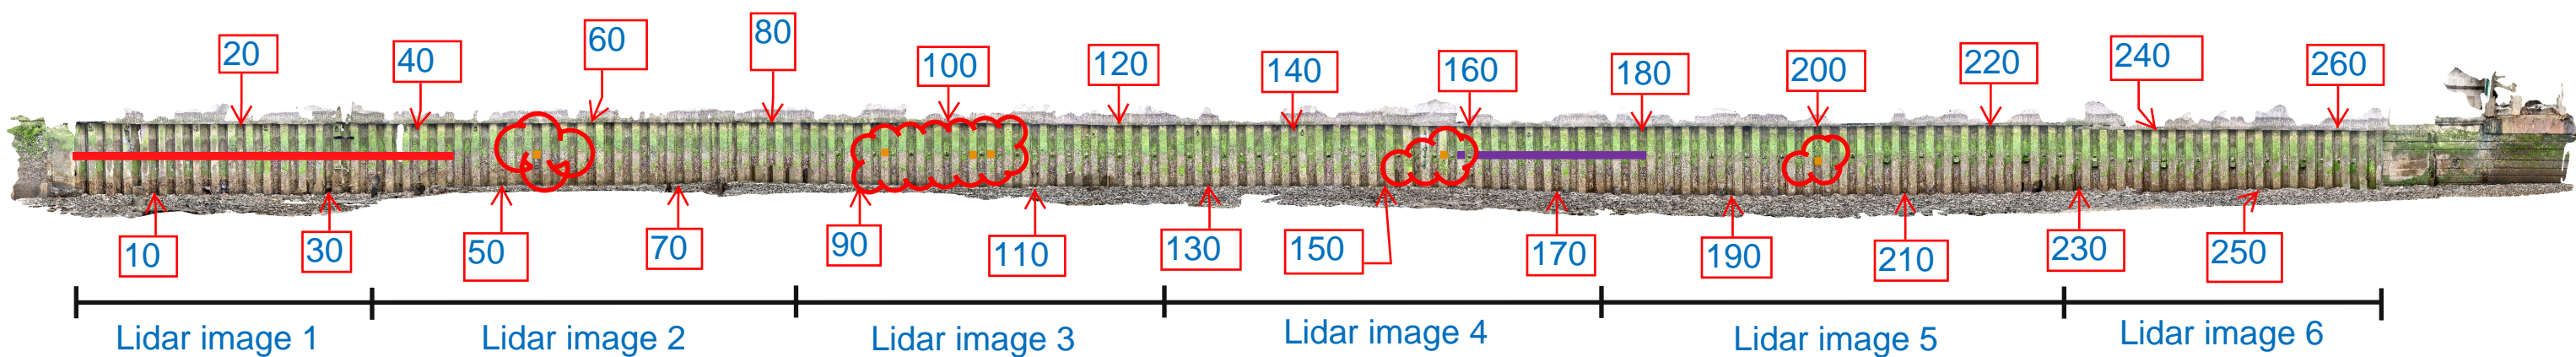
- Corrosion noted on lower piles
- ☁ Local delamination (at orange square - cloud added for ease of visibility)
- 'Bubbling' of surface observed
