Design and Access Statement

Ref: 994-RP01

Proposed Chimney Repairs
At Ashfold School, Dorton House,
Dorton, Aylesbury HP18 9NG

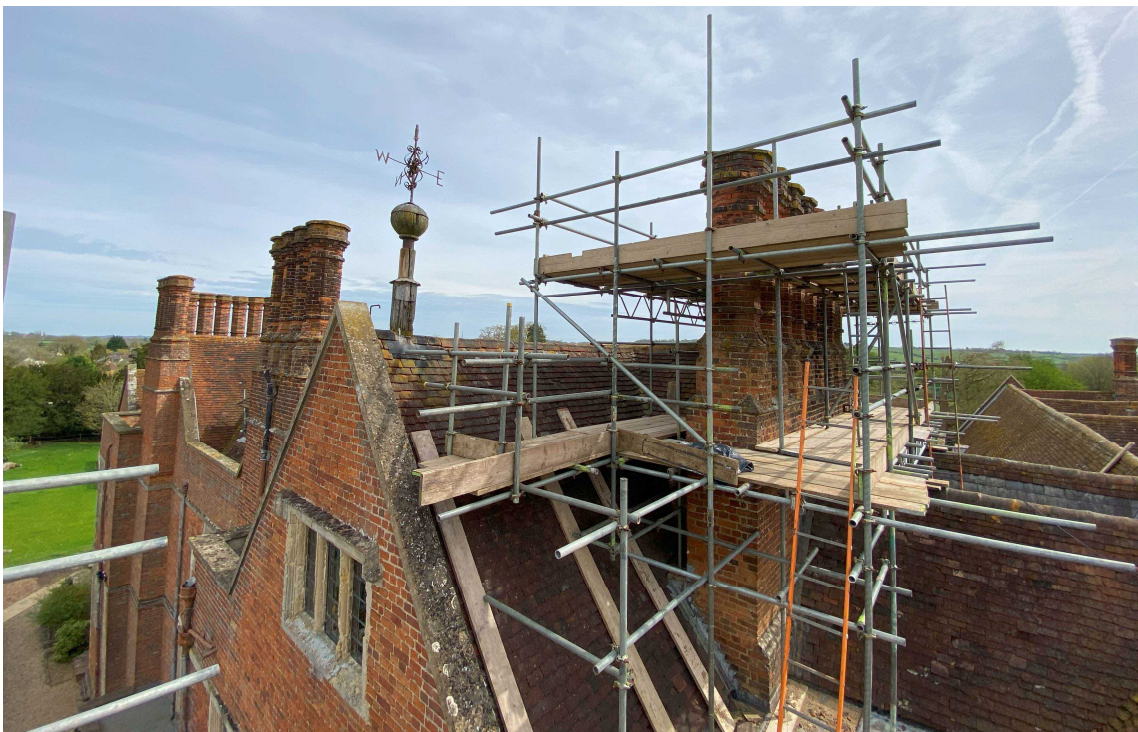
South Central Stack A

The existing chimneys of Dorton house all follow a similar arrangement and form albeit with varying numbers of flue shafts. The south central stack A is built of a red brick rectangular plinth projecting through the tiled roofs. The plinth brickwork is in English bond with a light lime mortar, generally in better condition than the flue stacks above, stepped lead flashing is dressed down onto the existing plain clay tiled roofs.

A projecting horizontal stringer course separates the plinth from a transition section which then separates out into separate octagonal flue stacks which meet again at their heads. The chimney above the stringer is generally in poor condition and has seen poor quality repair with inappropriate mortar over preceding years.

The chimneys are to be taken down to the projecting stringer course below the transition section. Further inspection by the structural engineer is to be carried out at this point. During breaks in the works each flue is to be temporary capped with paving slabs on bricks to protect the shaft from weather while allowing ventilation.

The existing chimneys are to be carefully de-constructed with the aim of retaining for re-use as much material as possible. Brickwork is to be taken down and locations recorded for re-use. Bricks are to be carefully cleaned of previous mortar and inspected for integrity. Retained masonry is to be stored on site. Storage is to be raised off the ground and always protected from the weather.

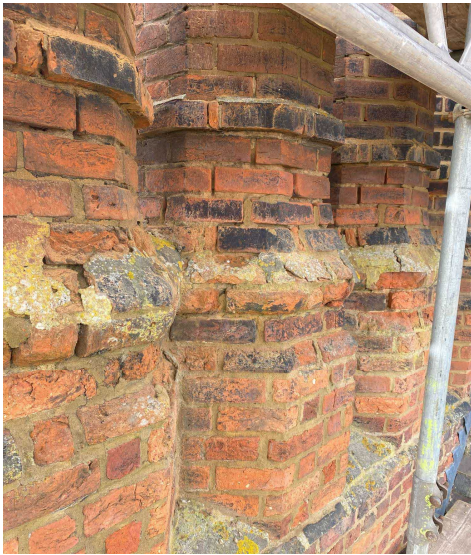
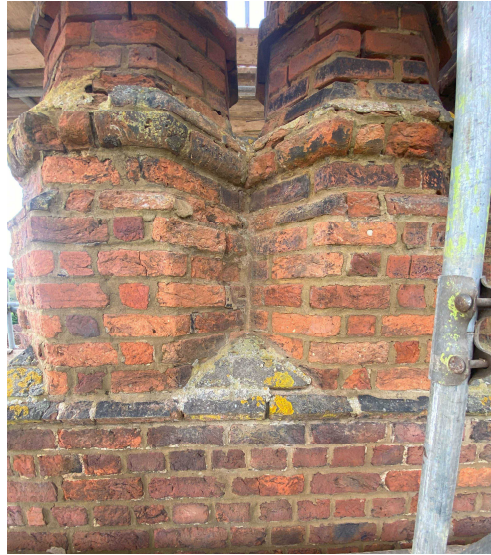
Transition section of stack A

The transition section is made up of several shaped projecting brick courses, with plinths, radius and watertable shapes vertically as well as the transition from rectangular to octagonal via 135-degree shaped bricks. Most of the special shaped bricks have seen significant weathering with much of the detailed edges eroded by the elements forming rounded corners as well as more extreme spalling and missing bricks. Previous mortar repairs have been carried out with a hard cement-based mortar with aggregate.

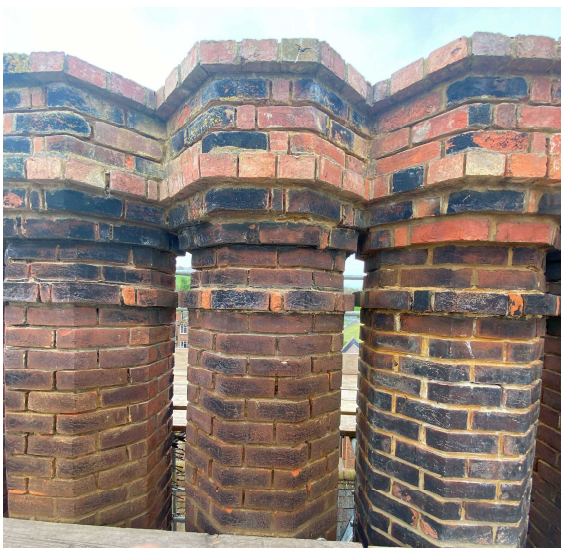
Flue stacks south central chimney A

The south central chimney stack A has eight octagonal flue stacks. The bricks to the main central section of the shaft are in average condition but had be re-pointed with a modern cement mortar with a course aggregate. There are also a number of replaced bricks with cut faces which have spalling. Stack 5A has an active metal gas flue with mesh cowl, this stack has a significant crack down both its south and north faces.

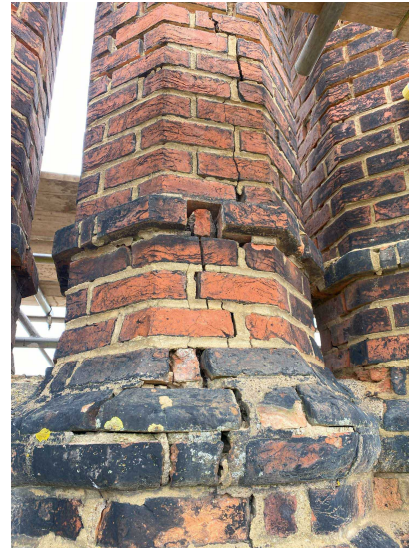
Flue stack 5A showing crack

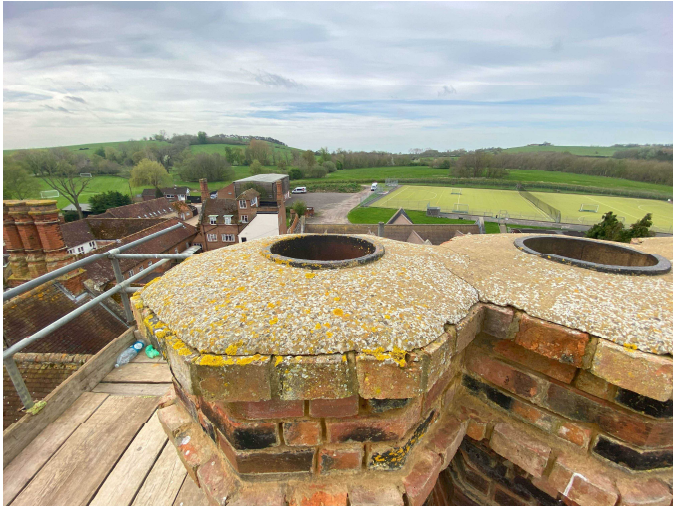
The heads of the flue stacks corbel outwards from the individual shafts to re-connect. The brickworks condition is better however the mortar joints again have failed with previous repairs breaking out and individual bricks lifts and falling away. Mortar flaunching closes of the head of each stack with the existing terracotta flue liner finished flush with the flaunching.

Flaunching and liner

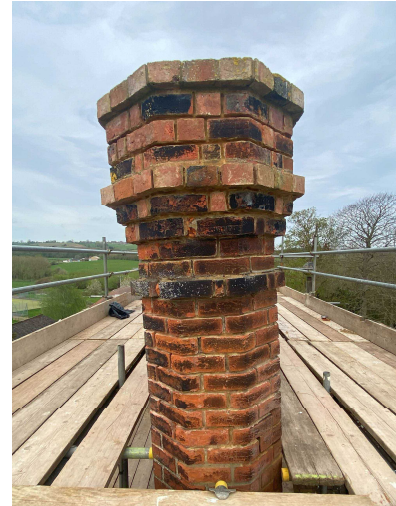
Tilt to stack head

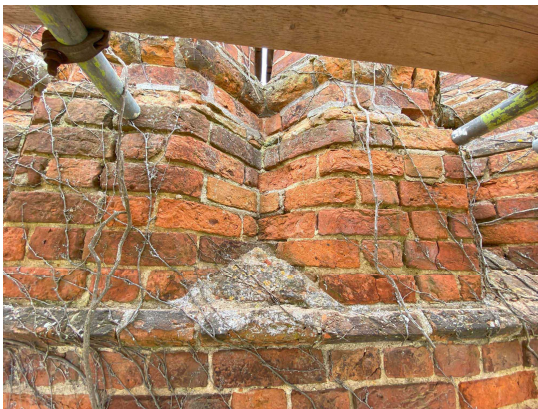
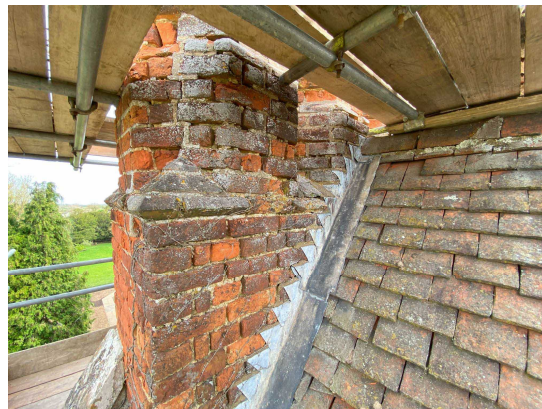
As with stack A the transition section is in a generally poor condition with significant weathering to the shaped bricks, open mortar joints and some loose or missing bricks.

There is a significant lean-to stack B as can be seen within the flue stacks. The flue stacks lean from the transition section towards the prevailing wind in the south.
