<b>CLIENT:</b>	AESCUK
<b>PROJECT:</b>	AESC Plant 3
<b>SUBJECT:</b>	Aerial tree inspection survey
<b>JOB NO.:</b>	NT15821
<b>DATE OF SITE VISITS:</b>	25 <sup>th</sup> – 26 <sup>th</sup> October 2023
<b>PREPARED BY:</b>	Lucia Ruiz Mut - Ecologist
<b>REVIEWED BY</b>	Tim Palmer – Technical Director (ecology)

# Technical Note

**Table 1:** *Climb and Inspect Survey Results*

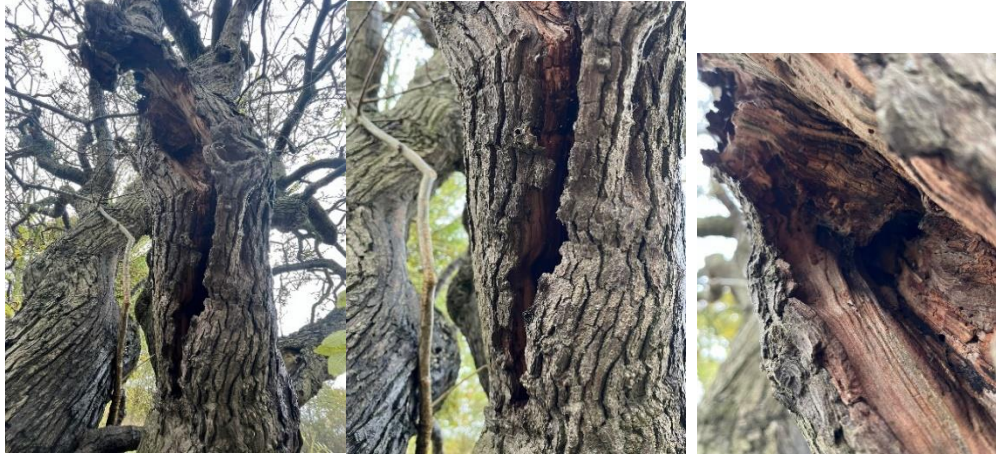
Label	Note	Photo	BRP
T7			
	<p>Cavity in trunk, N aspect c. 1.5m high, extending 20cm but exposed through a secondary hole above leading to element ingress. Potentially suitable for a limited number of individuals in summer.</p>

PRF-I

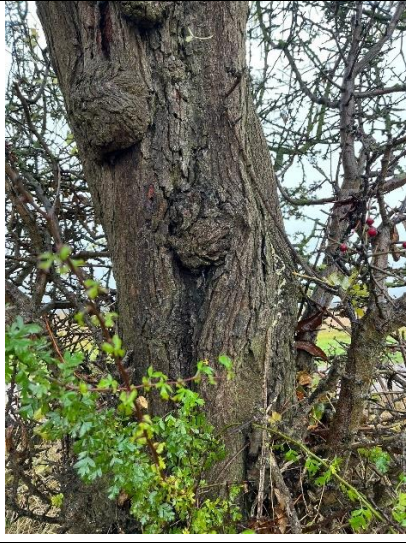
<p>Cavity in trunk on SE aspect approx. size 50cm length and 5 cm wide. Exposed to the elements. There is a superficial cavity within.</p>

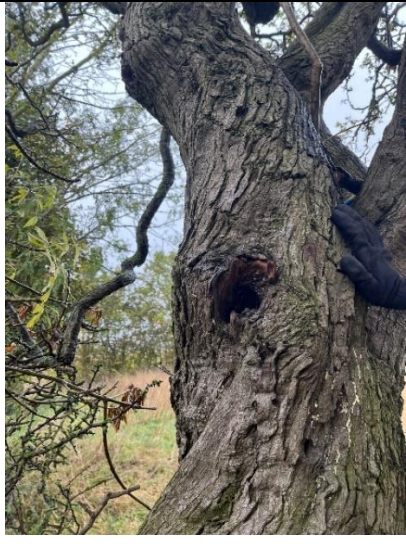
<p>Negligible</p>
	<p>Branch cavity on E aspect of the N facing main branch, approx. size 10x10cm, extending c. 20cm offering room for a small number of bats.</p>

<p>PRF- I</p>

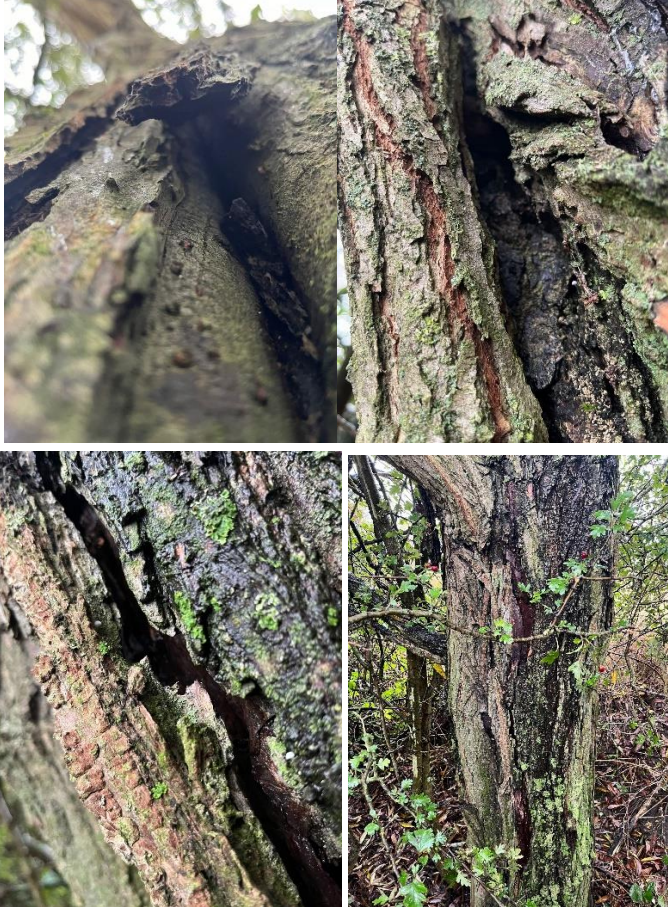
TG8			
Western tree	Loose bark on western tree around trunk base, primarily on the NE aspect but present in all directions, heavily open to the elements, i.e., rain, but well protected from wind dur to dense hawthorn surrounding the tree. Has the potential to be used opportunistically by a small number of bats.

PRF - I

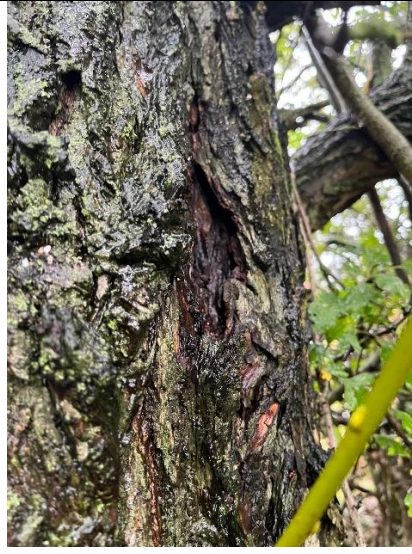
Eastern tree	Some loose bark on eastern tree but no significant void created, may increase suitable over time.

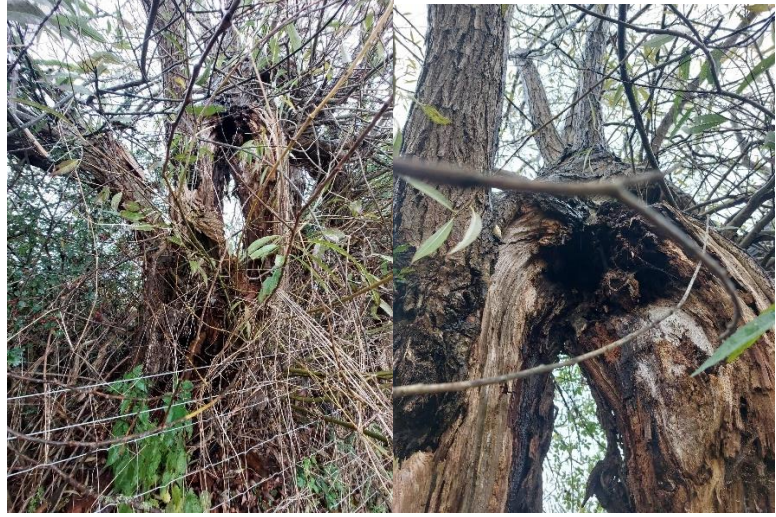
Negligible
Additional willow	Large branch tear out exposing heartwood of the tree on the S aspect 1.5-2m high, creating a large cavity within. It slightly exposed but cavity extends c. 40-50cm within

PRF - M

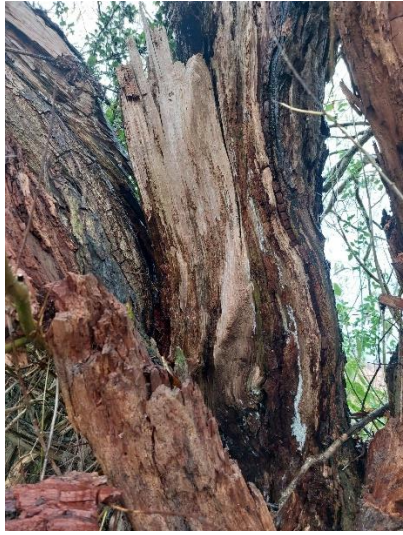
<p>Additional willow</p>	<p>Another cavity in branch, didn't appear to connect with the above-mentioned tear out but could not be further inspected for safety reasons.</p>

<p>PRF-M/H</p>
<p>T9</p>			
	<p>Trunk showing cavity/callus roll which does not extend or provide cavity and upward facing branch that has snapped off offering no entrance hole/cavity</p>

- 4.2.2 The willow tree to the west of TG8 has one feature of at least moderate suitability, which could not be safely accessed and therefore remains unchecked. It is therefore recommended that this feature is subject to emergence/dawn survey in advance of felling.

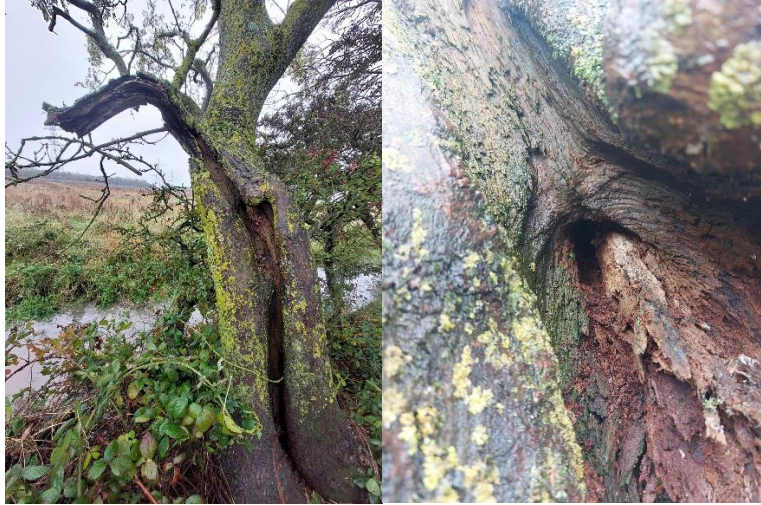
T9+			
	<p>Trunk cavity on the NE aspect at the base, extending c. 15-20cm into the heart of the tree</p>

<p>PRF-I</p>
T10			
	<p>Knot hole on the NE aspect c. 4m high, approx. size 5x5cm, superficial, does not extend further, plus 2 more, one on each main branch of the first fork.</p>
