Arboricultural Report to BS 5837:2012

3 Bacchus Lane South Cave Brough HU15 2ER

18th April 2024

240417

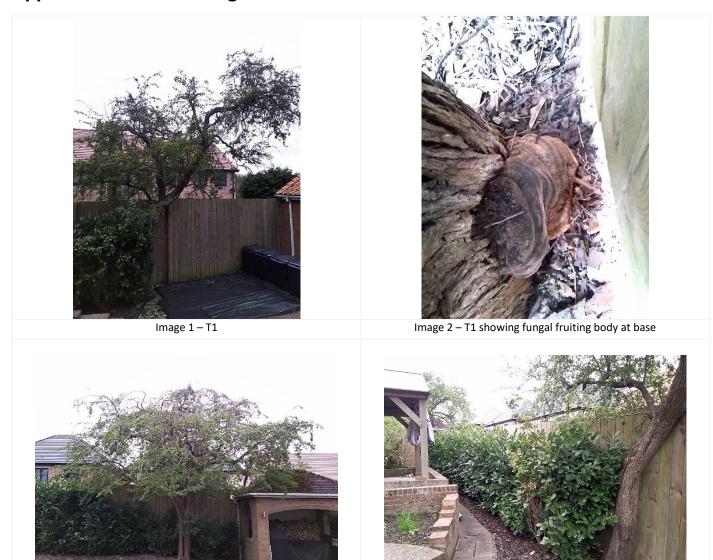
Image 3 – T2

- 2.2.1.The surrounding residential area is interspersed with a very modest number of young and semi-mature trees.
- 2.2.2.Trees T1 and T2 (see Appendix 4, images 1 & 3) form minor green features when viewed from the immediate surrounding area. These trees represent a modest part of the local treescape, and conveys a low visual amenity value.
- 2.2.3.Hedge H1 (see Appendix 4, image 4) is very modest in size, is hidden from public view, and conveys no visual amenity value.
