Cellar Floor Joist Replacement

Design & Access Statement
Risk Assessment & Method Statement

2 London Road
Tetbury
Gloucestershire
GL8 8JL

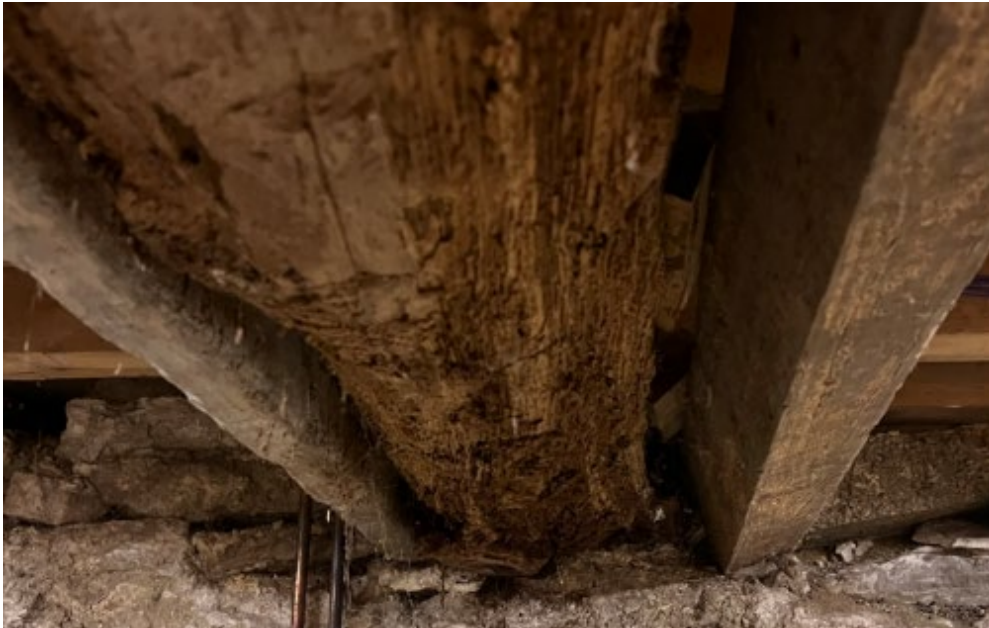
Original Timber Beam

The original beam is assumed to be oak, though this is not confirmed. It was approximately 3.15m long excluding the recess into the basement walls and with a cross section of approximately 200mm X 200mm. The beam was extremely decayed due to the damp conditions in the cellar and was supported by two scaffold planks, which it is believed were placed by a previous owner. See photo below.

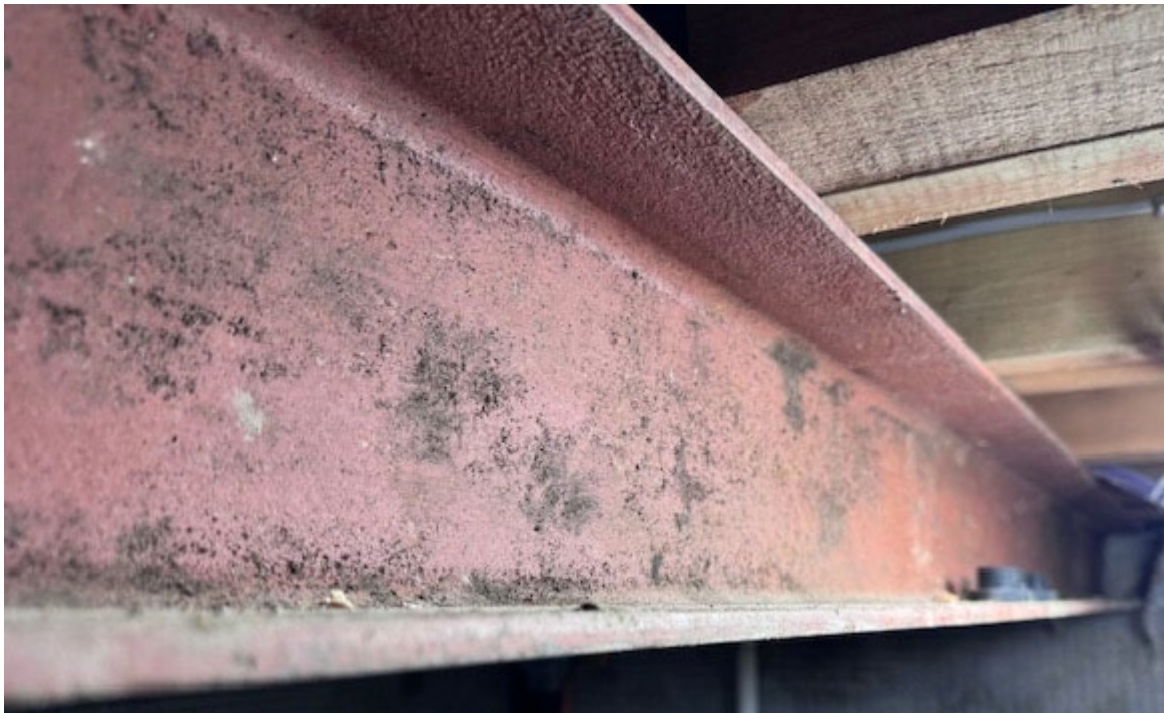
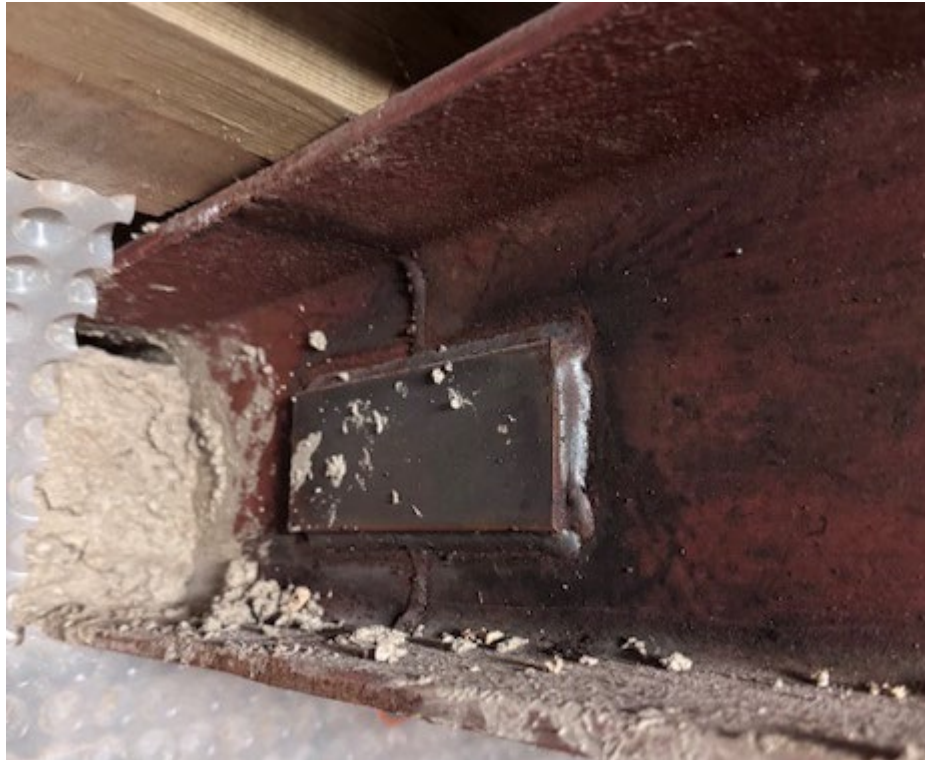
Replacement Steel Beam

For safety reasons and in order to preserve the structural integrity of the ground floor the decayed timber beam was removed and replaced with a steel beam approximately 160mm high by 160mm wide, see photos below. To install the new beam it was cut and welded in-situ as the access via the cellar hatch did not provide sufficient access to allow the full length to be manoeuvred in to the cellar.

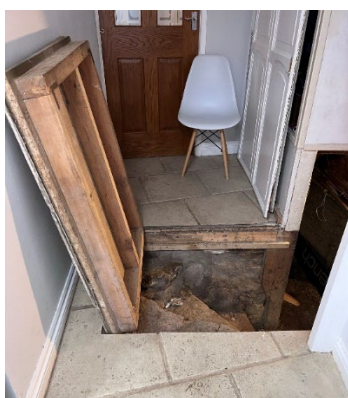
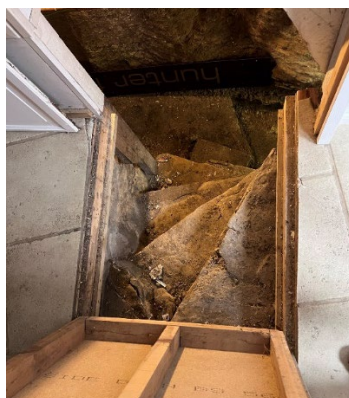
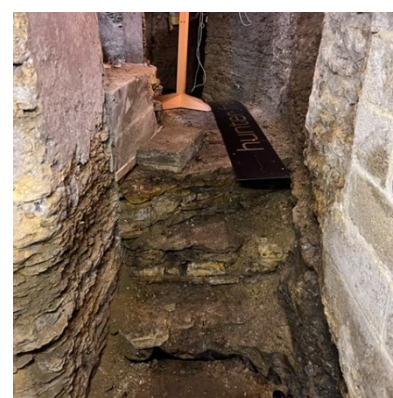
Access To Cellar

The stone steps from the ground floor office down to the basement turn around 90 degrees, the opening is approximately 700mm x 900mm which significantly restricts access to the cellar. See photos below.

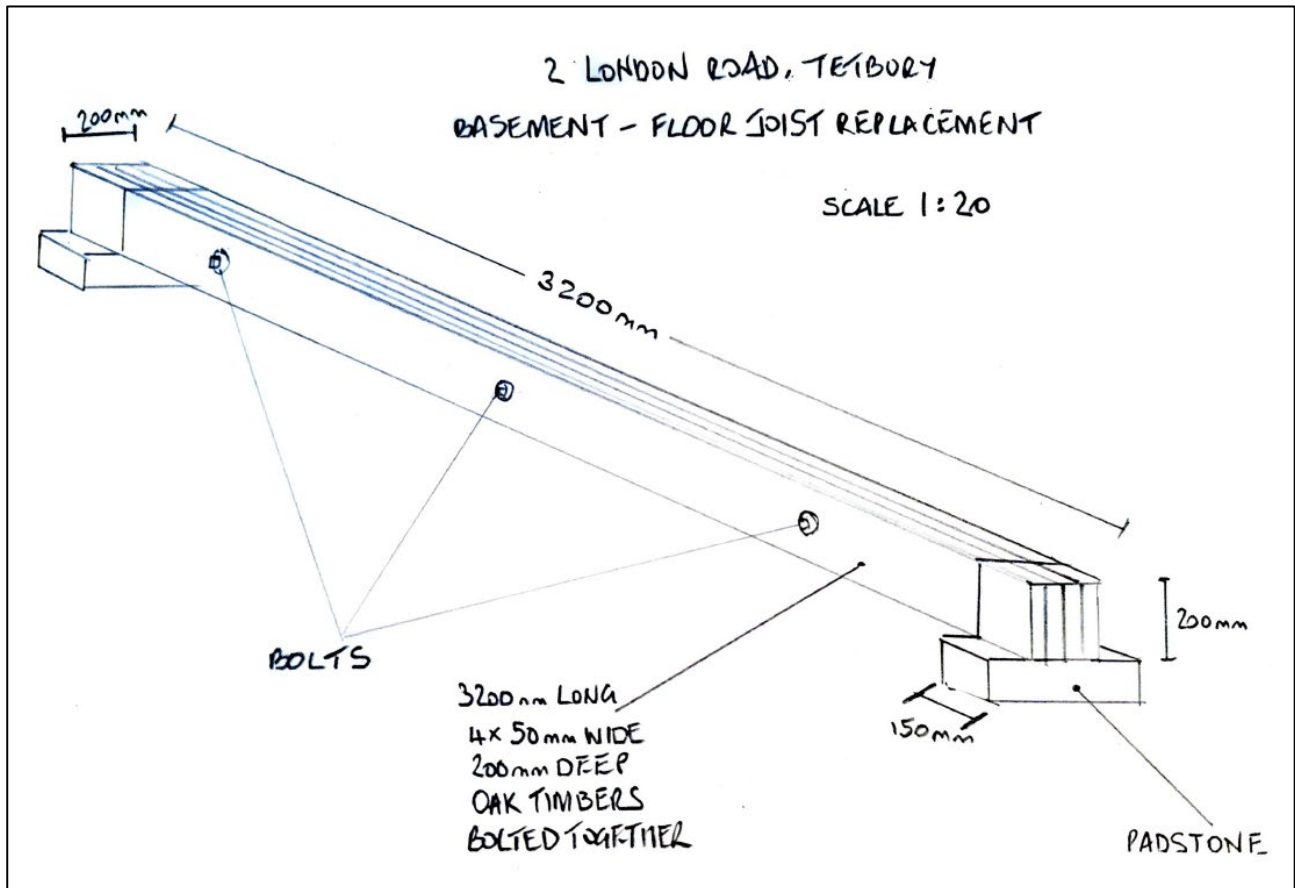
Replacement Timber Beam

It is impossible to manoeuvre a new timber beam with dimensions 3.5m long and cross section 200mm x 200mm into the cellar through the existing access hatch and there is no other access to the area. As such, an alternative solution is required. The proposal, as shown in the diagram below

is to cut the 200mm x 200mm in to four sections lengthways each 50mm wide. This will allow the narrower beams to be manoeuvred into the cellar through the existing hatch. Once in place they 4nr 50mm beams will be connected together by bolts.

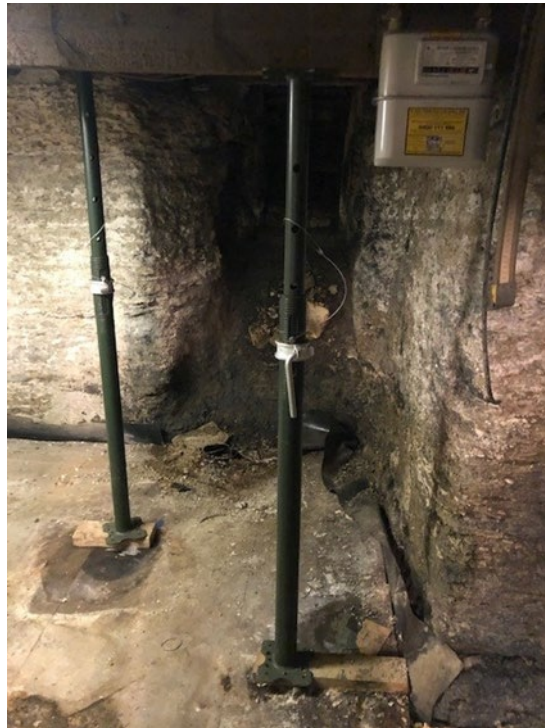
Example of acroprops currently in use in the front cellar
