Our Ref: 1049-2023 Demolition/Con Hill/JC/IH/03/24

TREES AT FORMER BOURNEMOUTH & POOLE COLLEGE, CONSTITUTION HILL ROAD, POOLE.

Brief: Survey trees at Former Bournemouth & Poole College, Constitution Hill Road, Poole from the plans provided. Comment upon their condition & suitability for retention. Design a tree protection plan for the demolition of the buildings on the site.

Date of Inspection: 15.11.23.

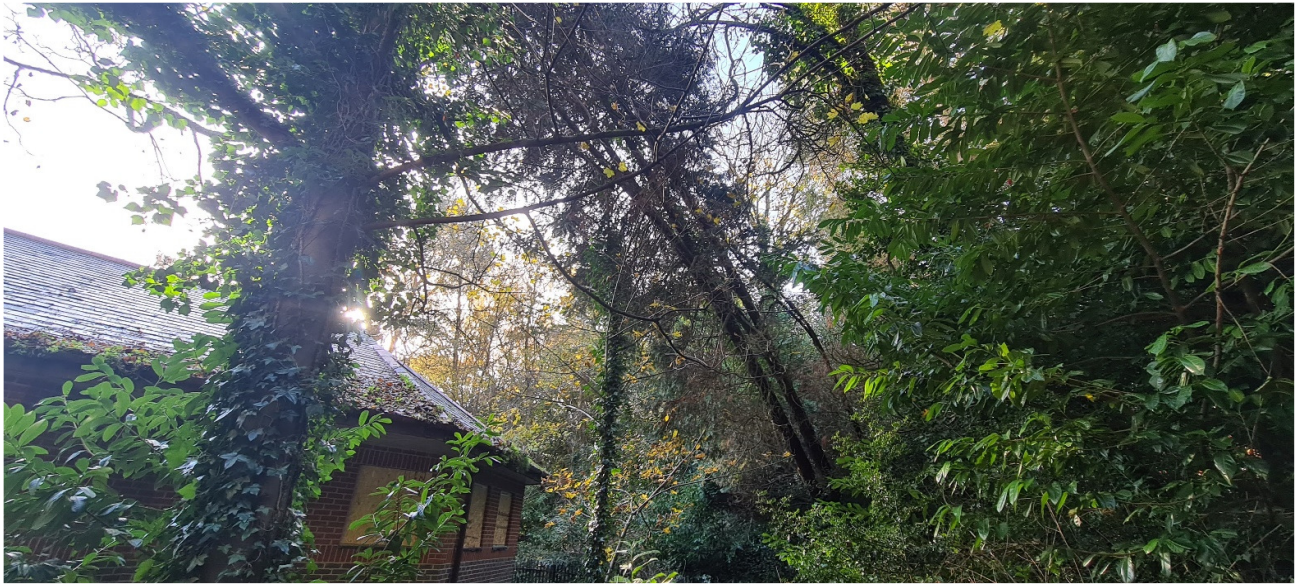
G26	<i>Juniperus chinensis</i> Chinese juniper	11	200 ave	2.4	N1 E1 S1 W1 FSB	3 3 3 3	M	20- 40	C	Overcrowded. No long-term future. OK. Failed tree leaning over learning resources centre, needs removing. One member of group heavily leaning towards octagonal building. Recommendation is to fell leaning tree.
27	<i>Pinus sylvestris</i> Scots pine	16	550	6.60	N7 E4 S1 W4 FSB W6	7 9 11 4	FM	40+	B	Edge of group. Dominant. Overhanging footpath and buildings. Close to hard surfacing. Wire embedded in main stem.

G26 Chinese Juniper in poor condition and leaning over octagonal building within site. This tree should be felled.

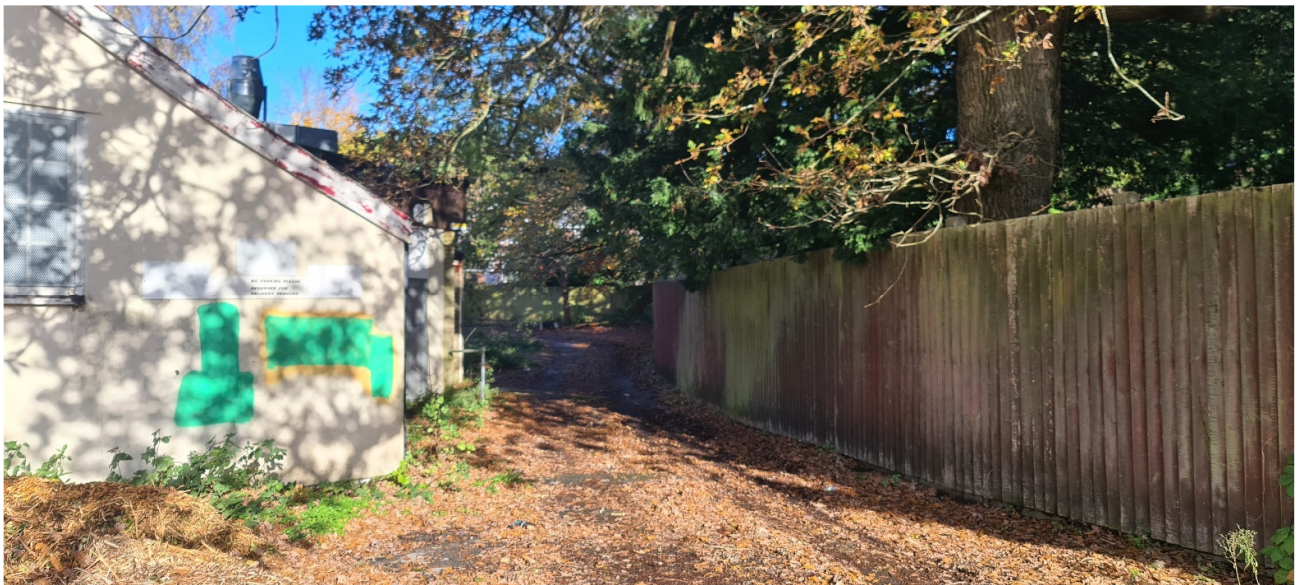
Low canopies of trees over access into middle of site. Crown lifting to canopies should be undertaken to create 4m ground clearance.

Several trees along the eastern boundary of the site, T48, T52, T53 and T54 will be crown lifted over the tarmac vehicular access along the eastern boundary of the site. This crown lifting will allow the free movement of demolition related plant into and out of the main site entrance along Constitution Hill Road.

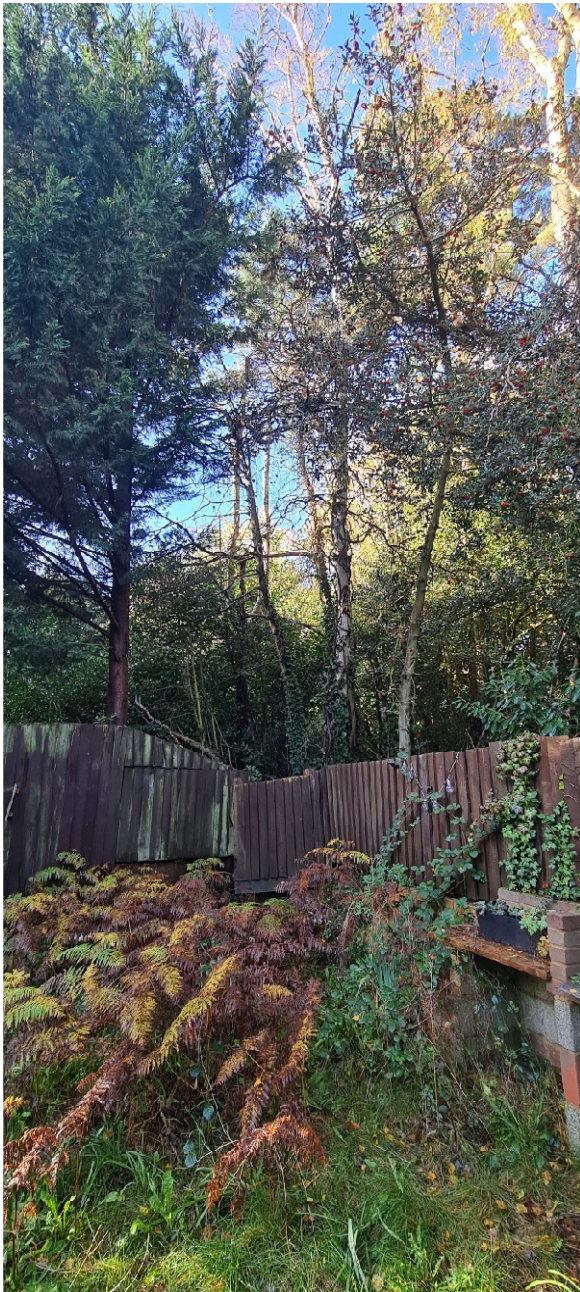
70	<i>Quercus robur</i> Oak	9	520	6.24	N5 E5 S3 W3 FSB S3	5 4 4 4	M	40+	C	Roadside tree. Stunted. Dead wood needing to be removed.
G71	<i>Betula pendula</i> Silver birch	12			N E S W FSB				U	Dead.

G71 Dead Silver Birch

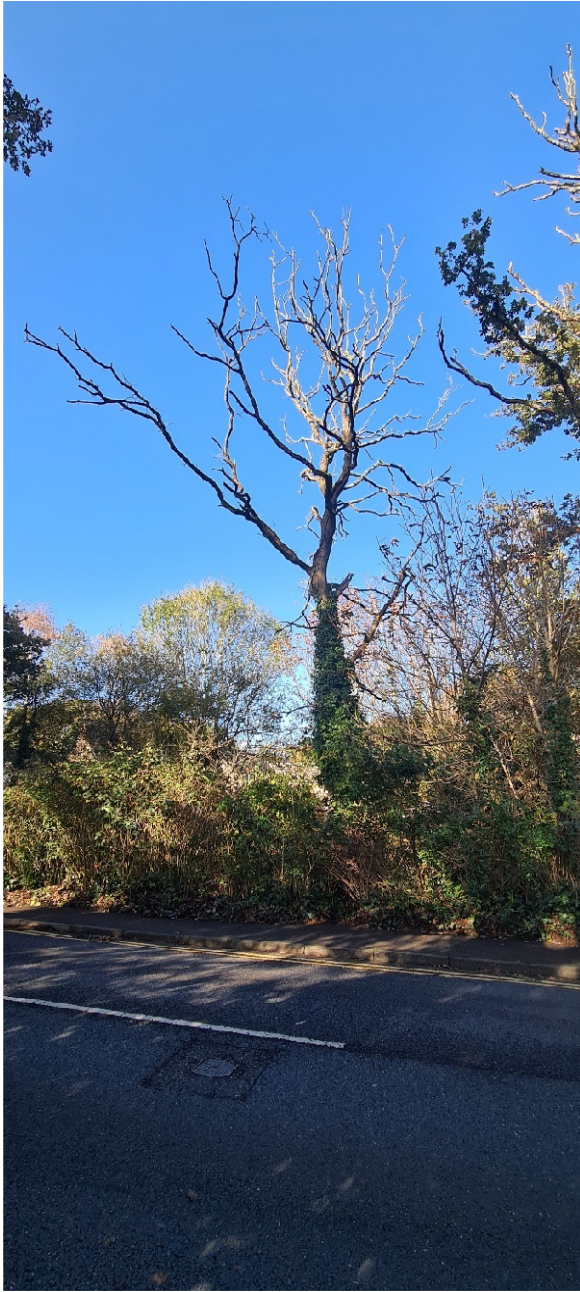
T	Name & Species	Hgt	Dbh	RPA	B/S	C/C	Age	R/C	Cat	General Observations
64	<i>Betula pendula</i> Silver birch	10	190	2.28	N2 E1 S1 W1 FSB	4 4 4 4	YM	20-40	C	Ivy. Reasonable. Visible from adjacent properties.
65	<i>Quercus robur</i> Oak	12	750	9.00	N8 E9 S9 W2 FSB W4	3 3 3 3	FM	40+	B	Edge of group. Dominant.
66	<i>Quercus robur</i> Oak	16	1150	13.80	N8 E7 S10 W7 FSB W4	3 3 3 3	FM	40+	B	Large. Dominant. Cavities from lost limbs. Dead wood in canopy. Ivy present, could not closely inspect base. Edge of group.
67	<i>Aesculus hippocastanum</i> Horse chestnut	8	420	5.00	N3 E5 S5 W4 FSB E2	3 3 3 3	SM	40+	C	Young. Woodland edge. Poor limb structure – crossing, rubbing limbs. Root girdling.
68	<i>Quercus robur</i> Oak	20	1200	14.40	N6 E7 S5 W7 FSB E4	9 9 7 7	FM	40+	B	Roadside. Significant dead wood in canopy. Needs to have dead wood removed. In decline.
69	<i>Quercus robur</i> Oak	17	750	9.00	N7 E3 S4 W3 FSB	4 3 4 4	M	40+	U	Fell. Standing dead.

T69 Standing dead Oak

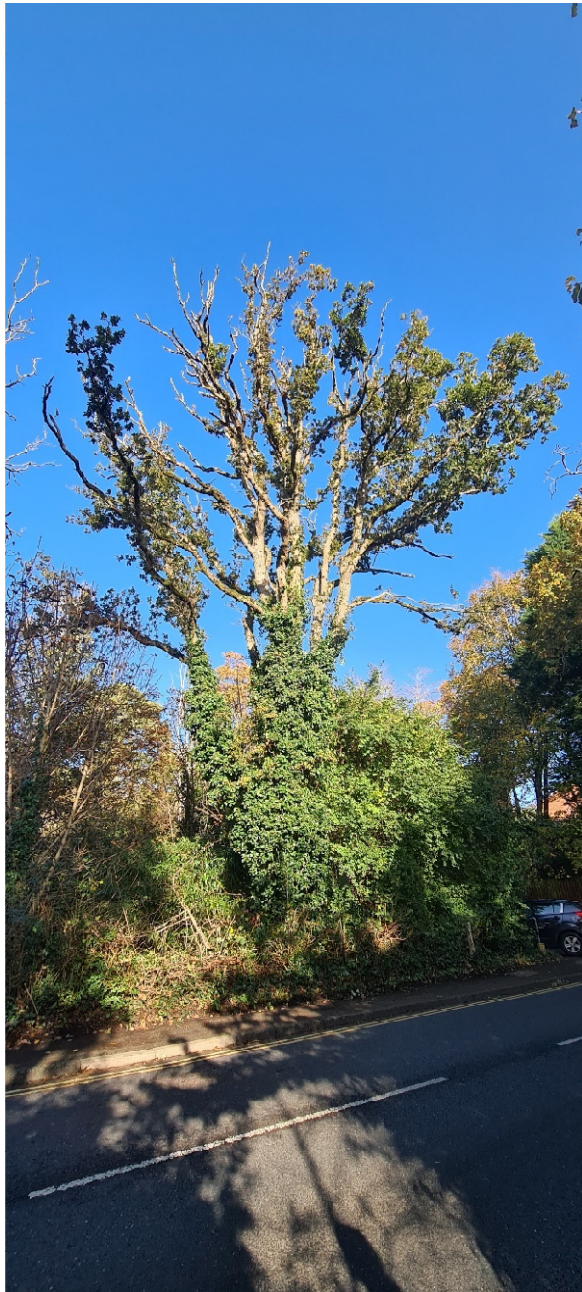
T68 Oak in decline. This tree should be monitored for further decline in condition.
