**Limited Visual Structural Condition and
Conversion Report**

Job No.	W20976
Client	Tim Davison
Project	Cow Barn, Tess View, Yarm
Reference	W20976-WBE-XX-XX-RP-S-1000
Date	April 2022

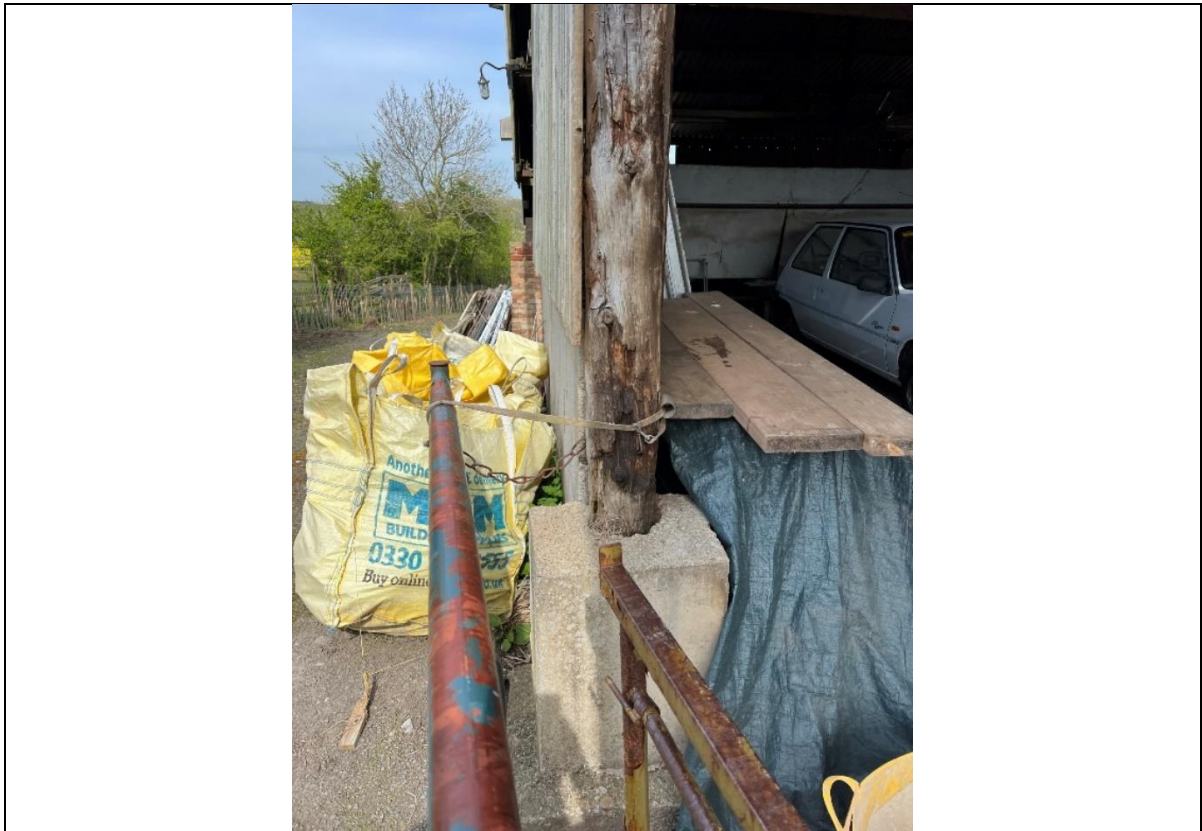
Photograph 1

- 2.2.1. Timber deterioration was noted at both ends of a car canopy post on the west elevation. (Photograph 1 and 2).
- 2.2.2. Signs of woodworm were present on cladding panels in multiple locations (photograph 3).

- 3.1.1. Generally, the cow barn was found to be in fair condition.
- 3.1.2. Timber deterioration and loss of section to the timber posts is associated with timber rot and a lack of maintenance. Surface water is considered to collect on the concrete encasement and locally increase the moisture content of the timbers. It is likely the timber has not been suitably protected and therefore the wet timber has decayed over a prolonged period. Without remedial works, further loss of section and eventual failure of the posts will occur.

- 4.2.1. Compromised timber post sections to be removed locally and new sections installed. New timber post to be suitably encased to existing concrete.
- 4.2.2. Barn timber door post to be replaced.
- 4.2.3. Failed or compromised timber rafters to be locally repaired or replaced.
- 4.2.4. Timber base connection of canopy post to be inspected following the removal of vegetation.
- 4.2.5. Canopy roof timber splice connections to be inspected and integrity confirmed as part of roof repairs/replacement.
- 4.2.6. Timber-to-timber steel connections to be inspected on a regular basis as part of the barn's future maintenance plan if to remain exposed.
- 4.2.7. As part of the timber repair works, additional timbers will be required to suit the desired roof fall to omit the internal drainage gutter between the original double roof ridge.

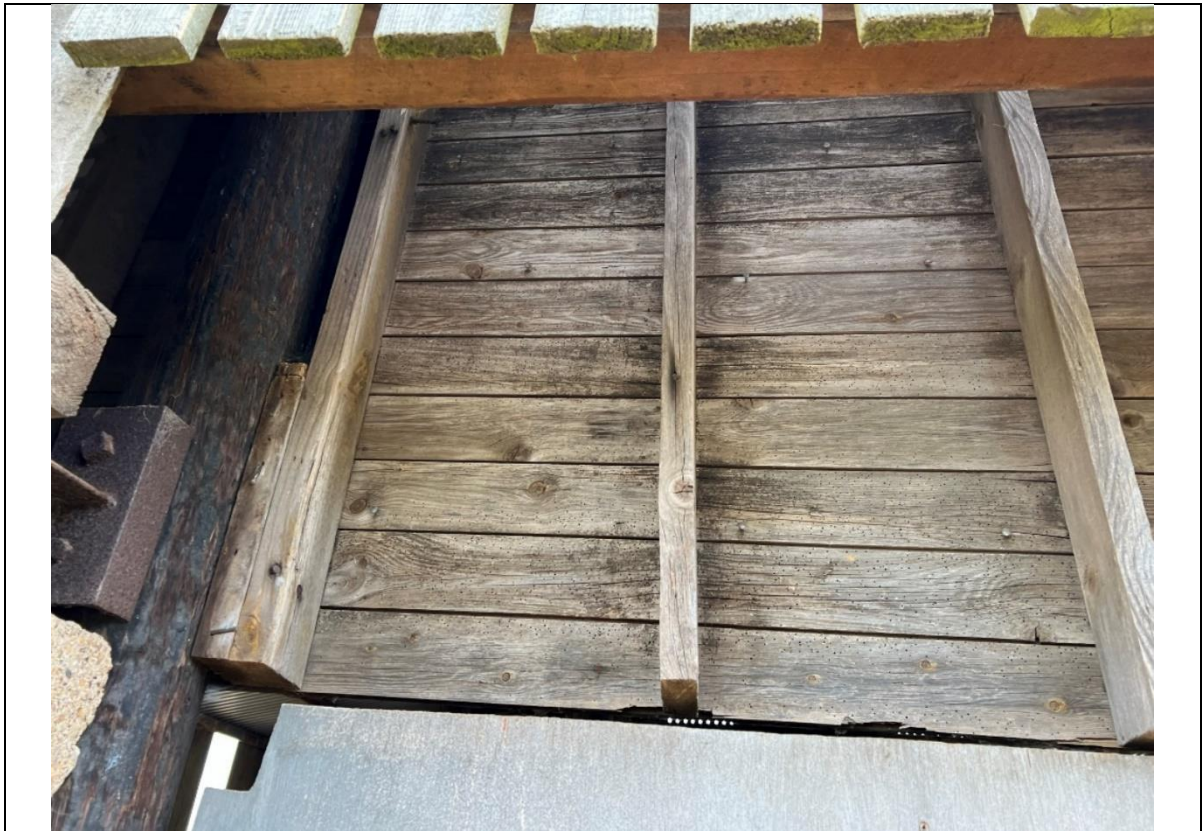
Photograph 3

- 3.1.3. Woodworm is associated with exposed timber and a lack of maintenance. Exposed timbers typically have higher moisture levels, this provides a fertile environment for woodworm infestations. Without protective treatment, further infestations may occur and result in the loss of section of timber cladding. It is considered that issues with the cladding system will be addressed as part of the proposed refurbishment cladding system.

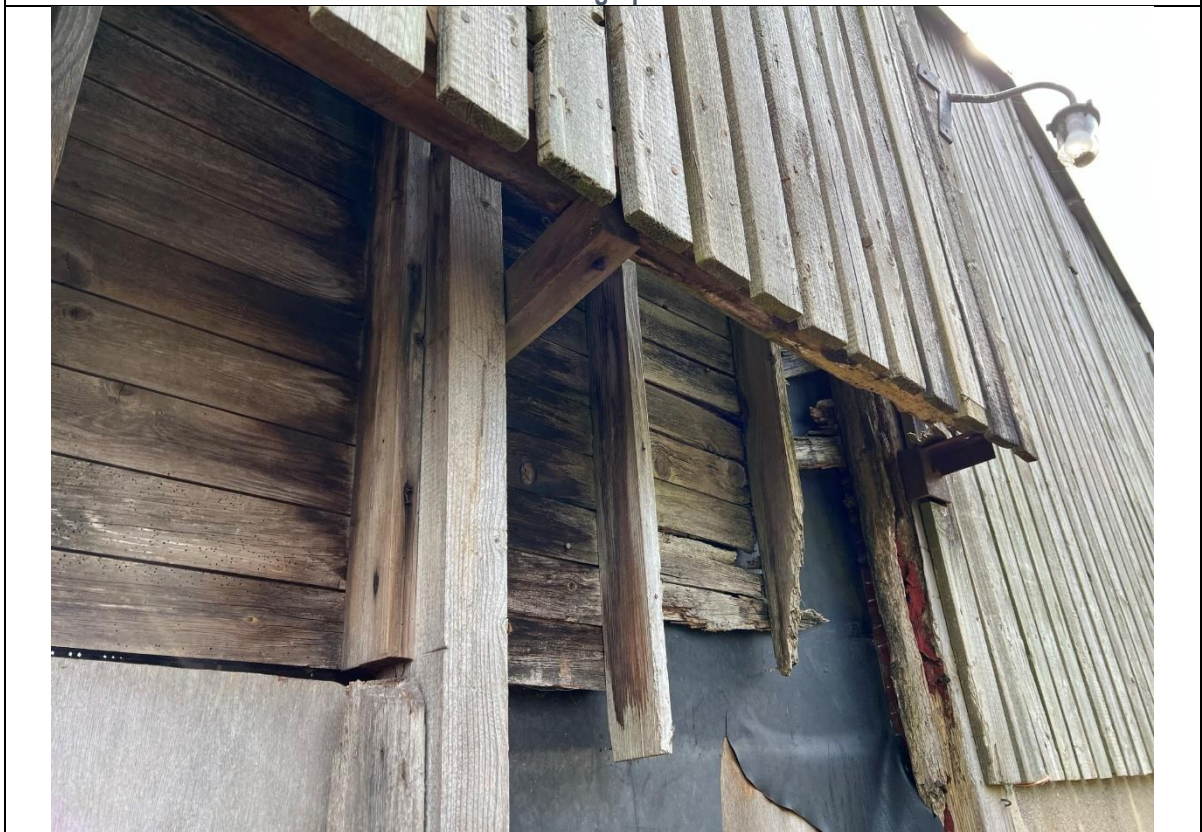
Photograph 4

- 2.2.3. A broken cladding panel was recorded on the west elevation towards the northwest corner of the barn (photograph 4).
- 2.2.4. Several missing fibre cement cladding panels were noted on the north elevation (Photograph 5).

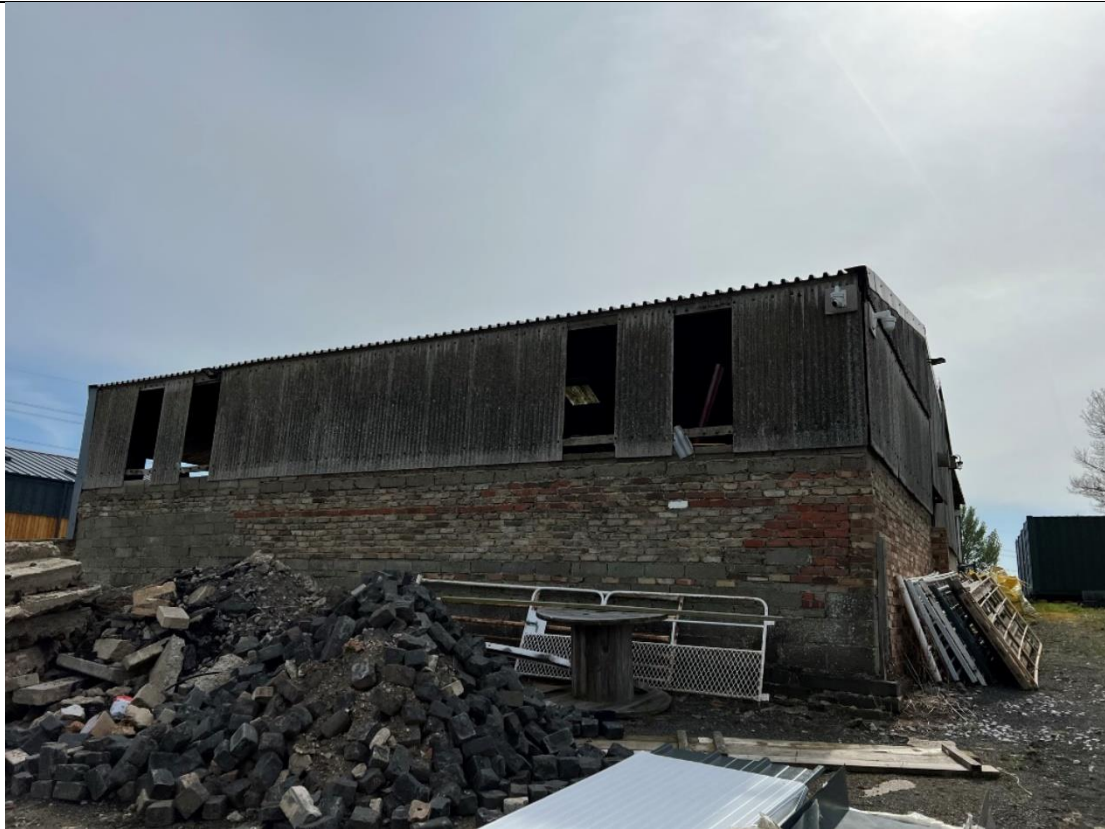
Photograph 5

- 3.1.4. Missing cladding panels are associated with the failure of panel fixings. The missing cladding panels reduce the weather-tightness of the barn and increase the risk of timber deterioration to structural elements from weathering or water ingress. It is considered that issues with the cladding system will be addressed as part of the proposed refurbishment cladding system.

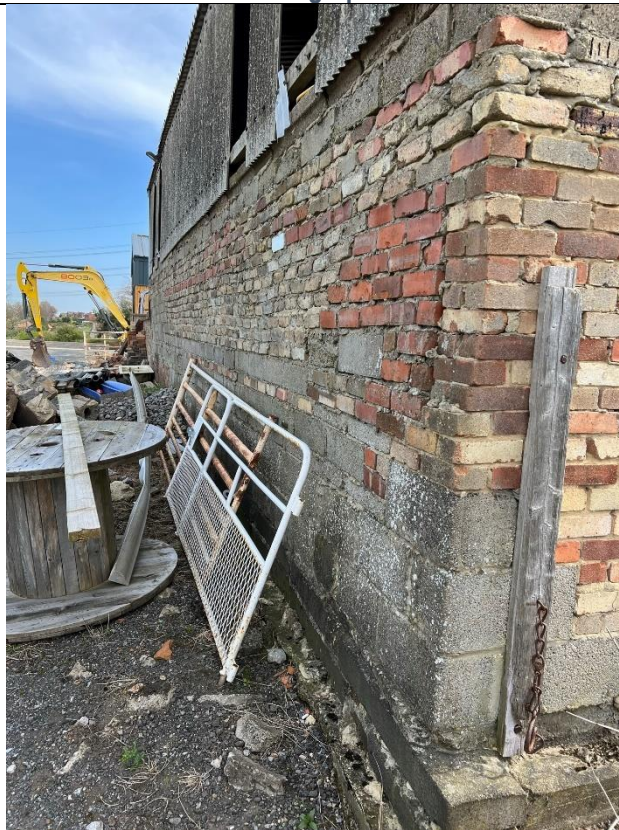
Photograph 6

- 2.2.5. Sections of the north elevation masonry wall appeared to lean at the top of wall (photograph 6).
- 2.2.6. Loss of timber section was recorded on several timber post above the concrete encasement in the car port (Photograph 7, 8 and 9).

- 3.1.5. The lean on the north elevation masonry wall is associated with age and movement over time. The lean is not considered a structural issue at present and risk of instability is low.

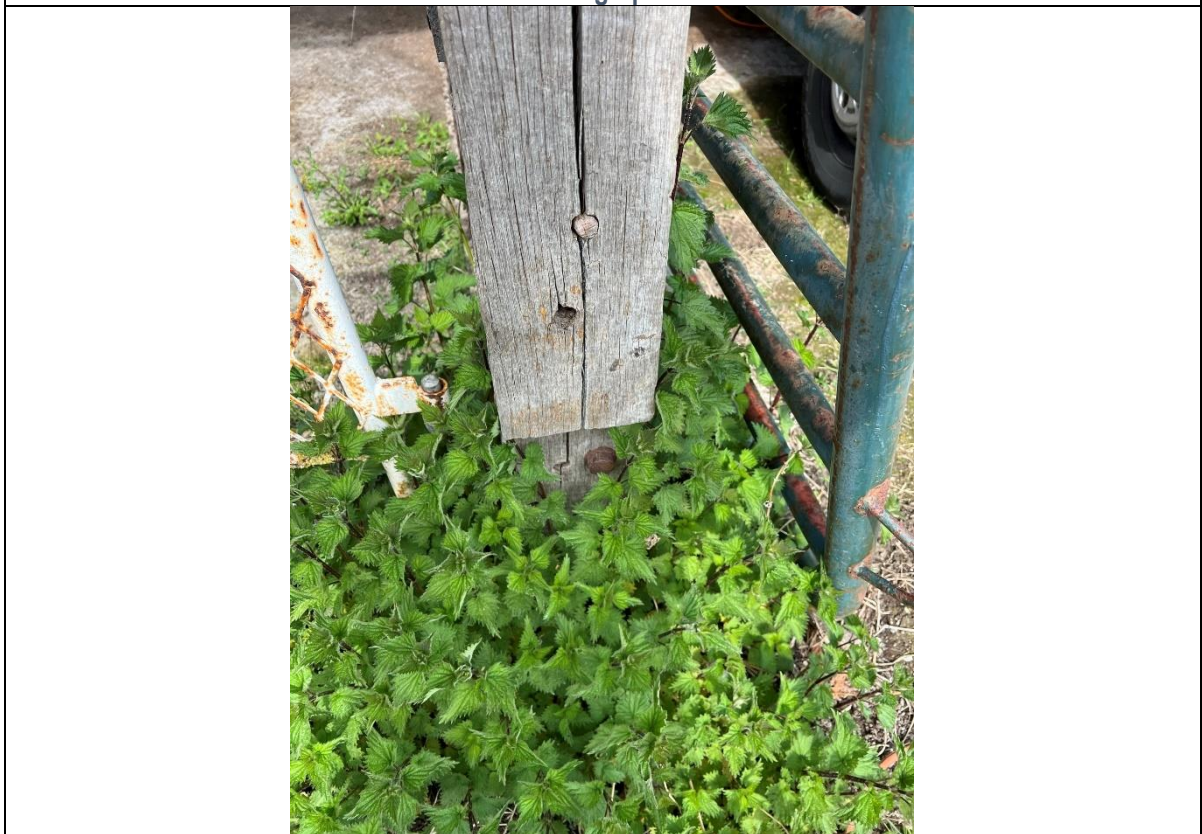
Photograph 10

- 2.2.7. A car port canopy post base connection could not be inspected due to vegetation growth on the south elevation (photograph 10).
- 2.2.8. Signs of timber deterioration at a rafter bearing were noted below the valley gutter in the barn (photograph 11).

- 3.1.6. The timber base connection is hidden by vegetation and requires inspecting onsite following the removal of vegetation.
- 3.1.7. Timber deterioration at the rafter bearing is associated with water damage as a result of the failure of the valley gutter. Without repair, further deterioration will result in the failure of the rafter. The failing rafter element requires repair/local replacement.

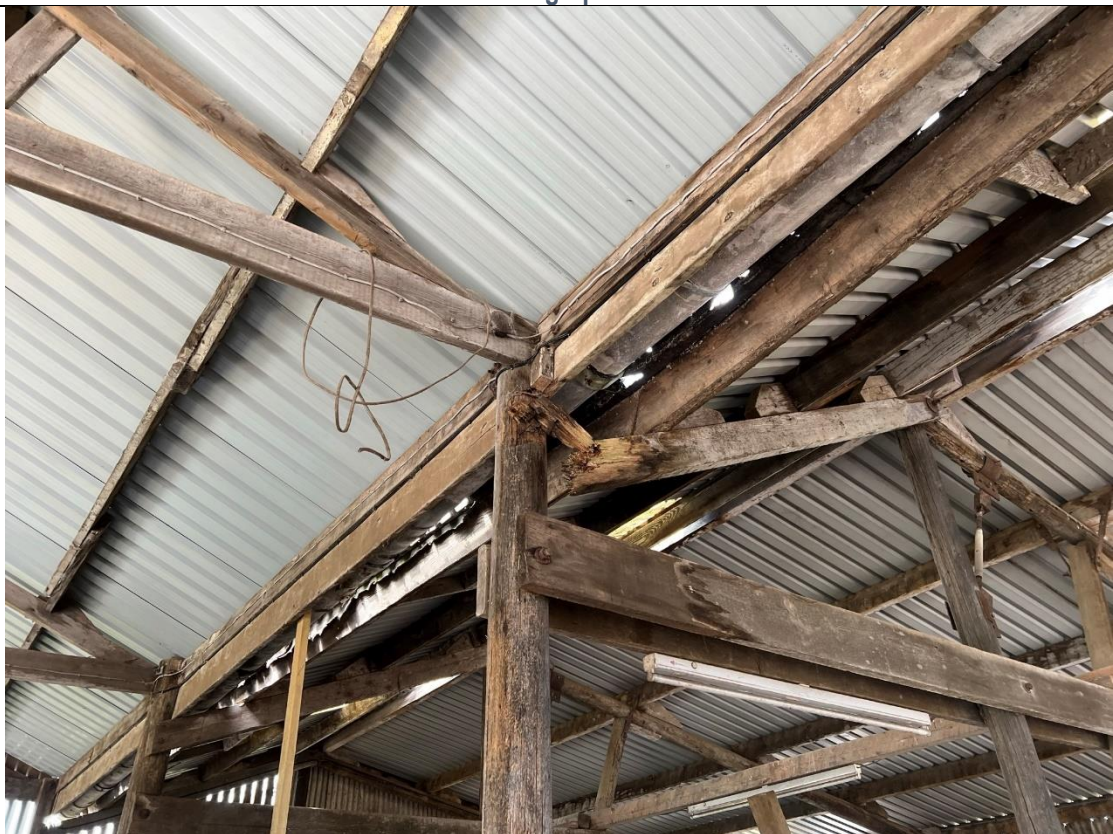
Photograph 12

- 2.2.9. Timber rafter failure was noted at the bearing below the valley gutter in the barn (photograph 12).
- 2.2.10. Timber deterioration and loss of timber section were recorded to the barn door post (photograph 13).

- 3.1.8. Similar to 3.1.7, failure of the timber rafter is associated with water damage due to the failure of the valley gutter. It is considered that as result of the failure of the rafter that other structural elements will be taking additional loads greater than the designed loads. The failing rafter element requires repair/local replacement.

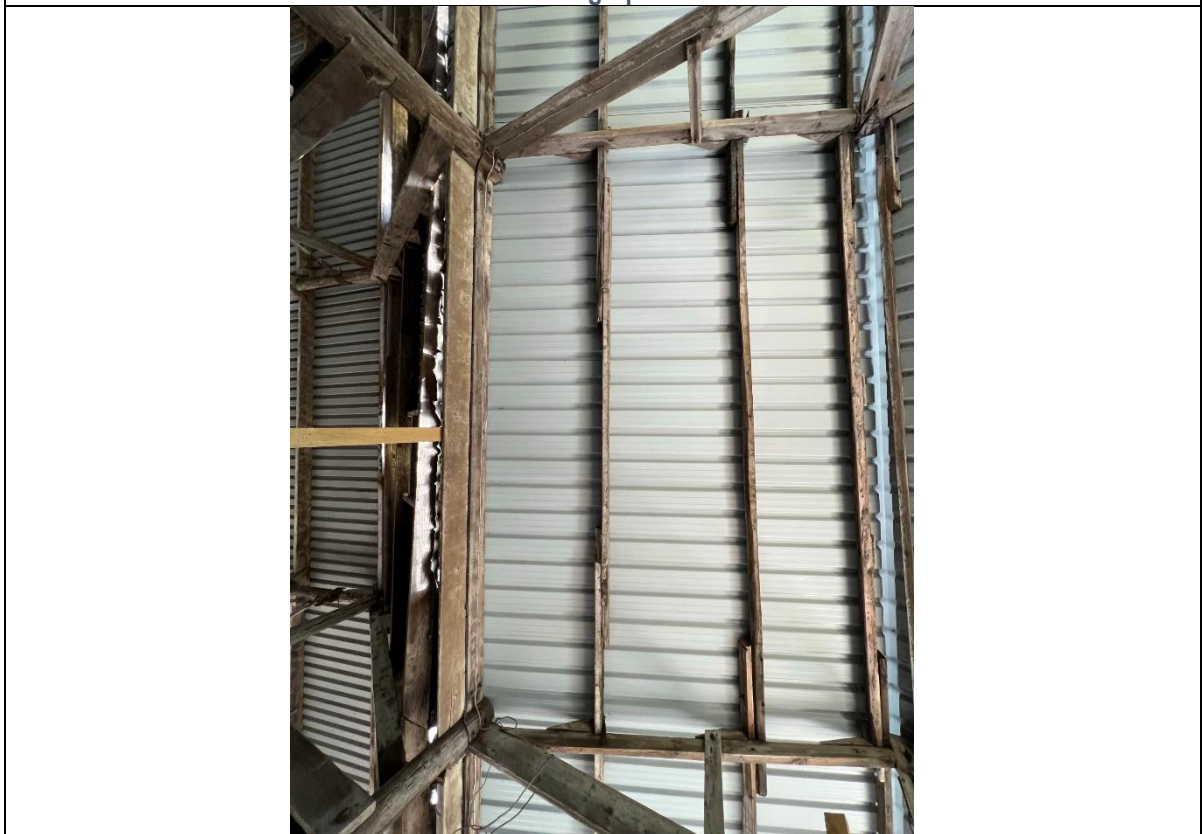
Photograph 14

- 2.2.11. Several timber canopy roof purlins were noted as splice construction (photograph 14).
- 2.2.12. Signs of rust and surface corrosion were present on bolts in timber-to-timber connections in multiple locations of the barn (photograph 15 and 16).

- 3.1.9. The timber roof purlins splice connections are associated with ease of construction and material availability. No defects were identified from ground level inspection, but the splice connections require further inspection at a closer distance as part of any roof cladding replacement to confirm suitability.

- 4.1.8. The car port purlin splice connections appeared suitable. However, a visual inspection of the connections is required to confirm connection integrity as part of any roof cladding replacement or repairs.

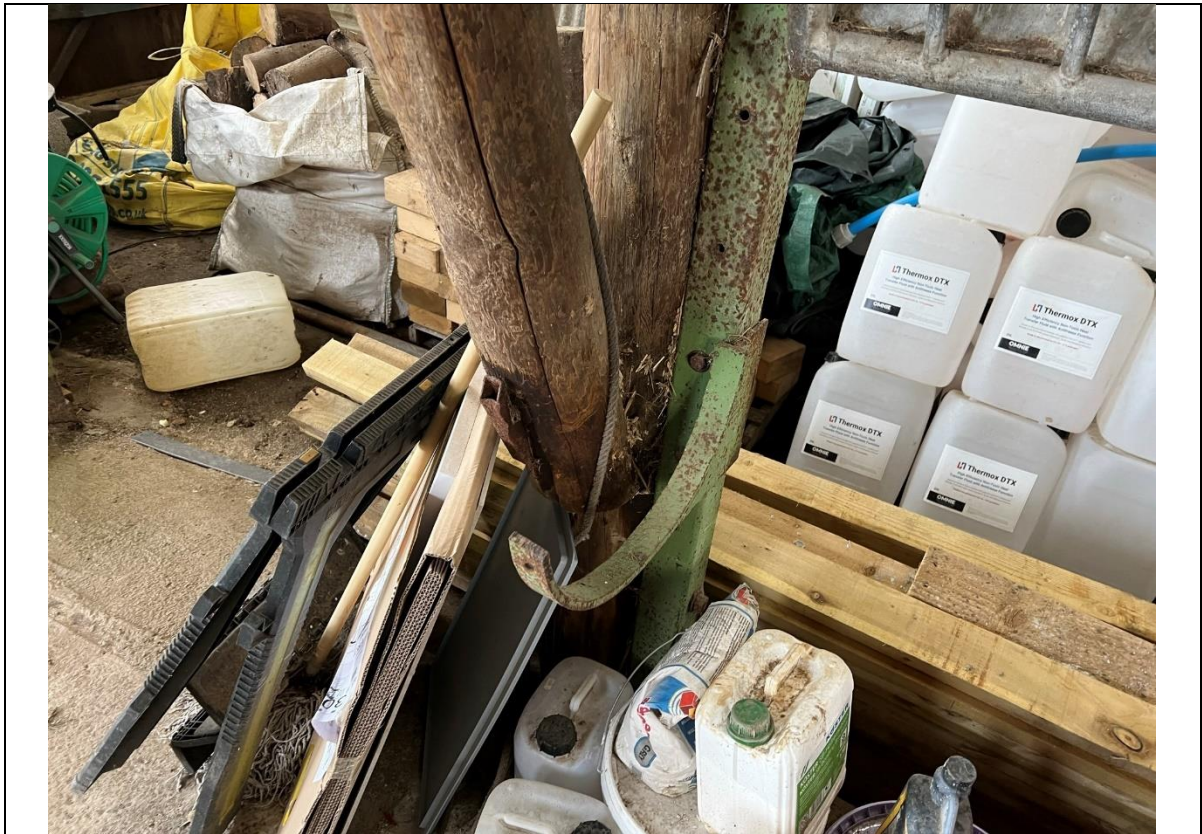
Photograph 15

- 3.1.10. Surface corrosion of the timber-to-timber steel connections is due to exposure. Connections appear to be functioning as designed with no signs

of failure. Connections should be inspected as part of the future maintenance plan and/or major refurbishment works.

- 4.1.9. Surface corrosion of the timber-to-timber steel connection is a not a current structural issue. Connections should be inspected and monitored as part of the proposed buildings future maintenance plan if to remain exposed.
