Notification of Proposed Tree Works in a conservation area.

Site: 44 Dyke Road Avenue, Brighton BN1 5LE

Description of Proposed Tree Works:

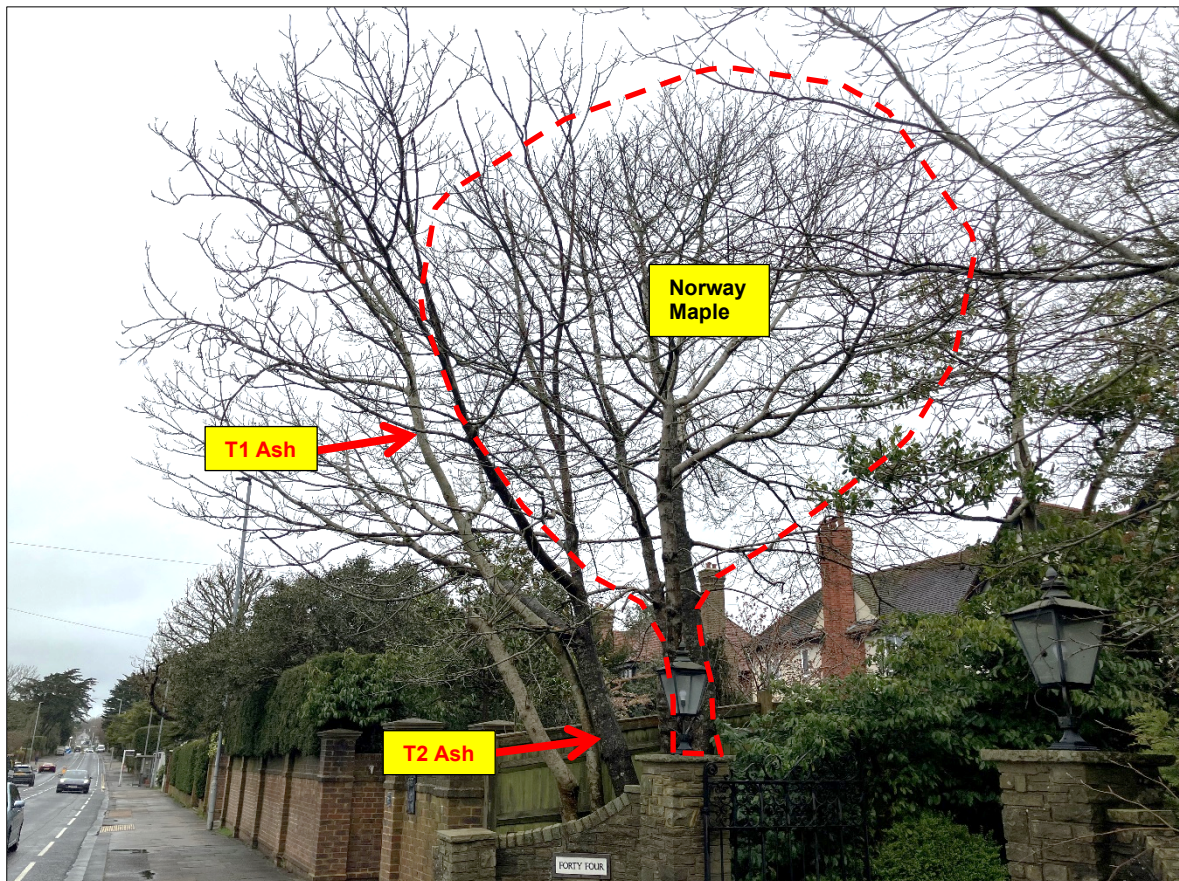
Fig. 1. Arrows indicate small self-sown Ash trees T1 and T2, to be removed with the larger Norway Maple directly behind, outlined, which is to be retained.

Sp6. Felling involves the careful removal of a tree to ground level (or other specified height), either in sections or in one unit (straight felling). The method of felling will be suited to the constraints of the site and judged by the competent operator undertaking the task. Removing the stump may be part of the requirements and this will be carried out using a mechanical stump grinder where accessible.

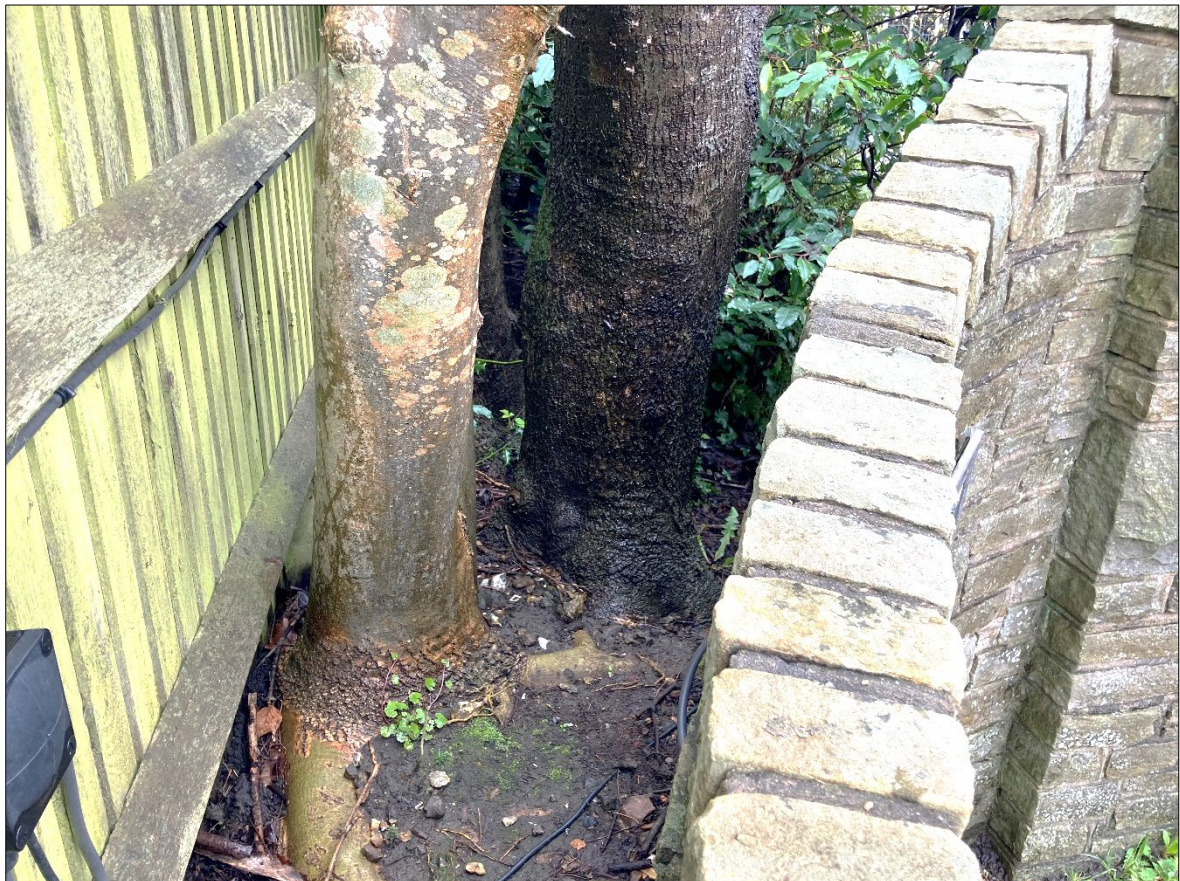
- 1) The Ash trees T1 and T2 are low-quality self-seeded trees (not planted) growing within 500mm of the boundary wall. The trees have been permitted to grow in their position unchecked. As a consequence of their annual incremental growth and expansion, direct mechanical forces have been exerted upon the adjacent wall, which has cracked.
- 2) Both trees are suppressed and dominated by a more vigorous and adjacent Norway Maple tree, which if the Ash trees were to be removed, would enjoy more space and light to enable it to improve in form and quality.
- 3) Should the Ash trees be retained, more damage is inevitable with increasing size and mechanical pressure.
- 4) Removing both trees will have no material adverse impact upon visual amenity.

Fig.2 Bases of Ash trees T1 and T2 adjacent to the brick boundary wall, which is cracked.

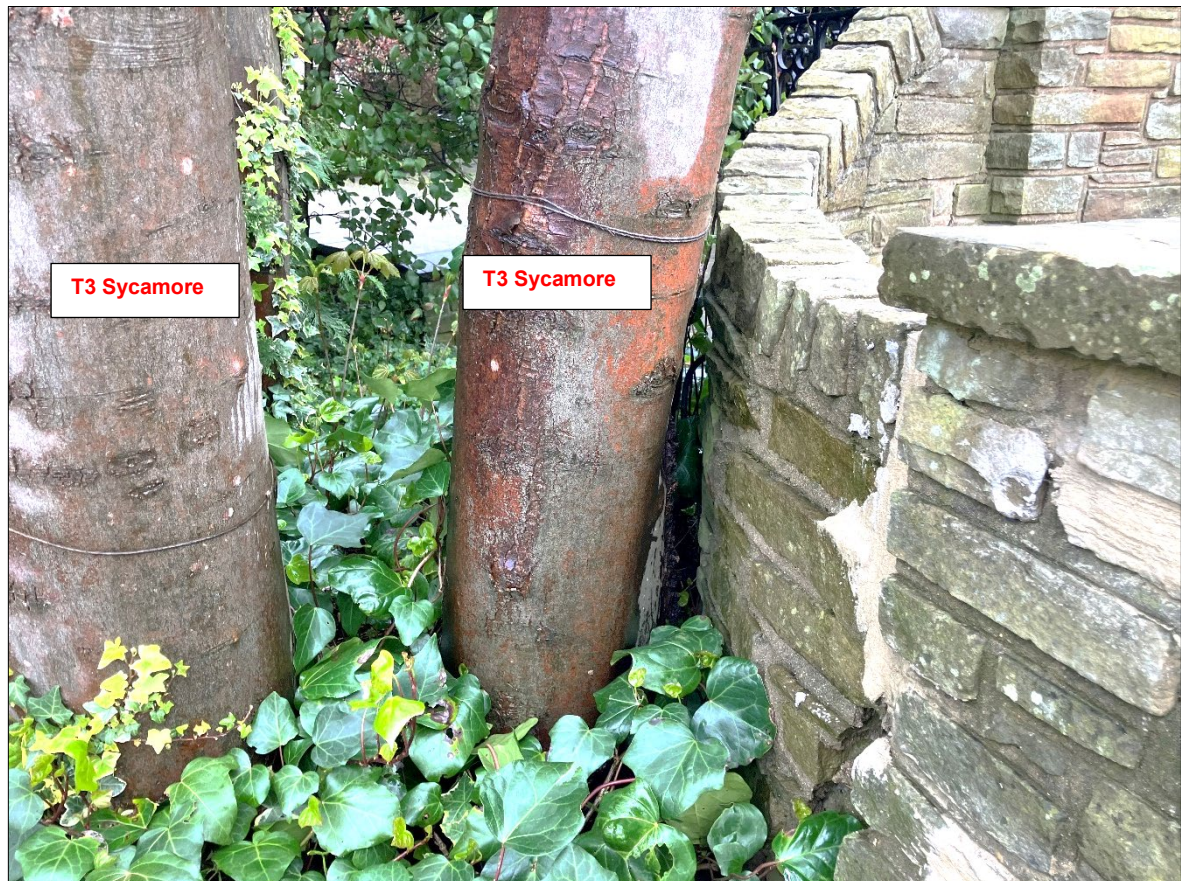
7) The Sycamore has been omitted from the current TPO, doubtless because the tree is of low quality and that it is evidently causing quite significant damage to the boundary wall and gate piers. The wall has been misaligned by mechanical root pressure and now extends over the public pavement. The adjacent wall has been cracked not only by root pressure but also direct impacts from the nearest stems.

Fig. 3 T3 Sycamore stems adjacent to boundary wall and gate piers, which have been damaged.

8) Leaving the tree in position, will result in further damage to the walls and structures and will prevent a realistic and lasting repair, because severing roots to enable the repair would render the tree unsafe and liable to die off. Removal of the tree will enable the wall to be realigned because the inevitable removal of significant roots will have no detrimental impact, where the Sycamore has already been removed.

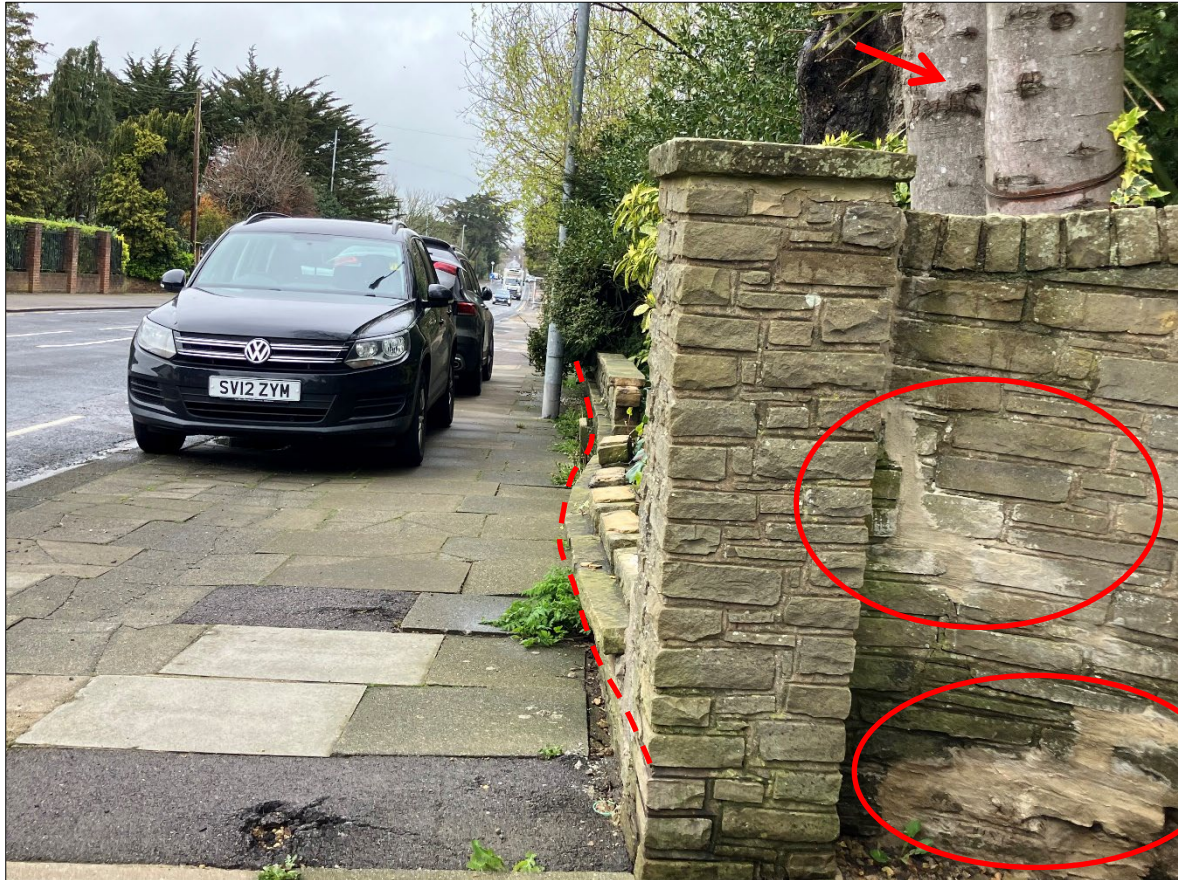
Fig. 4 - Sycamore T3 trunks arrowed and temporary damage repairs in cracked wall. The front boundary wall has now been forced over the public highway, which cannot be resolved where the Sycamore tree is retained.
