Mulberry Close, NW4 1QN

Prepared for
Arrow Leasehold
Management

14th August 2023

Preliminary Tree Condition Report PTCS-28606-T48

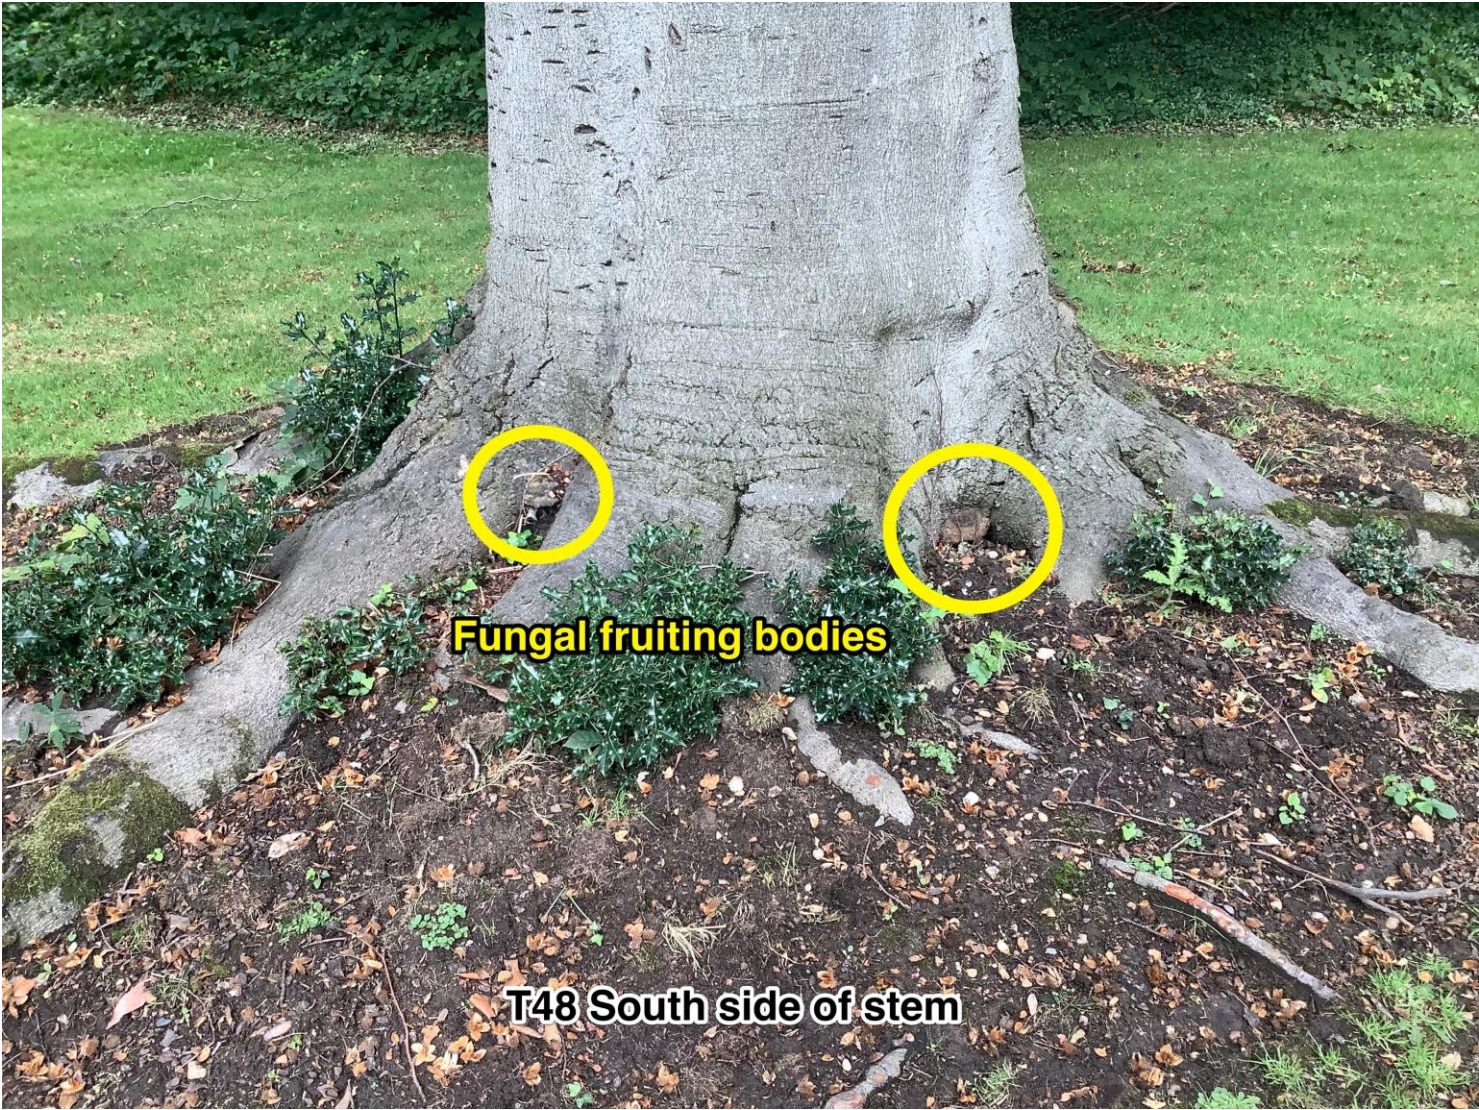
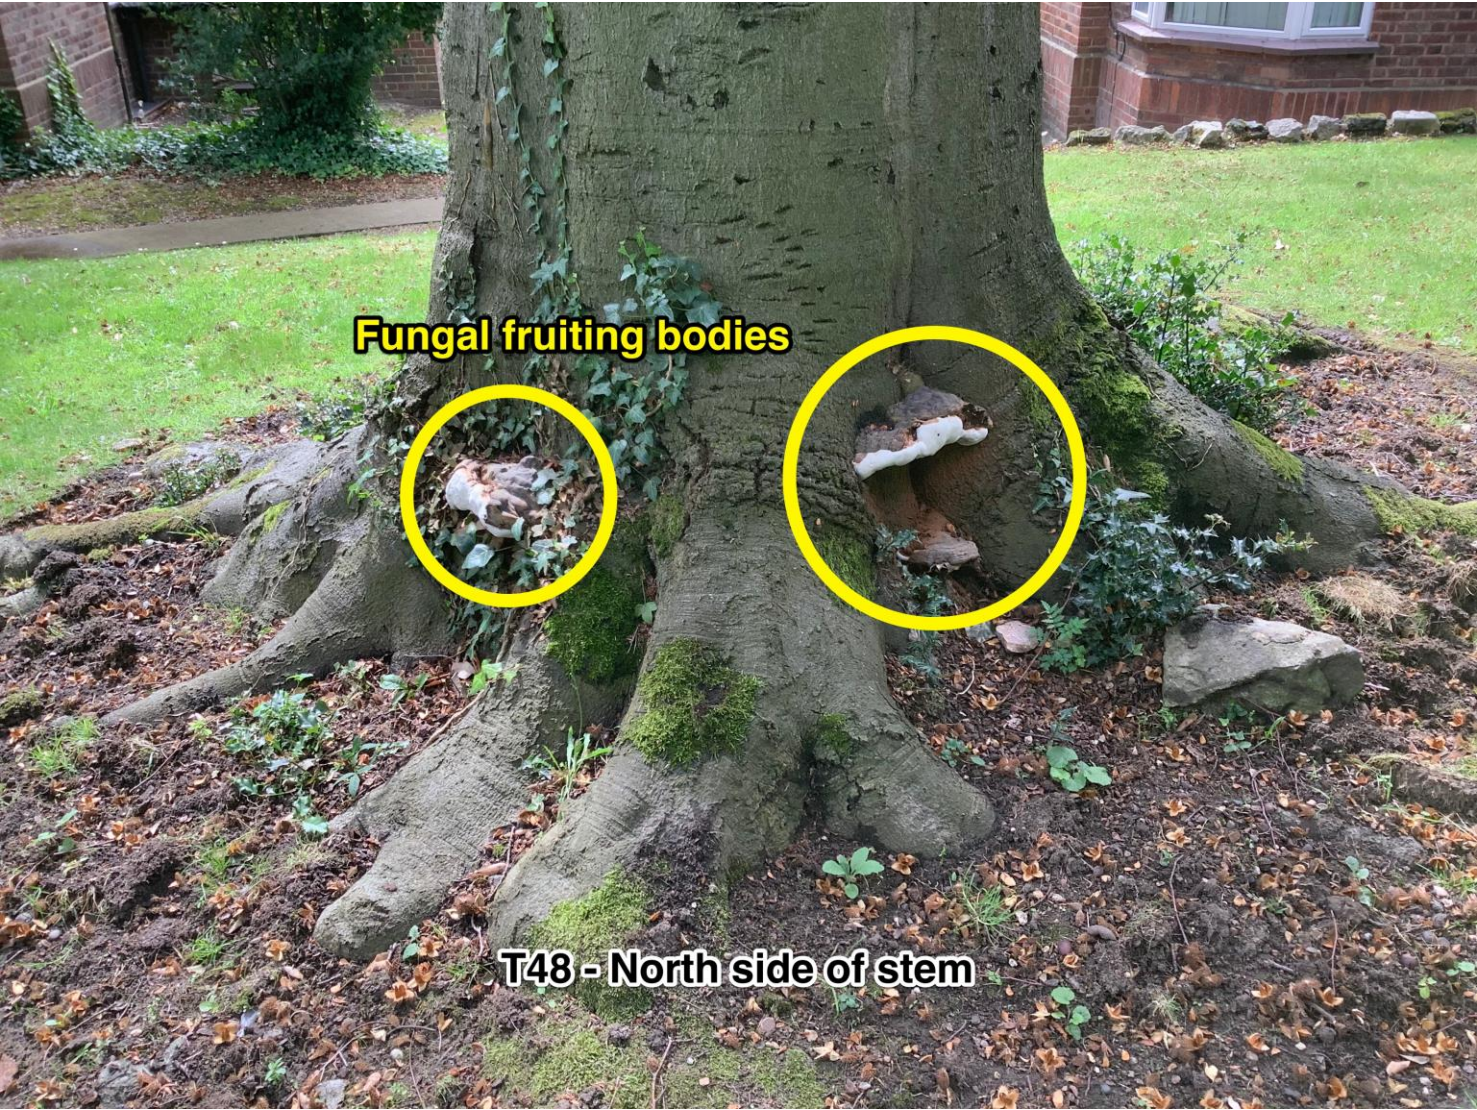
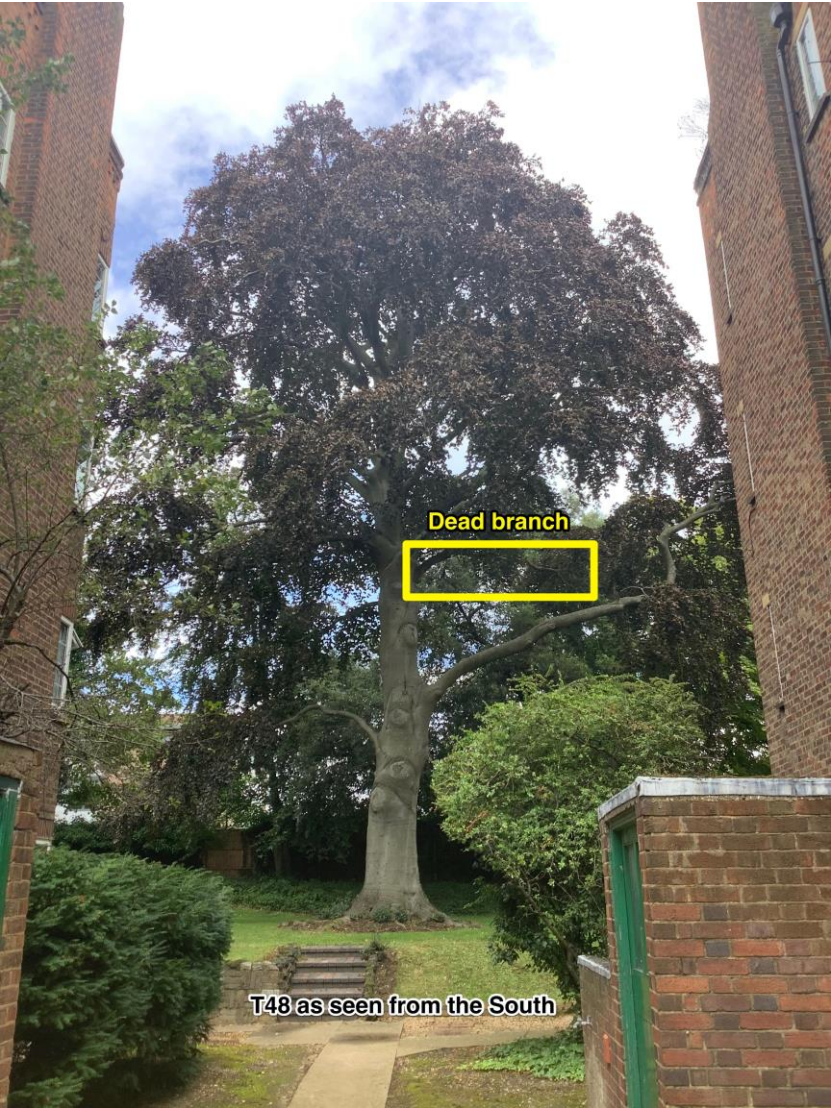
| Tree no. (Tag no.) | Species | Height (m) | Stem diameter (cm) | Crown Spread (m) | Age class | Physiological condition | Structural condition | Observations | Recommended management actions | Priority | Re-inspect (months) |
|---|---|---|---|---|---|---|---|--|--|---|---|
| T48 | Copper Beech (<i>Fagus sylvatica</i> var 'purpurea') | 18 | 106 | 14 | M | G | F | <p>Fungal fruiting bodies at base to SW, SE, NE and N (<i>Ganoderma applanatum</i>). Some possible decay audible when stem is tapped with mallet near to fungi.</p> <p>Recent, minor bark damage to surface roots, likely from mowing.</p> <p>Crown has been historically crown lifted and reduced with approx 1-1.5m regrowth and occluded wounds. Some deadwood visible on NE side of crown. Large quantity of Beech nuts/casings on the ground.</p> | <p>Undertake decay detection (Picus – sonic tomography) around the base of the stem to better ascertain quantity of sound wood remaining and provide further management recommendations if required (B).</p> <p>Remove deadwood over 25mm diameter and/or over 1m in length (A).</p> | A | 24 |
