Client/Site address;

Raj Padhiar Mulberry Close Properties Ltd

Undertake decay detection analysis of large Beech tree (T48 on report by Artimis tree services) using a combination of VTA (visual tree assessment), sounding hammer and Picus tomography.

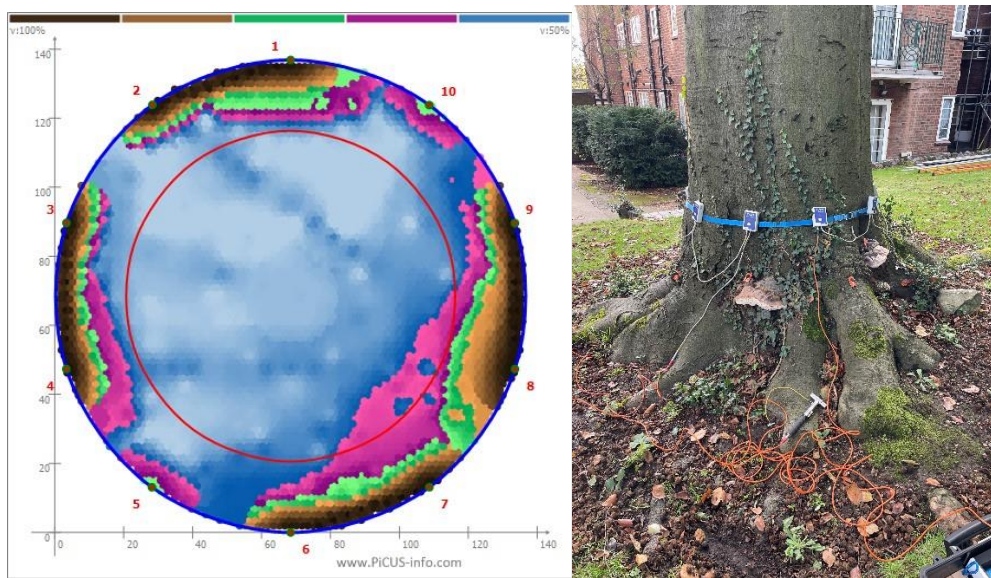
Test

Visual observation of Gannoderma fungal brackets between most of the buttress roots, stem struck with sounding hammer from ground level up to a height of 2m with an obvious drum sound at the lower level. This is where I placed the sensors to give the best indication of the extent of the decay.

The tomograph (image on left above) shows extensive decayed timber (see key above picture) with blue showing wood of 50% or less density.

The red circle overlaid shows the T/R 30% ratio which is recognised as a safe residual wall thickness, less than that showing as brown or black on the test means an intervention is required. In this case the tree has less than 10% in four patches and no unaffected wood in the remainder.

Using all of the above evidence and the species of tree we recommend that this tree is removed at the earliest opportunity, within 3 months.
