Arboricultural Advice Note

Project: No.5 Troutbeck Walk, Camberley

TN01: Actionable Nuisance Claim

January 2023

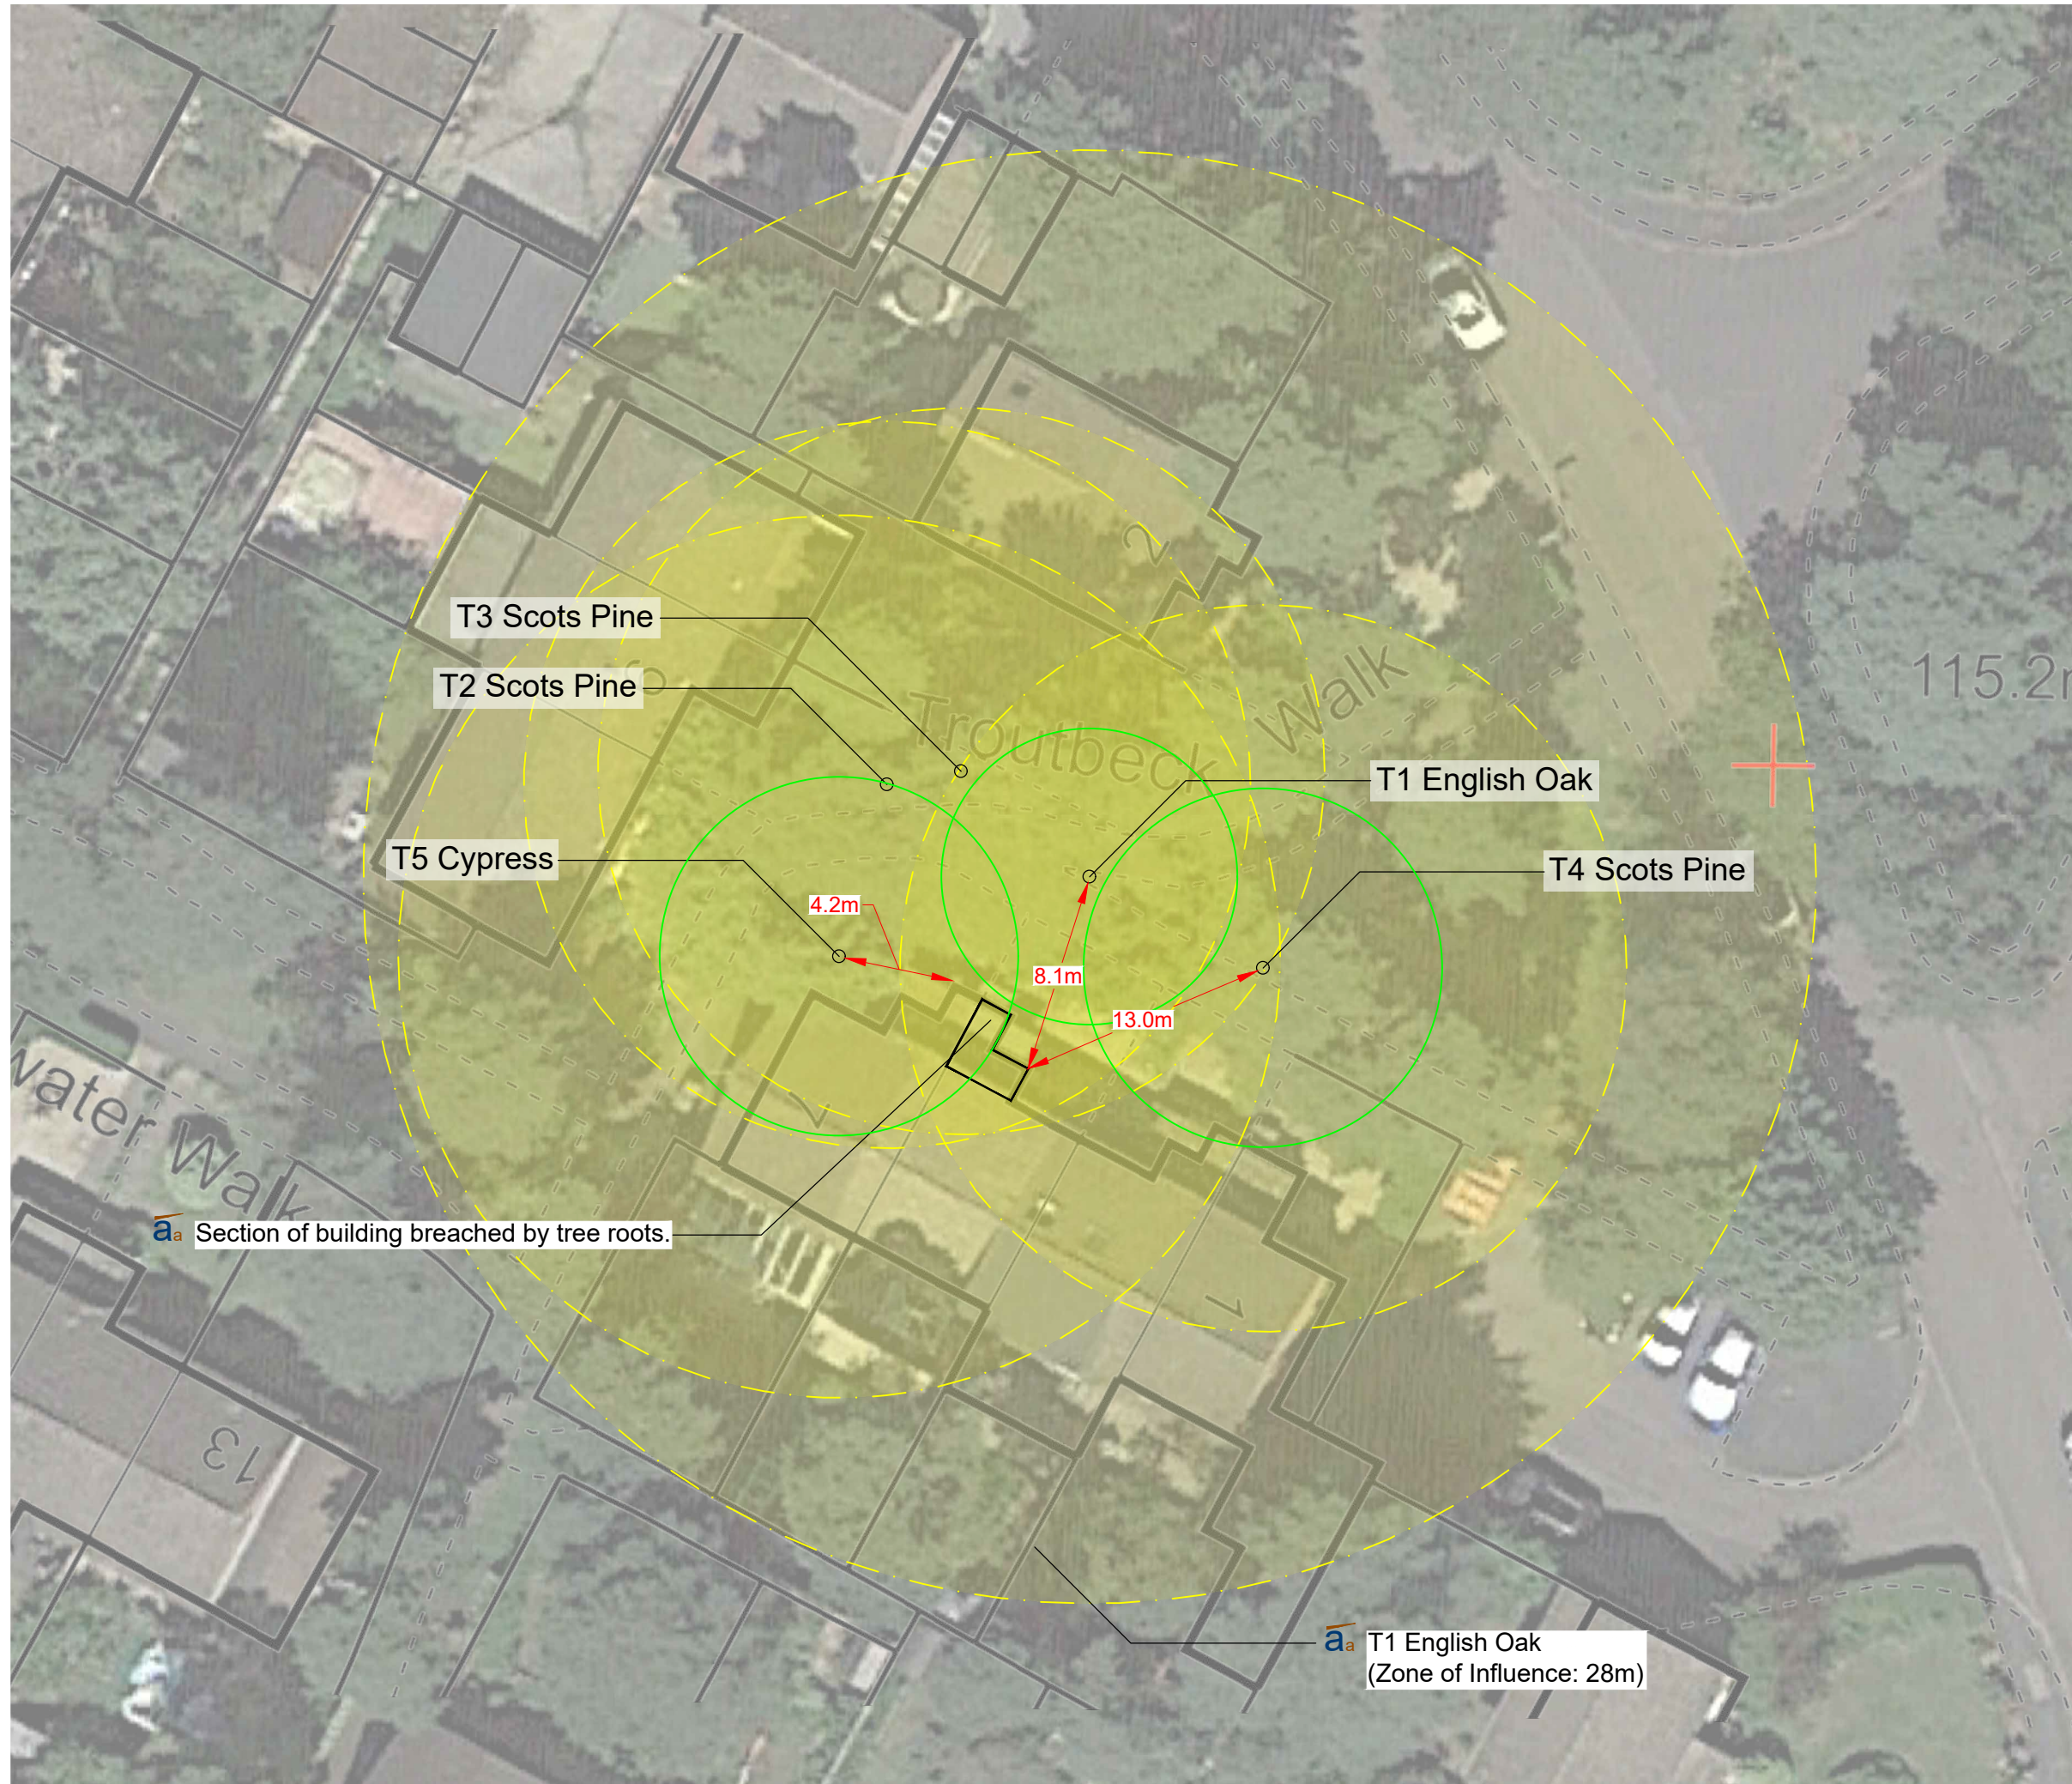
Appendix A: Tree Location Plan 11585 TLP 01

- g. The separation distance between the Oak tree and No.5 is within the conceptual zone of influence linked to Oak trees when considering claims for damage³; this relationship is illustrated at appendix A.

- h. Notwithstanding the bearing of existing built structures on root morphology, it is revealed that the degree of spatial separation between the Oak tree and No.5, is less than the planned distance one would afford the an Oak tree of its current size. i.e. if pursuing a harmonious relationship by contemporary standards⁴. This is demonstrated within Appendix A with a Root Protection Area footprint relative to the dwelling; since the RPA is the minimum area in which roots should be anticipated, there is negligible room for unconflicted, long-term root growth.

- i. Per Appendix A, there are four other trees with the realistic potential to be connected to the case. These were recorded as T2-T4 mature Scots Pine located within the public realm and, T5 a mature Cypress occurring within the front lawn of the adjacent property c.7m to the west of the utility room at No.5.
